NIST NCSTAR 1

Federal Building and Fire Safety Investigation
of the World Trade Center Disaster

Final Report on the **Collapse of** **the World Trade Center Towers**

September 2005

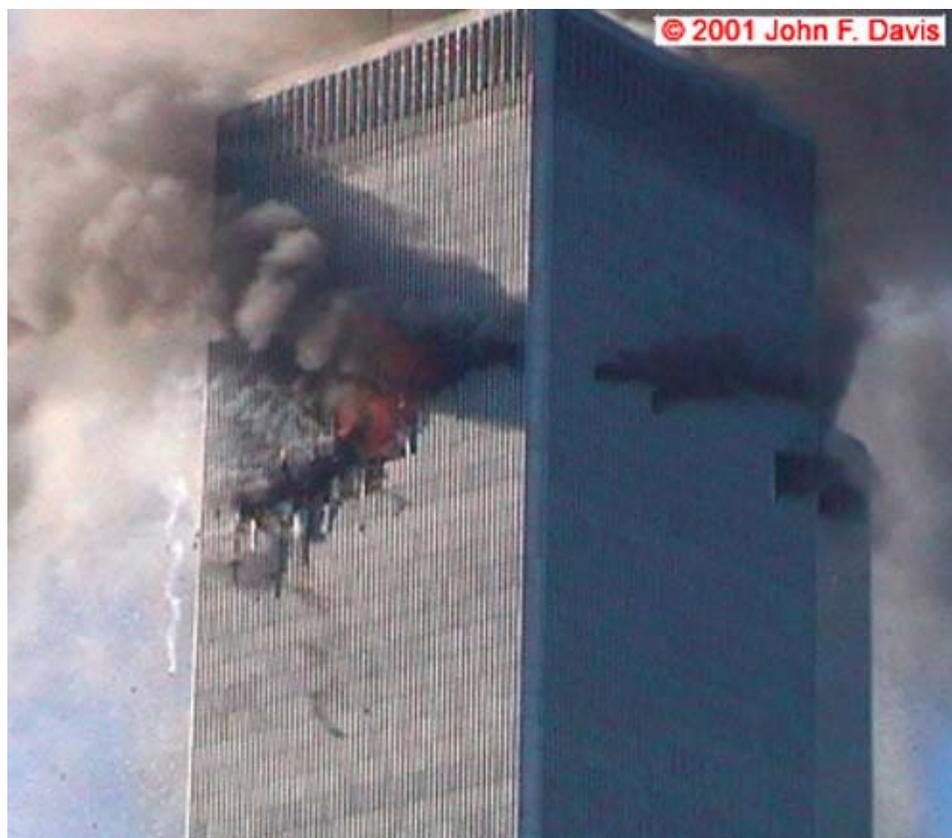
Figure 2–2. Aircraft entry hole on the north side of WTC 1, photographed 30 s after impact.

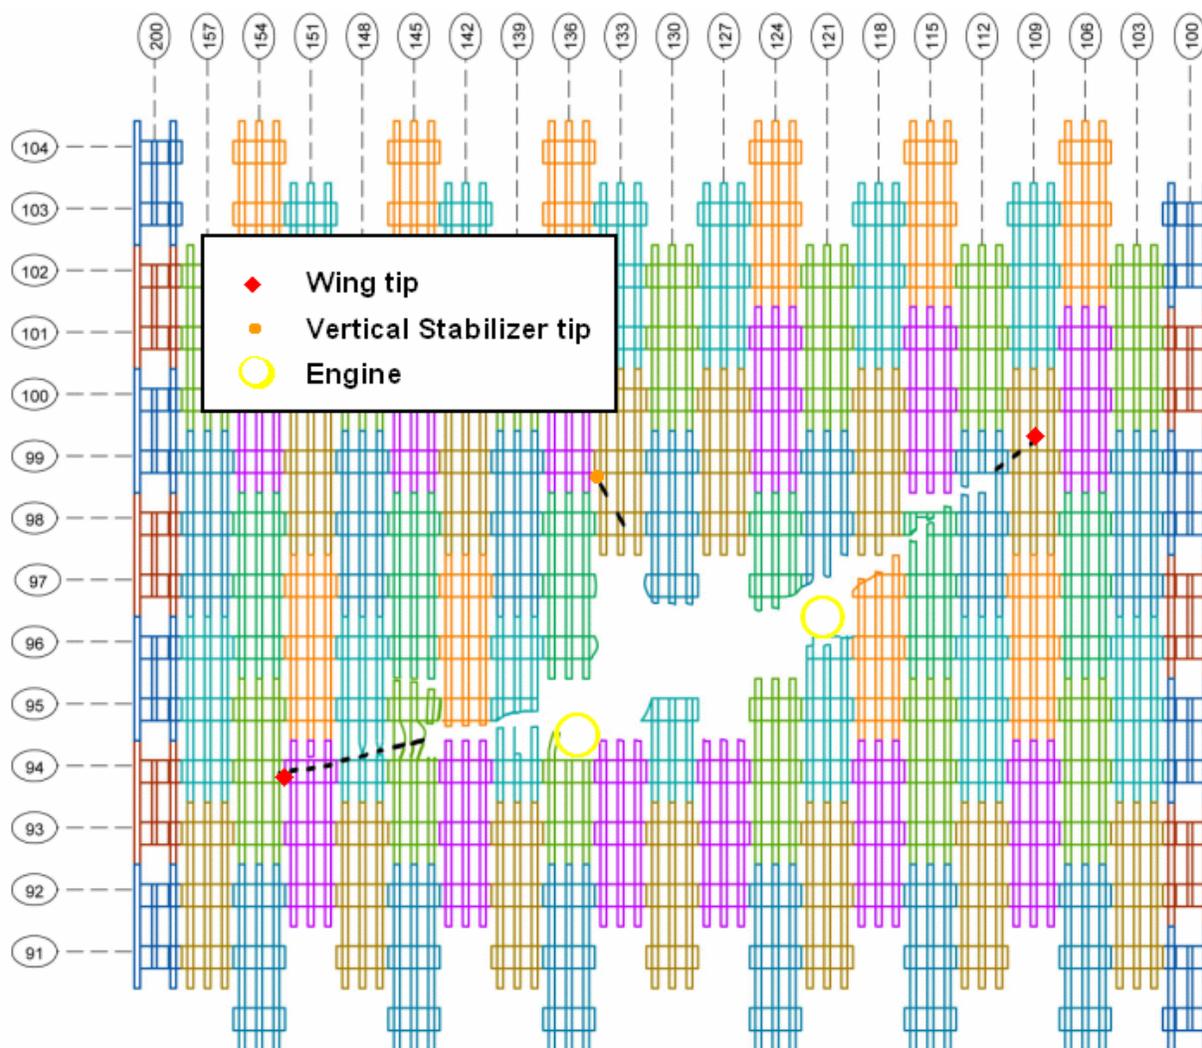
The aircraft did the most damage to the 95th and 96th floors. The fuel-heavy inner left wing hit the 95th floor slab, breaking it over the full 60 ft depth of tenant space and another 20 ft into the building core. The fuselage was centered on the 96th floor slab and filled the 95th and 96th floors top to bottom. The severity of the impact was clear. A wheel from the left wing landing gear flew through multiple partitions, through the core of the building, and became embedded in one of the exterior column panels on the south side of the tower. The impact severed the bolts connecting the panel to its neighbors, and the panel and tire landed on Cedar Street, some 700 ft to the south. A second wheel landed 700 ft further south. Within the two floors, 15 to 18 perimeter columns and five to six core columns were severed, and an additional one to three core columns were heavily damaged. A 40 ft width of the 96th floor slab was broken 80 ft into the building. The insulation was knocked off nearly all the core columns and over a 40 ft width of floor trusses from the south end of the core to the south face of the tower.

Figure 2–3. South face damage of WTC 1 with key aircraft component locations marked.

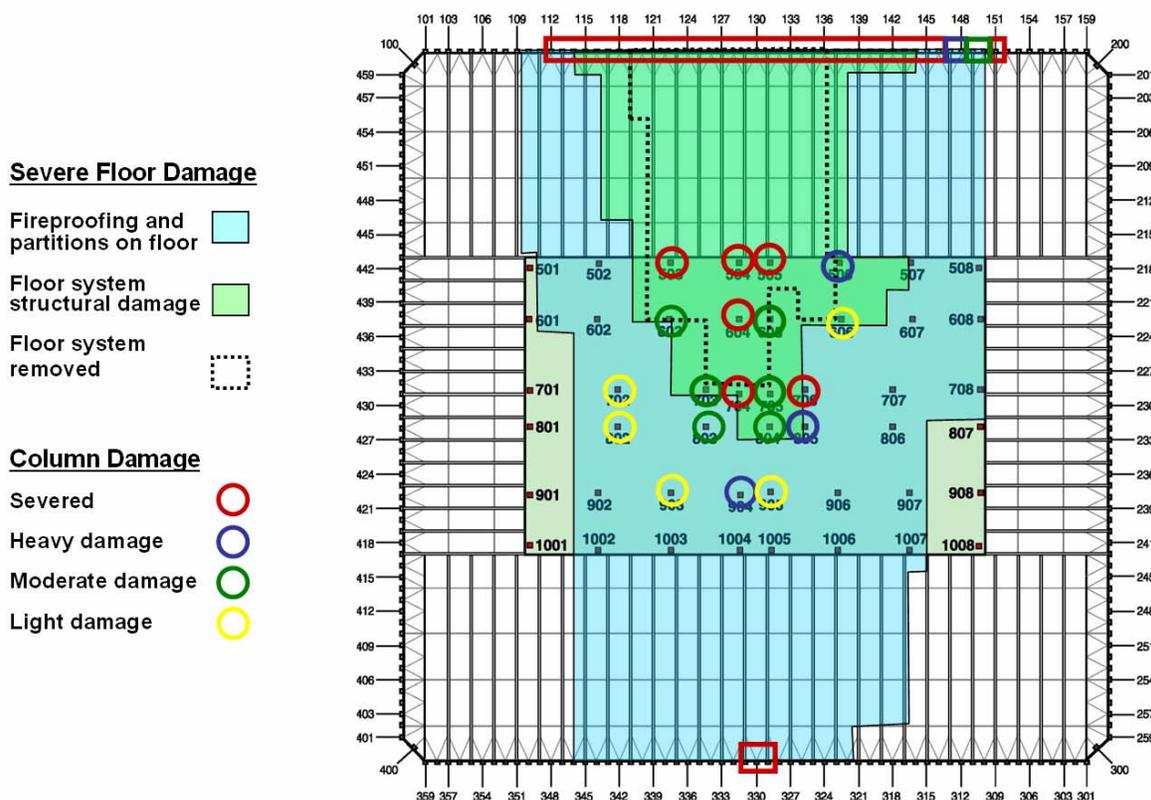
- 43 of 47 core columns stripped of insulation on one or more floors.
- Insulation stripped from trusses covering 60,000 ft² of floor area.

Figure 2–4. Simulation of cumulative aircraft impact damage to floors 93 through 98 in WTC 1.

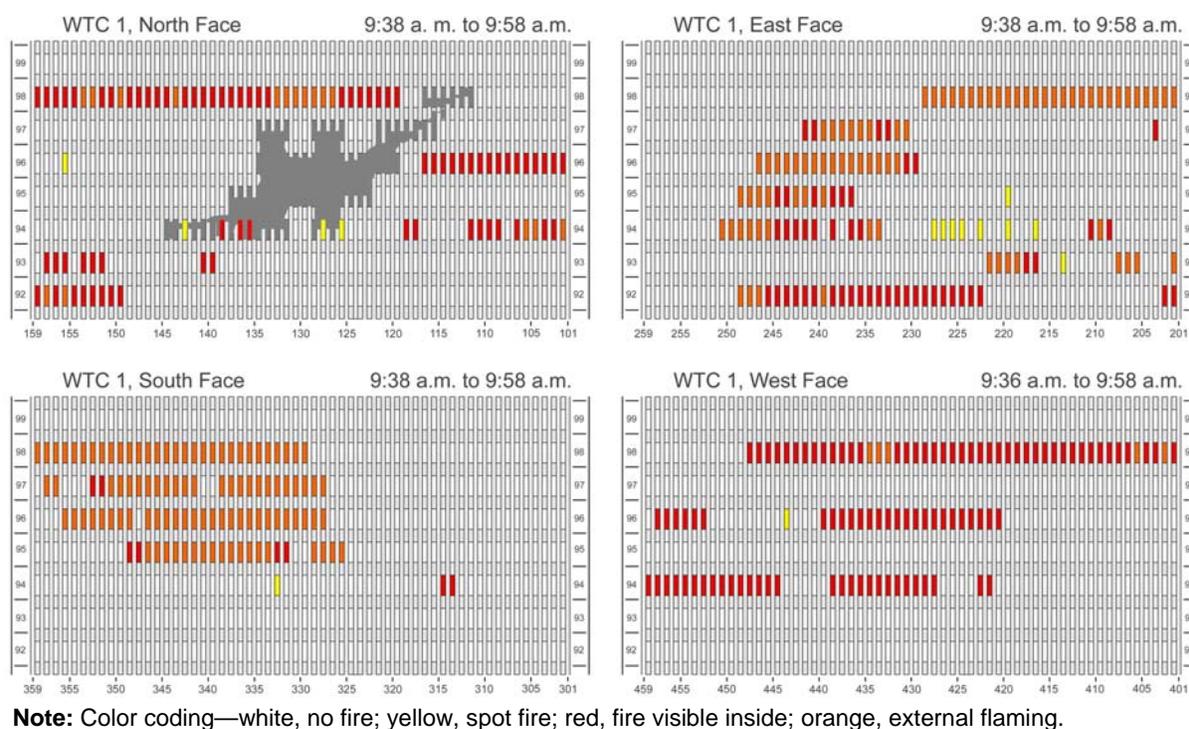
Seventy-five minutes after the impact, approaching 10:00 a.m., the fire on the 97th floor had begun to burn itself out, but the fire on the 94th floor had intensified and filled much of the north half of the floor (Figure 2–7). Starting about 9:30 a.m., there were vigorous fires on nearly the full perimeter of the 98th floor. There was still almost no burning on the 99th floor or above.

Figure 2–7. Representation of exterior views of the fires on the four faces of WTC 1 from about 9:38 a.m. to 9:58 a.m.

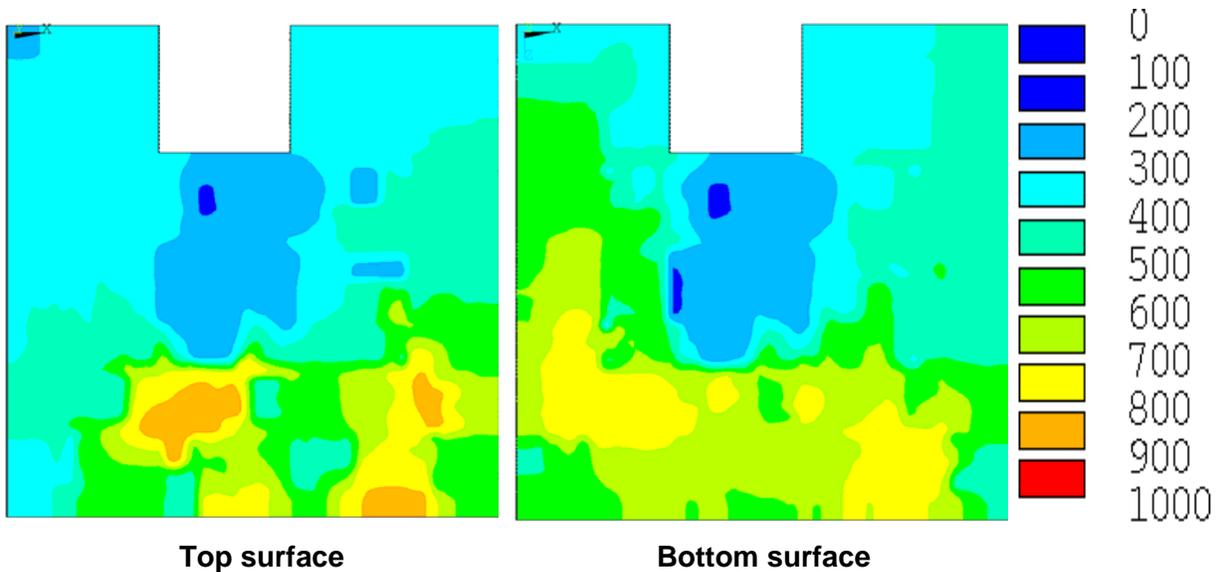
Figure 2–11. Temperature contours (°C) on the top and bottom faces of the concrete slab (96th floor, WTC 1) at 100 min after impact. A portion of the concrete slab on the north face (top) was damaged by the impact of the aircraft.

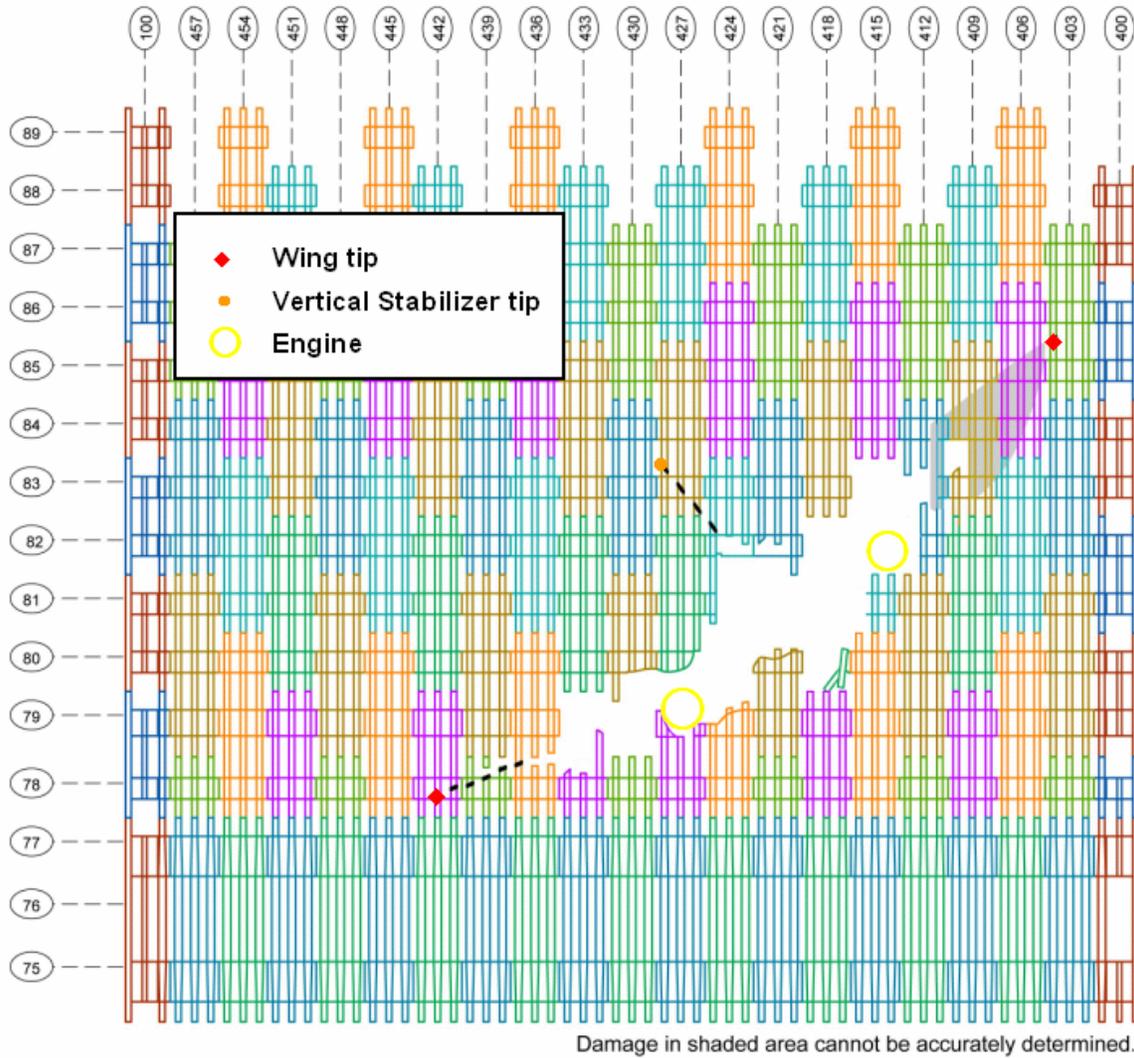
bank angle was steeper than that of AA Flight 11, this entry wound stretched over nine floors, from 77 to 85, rather than eight in WTC 1 (Figure 3–2). The occupancy of those floors is shown in Table 3–1.

Figure 3–2. South face damage of WTC 2 with key aircraft component locations marked.

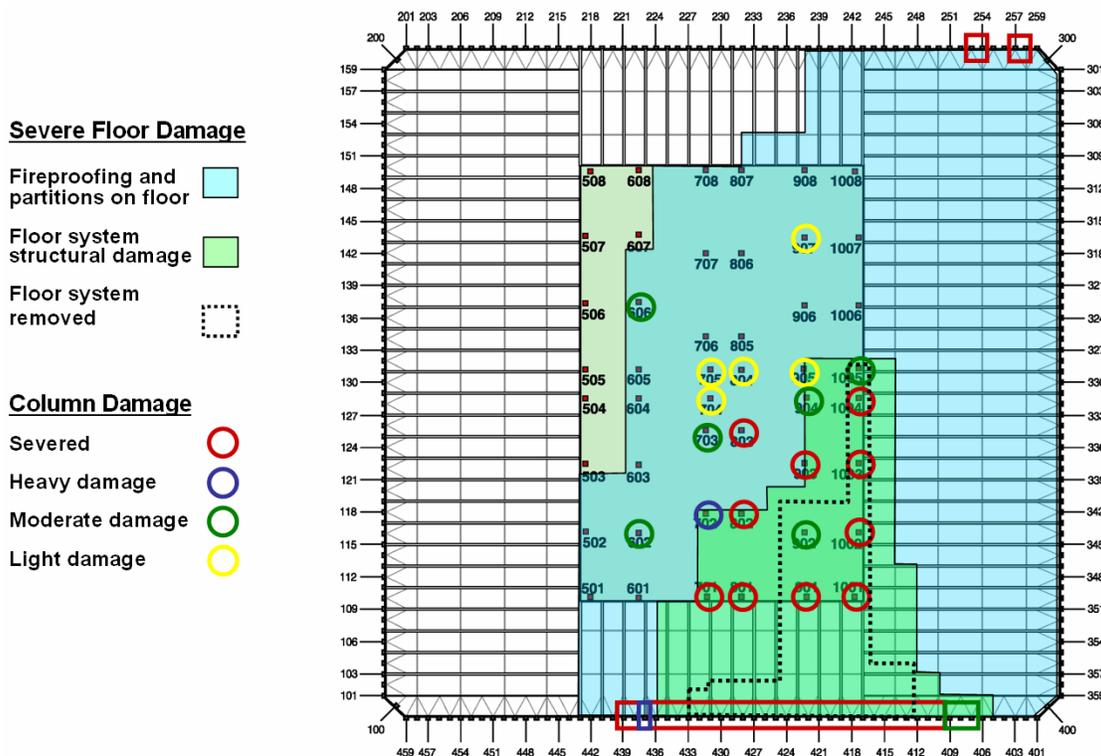
and aluminum sheet of the wing did little damage to the building structure or the SFRM on the columns and trusses on these floors. There were 433 broken windows on the north, east, and south facades.

Figure 3–3. Simulation of aircraft impact damage to the 78th through 83rd floors in WTC 2.

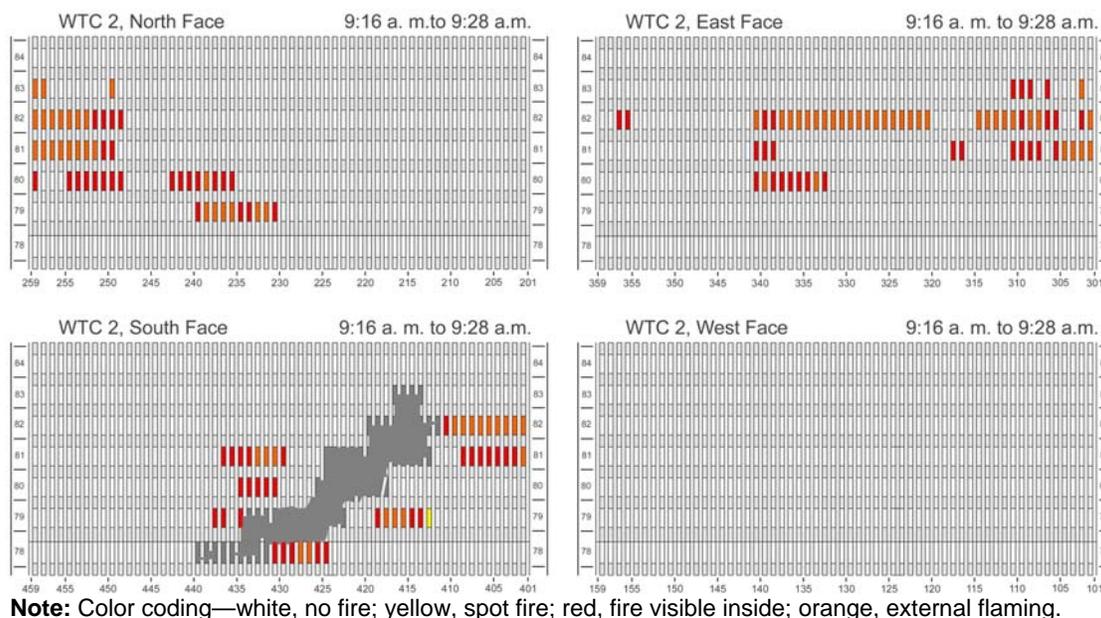
For the next half hour, small fires were burning in and near the aircraft impact cavity on the south side of the building. There were vigorous fires on the east side of the 80th through 83rd floors (Figure 3–4), especially on the northeast end of the 81st and 82nd floors, where the aircraft had bulldozed the office desks and chairs and added its own combustibles. In addition to the ample supply of fuel, these fires had access to plenty of air, as numerous windows on the east face had been blown out by the impact or fireball. They would continue to burn as long as the building stood.

Figure 3–4. Representation of exterior views of the fires on the four faces of WTC 2 at about 9:20 a.m.

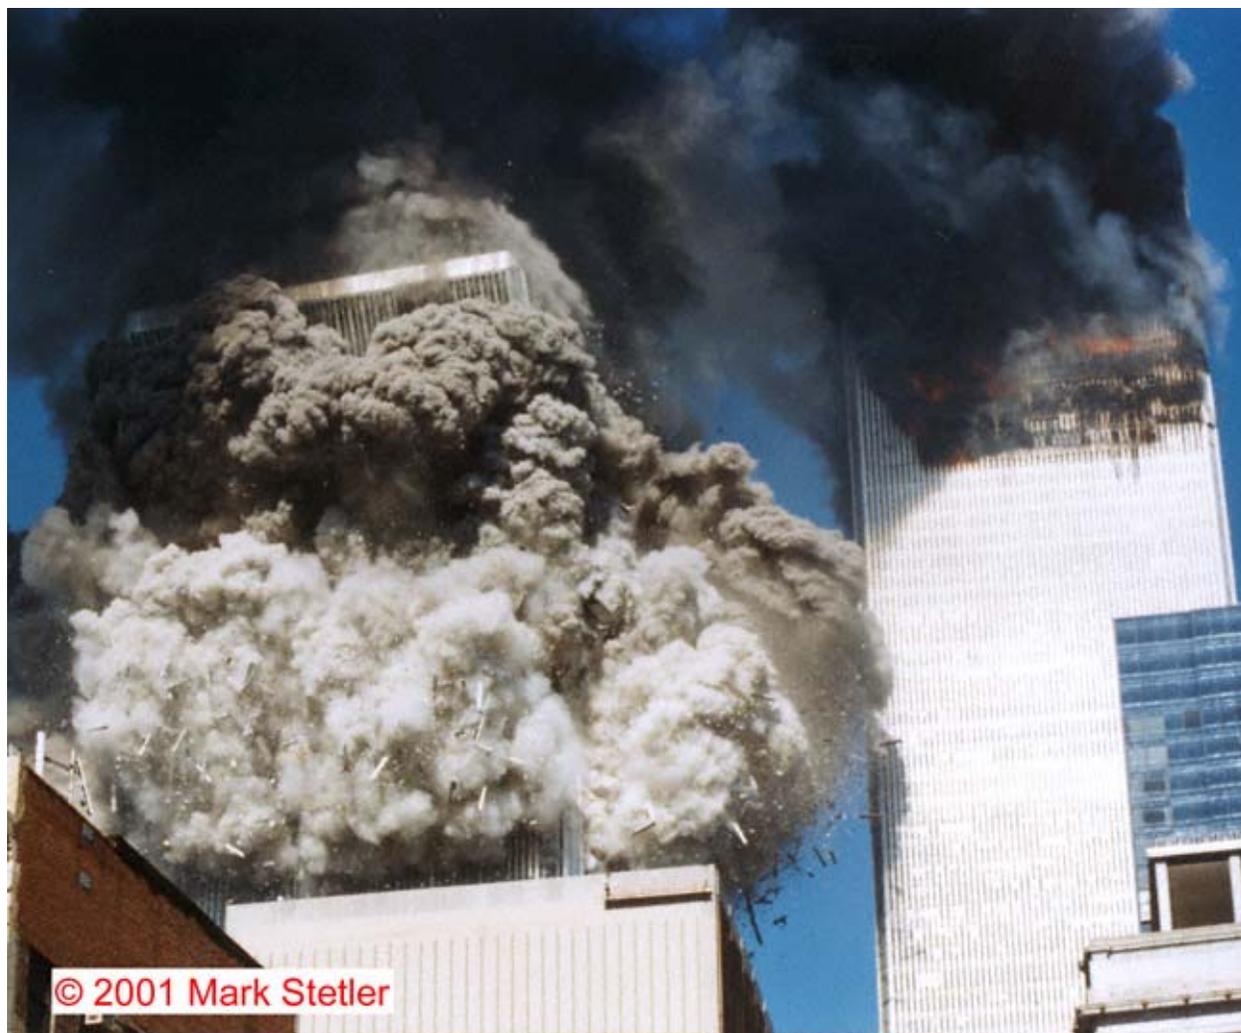
The physical condition of the tower had deteriorated seriously. The inward bowing of columns on the east wall spread along the east face. The east wall lost its ability to support gravity loads, and, consequently, redistributed the loads to the weakened core through the hat truss and to the adjacent north and south walls through the spandrels. But the loads could not be supported by the weakened structure, and the entire section of the building above the impact zone began tilting as a rigid block to the east and south (Figure 3–5). Column failure continued from the east wall around the corners to the north and south faces. The top of the building continued to tilt to the east and south, as, at 9:58:59 a.m., WTC 2 began to collapse.

Figure 3–5. Photograph of WTC 2 tilting to the southeast at the onset of collapse.

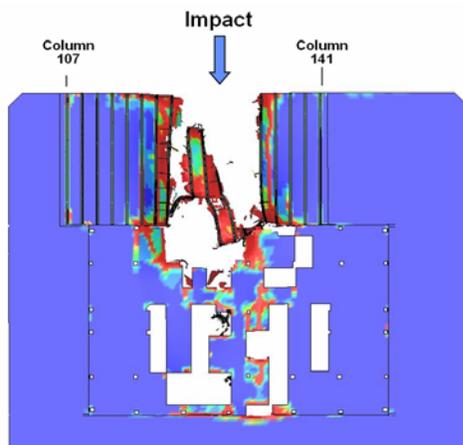
Figure 6–20. Case B damage to the slab of floor 96 of WTC 1.

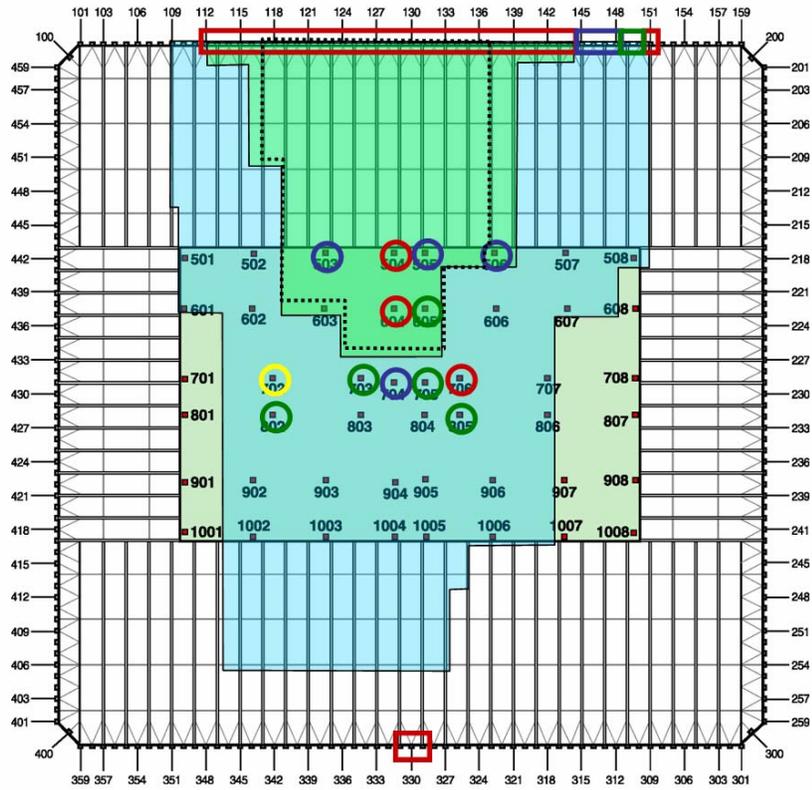
Figure 6–22. Combined structural damage to the floors and columns of WTC 1, Case A.

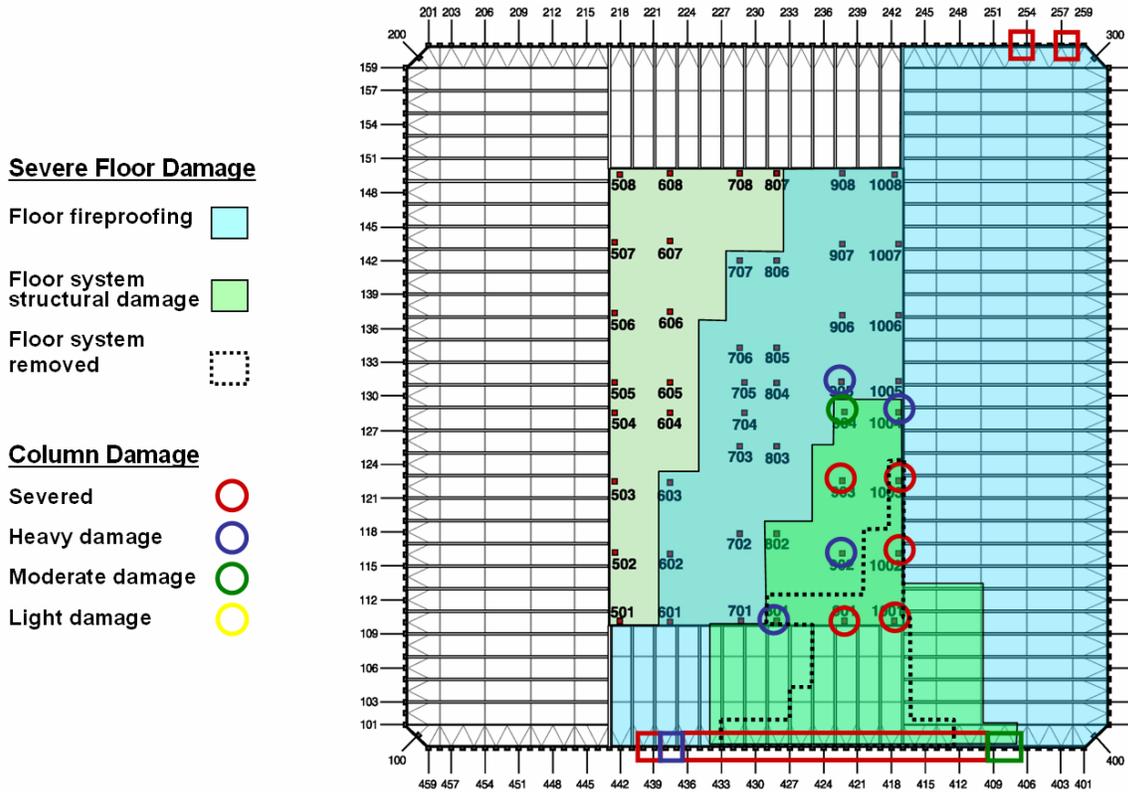
Figure 6-24. Combined structural damage to the floors and columns of WTC 2, Case C.

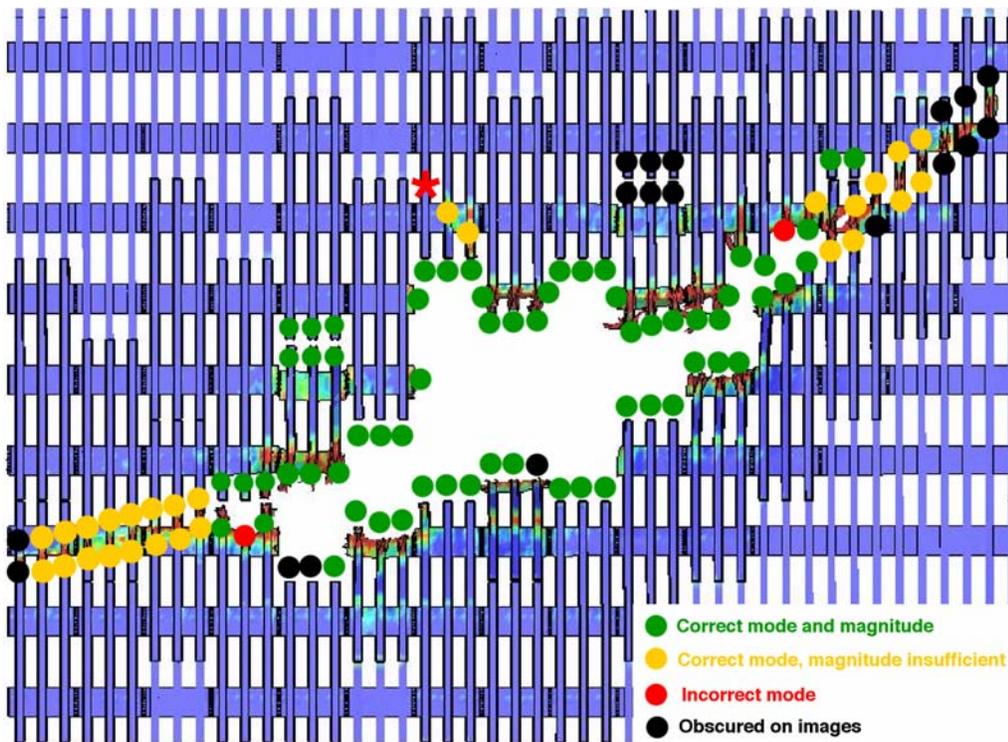
Figure 6–27. Schematic of observed damage (top) and Case A calculated damage (lower) to the north face of WTC 1.

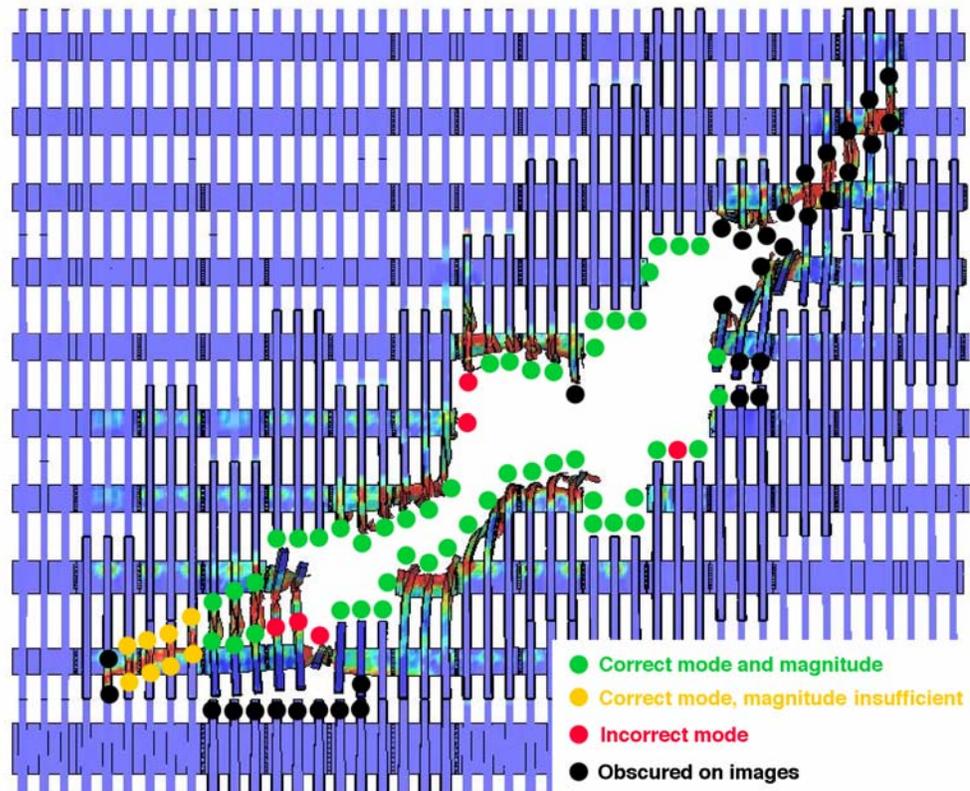
Figure 6–28. Schematic of observed damage (above) and Case C calculated damage (right) to the south face of WTC 2.

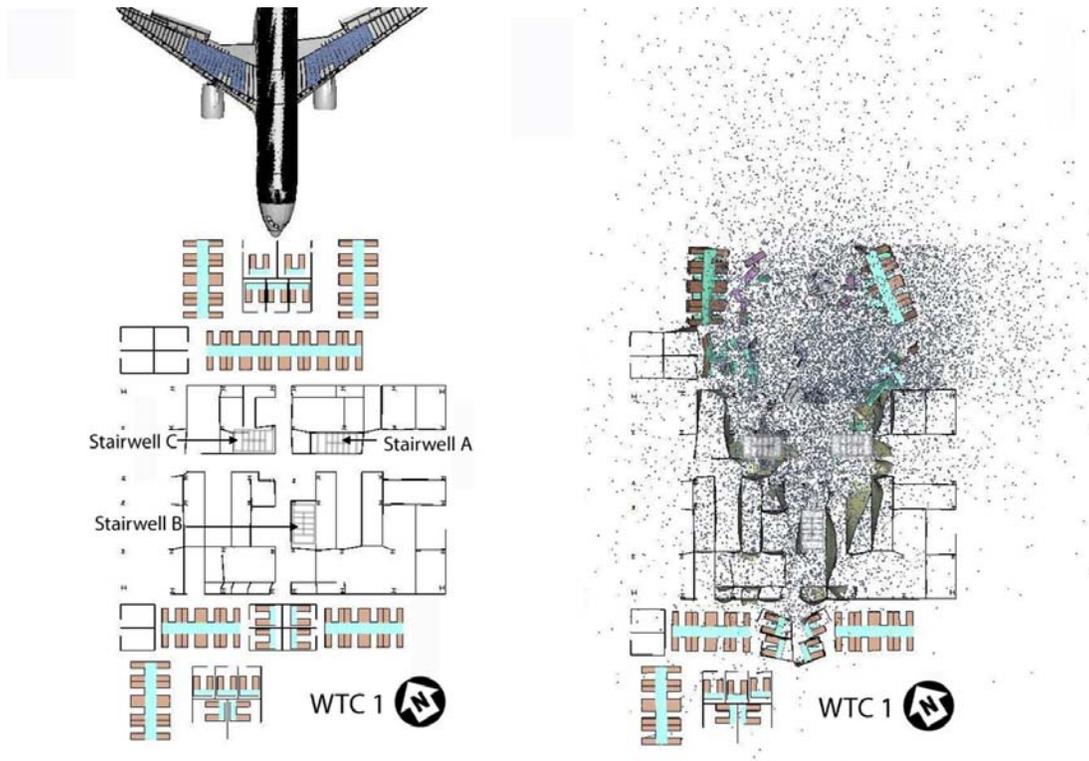
Figure 7-1. Simulated impact damage to 95th floor of WTC 1, including stairwells, 0.7 s after impact.

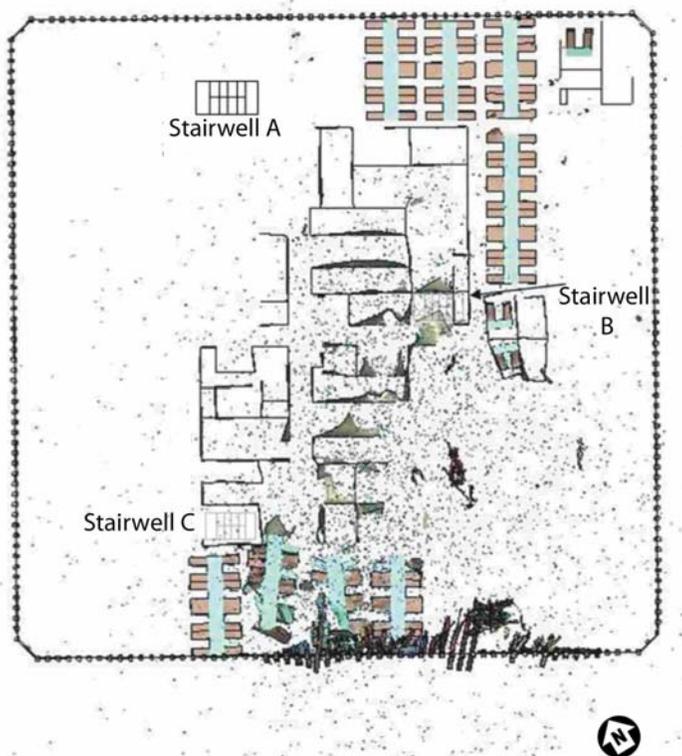
Figure 7-2. Simulated impact damage to WTC 2 on floor 78, 0.62 s after impact.

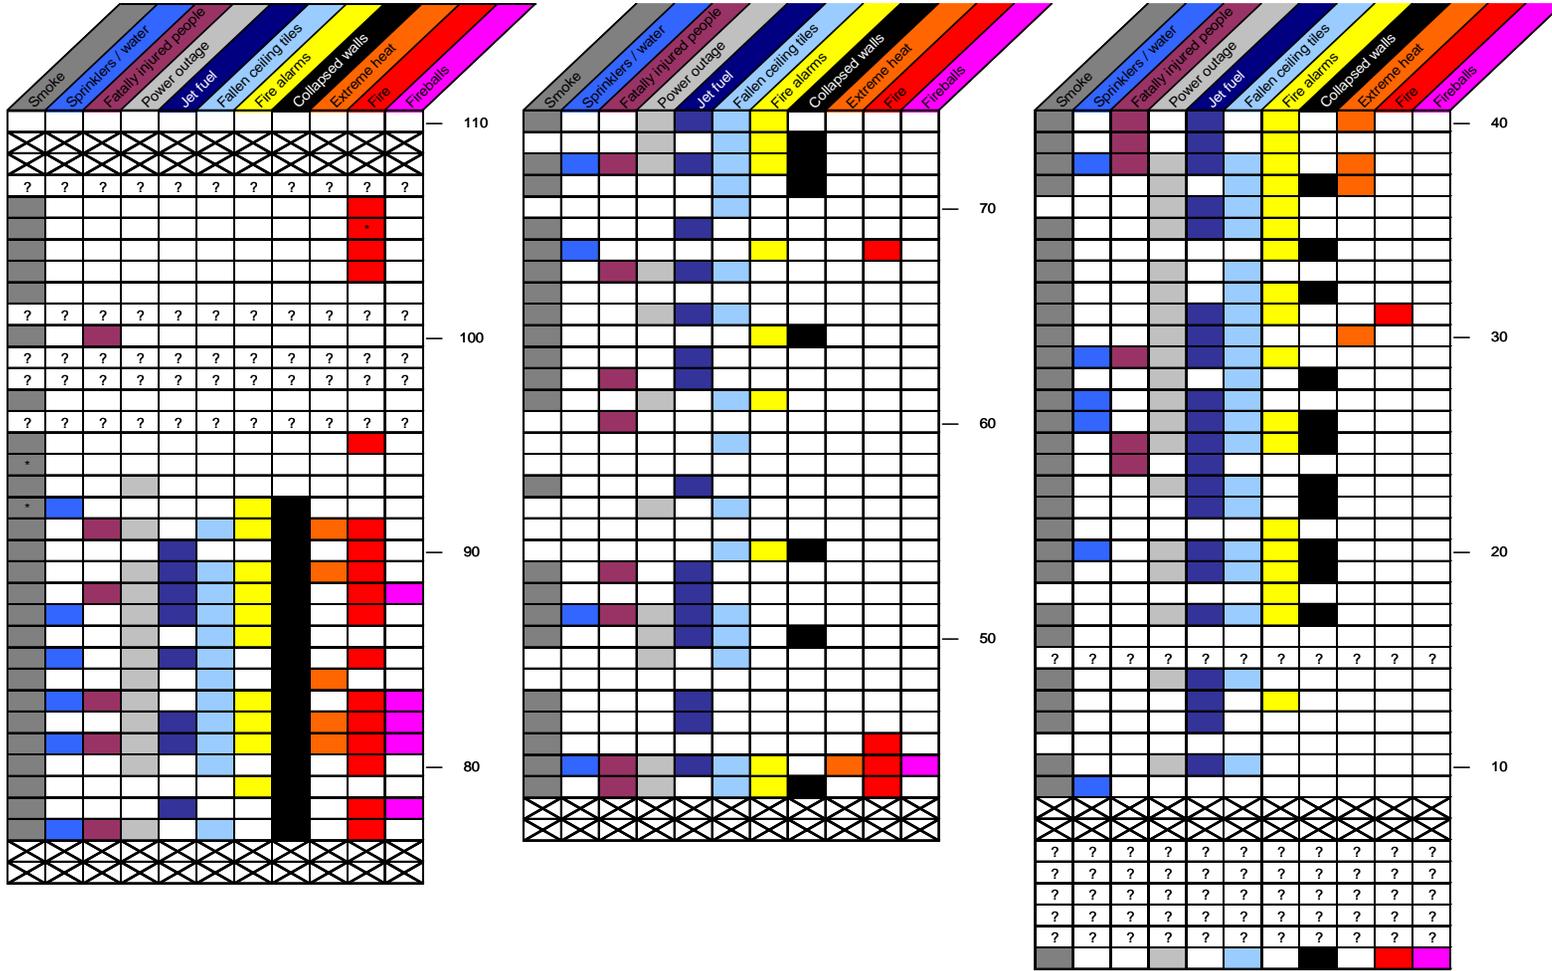
Figure 7-3. Observations of building damage after initial awareness but before beginning evacuation in WTC 1.

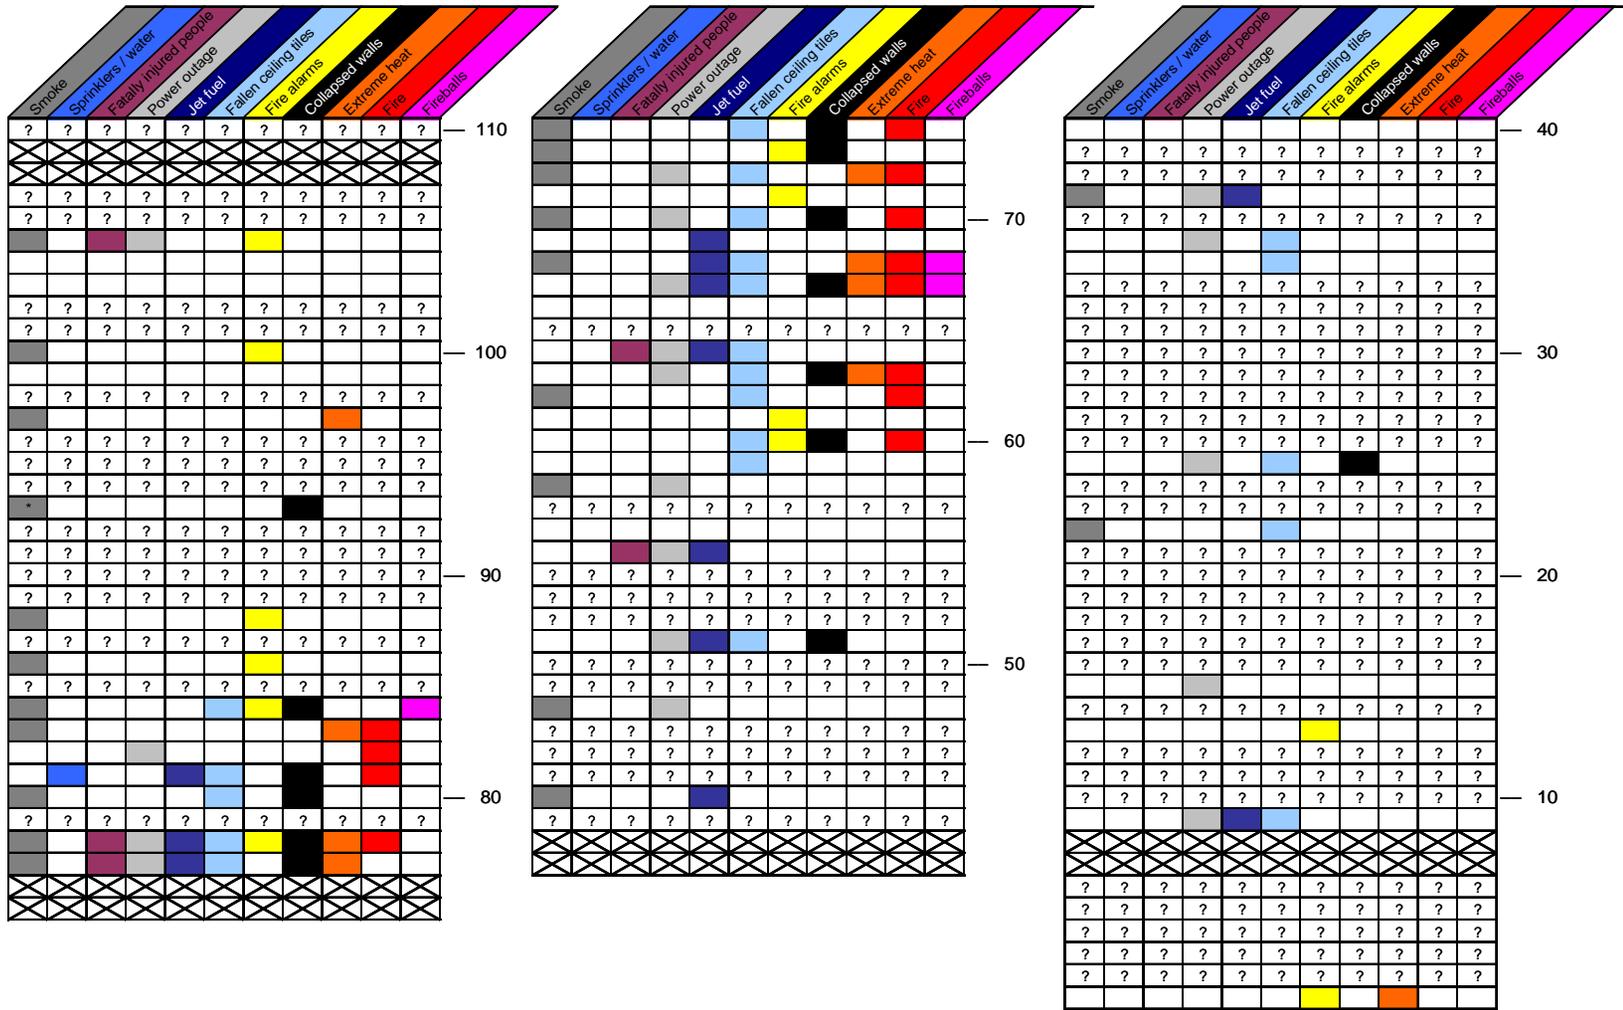
Figure 7-4. Observations of building damage from tenant spaces in WTC 2.
