**NIST NCSTAR 1-5A**

**Federal Building and Fire Safety Investigation of the  
World Trade Center Disaster**

**Visual Evidence, Damage Estimates,  
and Timeline Analysis**

September 2005

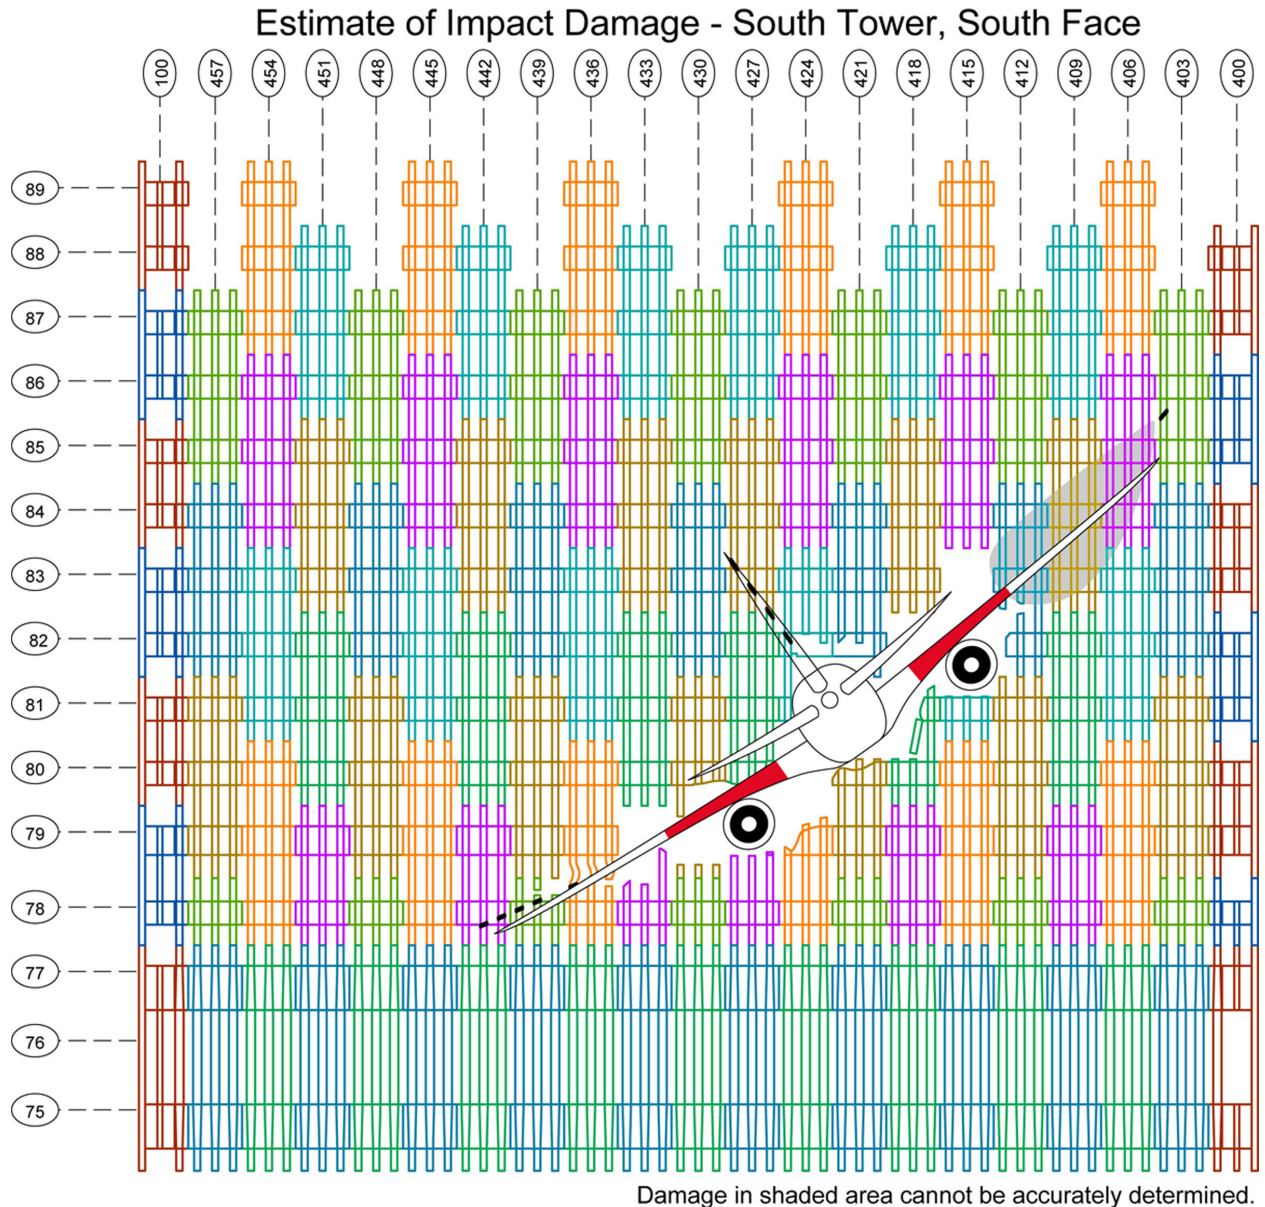
**Figure E-3. A scaled outline of a Boeing 767-200ER is superimposed on the damage diagram for the south face of WTC 2. The position of the aircraft has been adjusted to best match the damage pattern and marks showing where the wing tips and vertical stabilizer struck. The red areas correspond to the approximate locations of fuel on the aircraft based on an analysis reported elsewhere (NCSTAR 1-2B).**

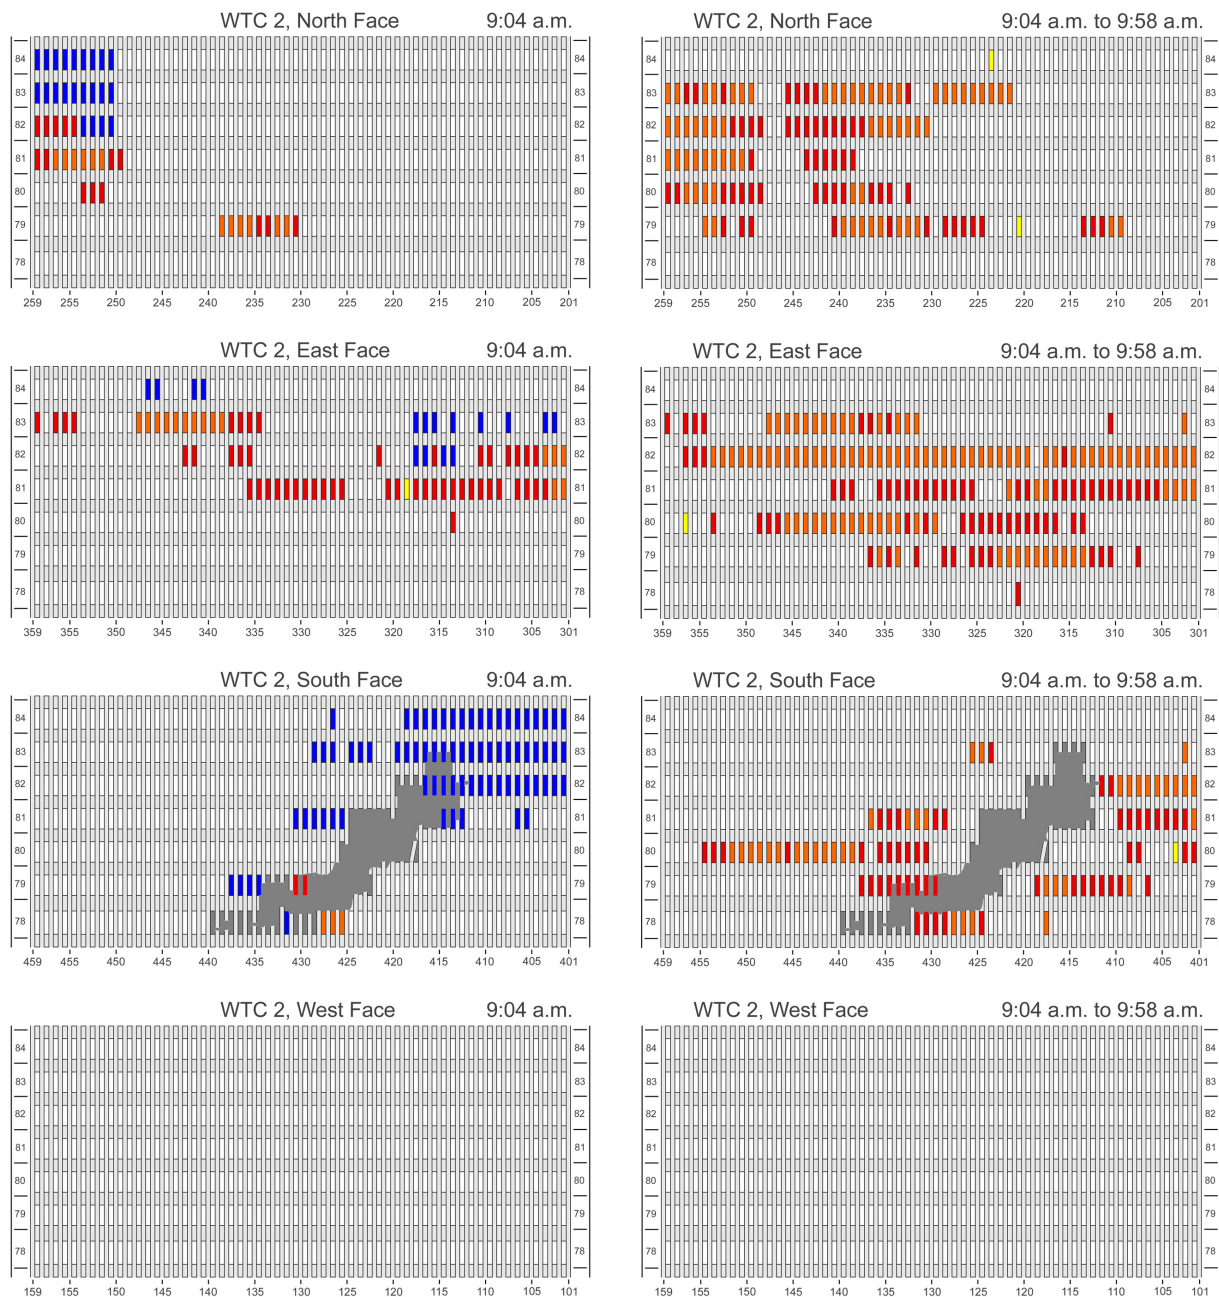
**Figure E-18. Maps of observed fire distributions on the four faces of WTC 2 shortly after the aircraft impact (near 9:04 a.m.) are compared with the corresponding integrated fire observations for the entire period between 9:03 a.m. and 9:59 a.m. Blue represents windows where observations were not possible.**

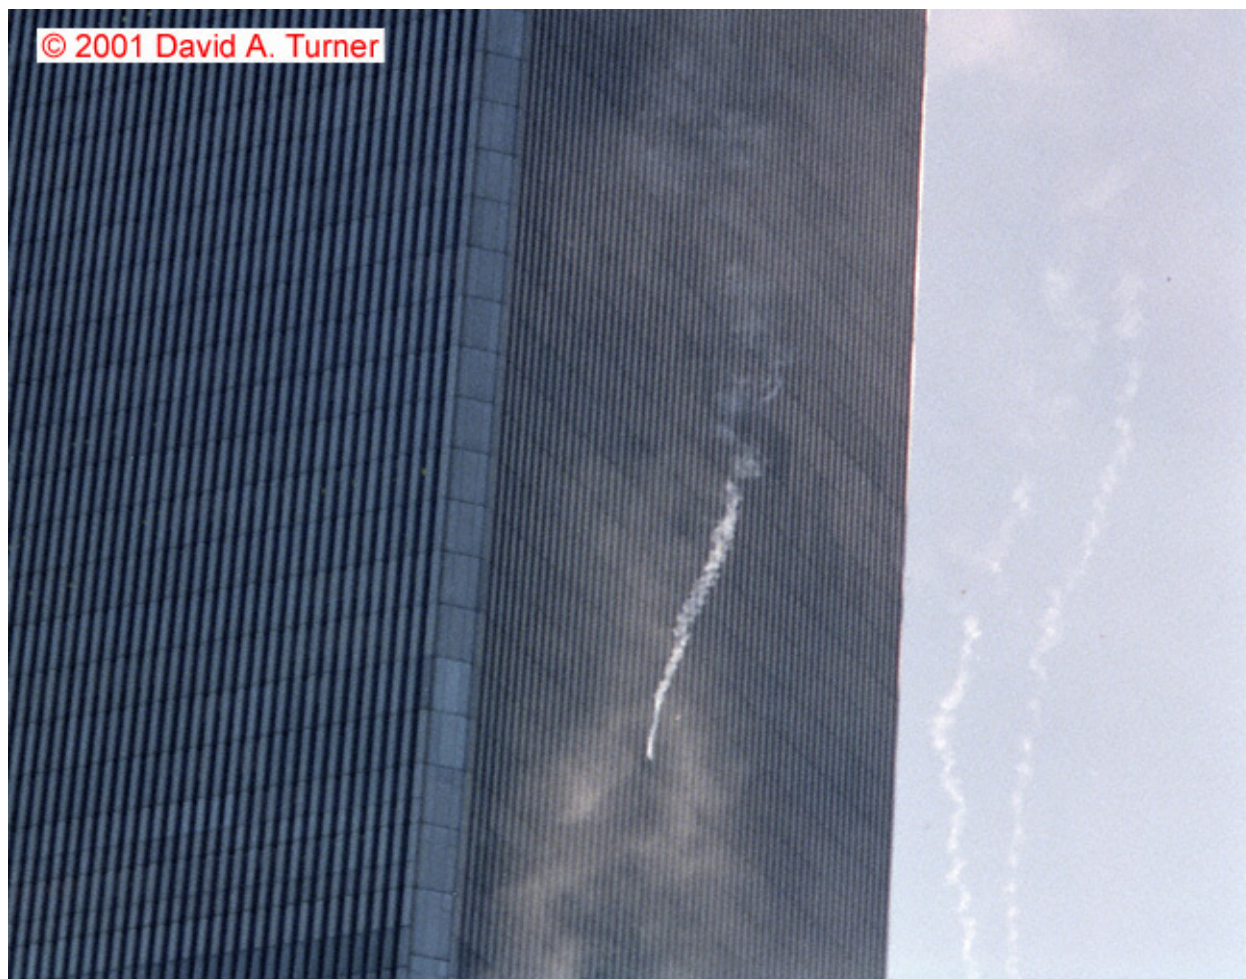
**Figure 5-7. This cropped and enhanced photograph shows the west and south faces of WTC 1. An intense streamer is falling near the south face of the tower, and two additional streamers have already fallen through the image to the south. The exact time of this photograph is unknown.**

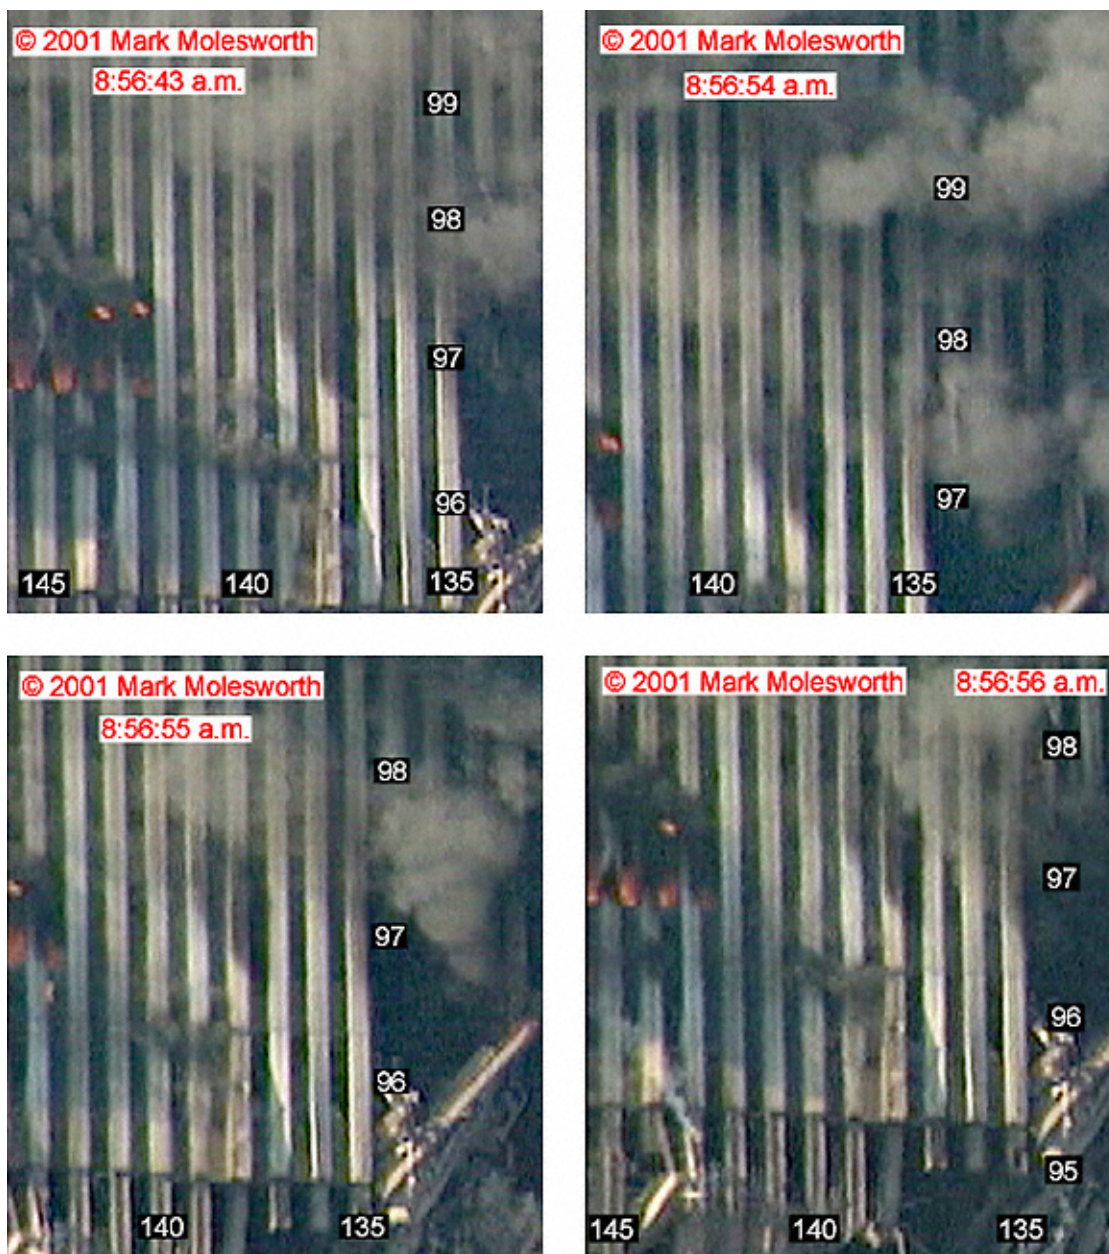
**Figure 5-8. A series of four cropped frames from a video were recorded during the period when an isolated area of fire at the top of window 97-142 on the 97th floor dropped and formed a streamer. The intensity levels have been adjusted. Column and floor numbers have been added.**

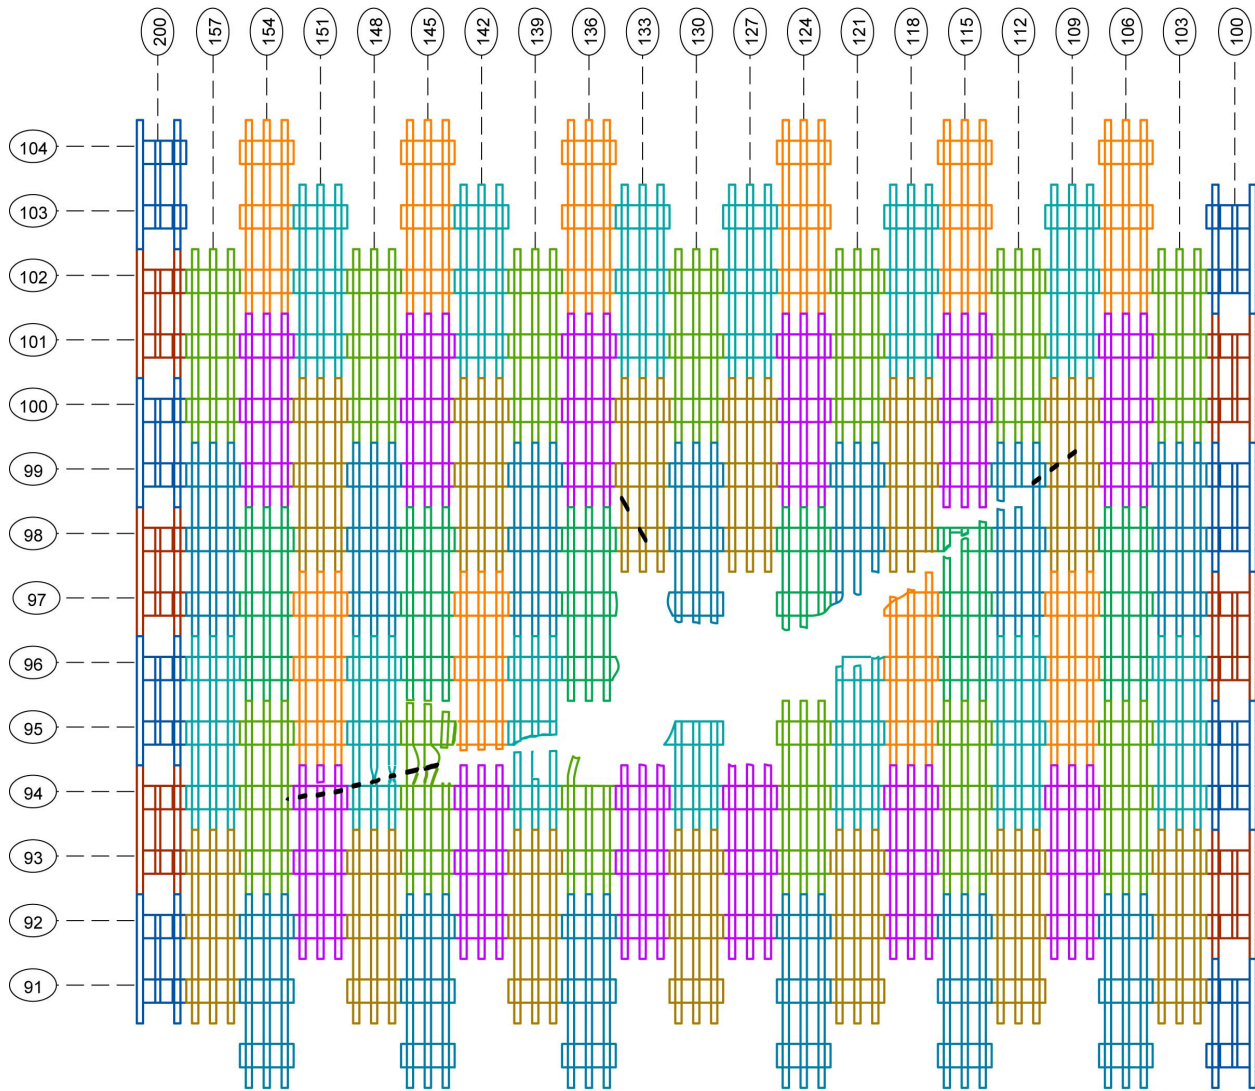
**Figure 6-6. A drawing shows the aircraft impact damage to the steel façade of WTC 1. The dark dotted lines indicate locations where the wings and vertical stabilizer of the aircraft marked the aluminum cladding on columns.**

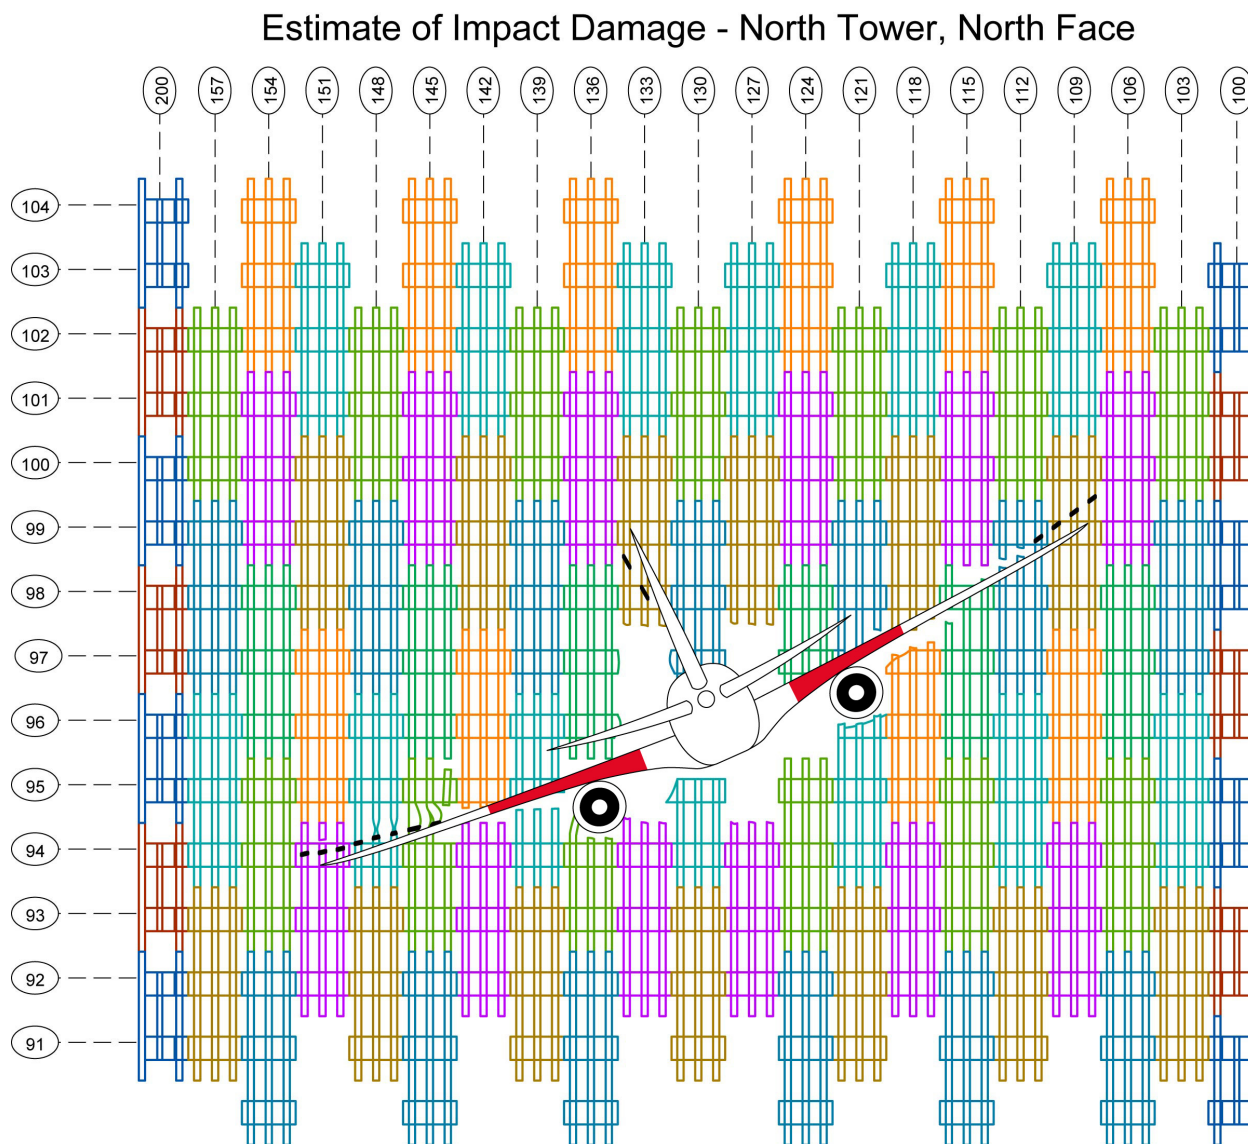
**Figure 6-7. A scaled outline of a Boeing 767-200ER is superimposed on the damage diagram shown in Figure 6-6. The position of the aircraft has been adjusted to give the best match with the damage pattern and marks showing where the wing tips and vertical stabilizer struck. The red areas correspond to the approximate locations of fuel on the aircraft based on an analysis reported elsewhere (NIST NCSTAR 1-2B).**

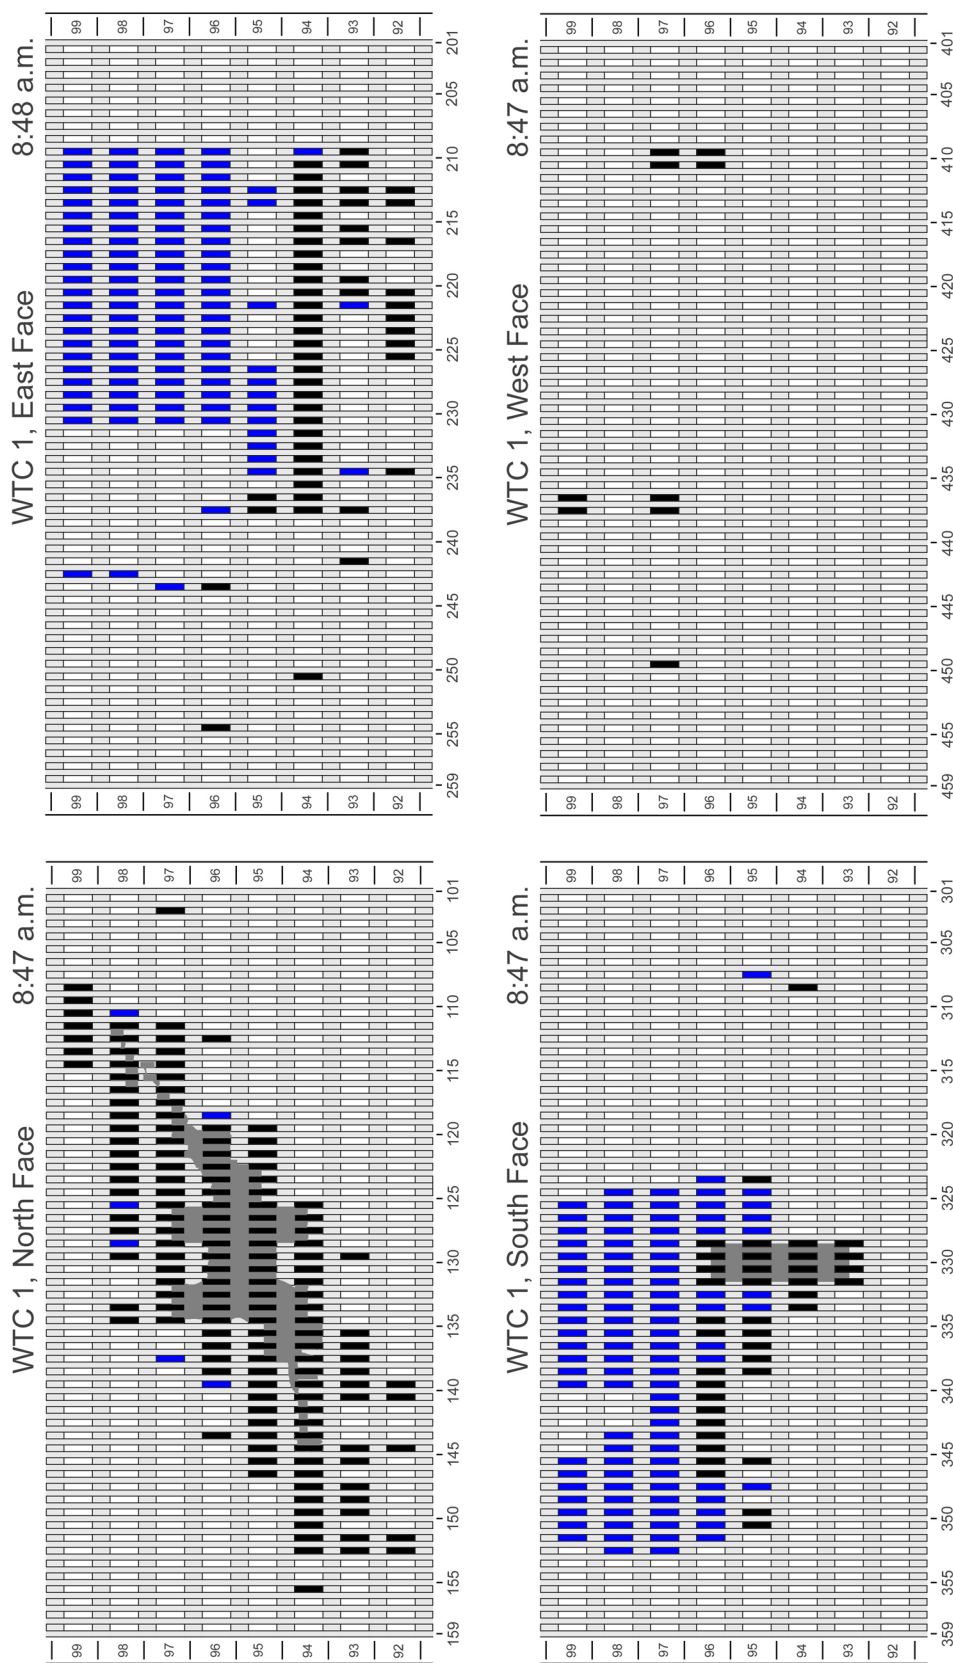
**Figure 6-9.** The condition of windows is shown for the four faces of WTC 1 around 8:47 a.m. shortly after it was struck by American Airlines Flight 11. The colors represent ■ - window broken open, ■ - glass in place, and ■ - not visible.

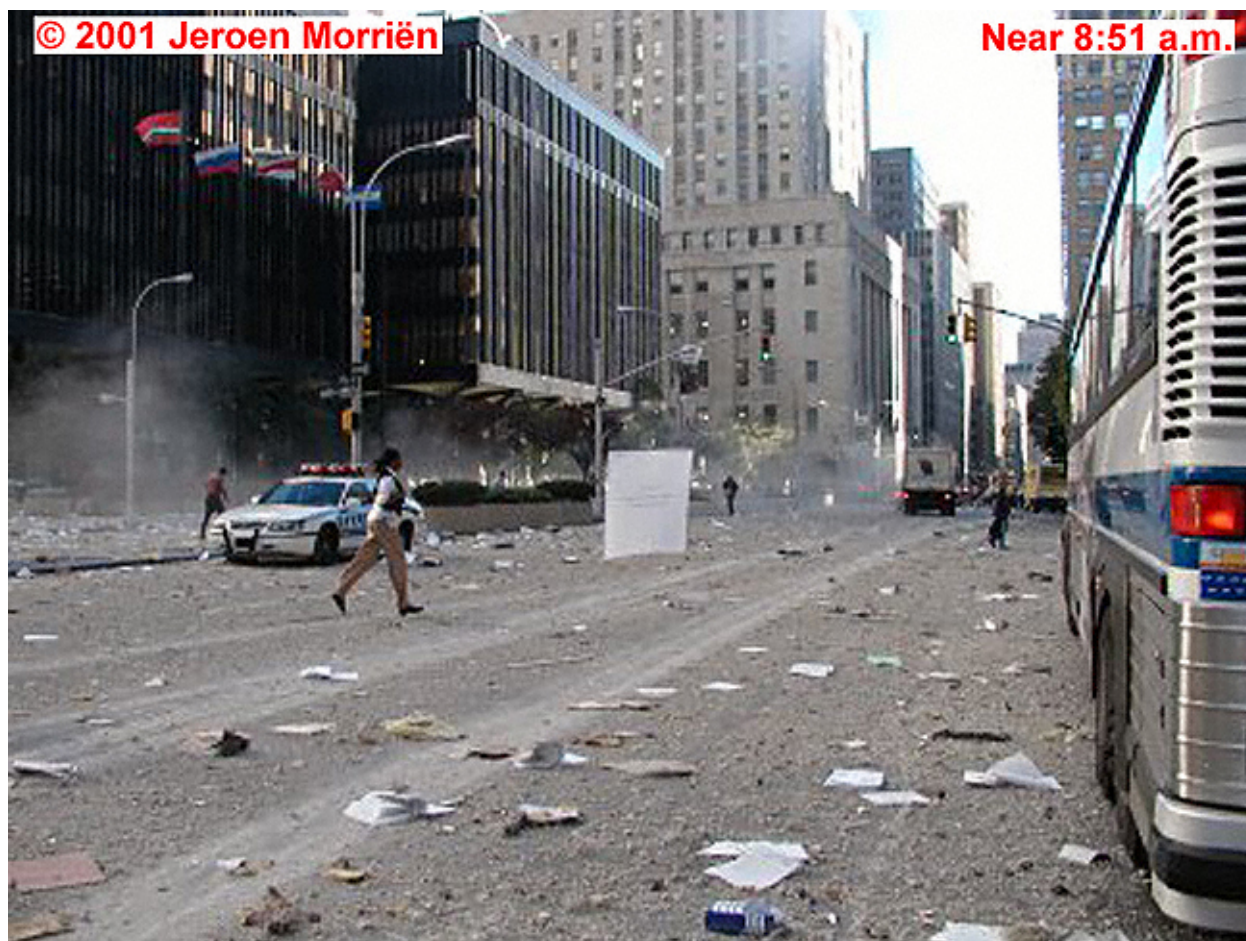
**Figure 6-14. A photograph recorded around 8:51 a.m. shows debris present on Church Street, which ran along the east side of the WTC complex. WTC 5 is located on the left-hand side.**

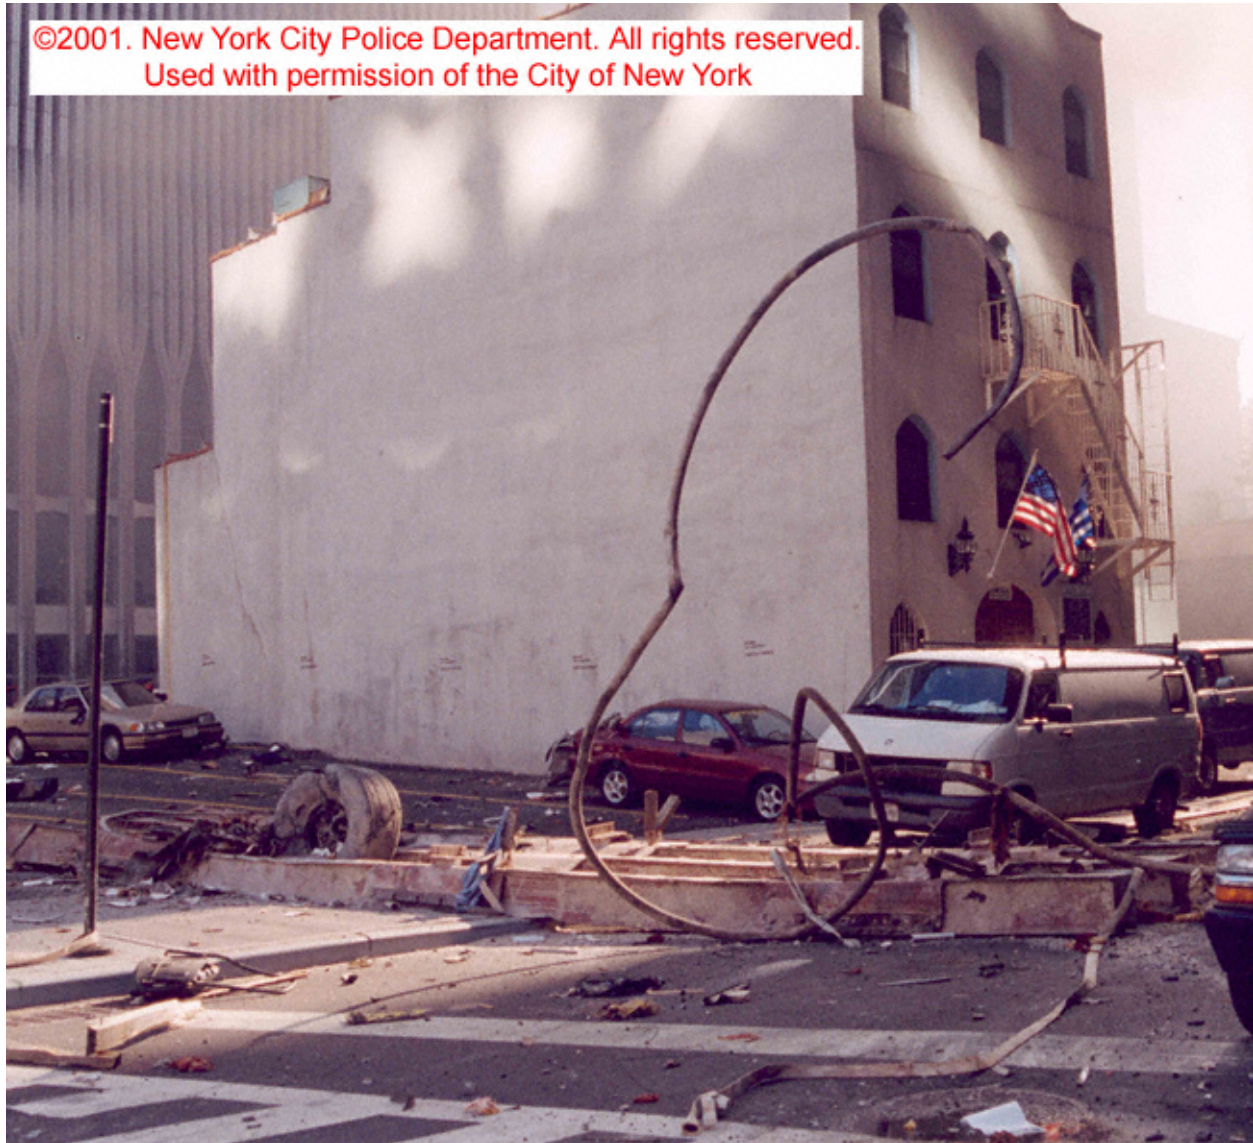
**Figure 6-16. Photograph showing a full steel panel section lying in Cedar Street near its intersection with West Street. An aircraft wheel is embedded in one of the windows. The building behind the panel is Saint Nicholas Greek Orthodox Church and the lower section of WTC 2 can be seen across Liberty Street.**

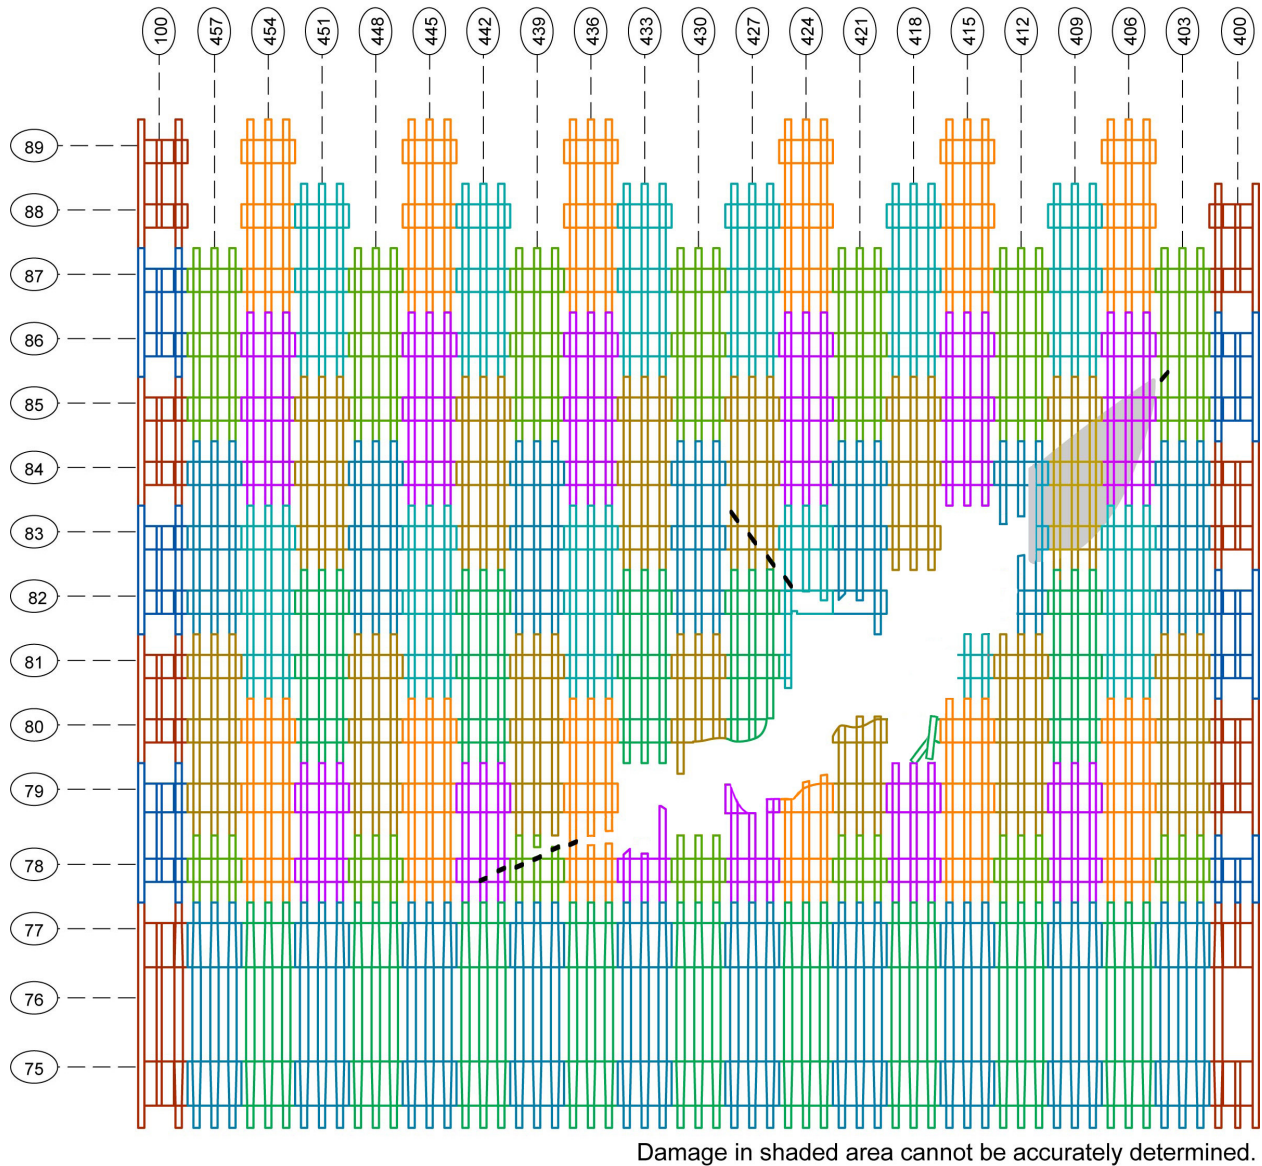
**Figure 7-25. A diagram of the south-face steel façade of WTC 2 shows the damage inflicted by the aircraft impact. The dark dotted lines indicate locations where the wings and tail of the aircraft marked the aluminum cladding on columns. The area shaded in gray was hidden by smoke and could not be observed.**

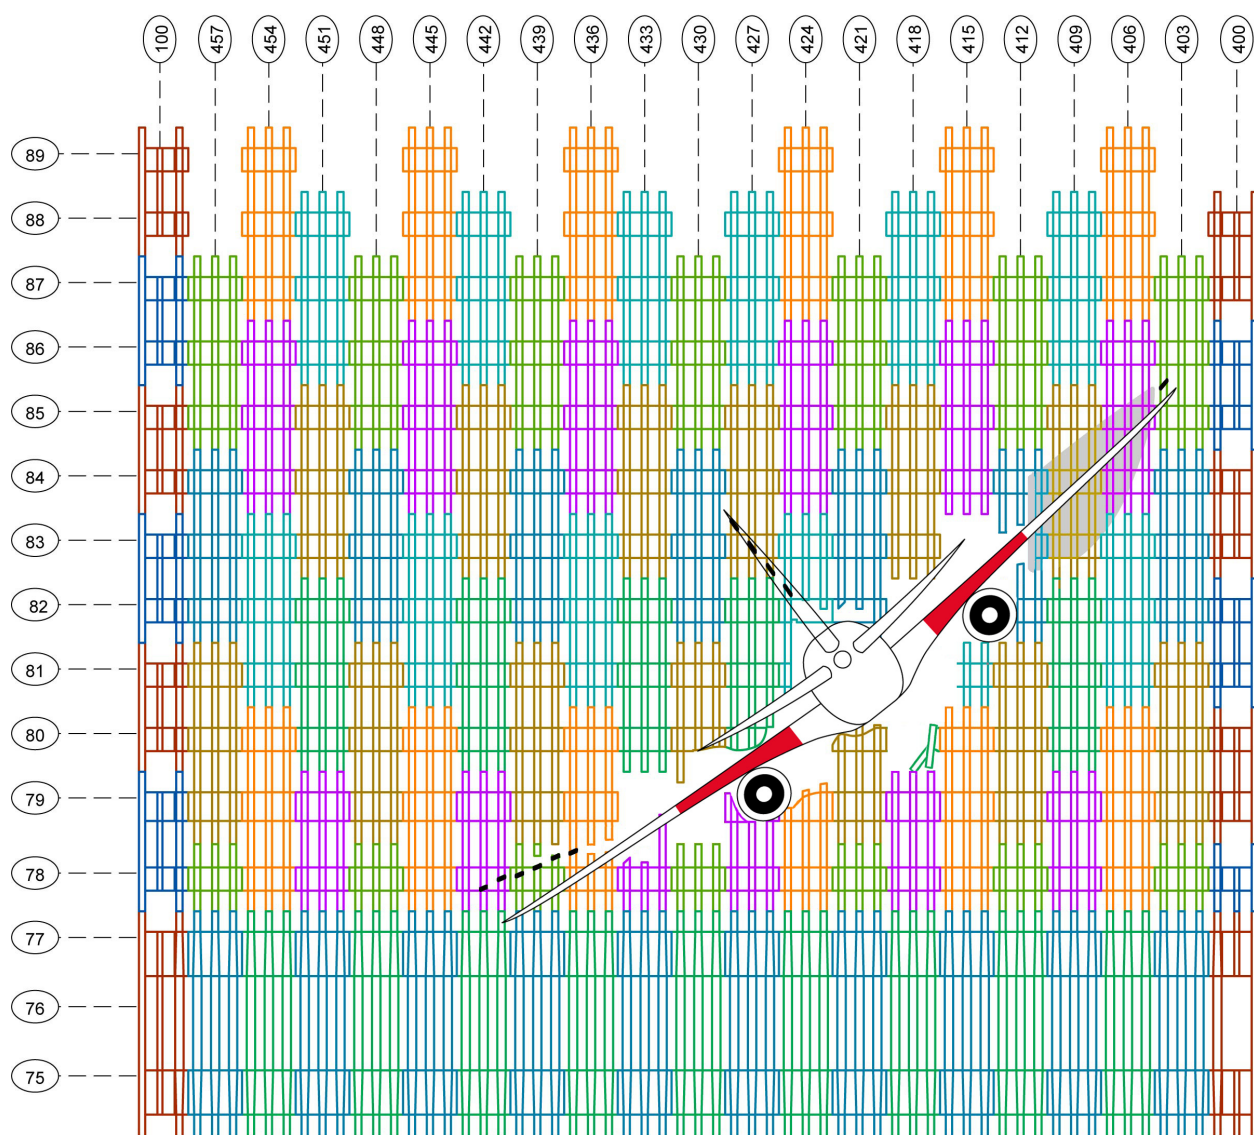
Damage in shaded area cannot be accurately determined.

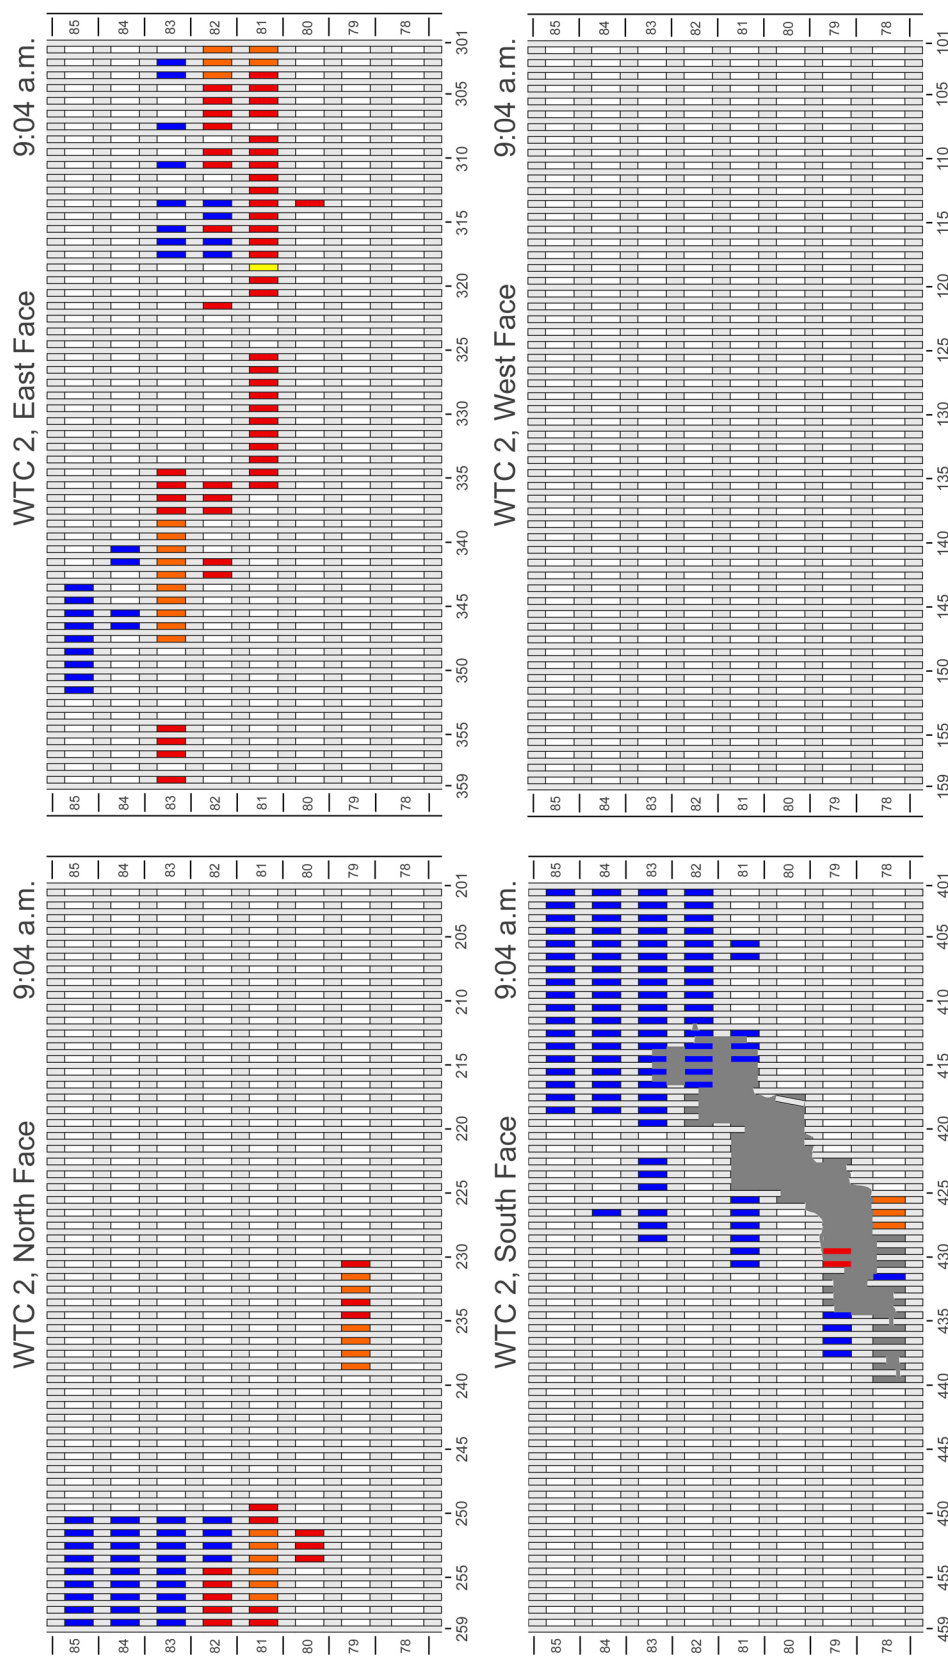
**Figure 7-39. Maps of observed fires on the four faces of WTC 2 are shown for the period shortly after the rapid burn off of aviation fuel released during the aircraft impact. The colors represent □ - no fire observed, ■ - spot fire, ■ - fire inside, ■ - external flaming, and ■ - not visible.**

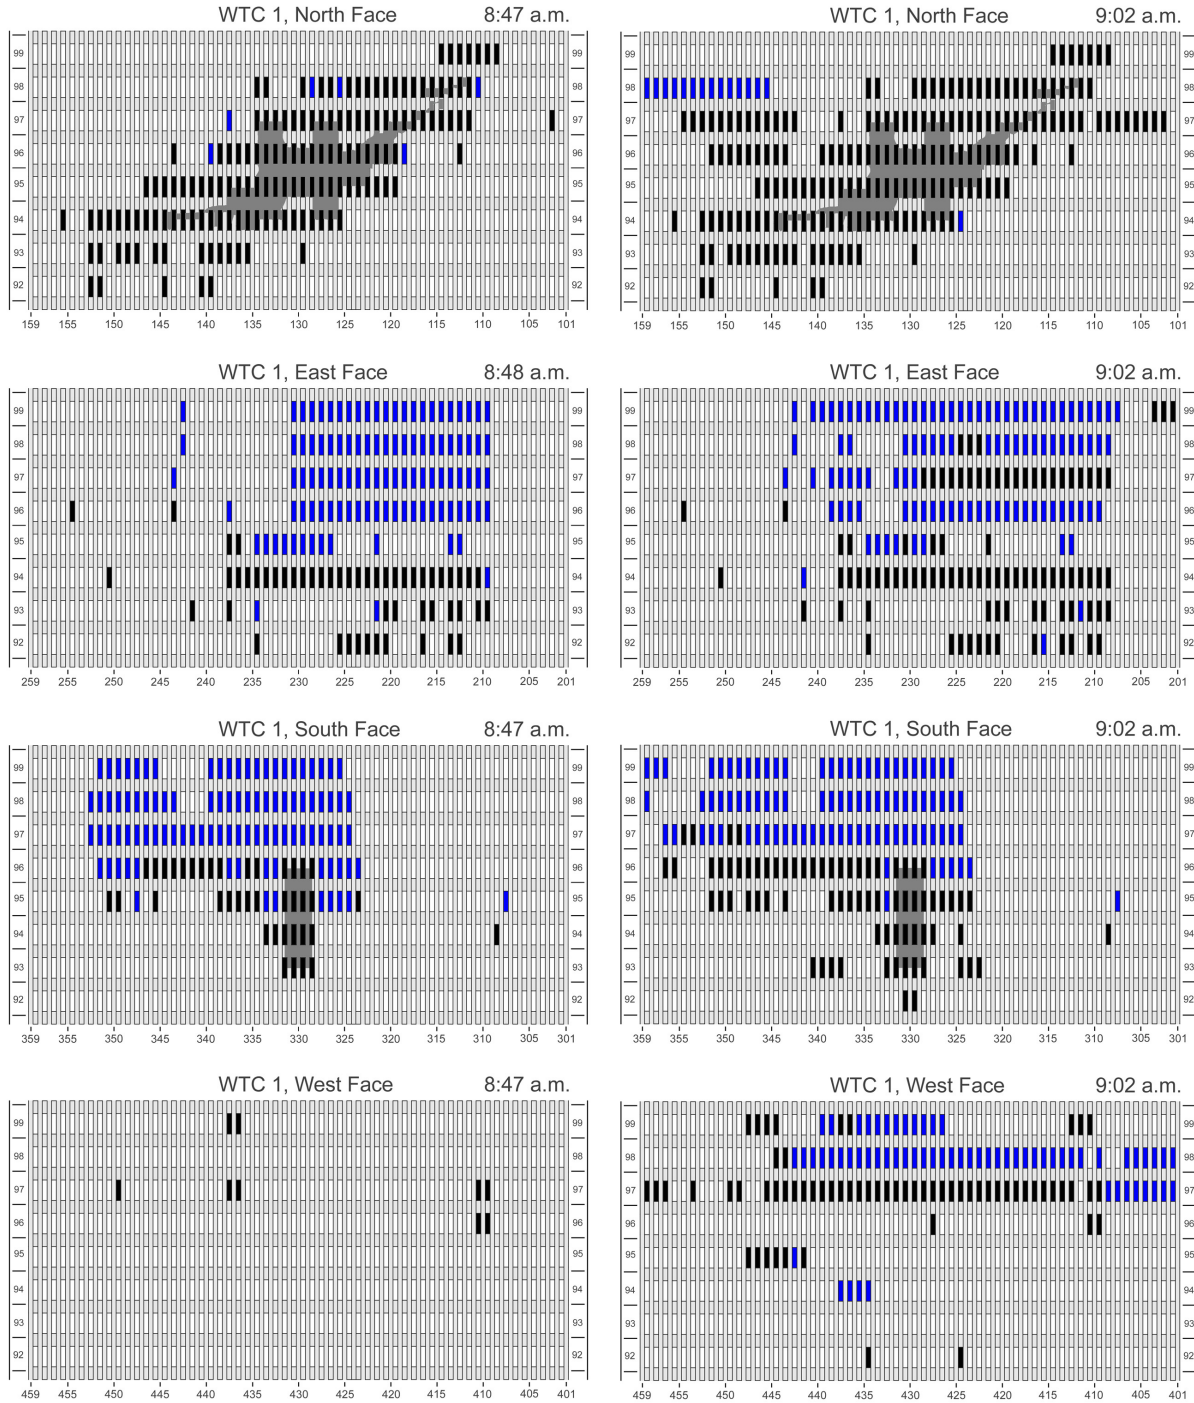
**Figure 8-13. Maps for the 92nd through the 99th floors compare missing window glass for the four faces of WTC 1 at two times, shortly after the aircraft impact and roughly 15 minutes later. The color coding used for the maps is indicated in Figure 5-1.**

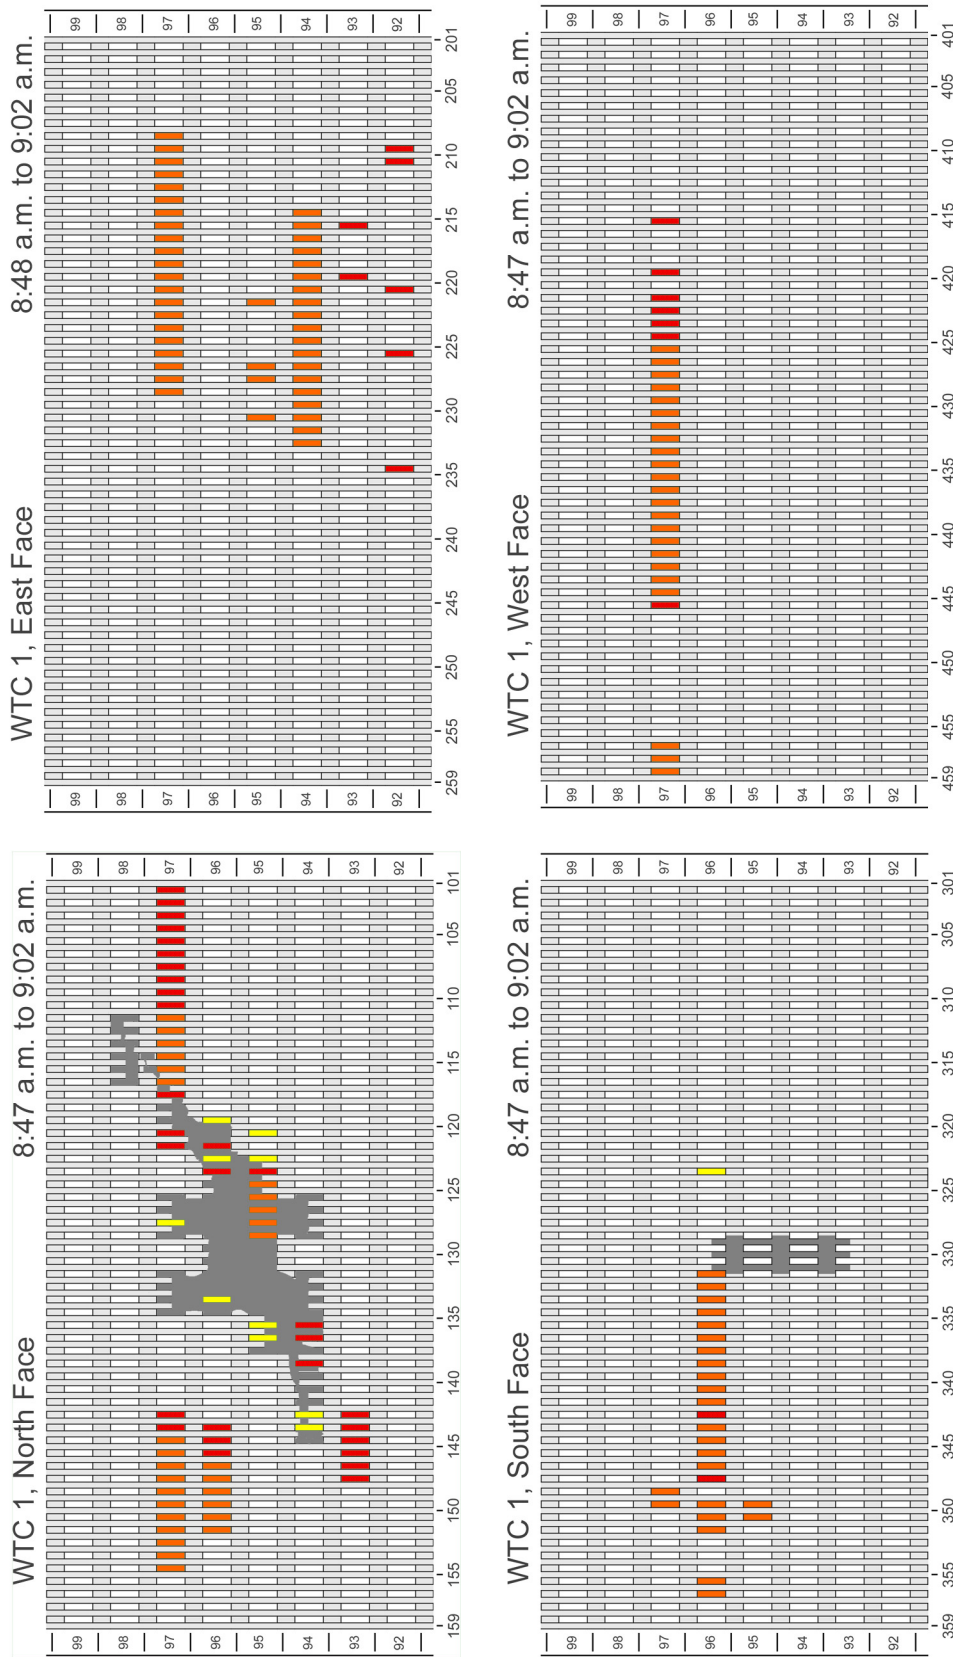
**Figure 8-14. Maps of integrated fire observations between 8:47 a.m. and 9:03 a.m. are shown for the four faces of WTC 1. Colors represent the highest intensity fire observed in a window using the color scale defined in Figure 5-1.**

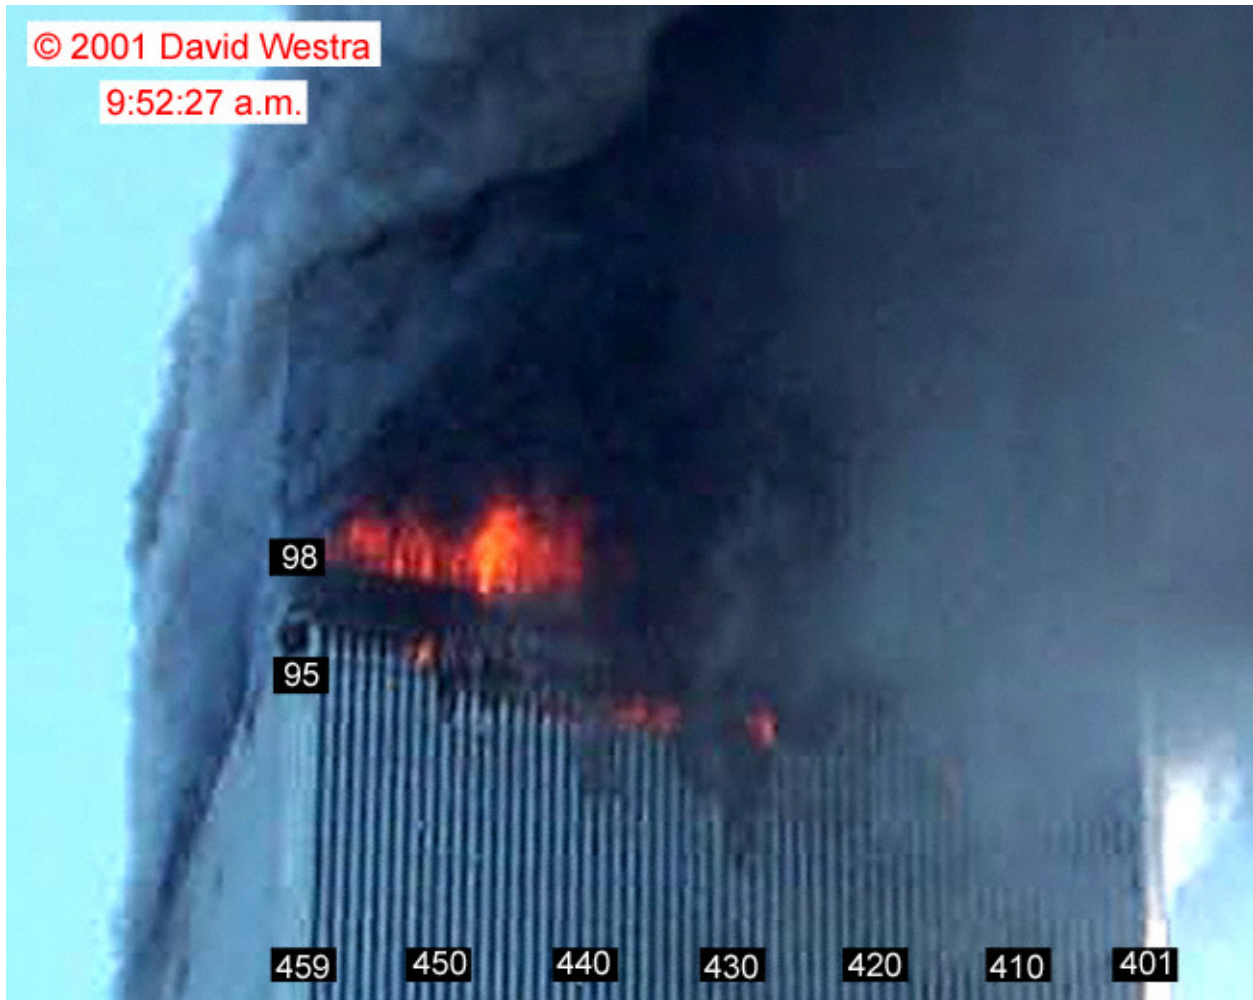
**Figure 8-64.** This cropped photograph shows the south face of WTC 1 at 9:52:27 a.m. The intensity levels have been adjusted and column and floor numbers have been added. For reference purposes, the missing aluminum panel on the southwest corner of the towers is on the 96th floor, and the heaviest fire is on the 98th floor.
