NIST NCSTAR 1

Federal Building and Fire Safety Investigation
of the World Trade Center Disaster

Final Report on the **Collapse of** **the World Trade Center Towers**

September 2005

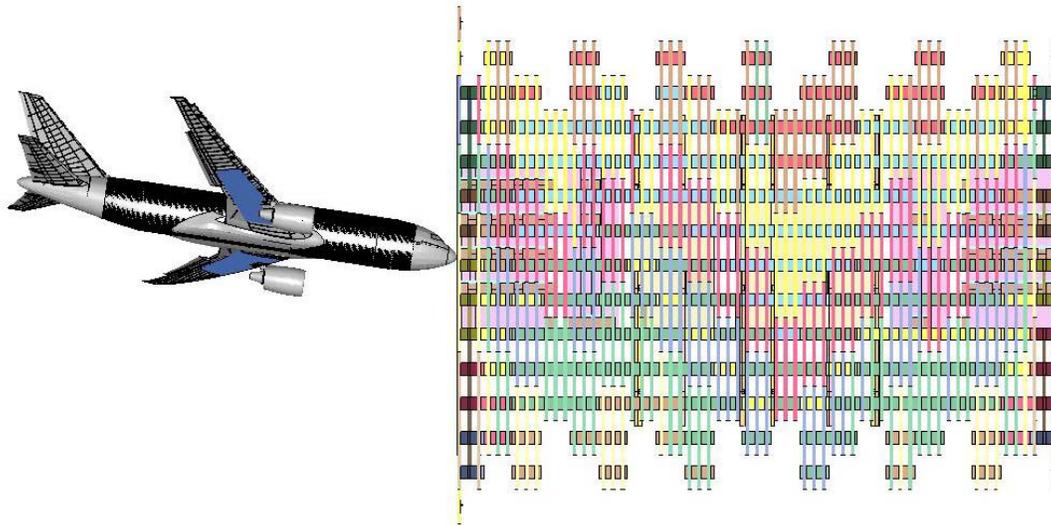
Figure 2–1. Simulated impact of American Airlines Flight 11 with WTC 1.

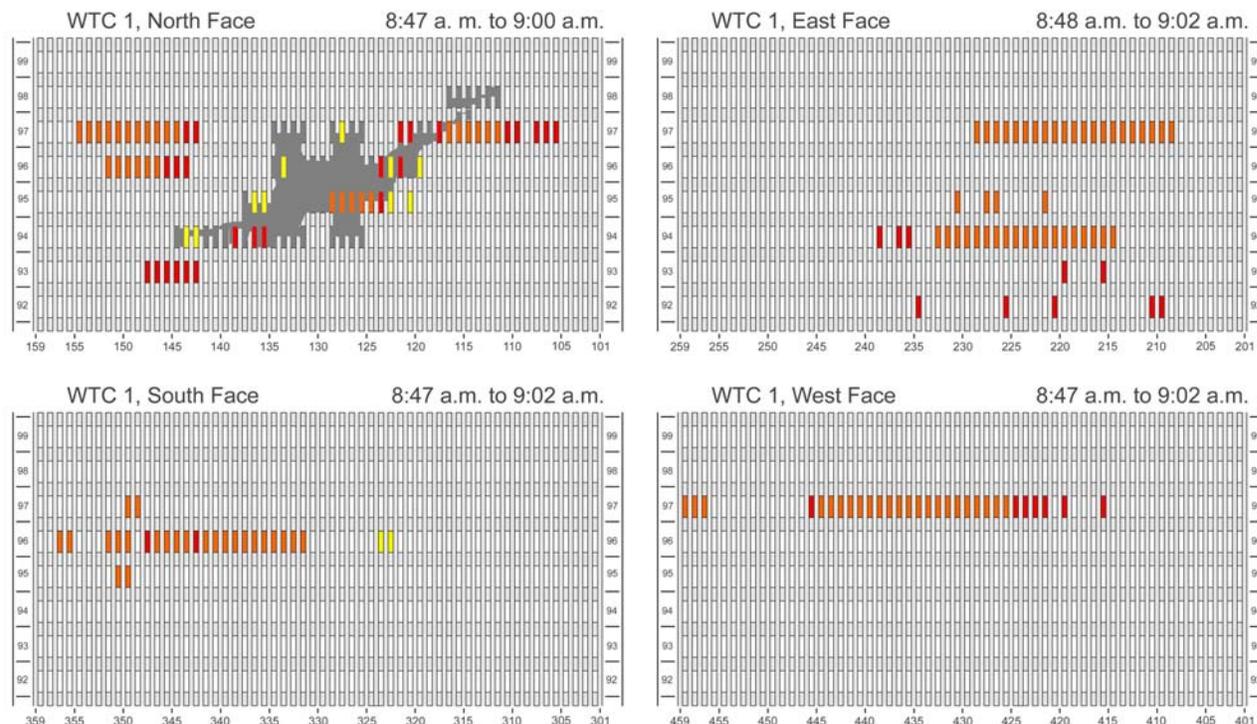
Note: Color coding—white, no fire; yellow, spot fire; red, fire visible inside; orange, external flaming.

Figure 2-5. Representation of exterior views of the fires on the four faces of WTC 1 from 8:47 a.m. to about 9:02 a.m.

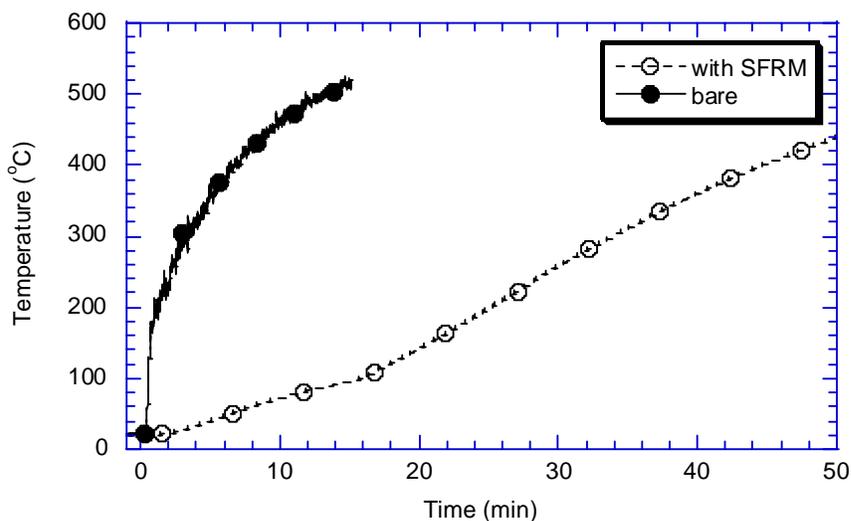
The perimeter columns, floors, and core columns were immersed in these hot gases and began to weaken. Where the insulation was dislodged, the temperature of the steel rose rapidly, in contrast to steel members where insulation was intact (Figure 2–8). The heaviest core columns with damaged insulation heated slowly, as the absorbed heat was dissipated through their massive cross sections. The temperatures of the lighter columns and the floor slabs rose more quickly, and those of the stripped trusses even more so.

Figure 2–8. Steel surface temperatures on the bottom chords of fire-exposed trusses, uninsulated and insulated with $\frac{3}{4}$ in. of BLAZE-SHIELD DC/F.

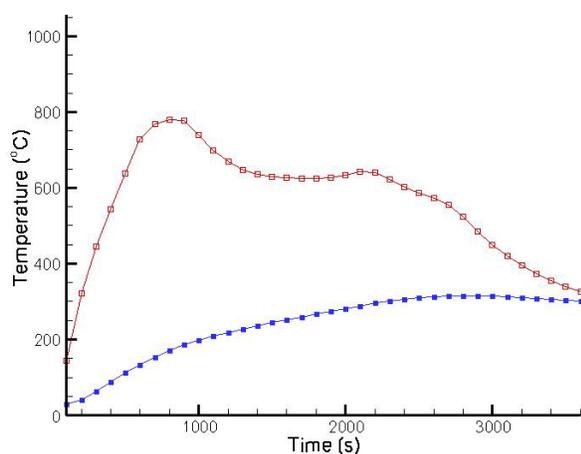
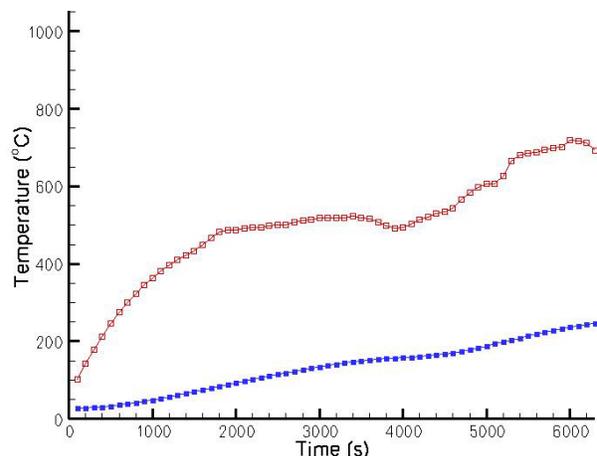
Figure 2–10. Simulated temperatures of two adjacent trusses (left) and two adjacent perimeter columns (right) exposed to the fires in WTC 1.

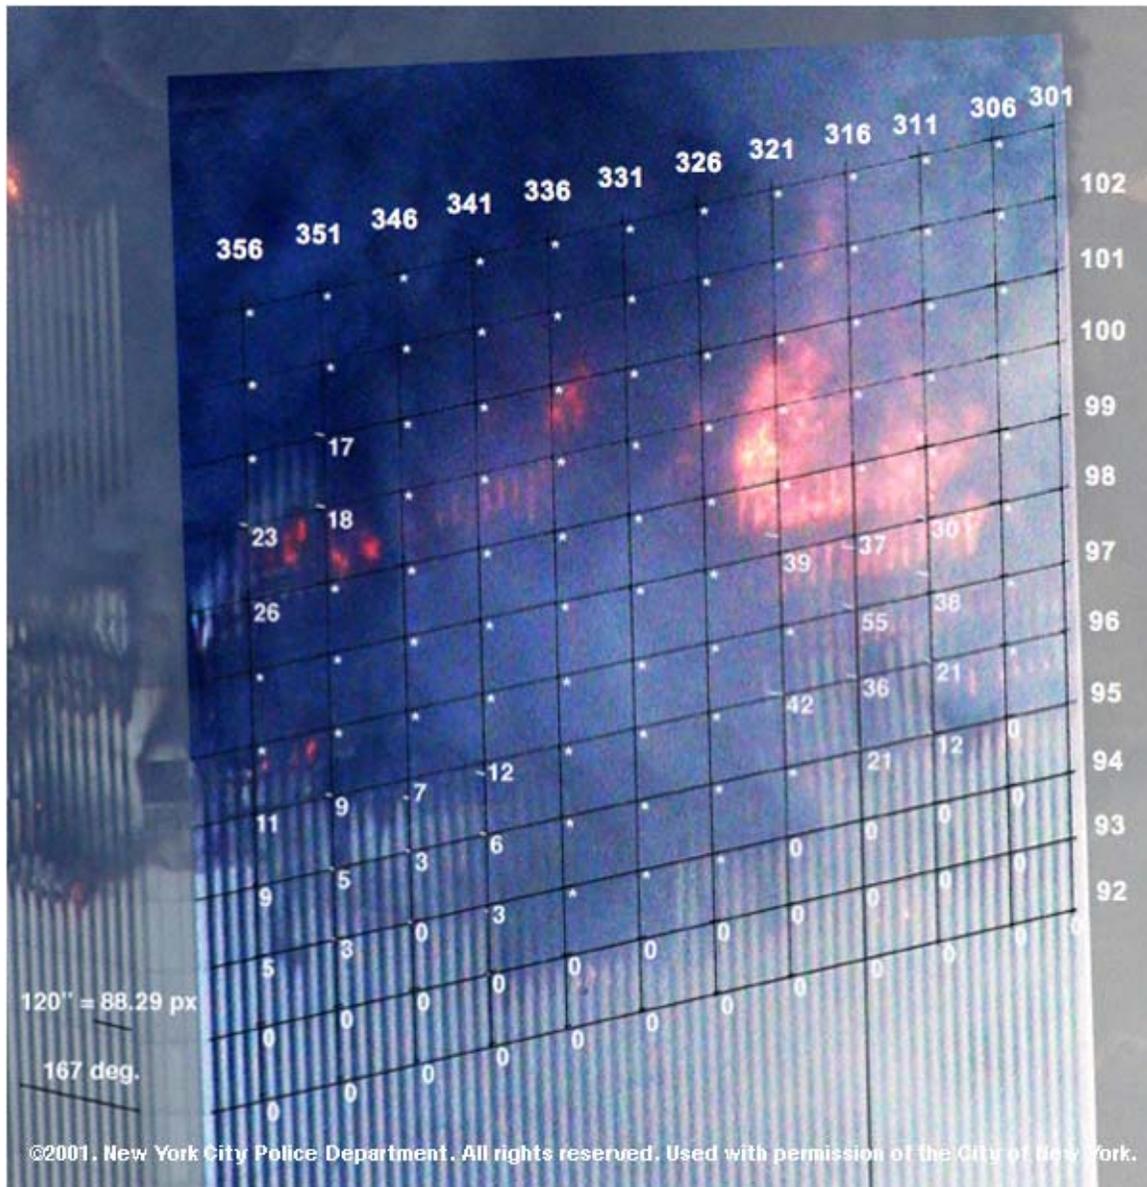
The sagging of the floors had increased. Although the floors on the north side of the tower had sagged first, they contracted due to cooling when the fires moved toward the south. Now, the south side floors had sagged to the point where the south perimeter columns bowed inward (Figure 2–12). By 10:23 a.m., the south exterior wall had bowed inward as much as 55 in.

At 10:06 a.m., an NYPD aviation unit advised that WTC 1 would come down and that all emergency vehicles should be moved away from it. At 10:20 a.m., observers in NYPD helicopters said that the top of the building was leaning; and at 10:21 a.m., they said that WTC 1 was buckling on the southwest corner and leaning to the south.

Figure 2-12. South face of WTC 1 at 10:23 a.m., showing inward buckling (in inches) of perimeter columns.

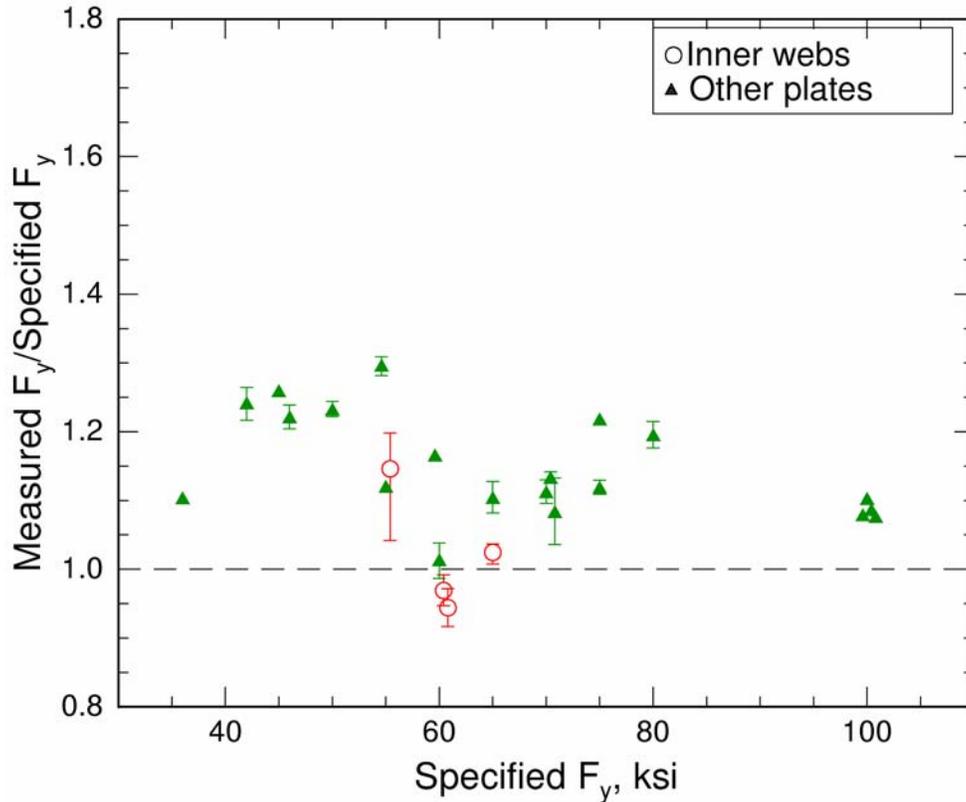
Note: The ratio values less than 1 arose from natural variation in the steel and did not affect the safety of the towers on September 11, 2001. The bars represent maximum and minimum values from multiple measurements.

Figure 5-4. Ratio of measured yield strength (F_y) to specified minimum yield strength for steels used in WTC perimeter columns.

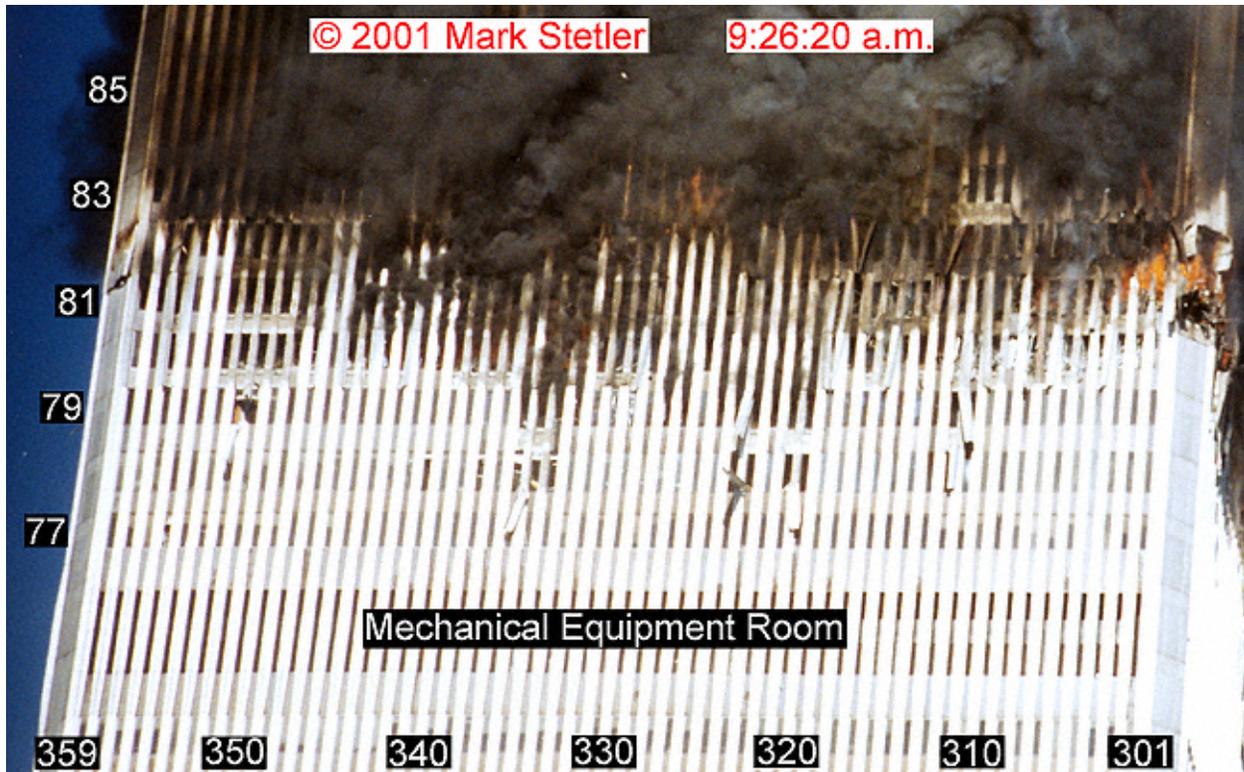
As an example of information that was extracted, Figure 6–1 shows an enhanced image of the east face of WTC 2. Figure 6–2 expands a section of interest. The amount of detail available is evident. For instance, large piles of debris are present on the north side of the tower on the 80th and 81st floors, and locations where fires are visible or where missing windows are easily identified. Many details of each frame were important in tracking the evolution of the fires and the damage to the buildings.

Figure 6–1. 9:26:20 a.m. showing the east face of WTC 2.

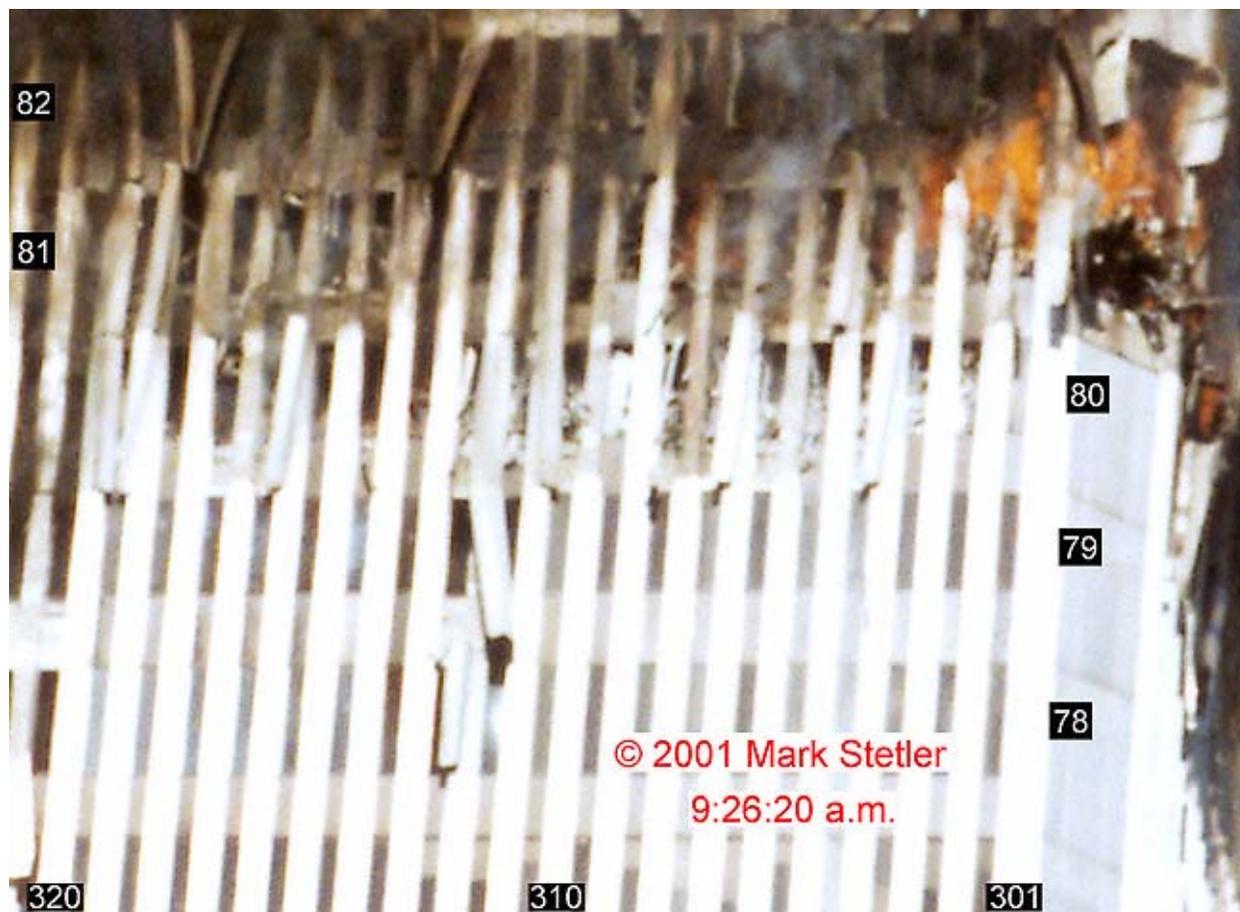
Figure 6–2. Close-up of section of Figure 6–1.

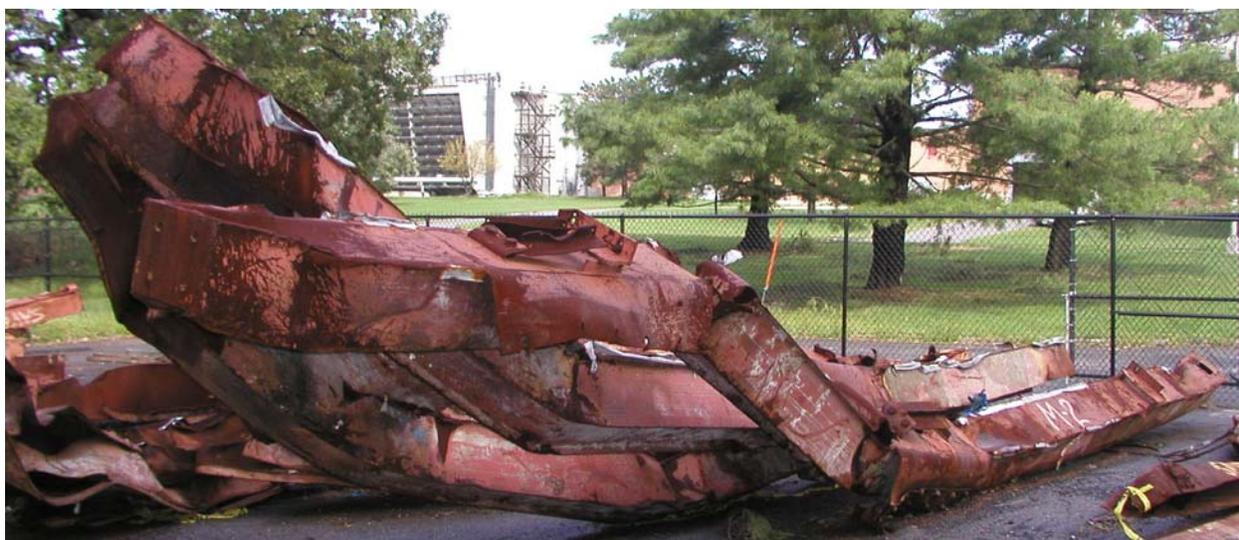
Figure 6–4. WTC 1 exterior panel hit by the fuselage of the aircraft.

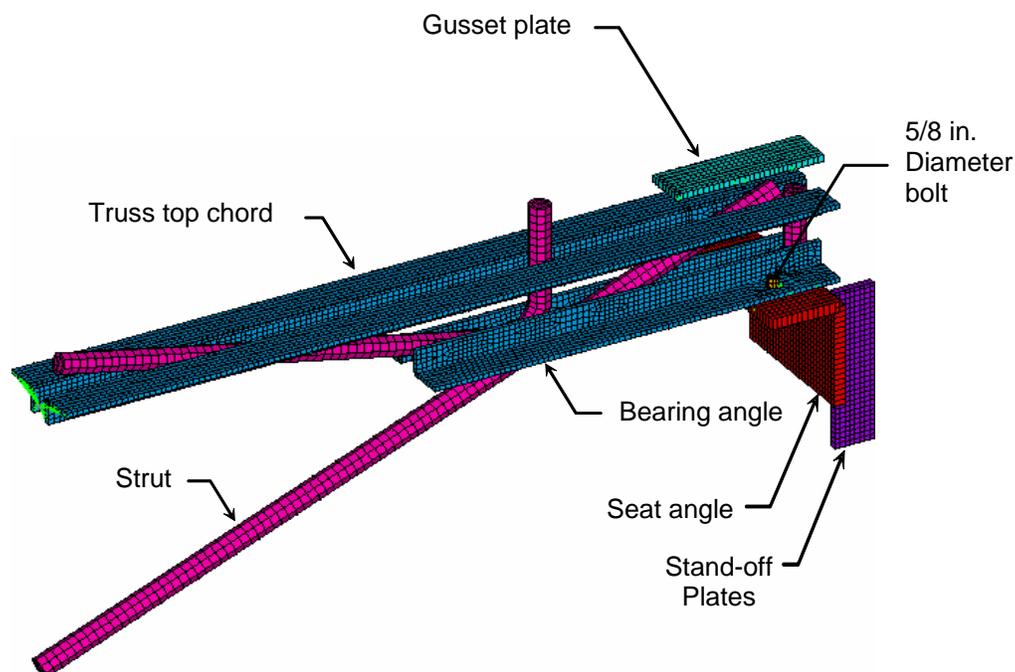
- **Truss seats.** Figure 6–10 shows how an exterior seat connection was represented in the finite element structural model. The component analysis determined that failure could occur at the bolted connection between the bearing angle and the seat angle, and the truss could slip off the seat. Truss seat connection failure from vertical loads was found to be unlikely, since the needed increase in vertical load was unreasonable for temperatures near 600 °C to 700 °C.
- **Knuckles.** The “knuckle” was formed by the extension of the truss diagonals into the concrete slab and provided for composite action of the steel truss and concrete slab. A model was developed to predict the knuckle performance when the truss and concrete slab acted compositely.

Figure 6–10. Finite element model of an exterior truss seat.

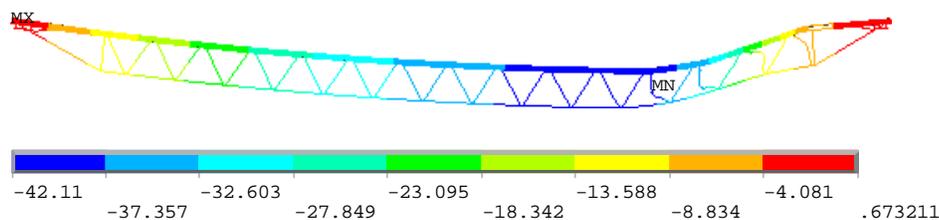
- Single composite truss and concrete slab section. A floor section was modeled to investigate failure modes and sequences of failures under combined gravity and thermal loads. The floor section was heated to 700 °C (with a linear thermal gradient through the slab thickness from 700 °C to 300 °C at the top surface of the slab) over a period of 30 min. Initially the thermal expansion of the floor pushed the columns outward, but with increased temperatures, the floor sagged and the columns were pulled inward. Knuckle failure was found to occur mainly at the ends of the trusses and had little effect on the deflection of the floor system. Figure 6–11 shows that the diagonals at the core (right) end of the truss buckled and caused an increase in the floor system deflection, ultimately reaching approximately 42 in. Two possible failure modes were identified for the floor-truss section: sagging of the floor and loss of truss seat support.

Figure 6–11. Vertical displacement at 700 °C.

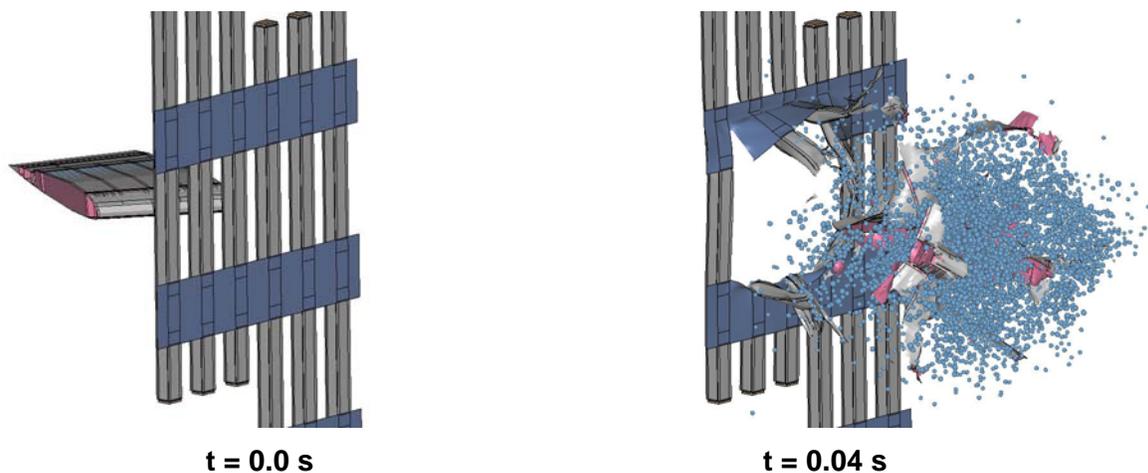
Figure 6–16 shows two frames from the last of these analyses, with the wing segment entering from the left, being fragmented as it penetrates the exterior columns, and spraying jet fuel downstream.

Figure 6–16. Calculated impact on an exterior wall by a fuel-laden wing section.

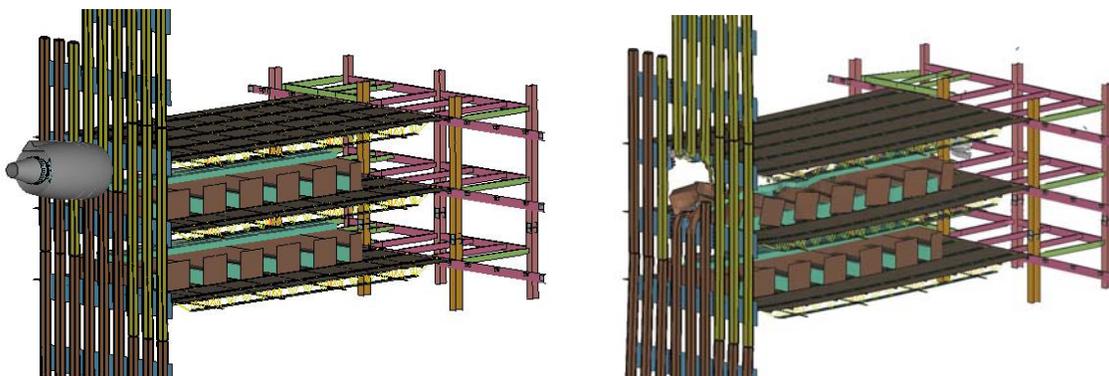
Next, a series of simulations were performed for intermediate-sized sections of a tower. These subassembly analyses investigated different modeling techniques and associated model sizes, run times, numerical stability, and impact response. Six simulations were performed of an aircraft engine impacting a subassembly that included structural components from the impact zone on the north face of WTC 1, exterior panels, truss floor structures, core framing, and interior contents (workstations). One response of the structure to the engine impact is shown in Figure 6–17.

Figure 6–17. Response of a tower subassembly model to engine impact.

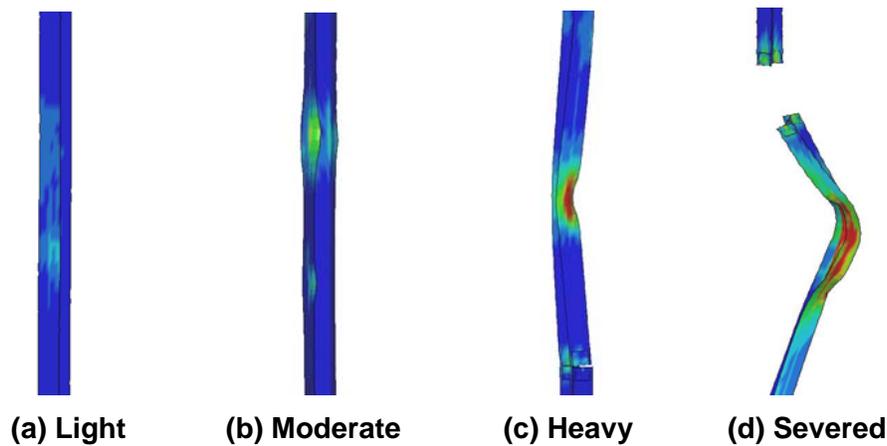
Each of the four global simulations generated information about the state of the structural components following the impact of the aircraft. The four degrees of column damage are defined as follows and shown graphically in Figure 6–19. The unstrained areas are blue and the highly strained areas are red.

- Lightly damaged column: column impacted, but without significant structural deformation;
- Moderately damaged column: visible local distortion, but no deformation of the column centerline;
- Heavily damaged column: Permanent deflection of the column centerline; and
- Failed column: Column severed.

Figure 6–19. Column damage levels.

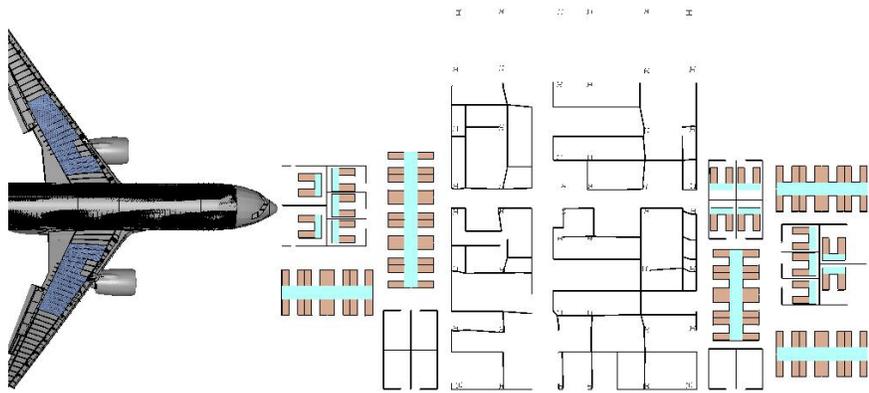
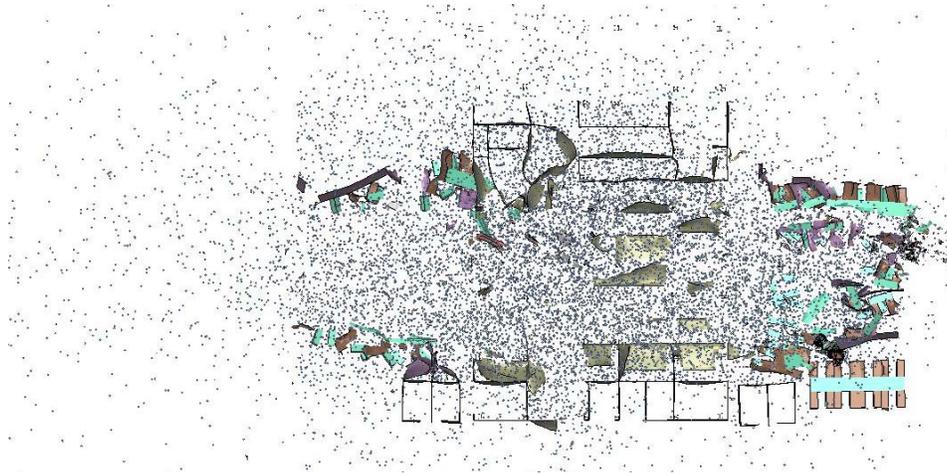
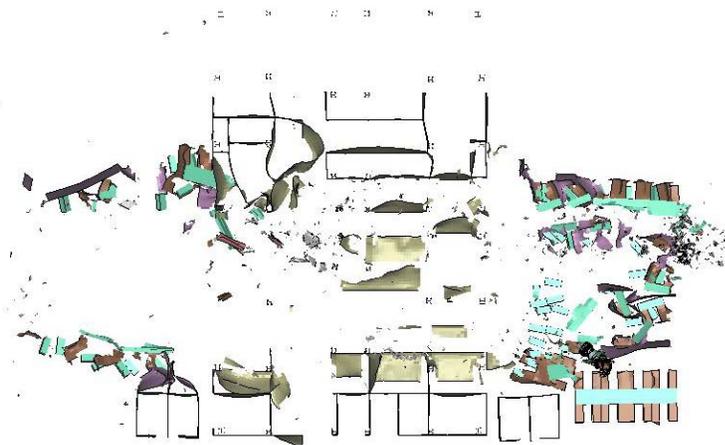
Figure 6–21. Case B simulation of response of contents of 96th floor of WTC 1.

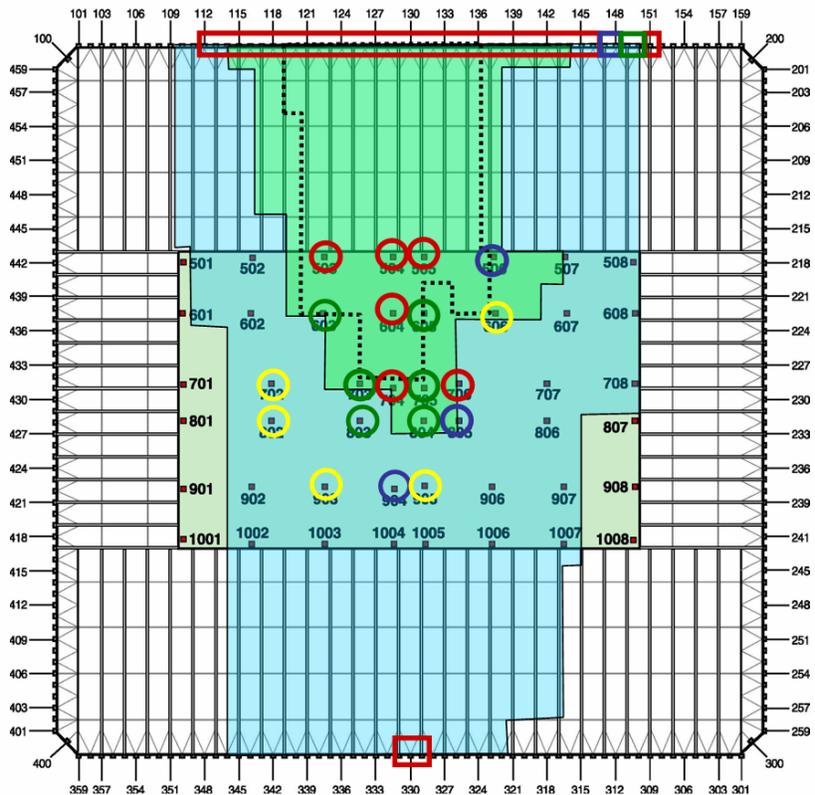
Figure 6–23. Combined structural damage to the floors and columns of WTC 1, Case B.

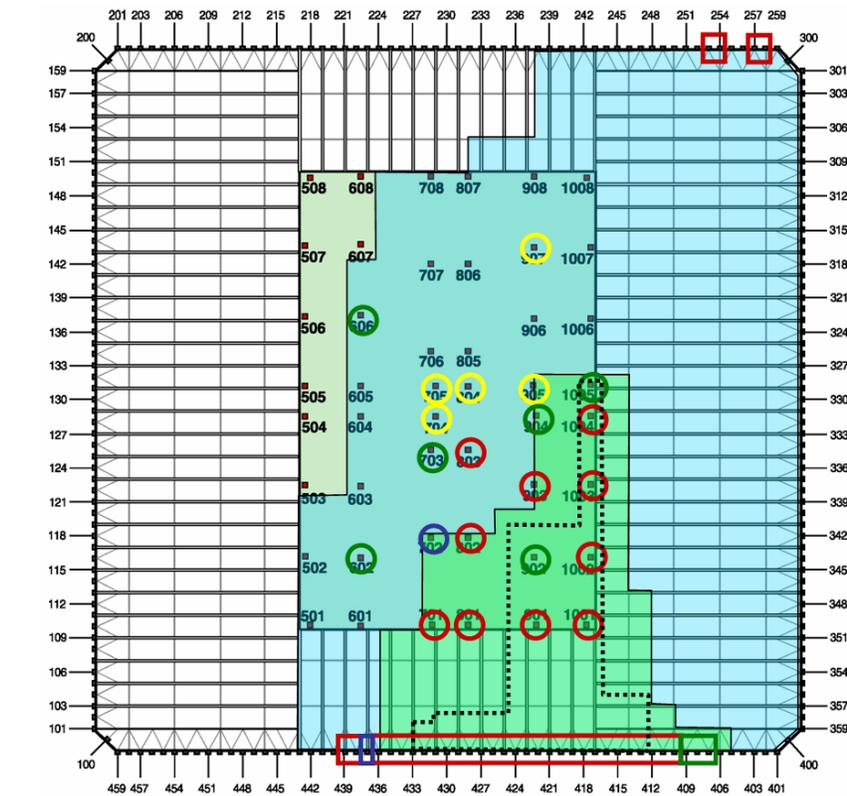
Figure 6-25. Combined structural damage to the floors and columns of WTC 2, Case D.

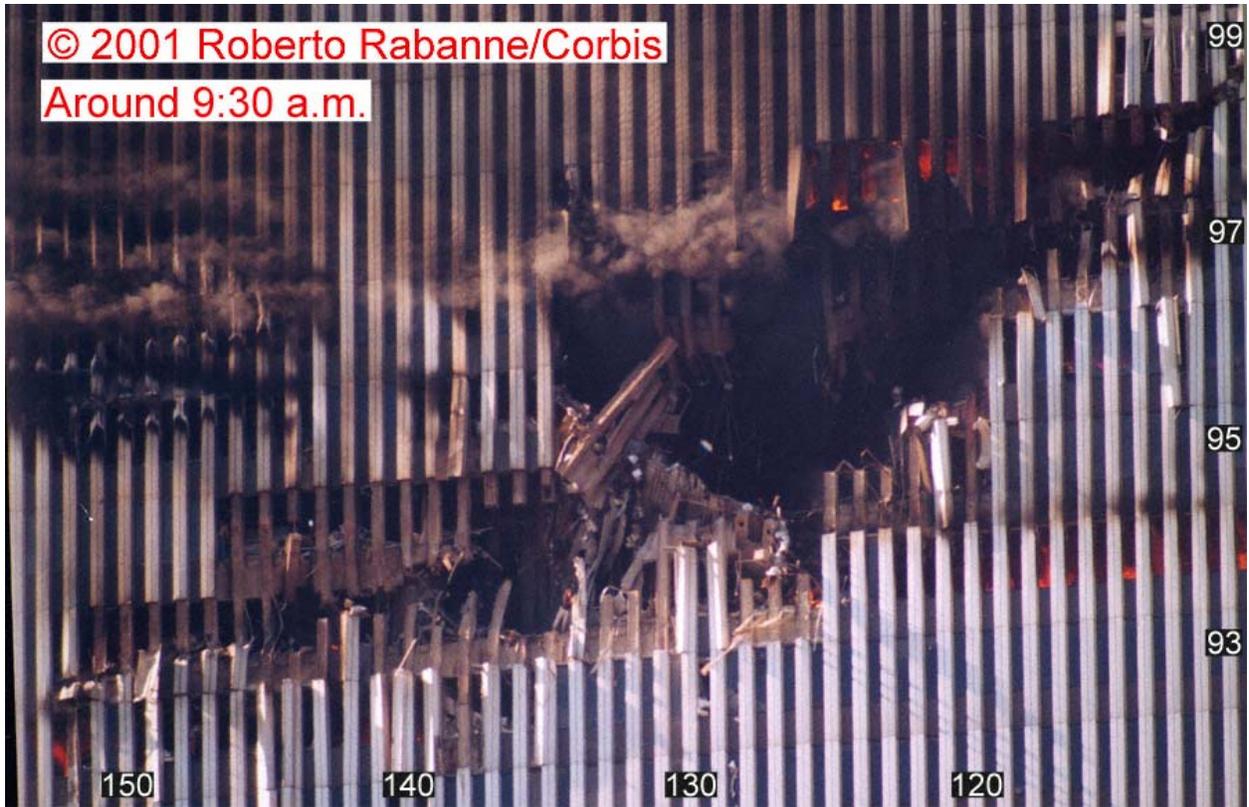
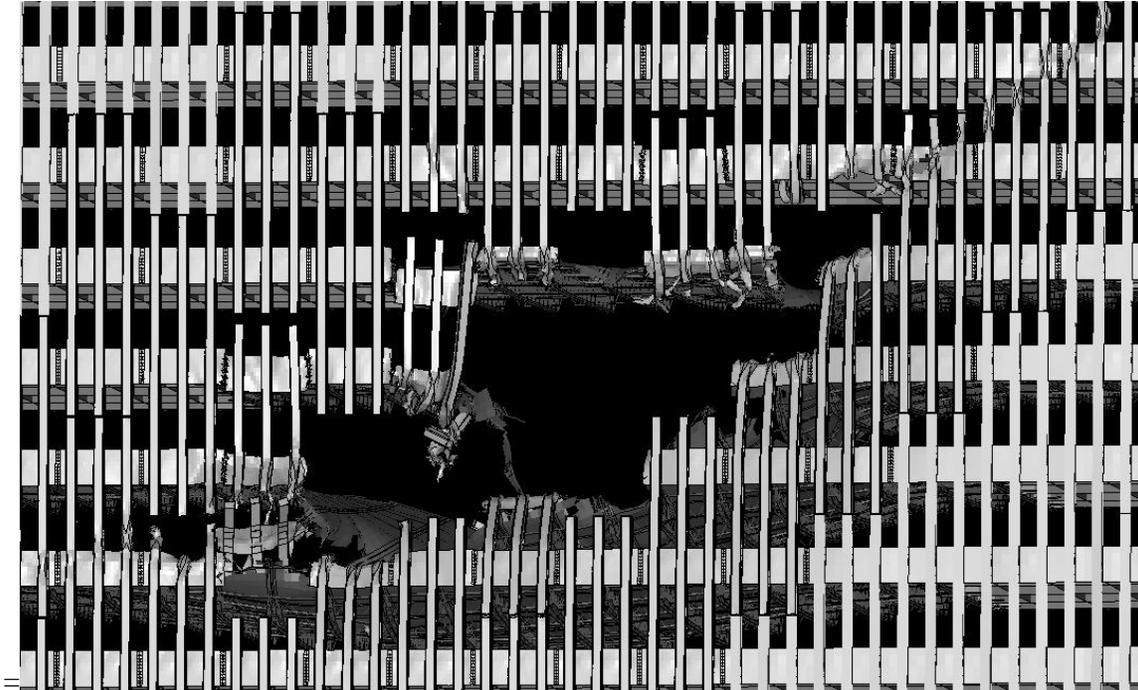
Assessment of the aircraft impact simulations of exterior damage to the towers involved comparing the predicted perimeter wall damage near the impact zone with post-impact photographs of the walls. Figure 6–26 shows a photograph of the north face of WTC 1 after impact and the results of the Case A simulation. The calculated silhouettes capture both the position and shape of the actual damage.

Figure 6–26. Observed and Case A calculated damage to the north face of WTC 1.

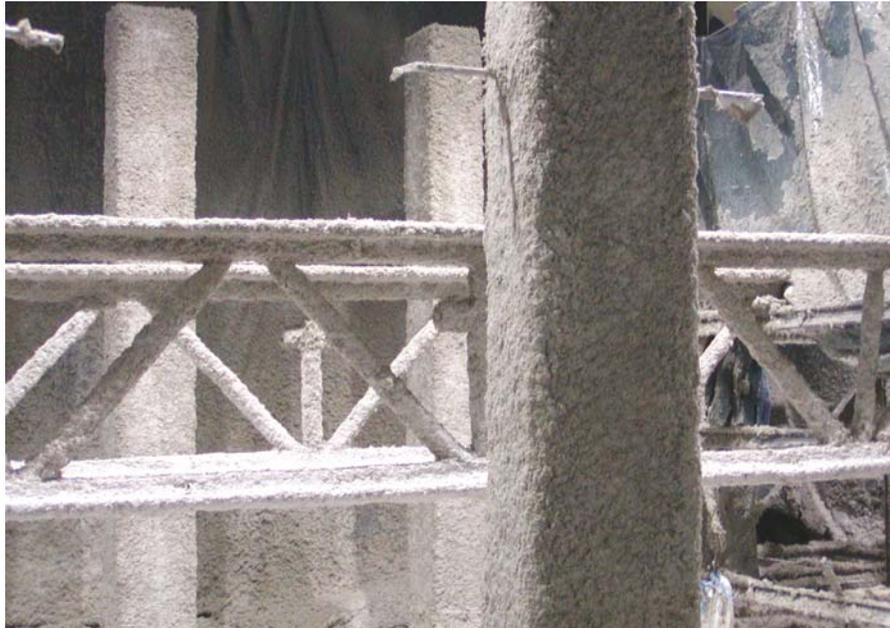
experienced applicator, who took considerable care to apply an even coating of the specified thickness. As such, the insulated test subjects represent a best case in terms of thickness and uniformity. Figure 6-42 shows some of the coated components.

Figure 6-42. SFRM-coated steel components prior to a test.

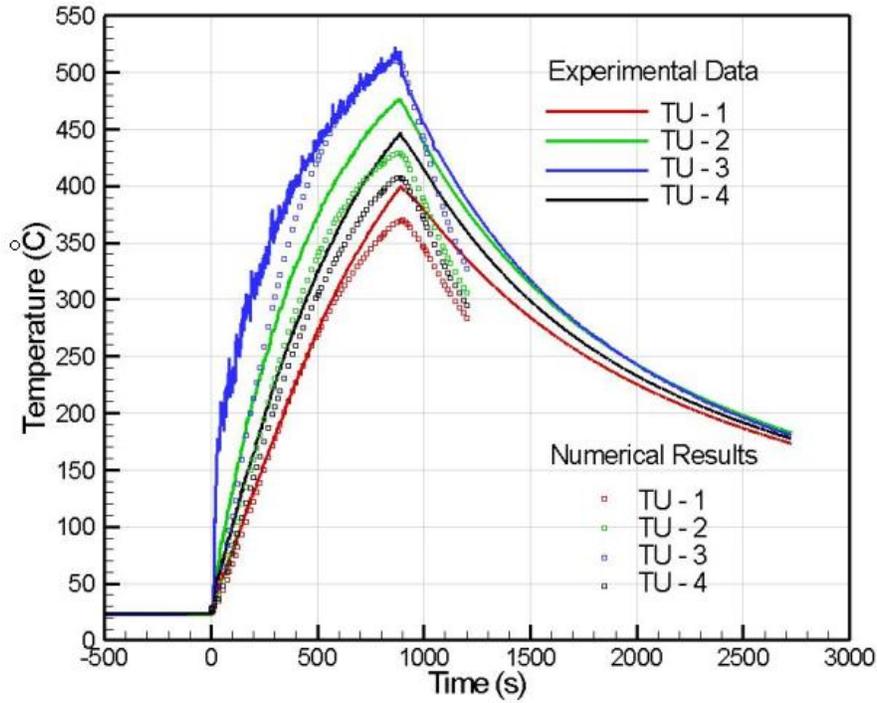
Figure 6-44. Comparison of numerical simulations with measurements for the steel surface temperature at four locations on the top chord of a bare truss.

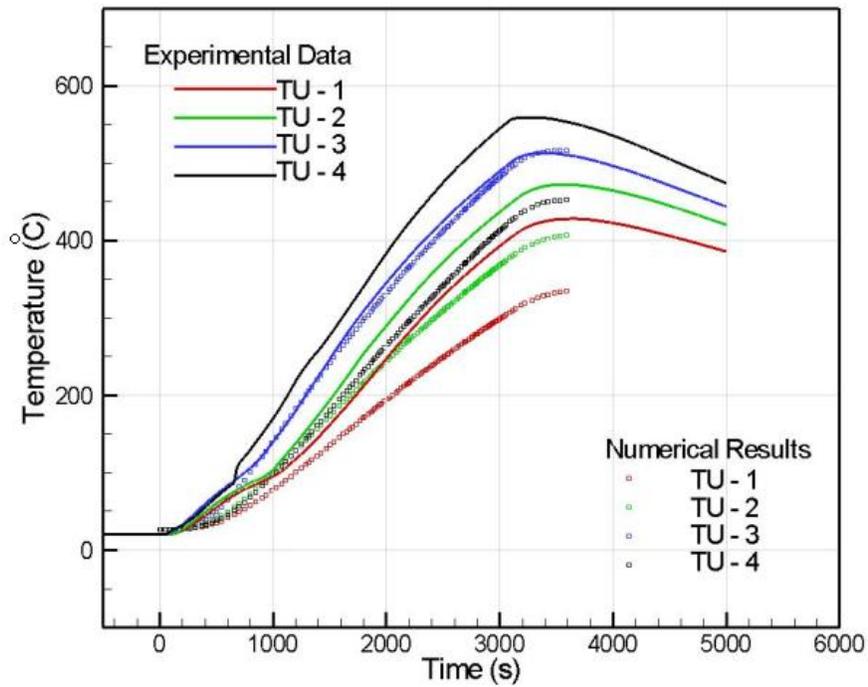
Figure 6-45. Comparison of numerical simulations with measurements for the temperature of the steel surface at four locations on the top chord of an insulated truss.

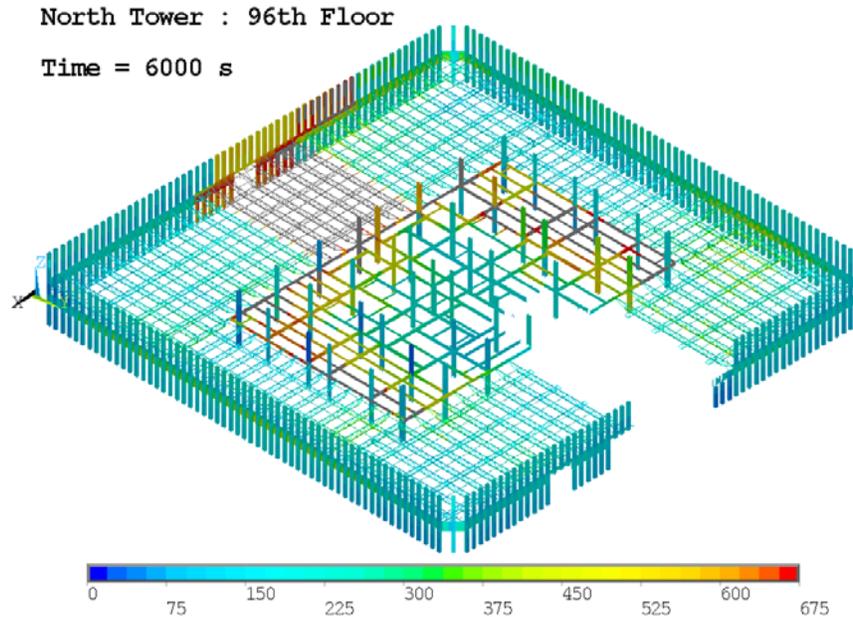
For ease of visualization, two graphic representations were developed. Figure 6–46 shows an example of the temperature map for the 96th floor of WTC 1. Severed columns and broken floor segments are not shown. Figure 6–47 shows a similar map for the 81st floor of WTC 2.

Figure 6–46. Temperatures (°C) on the columns and trusses of the 96th floor of WTC 1 at 6,000 s after aircraft impact, Case B.

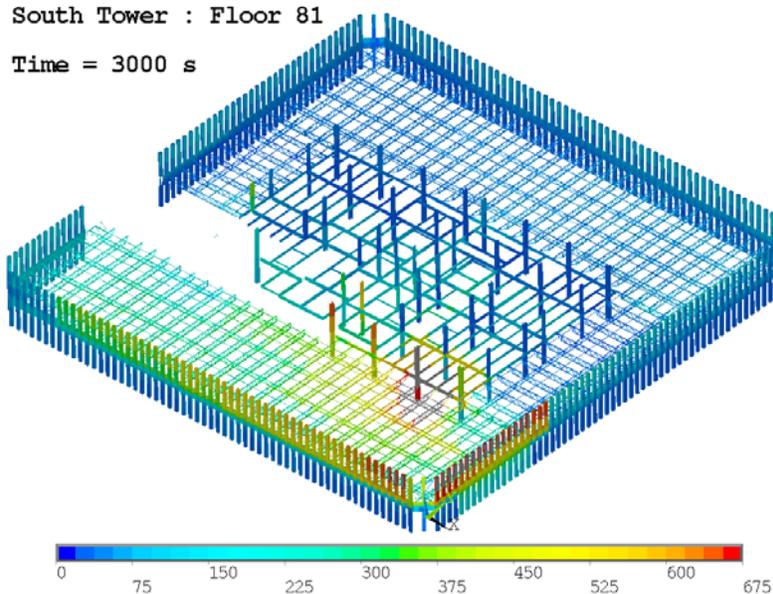
Figure 6–47. Temperatures (°C) on the columns and trusses of the 81st floor of WTC 2 at 3,000 s after aircraft impact, Case D.

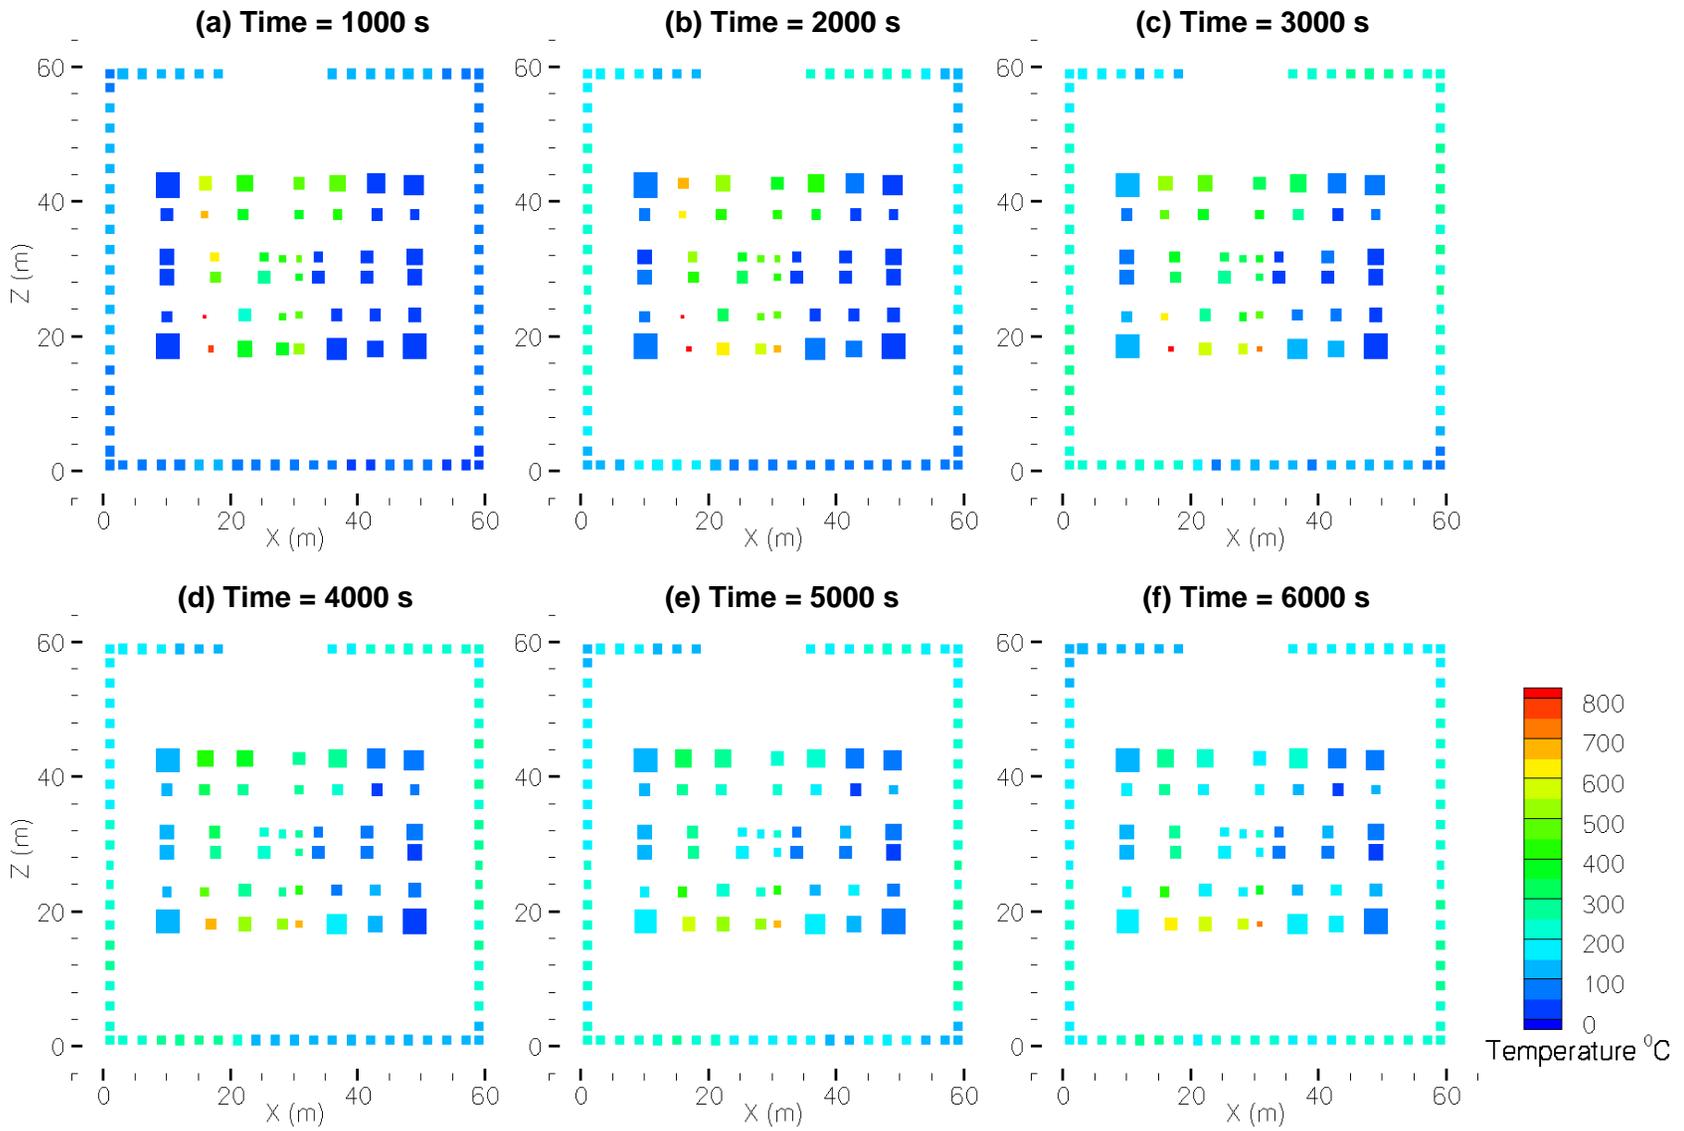
A third visualization tool was animation of the evolving temperatures of the columns. Frames from an example, again of the 96th floor of WTC 1, Case A, are shown in Figure 6–48. The size of the square representing a column represents its yield strength. Columns may have been heated when the fire was nearby and then cooled after the local combustibles were consumed.

Figure 6–48. Frames from animation of the thermal response of columns on the 96th floor of WTC 1, Case A.
