**NIST NCSTAR 1-5A**

**Federal Building and Fire Safety Investigation of the  
World Trade Center Disaster**

**Visual Evidence, Damage Estimates,  
and Timeline Analysis**

September 2005

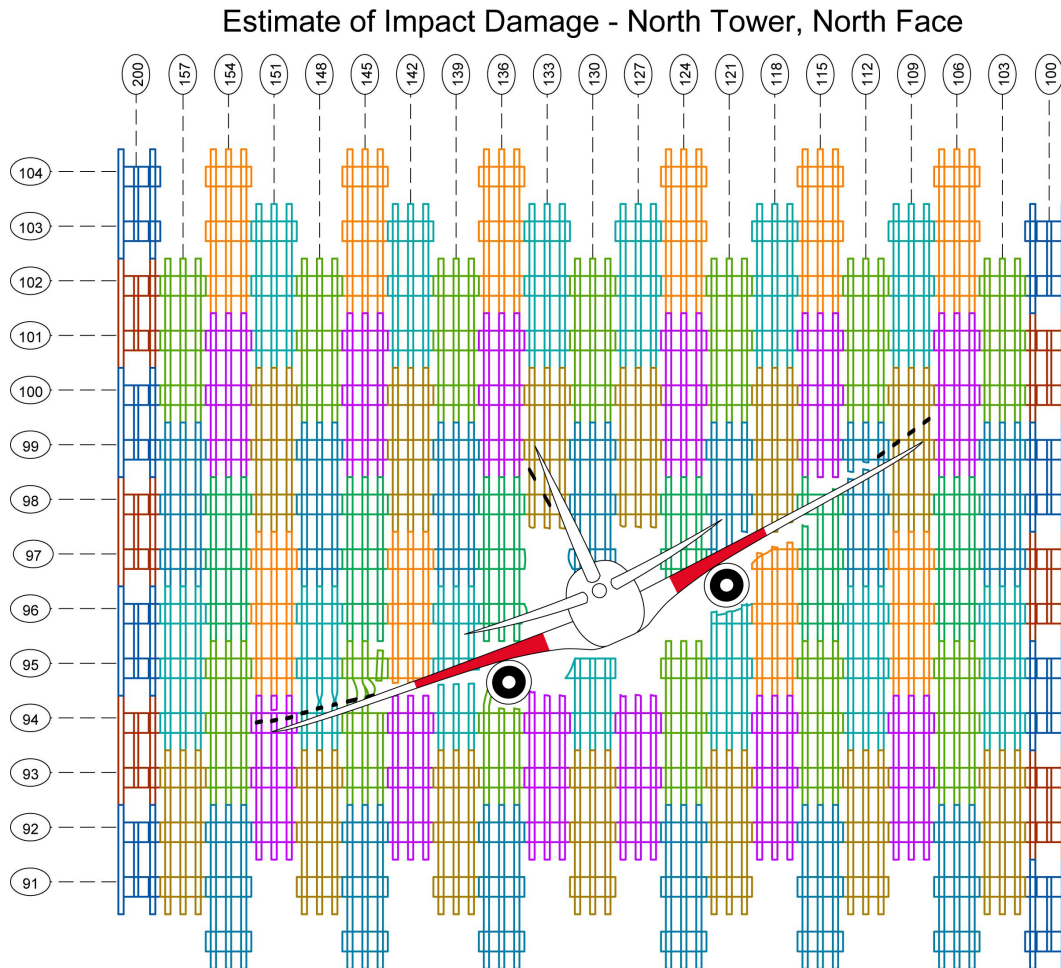
Close-up photographs and videos showing the area of the aircraft impact on the north face were used to generate the damage diagram shown in Figure E-1. Images show that substantial areas of the concrete floor slabs for the 95th through 97th floors were destroyed to an unknown depth within the tower in the immediate vicinity of the aircraft impact area. Locations where the two wing tips and the aircraft’s vertical stabilizer struck the façade are represented by dashed lines in Figure E-1. The locations of the wing marks indicate that the aircraft struck between the 93rd and 99th floors. A properly scaled outline of a Boeing 767-200ER is superimposed on the damage diagram. The position of the aircraft has been adjusted to provide good agreement with the observed damage pattern and the wing and vertical stabilizer marks. The drawing indicates that the nose of the aircraft struck close to the center of the face near columns 129 and 130 at a height that was near the concrete floor slab for the 96th floor.

**Figure E-1. A scaled outline of a Boeing 767-200ER is superimposed on the damage diagram for the north face of WTC 1. The position of the aircraft has been adjusted to best match the damage pattern and marks showing where the wing tips and vertical stabilizer struck. The red areas correspond to the approximate locations of fuel on the aircraft based on an analysis reported elsewhere (NIST NCSTAR 1-2B).**

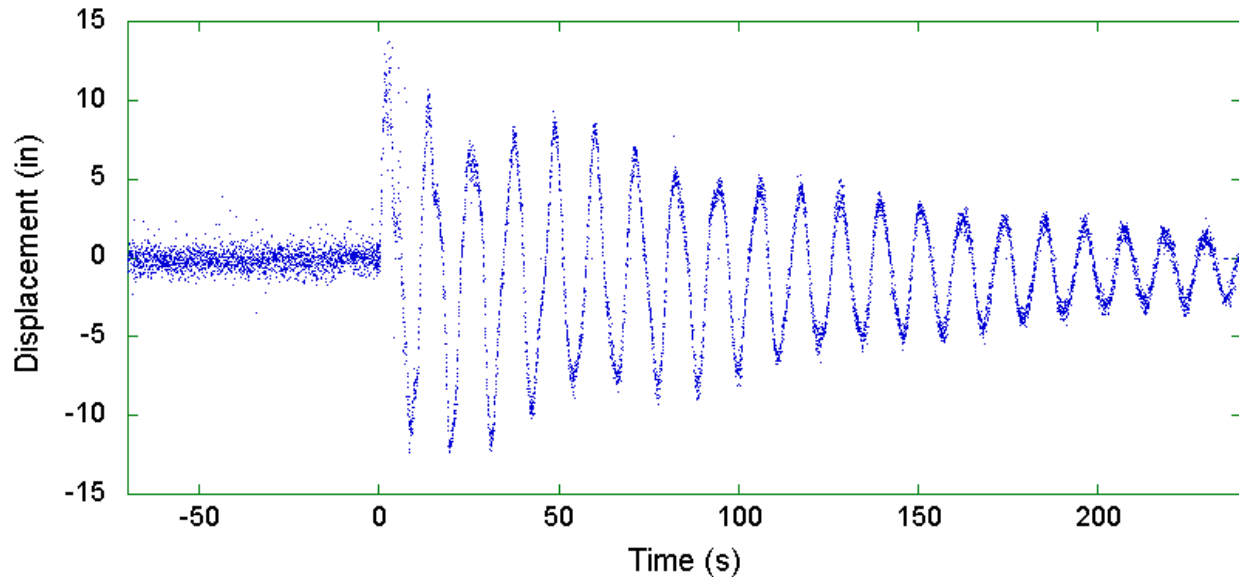
Close examination of this video revealed a perceptible north-south movement of WTC 2 after it was struck by the aircraft. Image analysis of the video allowed the movement of the tower at the 70th floor to be determined as shown in Figure E-2. The maximum deflection was determined to be  $12 \text{ in.} \pm 1 \text{ in.}$  at this height, which extrapolates to a value of  $22 \text{ in.} \pm 5 \text{ in.}$  at the roofline. The primary period for the motion was  $11.4 \text{ s} \pm 0.1 \text{ s}$ , consistent with the fundamental natural mode of the building. Similar measurements using a brief video shot from the north yielded an amplitude near the roof line of  $6 \text{ in.} \pm 1 \text{ in.}$  for the east-west direction with a period of  $5.3 \text{ s} \pm 0.1 \text{ s}$ . This period and motion are consistent with the first torsional (twisting) mode of the tower.

**Figure E-2. The displacement of the first (left-most) window line on the 70th floor of WTC 2 determined using moiré analysis is shown as a function of time.**

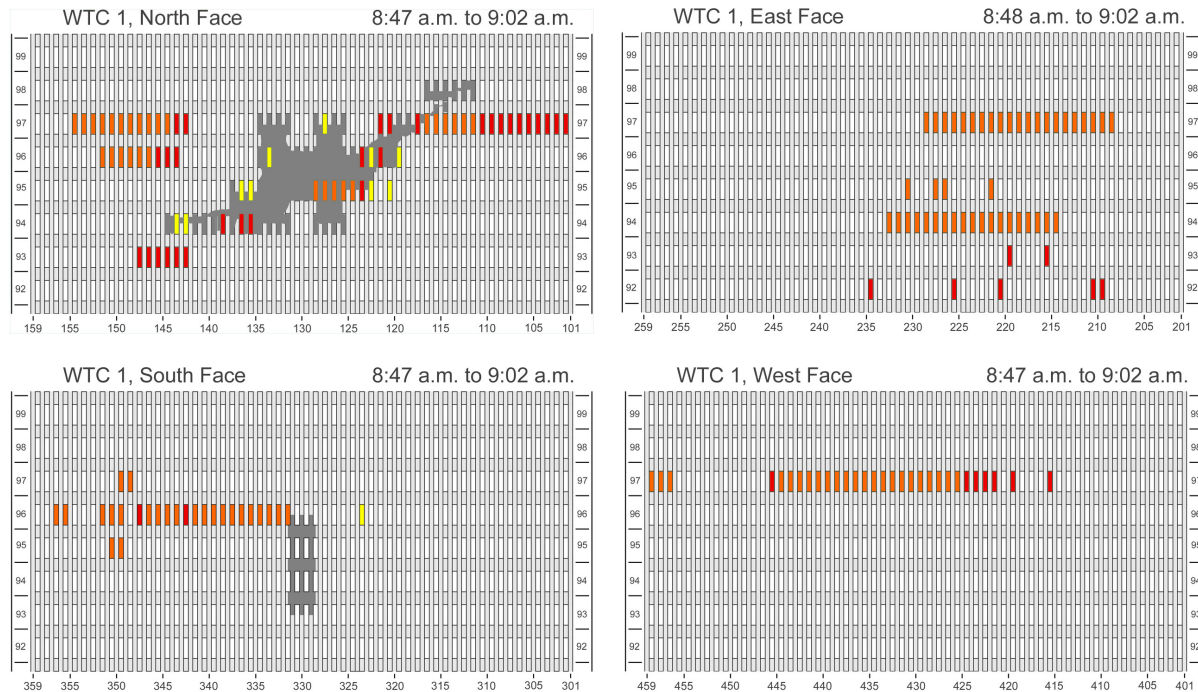
Fire observations for the period are summarized by the façade maps in Figure E-4, which show fire locations integrated over the period. The color coding indicates the highest fire intensity recorded during the period, with yellow representing a spot fire, red a more extensive fire burning inside the tower, and orange a fire with flames extending out of the window.

**Figure E-4. Maps of integrated fire observations between 8:47 a.m. and 9:03 a.m. are shown for the four faces of WTC 1.**

The most extensive fire growth took place on the 97th floor. The apparent rapid development of these fires, particularly on the west face, may be an indication that the fire growth and spread was accelerated by the presence of initially unburned aviation fuel that may have been dispersed over this floor during the aircraft impact.

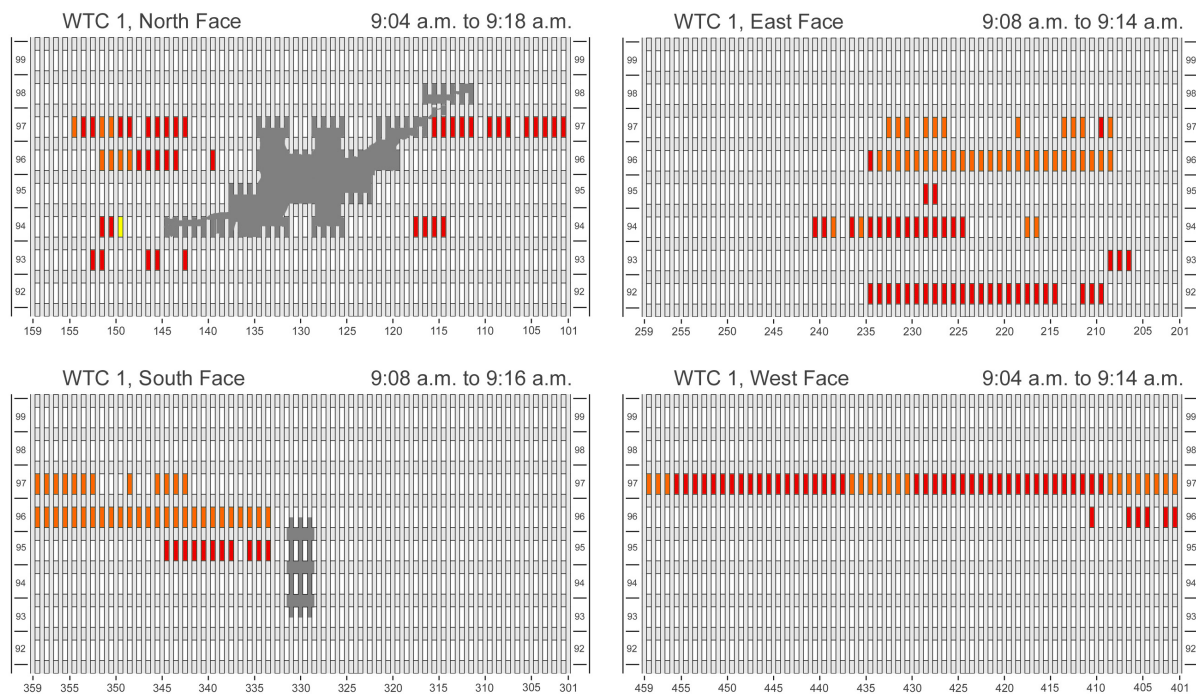
Figure E-5 shows integrated fire maps for the four faces of WTC 1 covering the period. Comparison with Figure E-4 reveals the changes in fire distributions between the two time periods. The most prominent feature in Figure E-5 is the extent of the fires on the 97th floor, with flames visible in a nearly continuous band running clockwise from just west of the center of the south face, along the western and northern faces, and reaching just past the center of the east face. Another feature which stands out is the general lack of visible fire in the southwest quadrant of the tower.

**Figure E-5. Maps of integrated fire observations between 9:03 a.m. and 9:18 a.m. are shown for the four faces of WTC 1.**

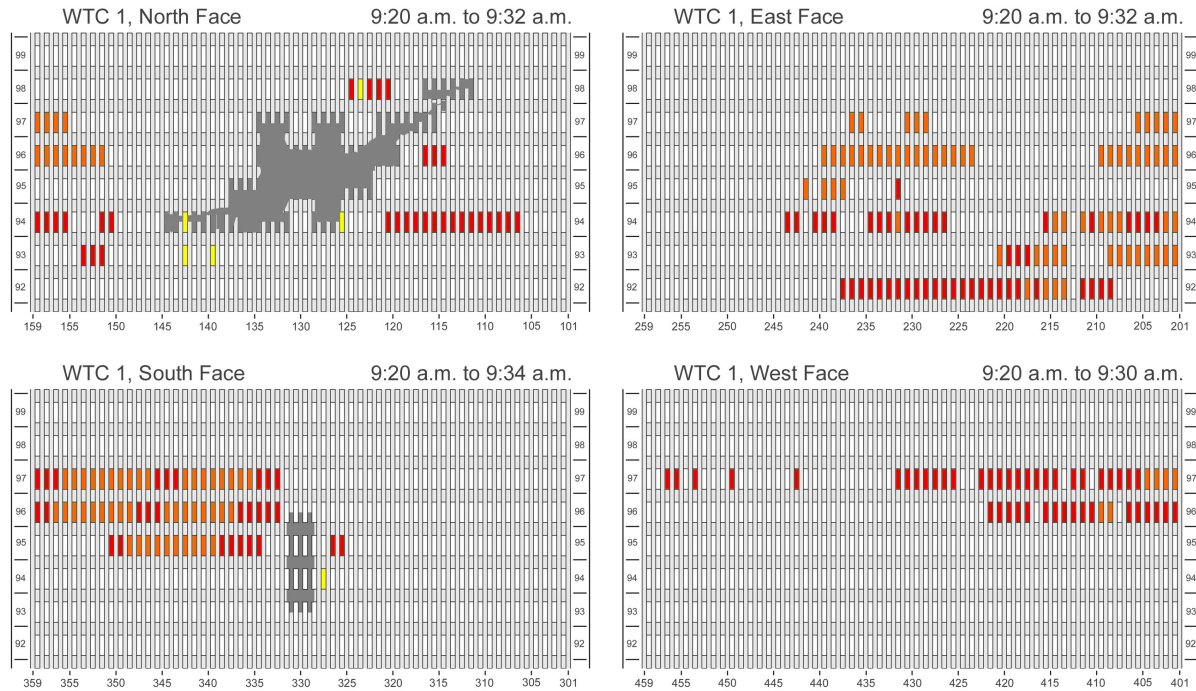
Integrated façade maps for the fires observed during the period are shown in Figure E-6. In general, fire spread during this period was reduced compared to the first two periods. While intensely burning fires with extended flames developed in northeast corner rooms on several floors, most of the new fire growth involved less intense flames that did not extend from windows. Such fires included those on the west side of the 94th floor and the central section of the 98th floor on the north face and the south side of the 96th floor on the west face.

**Figure E-6. Maps of integrated fire observations between 9:19 a.m. and 9:35 a.m. are shown for the four faces of WTC 1.**

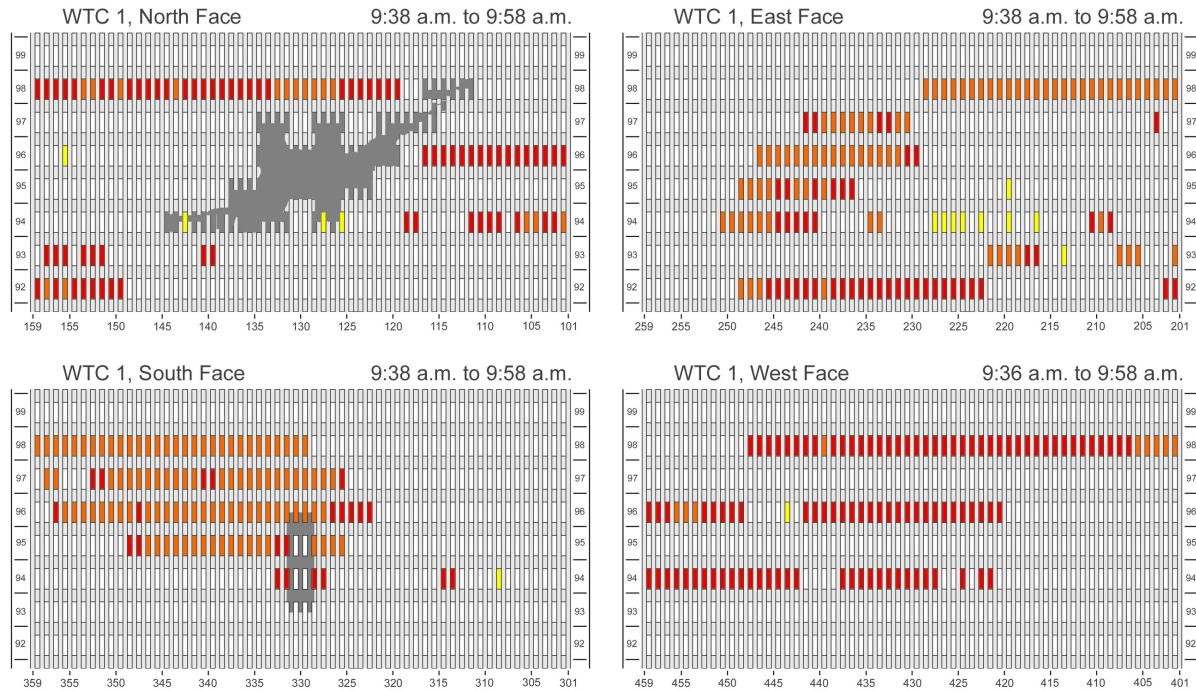
**Figure E-7. Maps of integrated fire observations between 9:36 a.m. and 9:59 a.m. are shown for the four faces of WTC 1.**

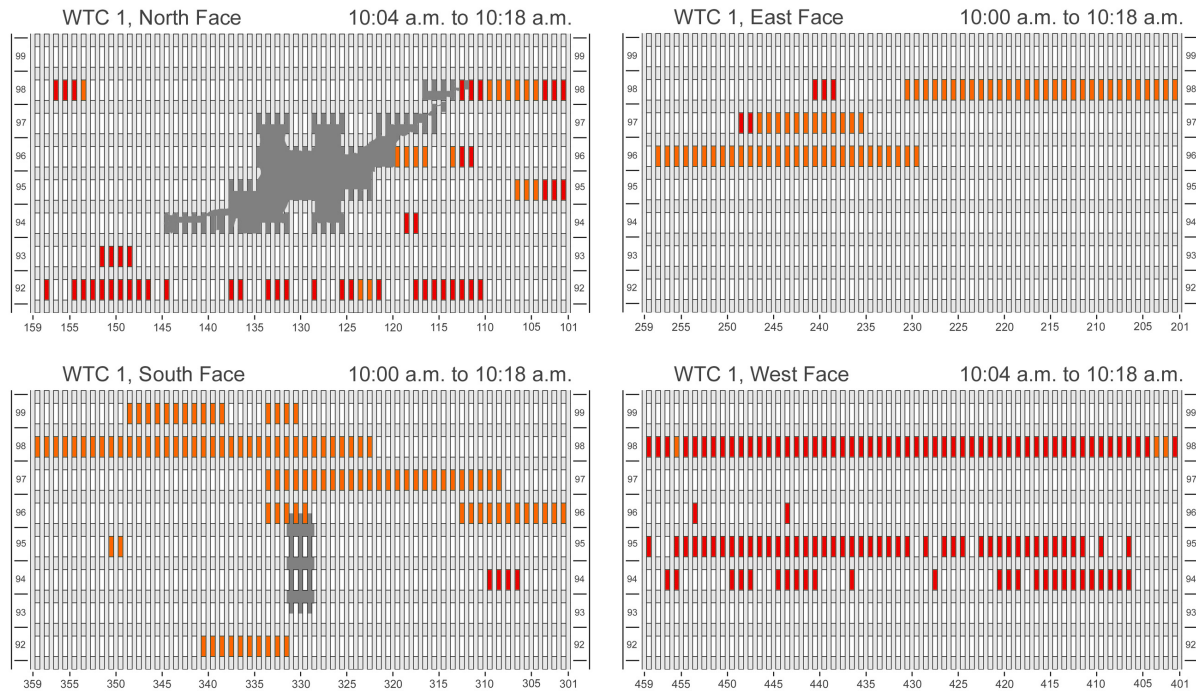
Integrated fire maps of the four faces for the period are included in Figure E-8. These maps likely underestimate the actual extent of the fires due to the limited visibility on the east and south faces. The extensive fires on the 98th floor are a dominant feature. Keep in mind that the much of the fire on the north side of this floor had already died down. The intense fires that developed rapidly along the periphery of the southeast quadrant also stand out. The broad extent of the low intensity fires on the west

sides of the 94th and 95th floors is also evident. Note that the intense fire that grew on the south side of the west face of the 104th floor is not displayed in the façade map.

**Figure E-8. Maps of integrated fire observations between 10:00 a.m. and 10:18 a.m. are shown for the four faces of WTC 1.**

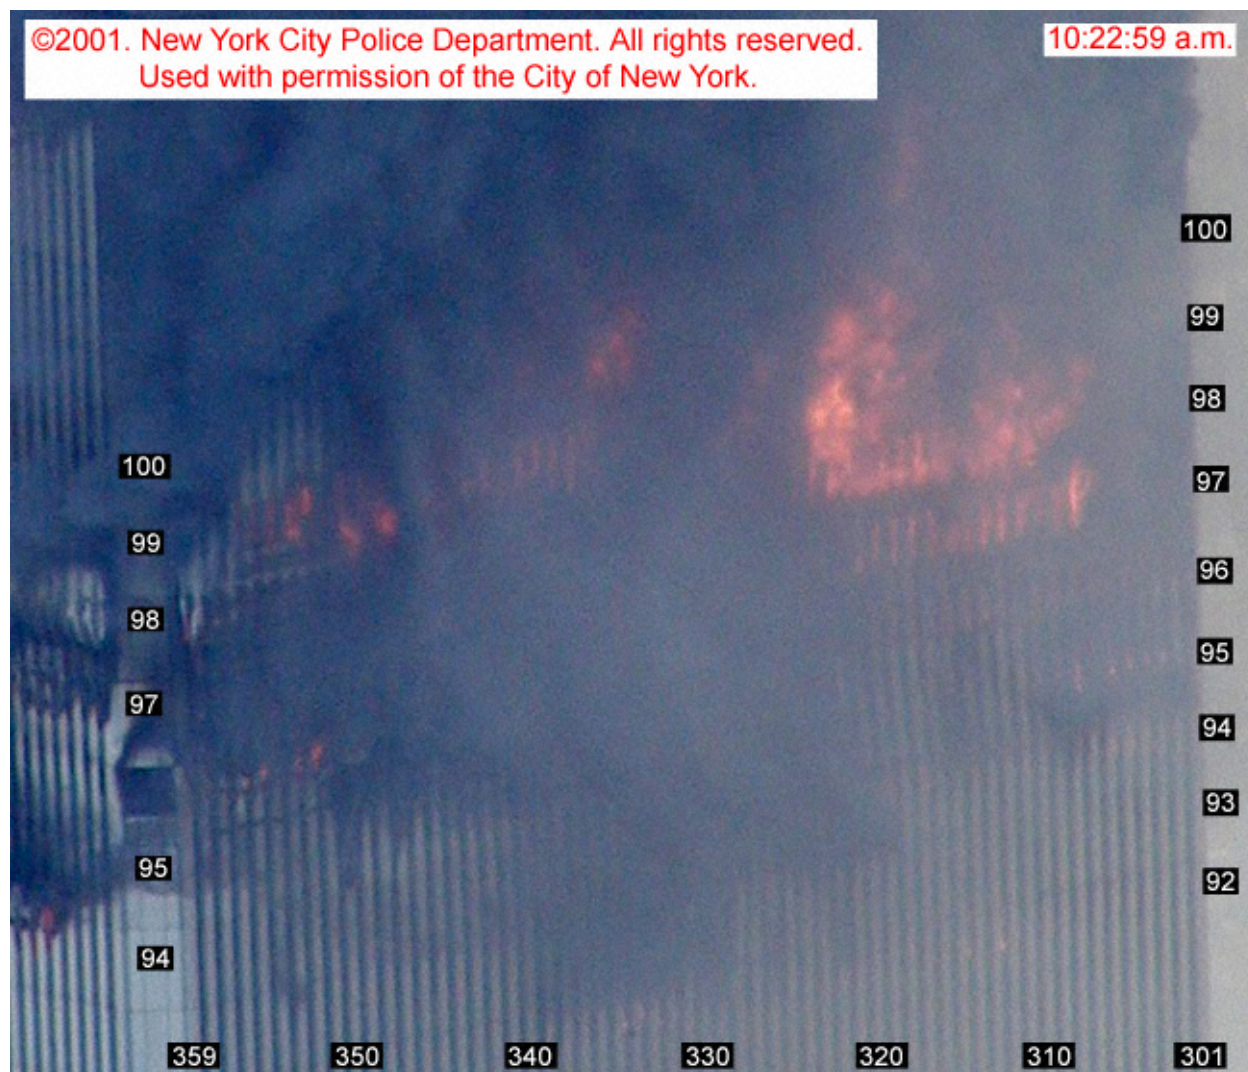
Views of the south face of WTC 1 were also limited for this time period, but several photographs taken from a helicopter flying relatively close to the tower provided a good indication of conditions on this face roughly half way through the period. Figure E–9 shows a cropped view of one of these photographs shot from the southwest at 10:22:59 a.m. Fires are visible on the east side of the face on the 92nd through 98th floors. A long distance video showed that the particularly intense fire on the 98th floor moved into the area around 10:19 a.m. Closer inspection reveals that many of the columns on the south face in the vicinity of 95th floor to the 98th floors were bowed inward at this time. Somewhat smaller flames are visible on the west side of the face on the 92nd, 96th, 98th, 99th, and 100th floors. Around 10:25 a.m. heavy smoke and fire appeared from windows in a room located in the southwest corner of the 94th floor. Long distance videos show that during the period leading up to the tower collapse the line of fire on the 98th floor continued to burn vigorously. The fire on the 99th floor appeared to intensify and move toward the east, eventually reaching a location more than half way between the center of the face and the east edge. When WTC 1 began to collapse, a large amount of flame was pushed from openings on the south face, with flames appearing to come from three separate locations. The first was from the vicinity of the intense fire burning on the east sides of the 98th and 99th floors, the second was from the fire burning on the western edge of the 94th floor, and the third came from around the center of the face near the 94th floor.

**Figure E–9.** This photograph showing the south face of WTC 1 is a cropped version of a photograph shot from a helicopter at 10:22:59 a.m. It has been enhanced by adjusting the intensity levels, and column and floor numbers have been added.

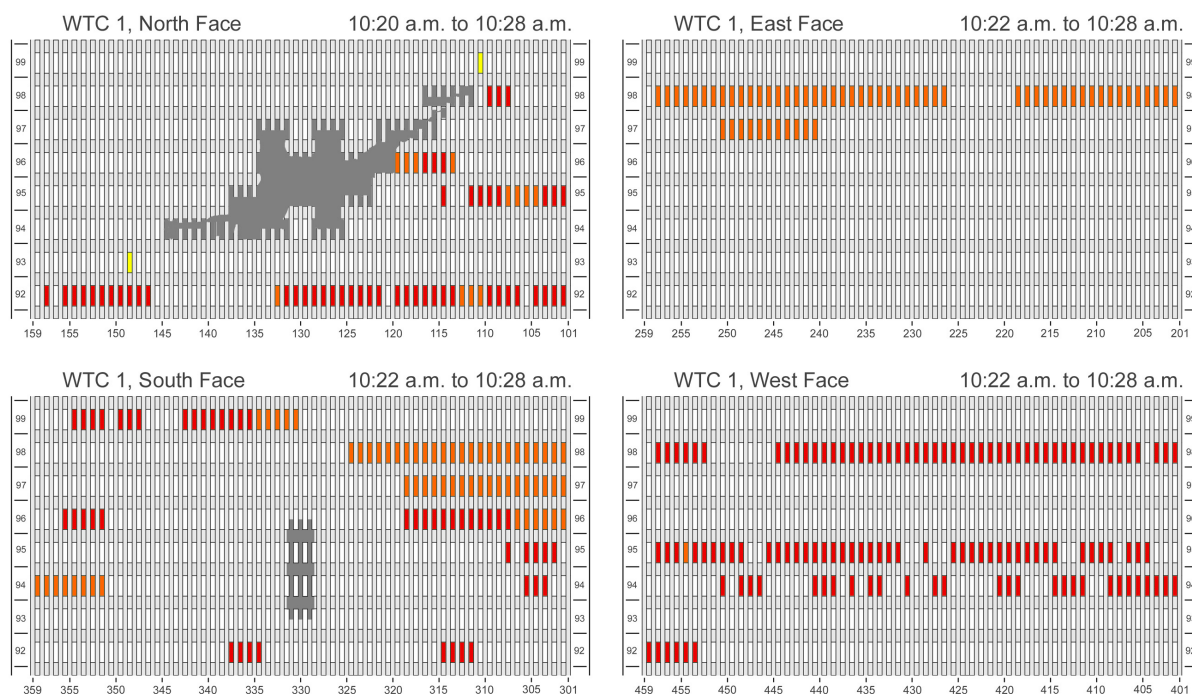
The integrated fire data for the period are shown in Figure E–10. A notable feature is the widespread presence of intense fire in the southeast quadrant of the tower following a long period when the area seemed to be isolated from fires burning elsewhere.

**Figure E–10. Maps of integrated fire observations between 10:20 a.m. and 10:28 a.m. are shown for the four faces of WTC 1.**

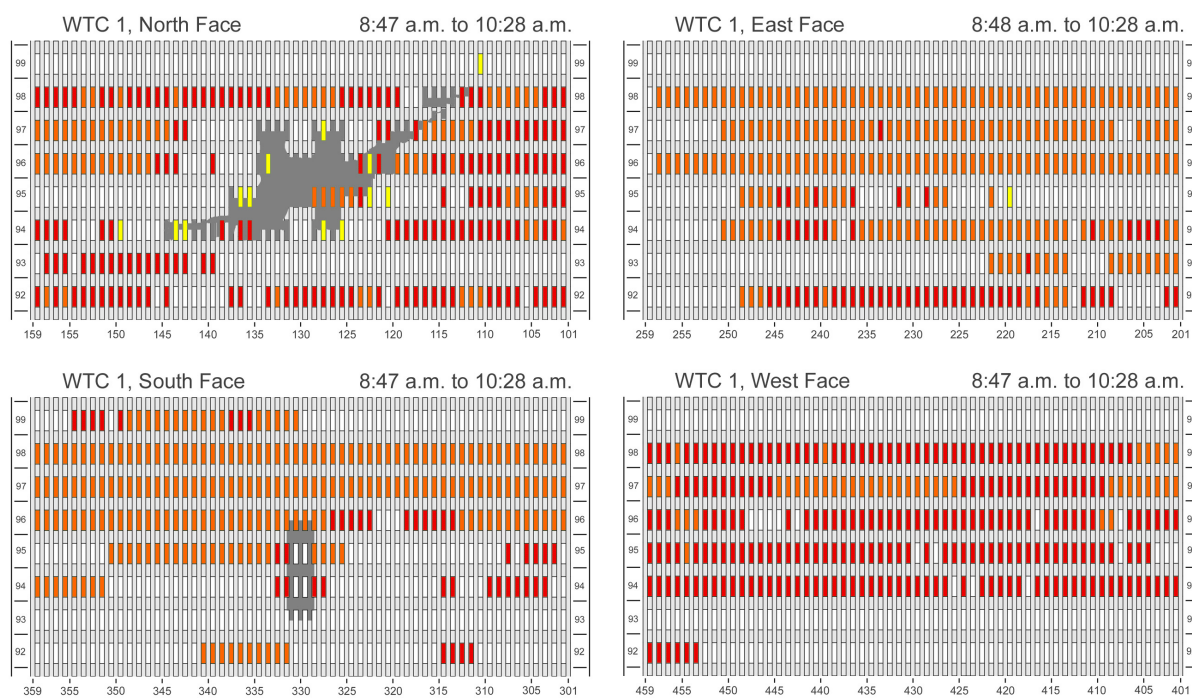
An interesting aspect of the fire behavior in WTC 1 was the variation in burning behavior observed on the different faces. Fires at most locations on the west and north faces of the towers burned without flame extension or release of large amounts of smoke from nearby windows. In many cases the fires appeared to burn as relatively low intensity distributed flames. The preponderance of red in the north and west face maps in Figure E-11 reflects this type of burning. In contrast, the fires burning on the east and south faces

most often generated external flames and heavy smoke flows at nearby windows as indicated by the extensive areas of orange on the façade fire maps. Various explanations for the different burning behaviors were considered. The most plausible is the effect of the prevailing wind. On September 11, the wind was striking WTC 1 from the northwest and then flowing down the north and west faces. This wind created positive pressures at the windows on these faces that tended to resist gas flows out of the tower. On the east and south faces the effect of the wind was the opposite, creating low pressure areas at the windows that tended to draw gases out of the building. The net effect of these pressure forces was a tendency for gases to flow internally on a floor, if a pathway was available, from the west and north faces to the east and south faces.

**Figure E-11. Maps of integrated fire observations between 8:47 a.m. and 10:28 a.m. are shown for the four faces of WTC 1.**

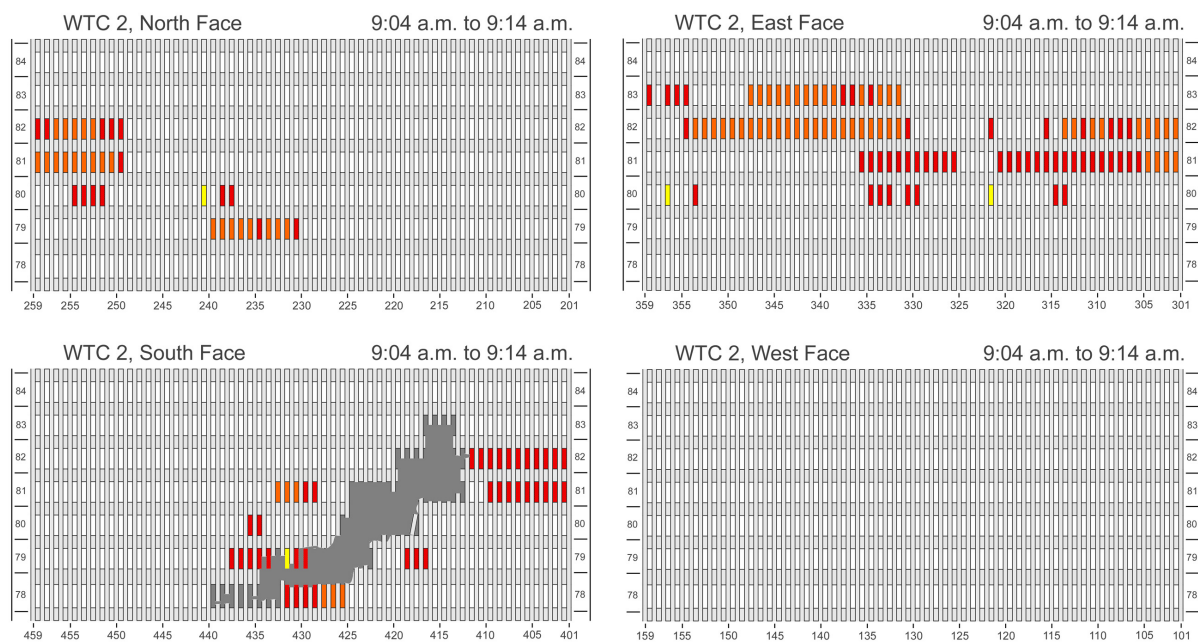
The fire data sheets for the period were integrated as a means for summarizing the fire distributions. The results are shown in Figure E-12. From these maps it is clear that the major visible fires were burning on the east and north faces of the tower. The most intense fires were on the 81st through 83rd floors, i.e., the upper portion of the floors impacted by the aircraft.

**Figure E-12. Maps of integrated fire observations between 9:04 a.m. and 9:14 a.m. are shown for the four faces of WTC 2.**

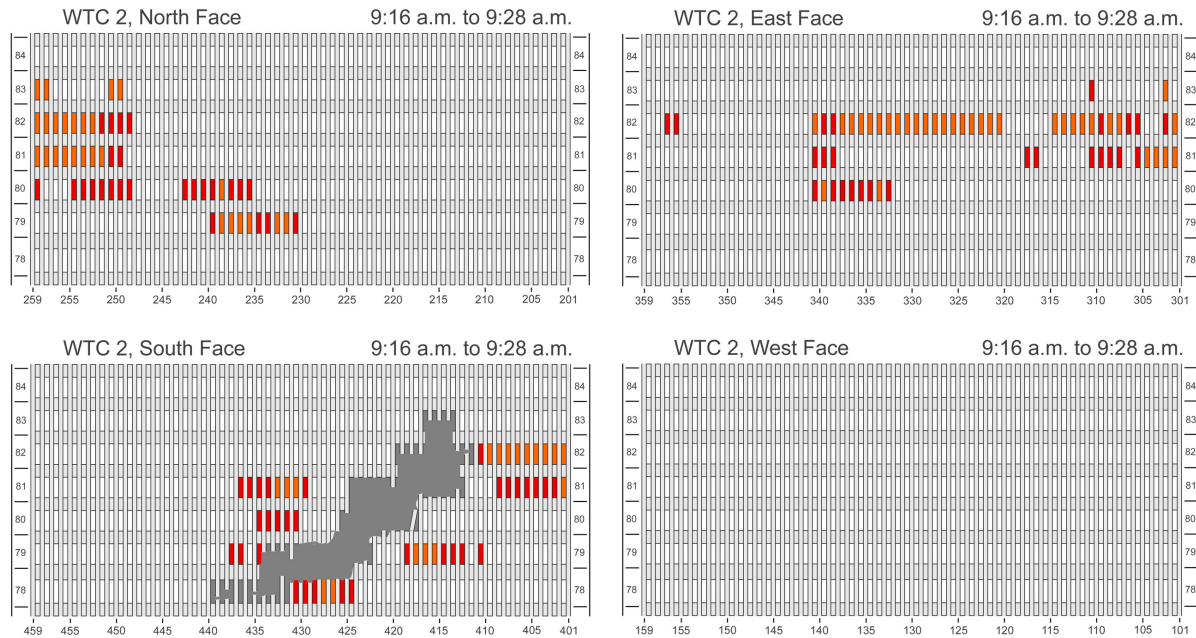
Maps of integrated fire intensities over the period for the four faces are shown in Figure E-13. Comparison with Figure E-12 confirms that minimal fire spread was taking place during the period. The fire distributions on the east face for the two periods appear quite different due to the rapid changes in the fires observed near the beginning of the first period and the continued northward spread of the fire on the 81st floor, which initially developed on the south side of the face, while going through a cycle of growth, intense burning, and decay. As during the initial time period, the largest fires were in the northeast corners of the tower on the 81st and 82nd floors and near the center of the north face on the 79th and 80th floors. These fires had been burning since the aircraft impact and were slowly dying down.

**Figure E-13. Maps of integrated fire observations between 9:15 a.m. and 9:29 a.m. are shown for the four faces of WTC 2.**

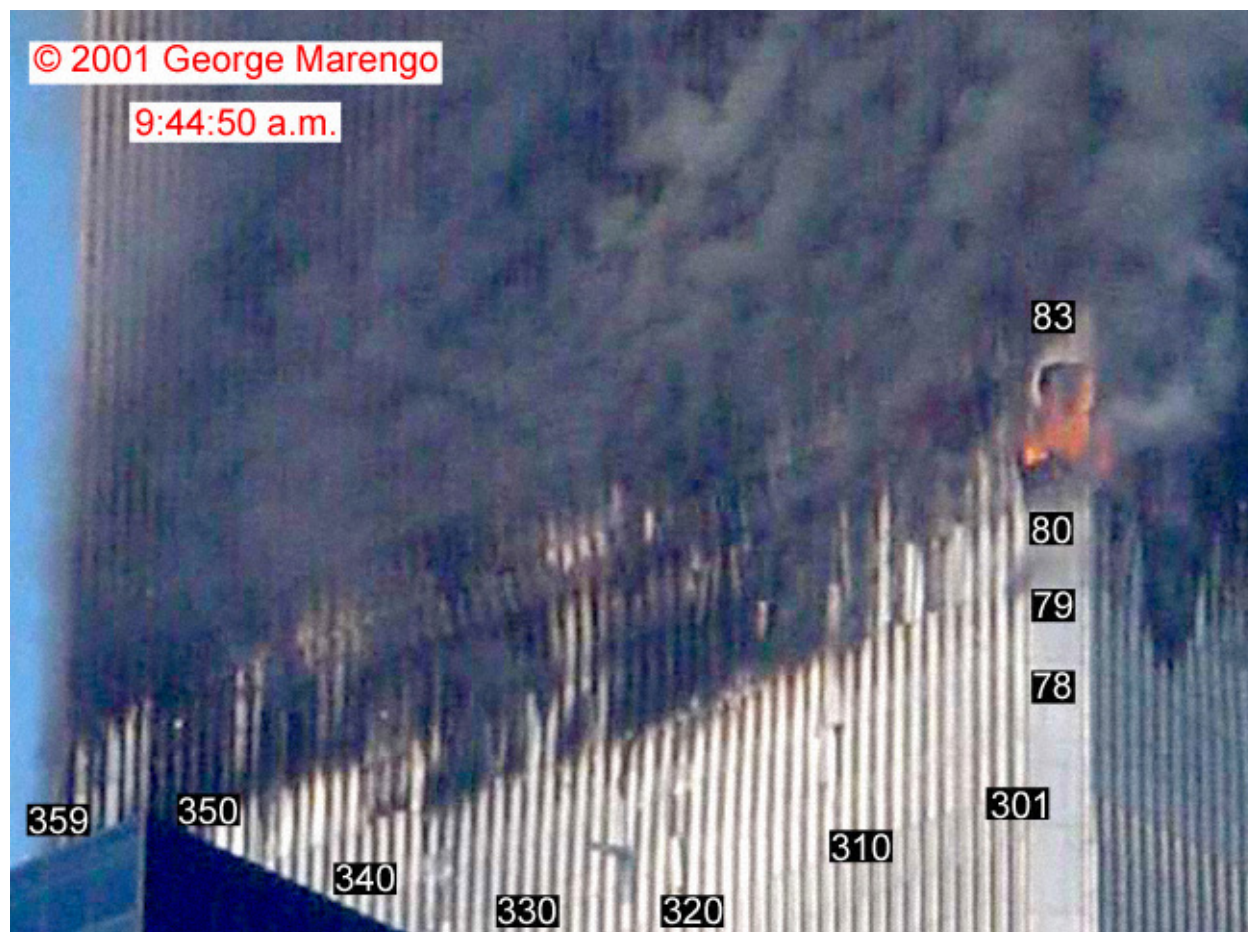
**Figure E-14.** This cropped photograph was shot from the northeast and shows the east face of WTC 2 at 9:44:50 a.m. The original intensity levels have been adjusted, and column and floor numbers have been added.

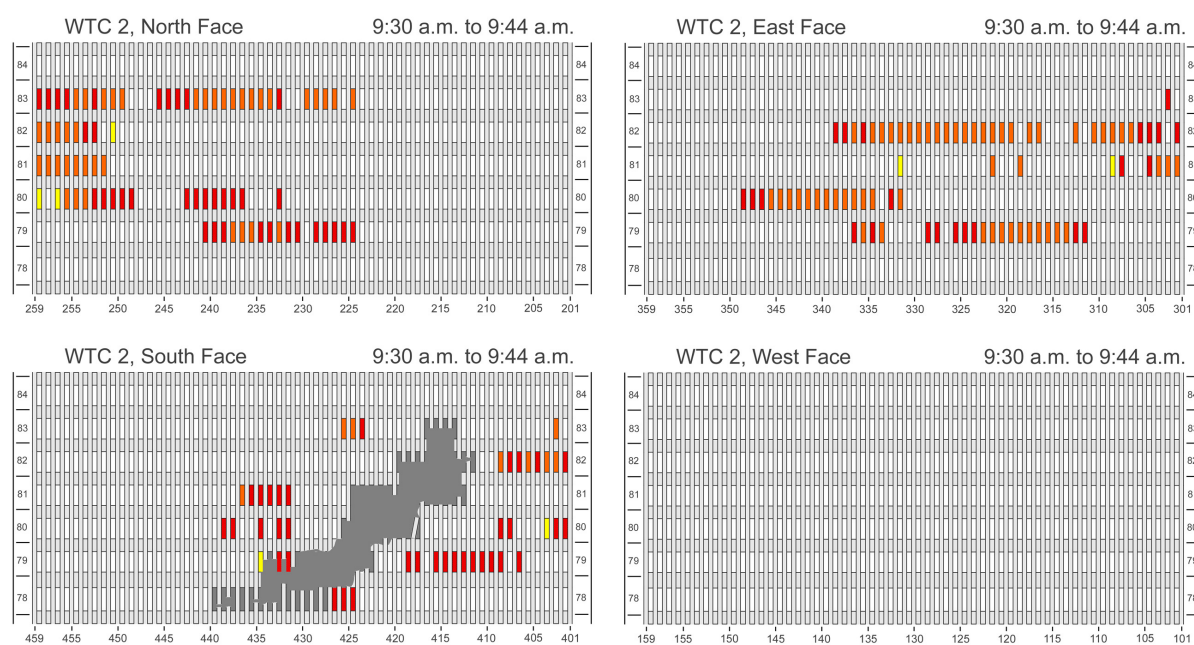
Figure E-15 shows integrated fire maps for the period. The new areas of fire that appeared on the 79th and 83rd floors of the north face are evident. Extensive new areas of fire were also present on the 79th and 80th floors of the east face. It should be remembered that a fraction of the observed fire indicated on the maps for these floors was associated with the three roughly one-minute-duration periods during which heavy smoke flows and fires were present.

**Figure E-15. Maps of integrated fire observations between 9:30 a.m. and 9:45 a.m. are shown for the four faces of WTC 2.**

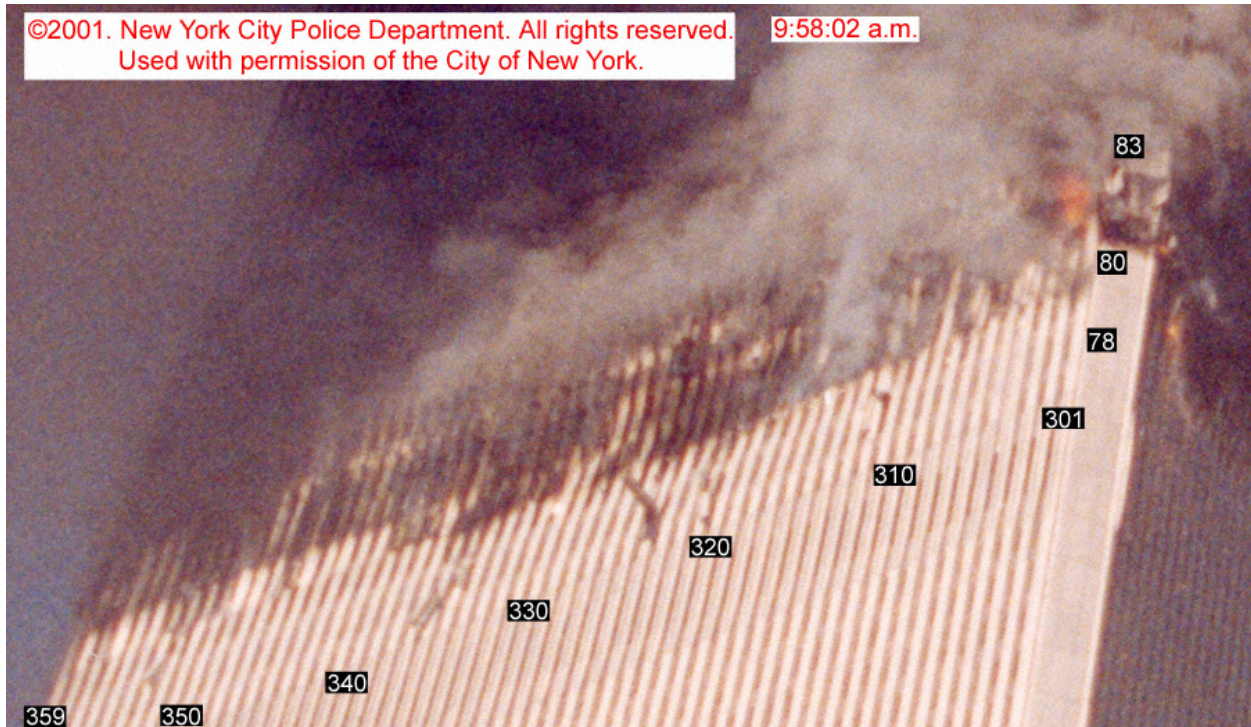
through windows on the 82nd floor changed again, with the northernmost window where the object could first be seen located slightly to the north. A prominent feature on the east face during the period was the inward bowing of the outer wall. This can be seen clearly over the 79th to 82nd floors in Figure E-16, which was taken less than a minute before the collapse started. During the 20 s prior to the collapse, a large number of pieces of debris fell from the northern sides of the 80th and 81st floors. The falling debris coincided with a heavy flow of molten metal from the north face. When WTC 2 collapsed, very little flame was expelled from the east face windows. Based on observations elsewhere on the two towers, regions of intense burning would have been expected to generate short-lived jets of flames. Their absence suggests that large fires were not burning near the east face at the time of collapse.

**Figure E-16.** This cropped image shows the east face of WTC 2 at 9:58:02 a.m. The intensity levels have been adjusted, and column and floor numbers have been added.

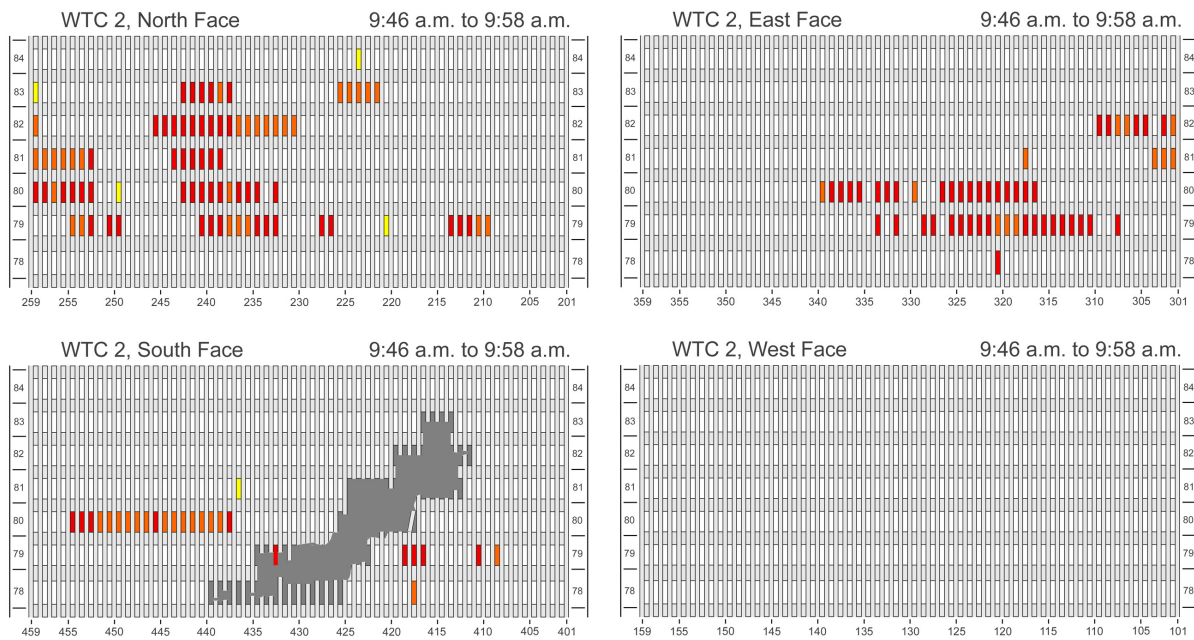
Façade maps of integrated fire intensities for the period are shown in Figure E-17. Many of the fires present during earlier periods were either no longer visible or were dying down during the final interval prior to the tower collapse. Some fire spread to the west had taken place on several floors on the north face. Areas with substantial fires included those on the north sides of the east face on the 79th and 80th floors (recall that the observed fires are combinations of sustained fires and short-lived flame releases) and the intense fire that grew on the west side of the south face on the 80th floor.

**Figure E-17. Maps of integrated fire observations between 9:45 a.m. and 9:59 a.m. are shown for the four faces of WTC 2.**

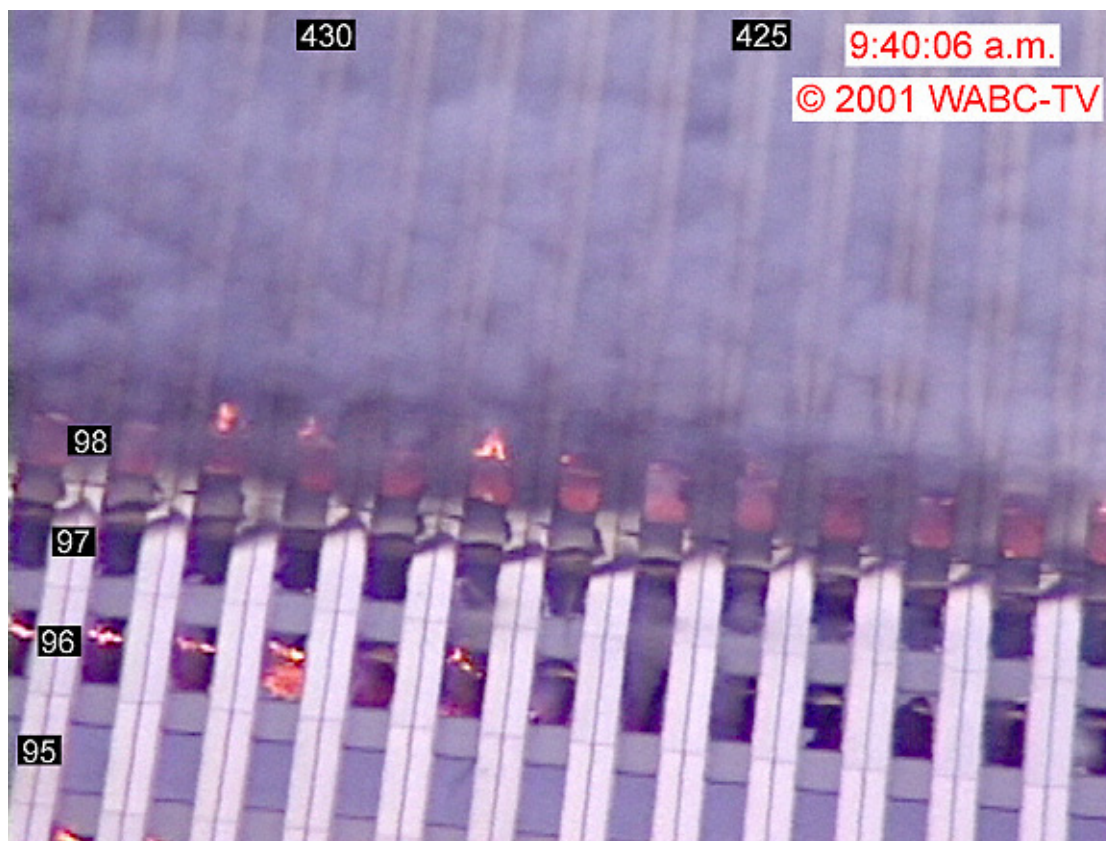
Relatively small fires at the tops of windows, such as those in Figure 5-8, were a common feature when active burning was present near the outer walls and the aluminum façade was intact. Such fires were often the only flames visible in a given window. Figure 5-9 shows a frame taken from a video in which a number of such fires burning on the 96th and 98th floors of the west face of WTC 1 are visible. As discussed in Section 8.5, the fires on this floor appeared to burn with low intensity. Nevertheless, the material at the tops of the window was exposed and ignited.

**Figure 5-9. This close up view of the west face of WTC 1 was captured from a video recorded at 9:40:06 a.m. It has been enhanced by adjusting the intensity levels. Column and floors numbers have been added.**

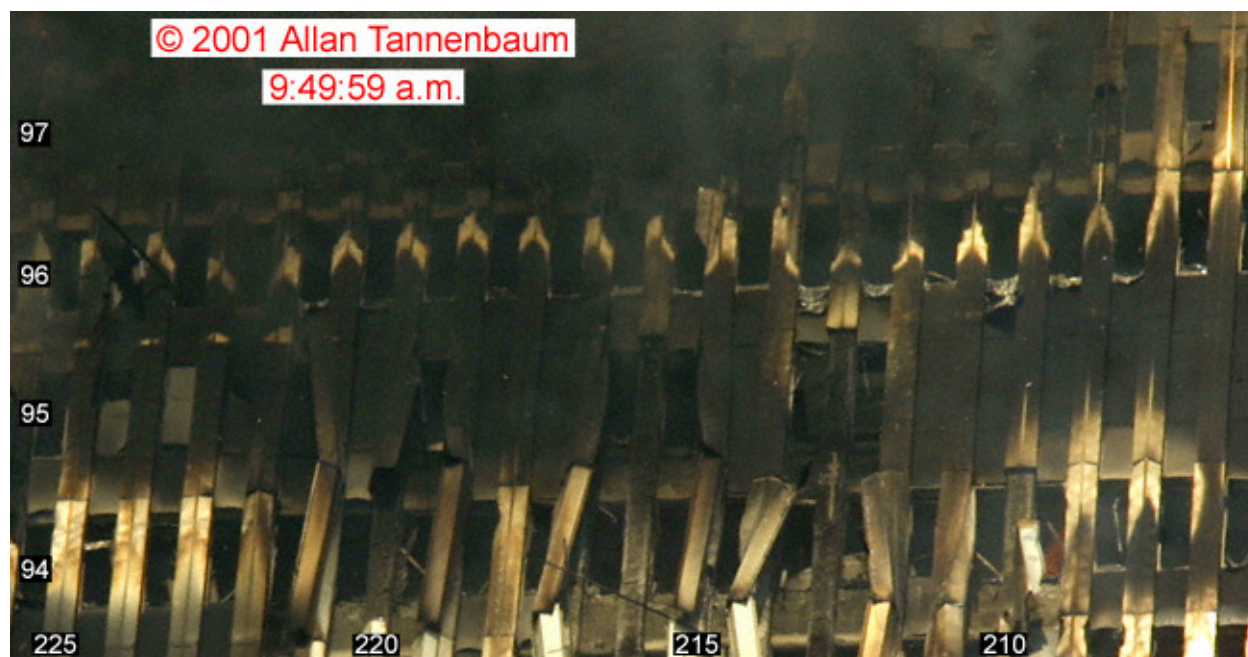
exiting a window. This flow pattern resulted in the formation of distinct patterns on the columns near the base of the burning flow that were easily identified. The marks resulted from deposited soot on the underside of the flames. Due to their shapes, this type of column pattern will be referred to as a “caret.” Figure 5–10 show examples of carets observed on the 96th floor of the east face of WTC 1. Variations in the heights of the patterns are evident from window to window. The location of a caret on a column cover provides an indication for the distance between the top of the window and the lower region of the burning gases leaving the window. This, in turn, reflects the depth of the layer of rich combustion gases behind the window. Typically, a deeper layer corresponds to a local region of higher combustion gas formation and temperature and generally indicates a location of more intense burning.

**Figure 5-10. This cropped photograph shows a portion of the east face of WTC 1 at 9:49:59 a.m. The image has been rotated and enhanced by adjusting the intensity levels. A number of carets are visible near the tops of windows on the 96th floor. These carets were created during periods of external flaming from adjacent open windows. Column and floor numbers have been added.**
