**NIST NCSTAR 1-5A**

**Federal Building and Fire Safety Investigation of the  
World Trade Center Disaster**

**Visual Evidence, Damage Estimates,  
and Timeline Analysis**

September 2005

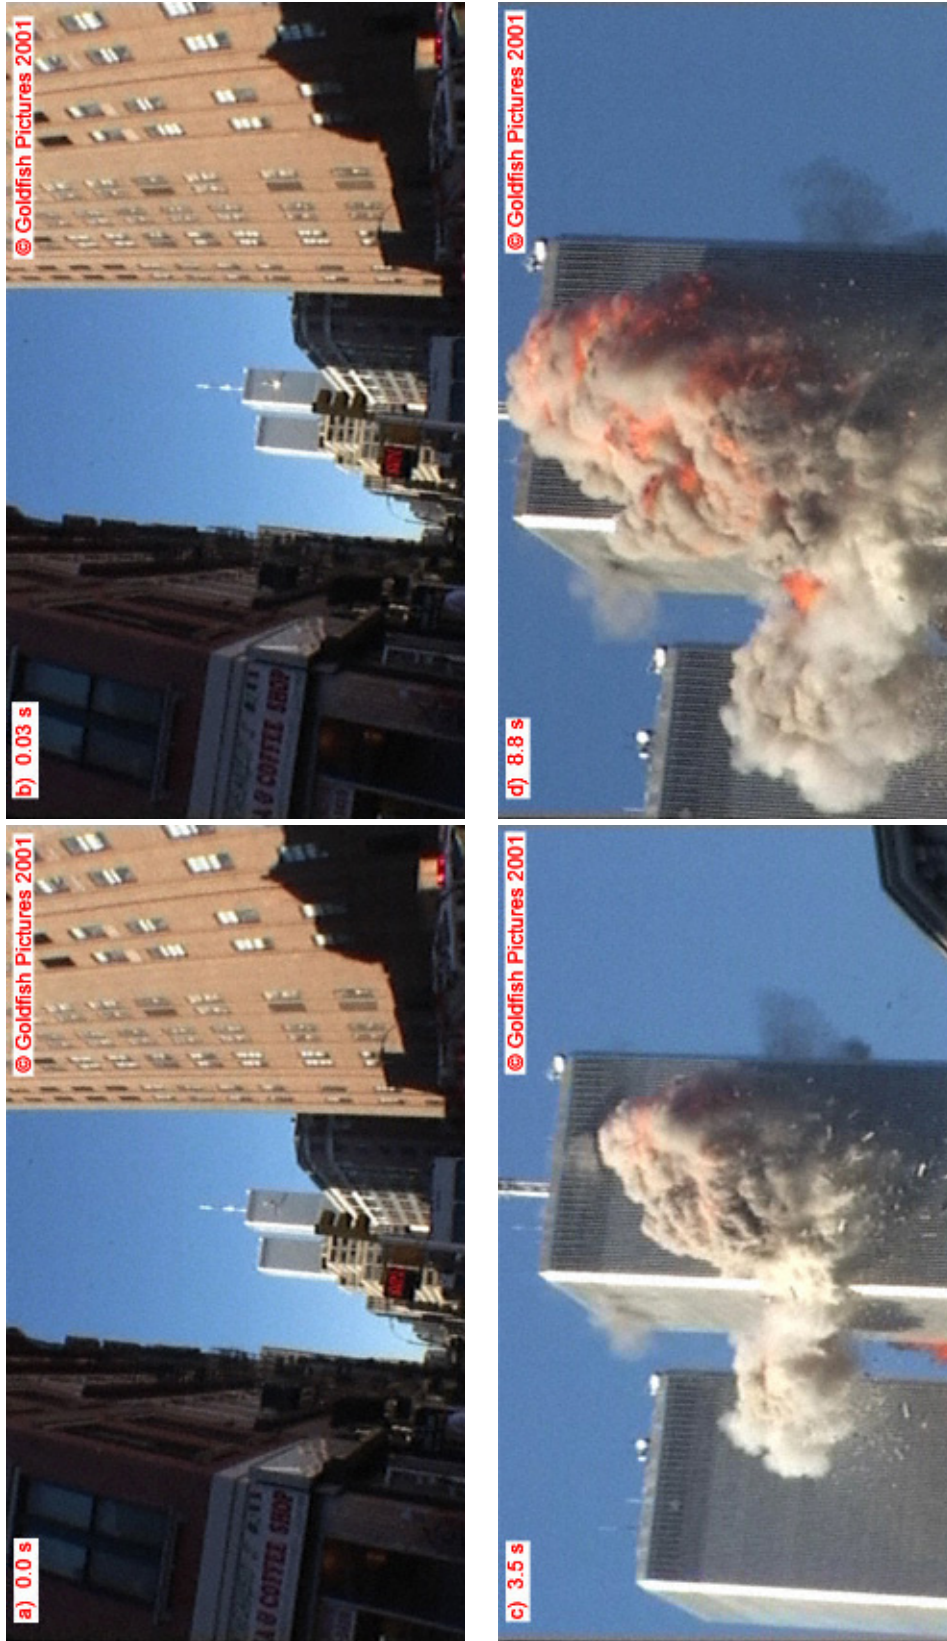
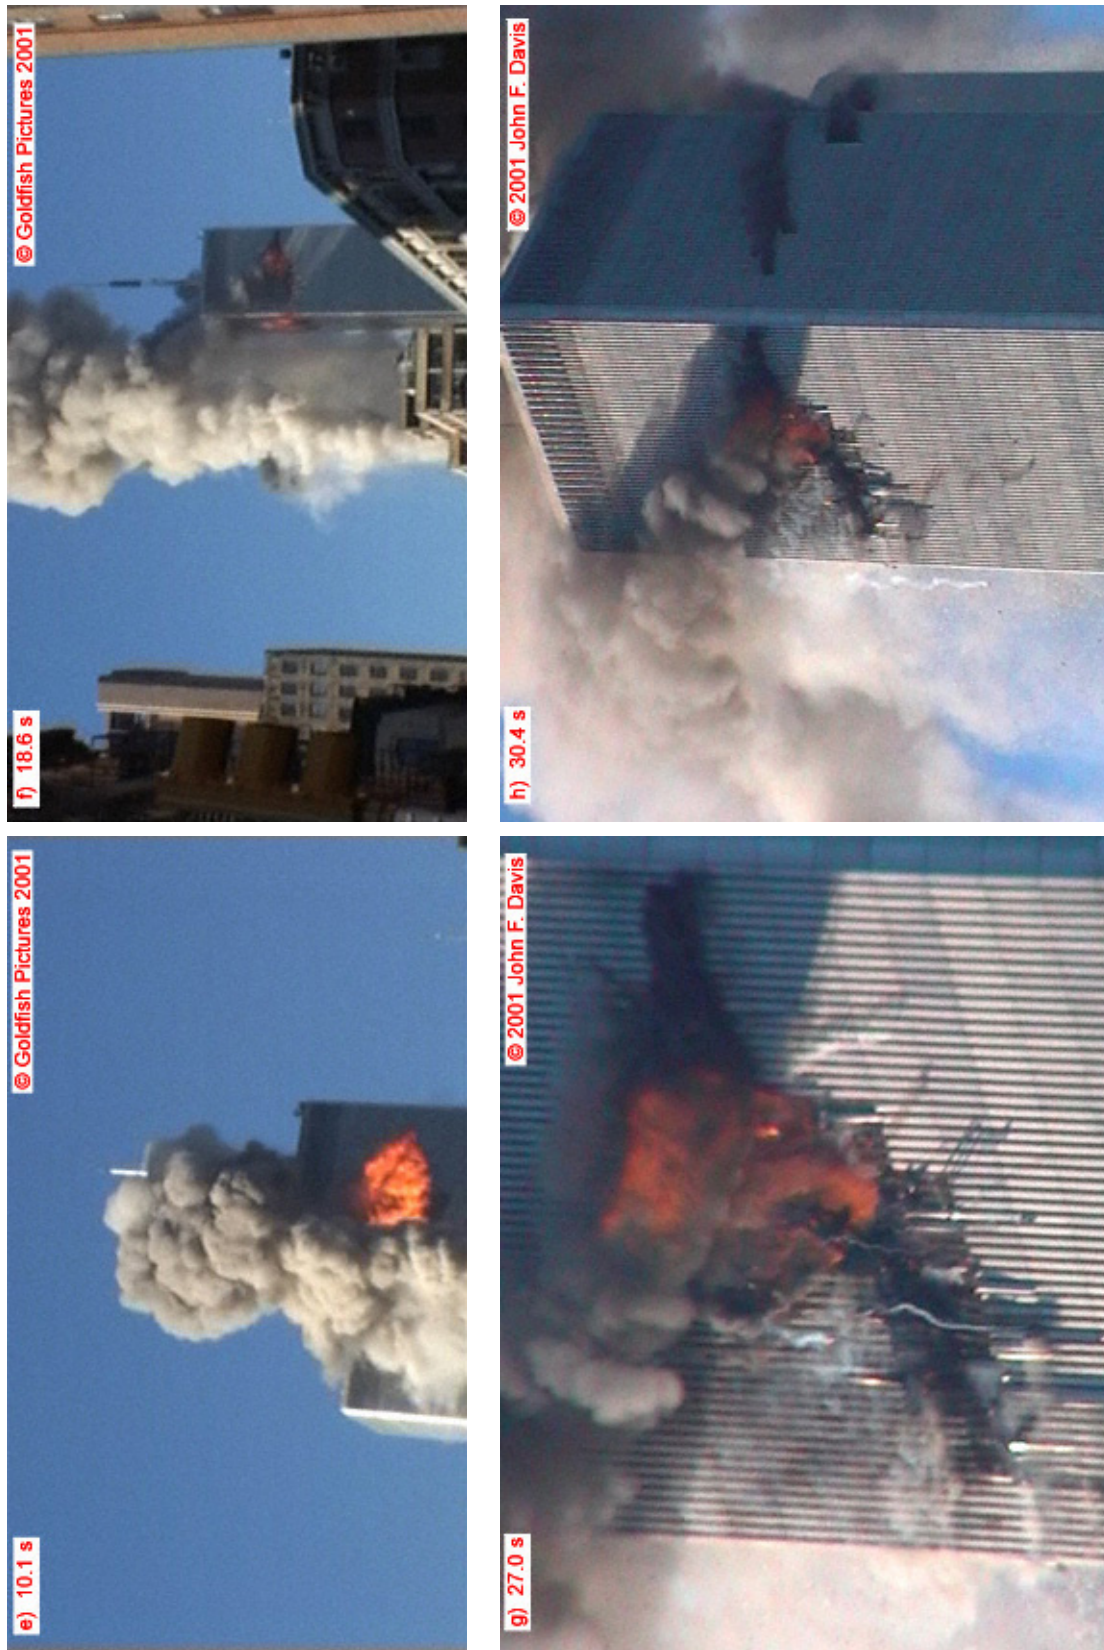
Roughly 5 s later (frame d), the dust clouds on the north and east faces have grown substantially. The north-face dust cloud is considerably larger, and extensive flames can now be seen throughout the cloud, interspersed with the white dust. A large amount of debris can be seen falling below the aircraft impact location. The prevailing wind has begun to blow the external fireball and falling debris across the north face toward the east. Flames on the east face seem to be present only near the building, suggesting that much less aviation fuel has been expelled on this face. A small region of fire is still visible extending beyond the southern edge of the east face, i.e., apparently coming from the south face of the tower.

At 10.07 s following the aircraft impact (frame e), the fireball that formed on the north face appears to have dissipated, leaving a “thermal” that is continuing to rise. For this report, the word “thermal” is used to identify a mushroom-shaped buoyant plume generated by the rapid release of a large amount of heat. The dust cloud created by debris falling from this face has developed a tube-like appearance and has been blown to the east edge of the tower. A bright region of flame is present across much of the region where the aircraft entered. The dust cloud on the east face has continued to expand, and no flames are now evident within this cloud.

Figure 6-1. A series of frames from videos shows American Airlines Flight 11 striking WTC 1 and the immediate aftermath. Times relative to the aircraft impact time are shown in the upper left-hand corner.

The next frame, (f), was recorded roughly 8.5 s later. At this time the dust-filled cloud sinking below the impact area and the rising thermal created on the north face have been blown further by the wind and are now more than a building width to the east of the northeast corner of the tower. The tube-like cloud of debris extends downward many stories and has developed the appearance of a concentrated vortex. The wind has also blown the debris away from the east face, and this face can now be observed. Substantial fires are now evident on the north and east faces in areas where the dust plumes were initially observed. Even though frame (f) is more zoomed out than frame (e), it is evident that the fire on the north face is much smaller than it was just 8.5 s earlier, suggesting that fires due to the aviation fuel released by the aircraft impact are already beginning to burn out. A thermal can be seen rising behind WTC 1, which provides additional evidence that the south face was damaged by debris passing through the tower.

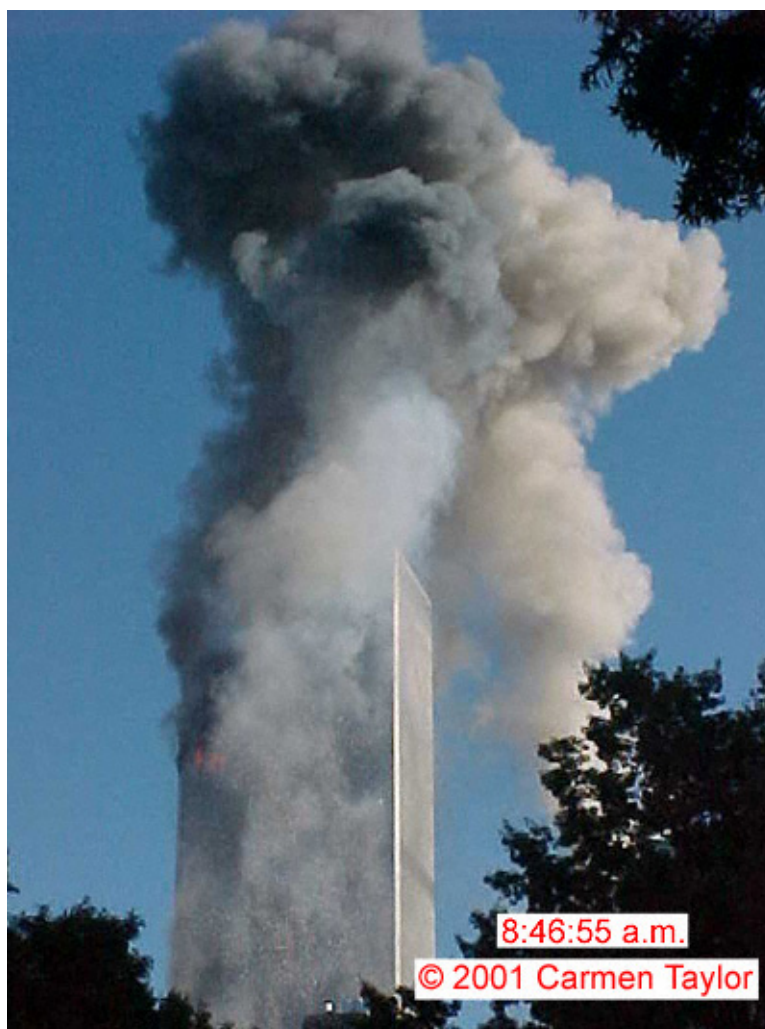
The photograph shows both WTC 1 and WTC 2, with the south face of WTC 1 partially hidden by WTC 2, which is in the foreground. An area of intense fire is apparent on the western side of the south face of WTC 1. This fire is in the vicinity of the 96th floor. An area of falling debris can be seen moving in front of the south face of WTC 2. This debris fell from the south face of WTC 1 and was blown to this location by the prevailing wind. Above the debris cloud a small thermal can be seen rising above the tower. This thermal must have resulted from a fireball that formed on the south face of WTC 2 following the aircraft impact. The occurrence of this fireball is consistent with the area of fire on the south face described above. The formation of a fireball on the south face indicates that a significant amount of aviation fuel from the aircraft passed all the way through the tower and burned on the other side.

**Figure 6-2. View of the WTC towers shot at 8:46:55 a.m. from the southeast shortly after American Airlines Flight 11 struck WTC 1. A dust-filled vortex is visible on the right side. A second area of falling debris can be seen passing on the south side of WTC 2. Significant fires are present on the west side of the south face of WTC 1, which can be seen to the left and behind WTC 2.**

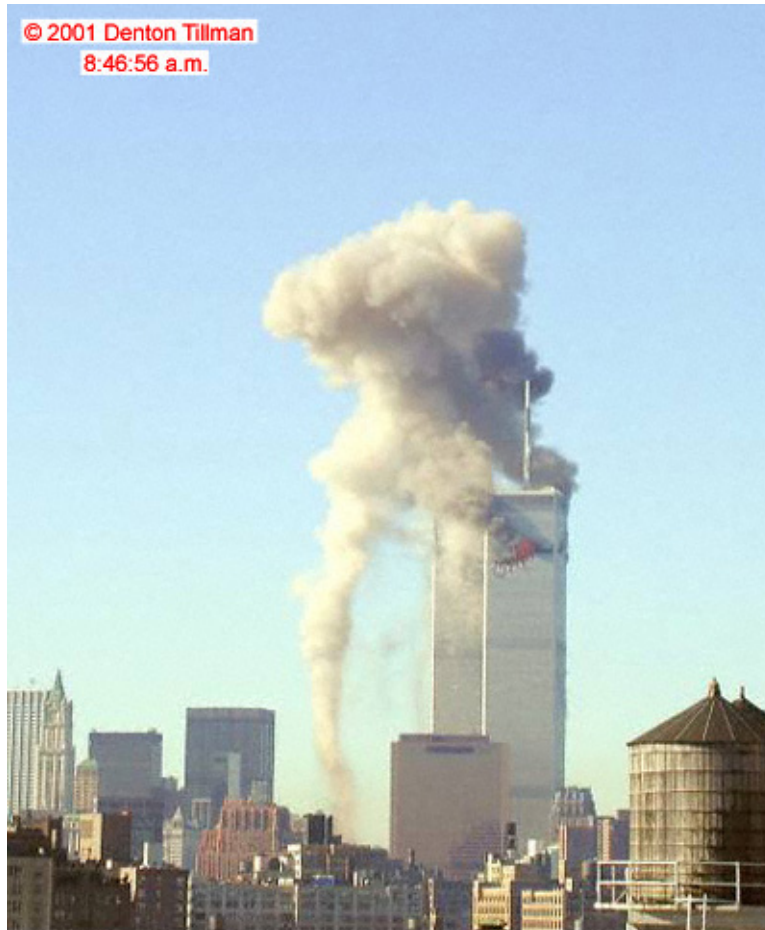
The presence of significant burning on the south face of WTC 1 is also indicated by the photograph shown in Figure 6-3 that was taken 26 s (i.e., 8:46:56 a.m.) after the aircraft impact on the tower. The thermal formed by the fireball on the rear side can be seen behind the large thermal formed by the fireball on the north face. A large amount of smoke is rising from behind the tower, consistent with the heavy fire seen on the south face in Figure 6-2. This photograph also provides an excellent view of the vortex generated on the north face of WTC 1 by the aircraft impact. The vortex is large, extending all the way down to near the ground. It has been transported a large distance by the prevailing wind. Even at this distance, the large fire burning inside the impact cavity in the tower is evident. This is consistent with Figure 6-1 (g), which was recorded at nearly the same time.

**Figure 6-3. A cropped photograph taken from the north shows the WTC towers at 8:46:56 a.m., i.e., 26 s after the aircraft impact on WTC 1. Colors have been adjusted.**

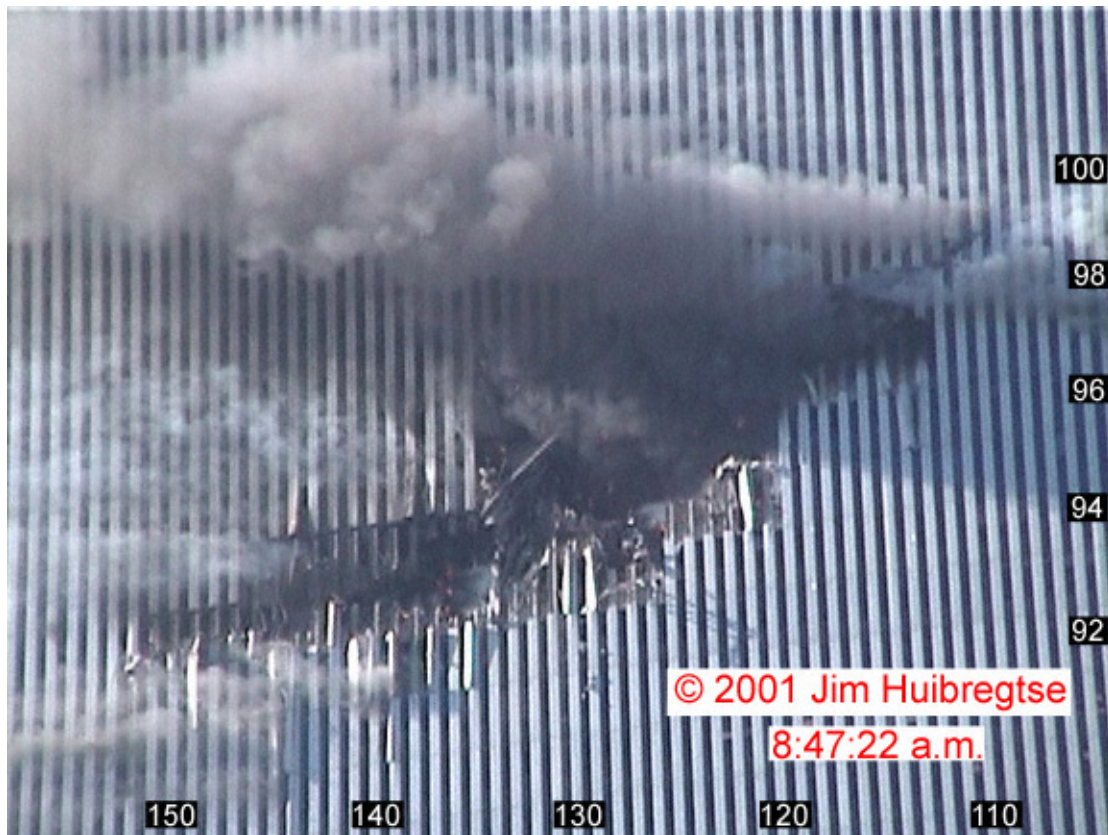
By inspection of Figure 6–4 and similar images, it was observed that the wing tips and the top of the vertical stabilizer at the tail of the aircraft damaged the aluminum column covers on the steel façade without cutting through the steel below or completely removing the covers. Using these images, it was possible to map out locations on columns where the wingtips and the vertical stabilizer struck the tower. These locations were then transferred to the representation of the damaged steel façade shown in Figure 6–6 and are represented by dashed lines, with wings to the right and left and the vertical stabilizer in the center. The good agreement between the damage pattern and the wing-tip locations is evident. It was reported in the FEMA report (McAllister 2002) and widely in the media that American Airlines Flight 11 struck floors 94 to 98 of WTC 1. The dotted horizontal lines on the left side of Figure 6–6 indicate the locations of concrete floor slabs. It can be seen that while the tip of the left wing of the aircraft struck very close to the base of the 94th floor, the wing end marked column 153 at the very top of the 93rd floor. It is evident from the Figure that the right wing actually struck well up on the 99th floor on column 109. The impacted floors therefore range from the 93rd floor to the 99th floor.

Figure 6-4. This image of the north face of WTC 2 is a frame taken from a video recorded at 8:47:22 a.m. Column and floor numbers have been added.

It is evident from Figure 6–4 and Figure 6–5 that substantial areas of the concrete floor slabs for the 95th through 97th floors were destroyed in the immediate vicinity of the aircraft impact location. There is a large open area in the impact region in which no floor slabs are visible. A substantial section of collapsed floor slab is apparent in the enlarged portion of Figure 6–5 shown in Figure 6–8. One of the trusses (indicated by an arrow) that supported the floor slab and the corrugated sheet metal on which the concrete was poured are visible. The floor slab section appears to have collapsed from above and is at least 17 ft wide. No visual material has been identified that allows the depth into the building of the floor removal and damage to be determined (it is apparently too dark to see inside), but it clearly extends many feet.

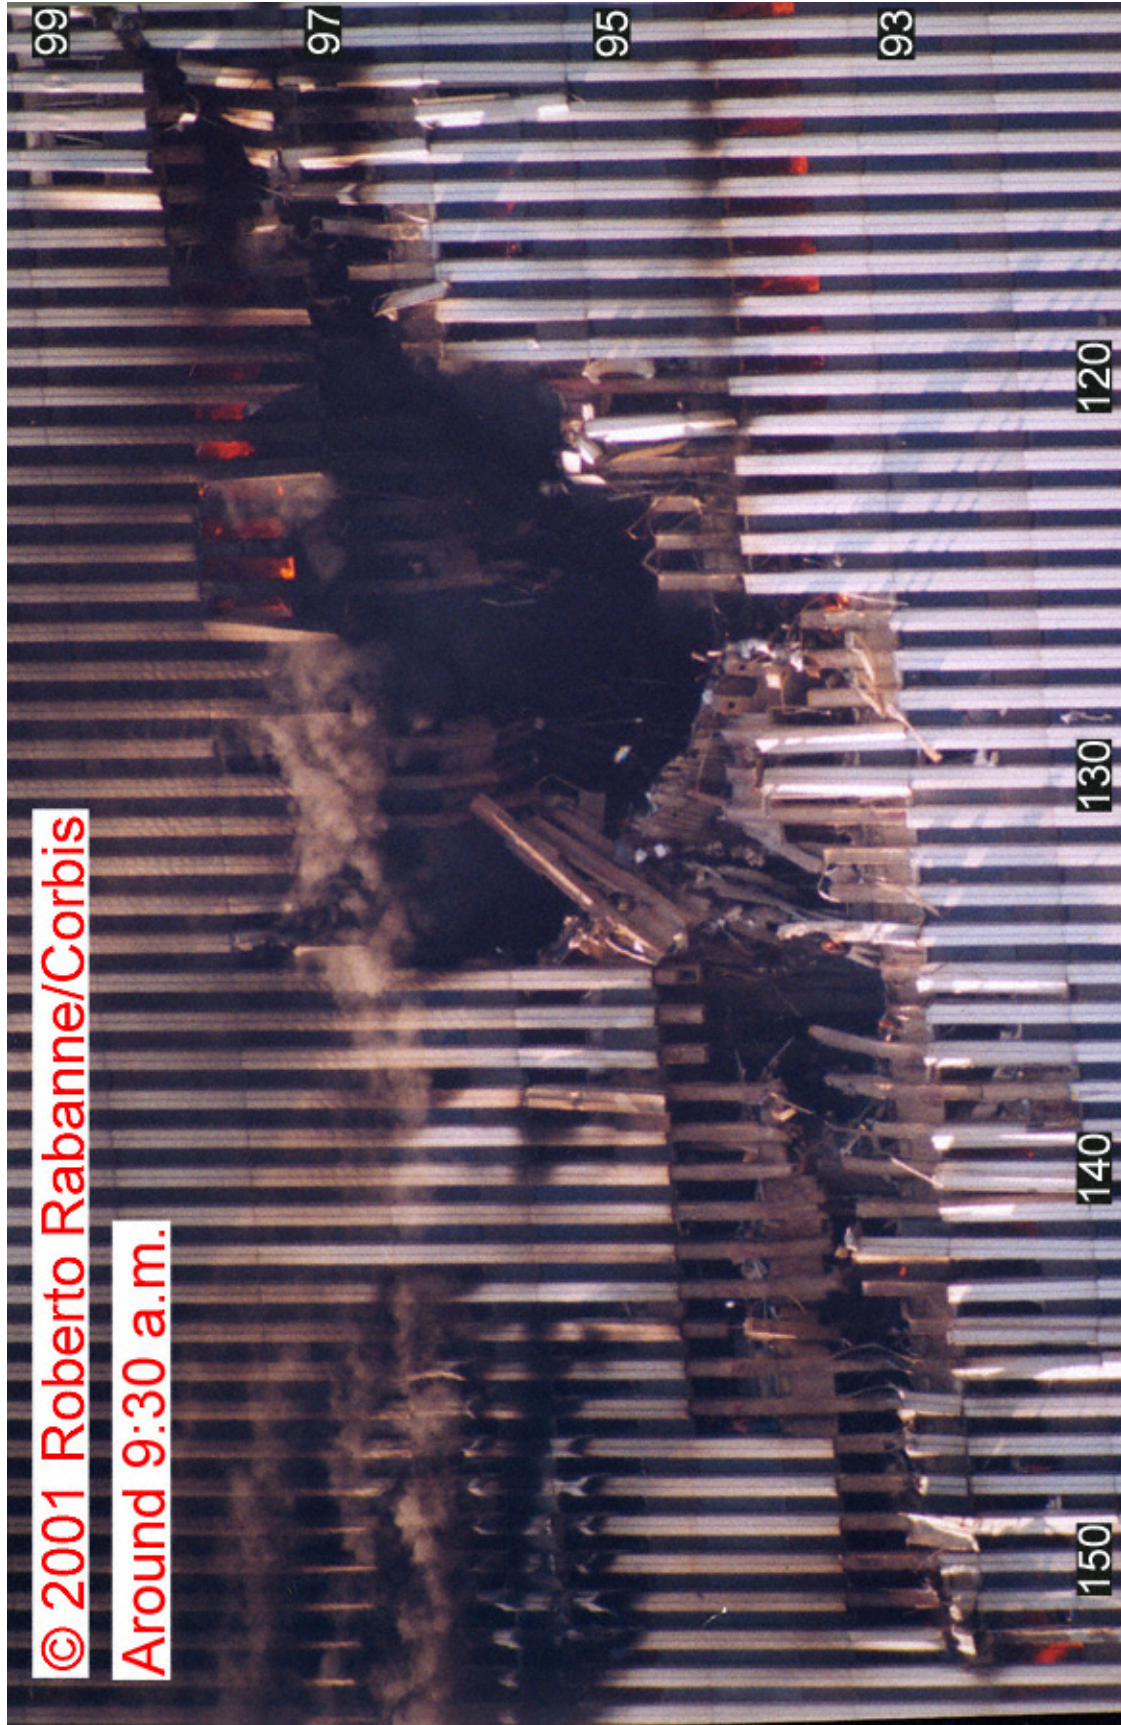
Figure 6-5. A close-up image of the north face of WTC 1 recorded around 9:30 a.m. shows the area of WTC 1 where the aircraft impacted. Column and floor numbers have been added.

From Figure 6-5 and Figure 6-6 it can be seen that the passage of the aircraft through the north face façade broke out two complete steel panel sections (columns 126 to 128 and columns 132 to 134 extending from the middle of the 94th floor to the middle of the 97th floor) as well as portions of several other panel sections. Most likely these were pushed into the building, since there is no visual evidence that they landed on the ground. The end of one of these panel sections can be seen sticking out of the building at the bottom of the opening in the figures.

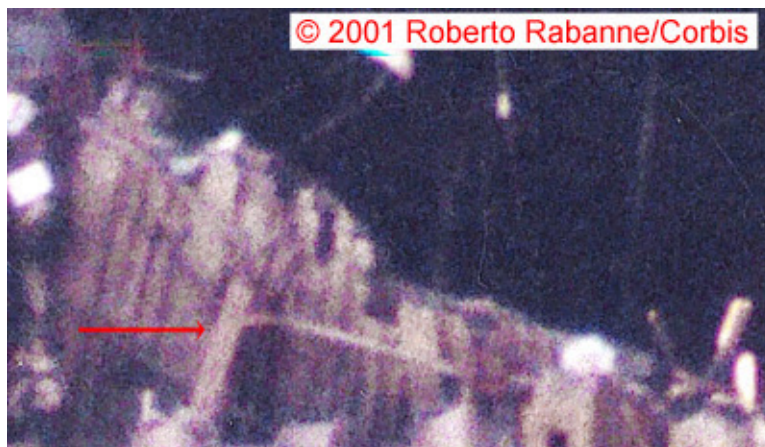
**Figure 6-8. An enlarged and enhanced portion of Figure 6–5 shows a portion of one of WTC 1’s floor slabs that has collapsed into the opening created by the aircraft impact. The corrugated steel on the bottom of the floor slab and a portion of one of the support trusses (indicated by an arrow) can be seen.**

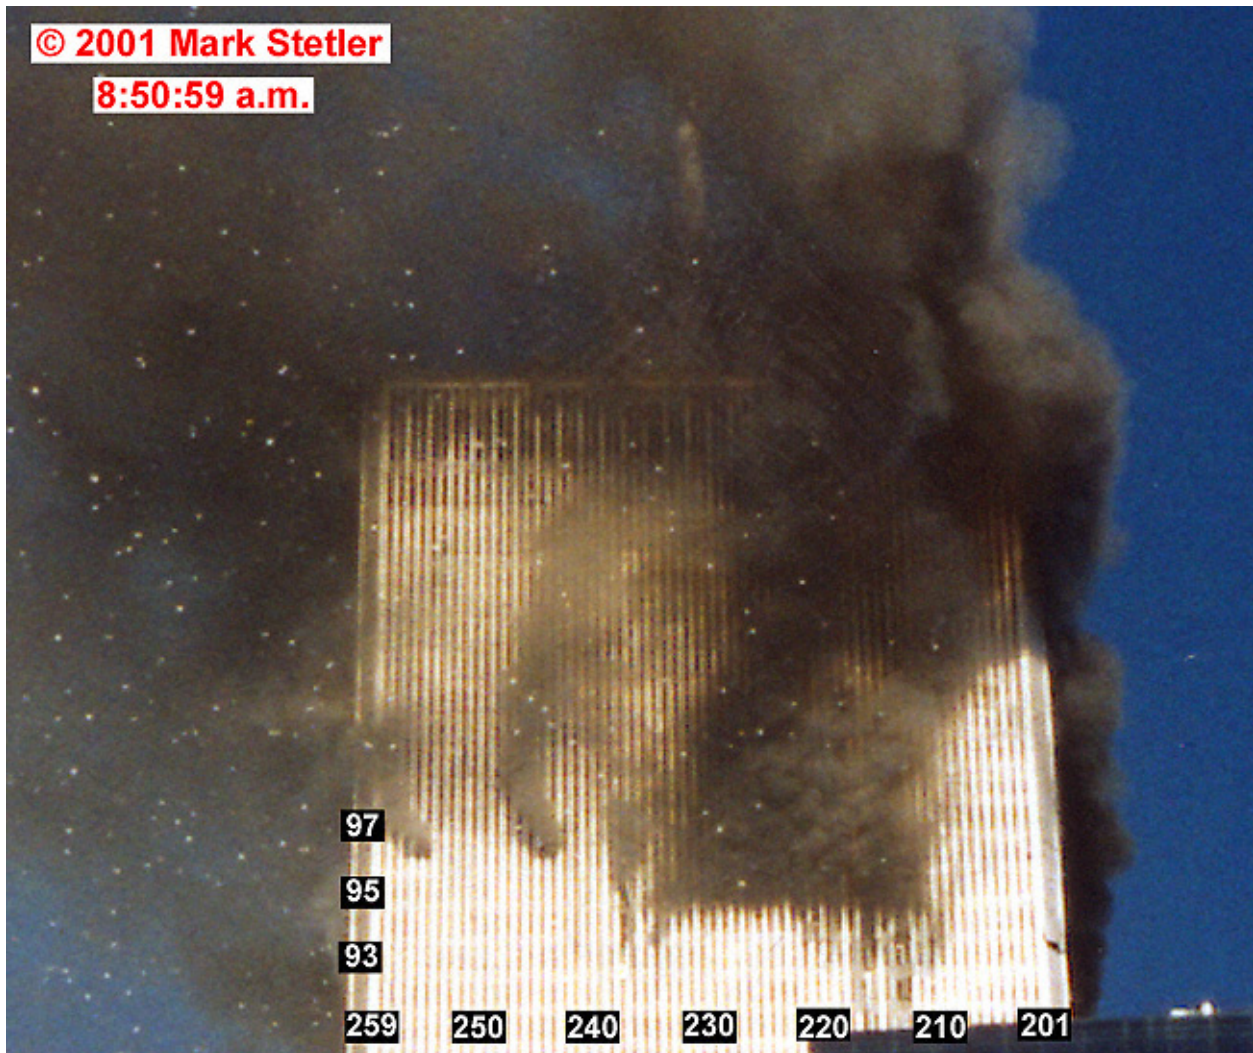
Figure 6–10 shows a photograph of the east face of WTC 1 taken roughly four and a half minutes after the aircraft impact. It looks similar to more distant videos that were recorded very shortly after the event, suggesting that the appearance of this face has not changed significantly since the aircraft impact. Figure 6–11, which also looks similar, was taken just over a minute later and provides a closer view. Numbers indicating floors and columns have been added to both figures for reference.

**Figure 6-10. Photograph showing the east face of WTC 1 recorded at 8:50:59 a.m. Column and floor numbers have been added.**

During the first few minutes following the aircraft impact, similar extensive fire growth or spread was not evident on the east face. The location and intensity of the fires was little changed between 8:48 a.m. and 8:52 a.m. Figure 6-10 in Chapter 6 shows the appearance of this face around 8:51 a.m. In contrast, the original area of external flaming present on the 96th floor of the south face doubled in size between 8:47 a.m. and 8:52 a.m., and new regions of flame appeared to the west on both the 95th and 96th floors.

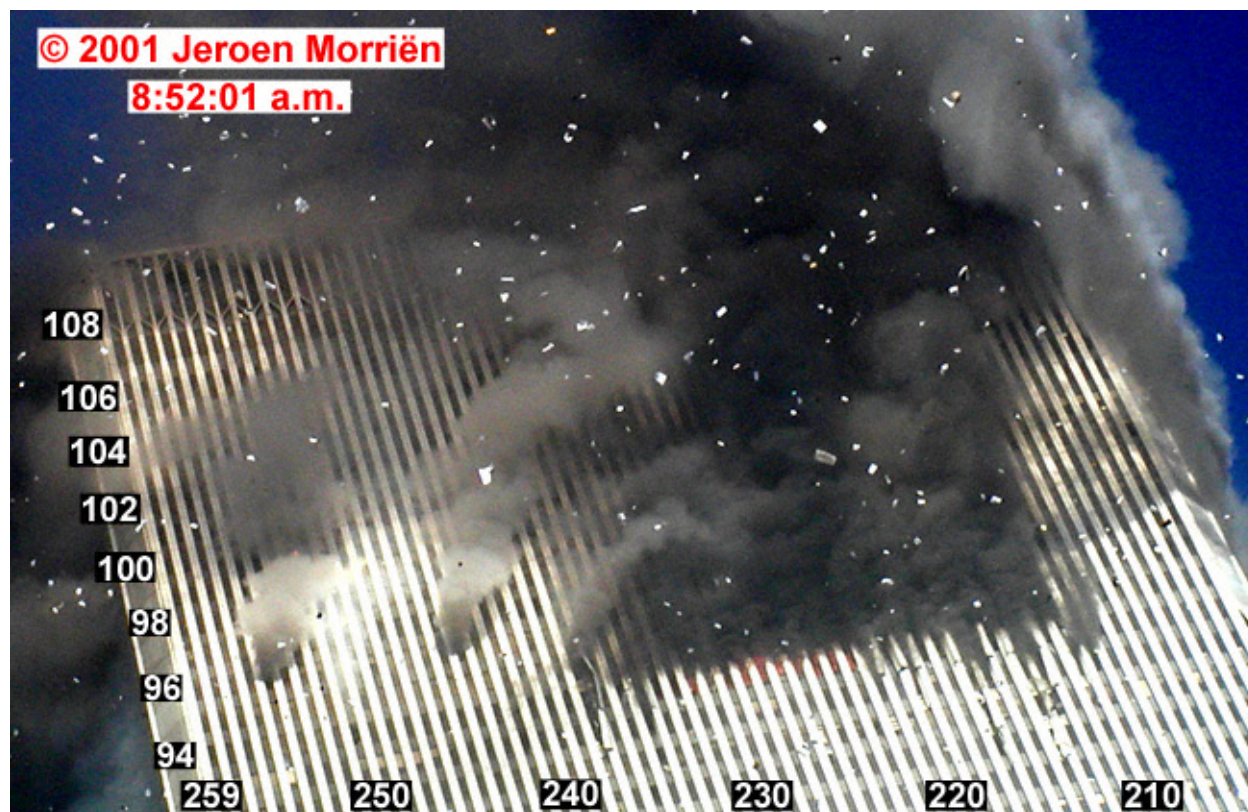
The most prominent feature in Figure 6–11 is a long line of smoke on the 94th floor extending from roughly window 94-210 to window 94-237, or a distance of nearly 90 feet. Clearly, all of the glass in the windows over this length has been broken out. Closer inspection shows that several of the aluminum covers on these columns have been partially dislodged as well. Most are near the right edge of the region, but the cover for column 94-237 has been nearly removed. Two covers, for columns 94-213 and 94-216, are missing completely. The aluminum cover on the northeast corner for this floor has also been partially

displaced. This proved to be an easily recognized marker for the floor. Isolated windows at 94-241 and 94-250 are also missing.

**Figure 6-11. Photograph of the east face of WTC 1 taken at 8:52:01 a.m. The photograph has been enhanced and cropped. Floor numbers are indicated along the left edge of the building and column numbers along the bottom of the photo.**

Some damage and missing window glass are present on lower floors that were not directly impacted by the aircraft. Window glass has been broken out and some column covers have been displaced or removed completely on the 93rd floor from columns 93-209 to 93-216 as well as columns 93-219 and 93-220. The glass for window 93-237 is missing, and the aluminum cover for column 93-237 has been displaced. Damage is also apparent on the 92nd floor, where windows 92-212 and 92-213 have been broken out. A chair is stuck in window 92-212, and the aluminum cover on column 92-212 has been removed. Covers on columns 92-216 and 92-217 have been displaced, and the window glass between these two columns is missing. On the 91st floor, the covers on columns 91-213, 91-214, and 91-216 have been displaced, and windows 91-213 and 91-216 are open. There is no apparent damage lower than the 91st floor.

Portions of the east face above the 94th floor are hidden by the smoke rising from this floor. Only minimal damage is seen on these higher floors, including a displaced column cover and missing window glass at window 95-237 and two broken windows on the 96th floor at windows 96-243 and 96-254. All window glass and column covers to the north of column 209 appear to be undisturbed.

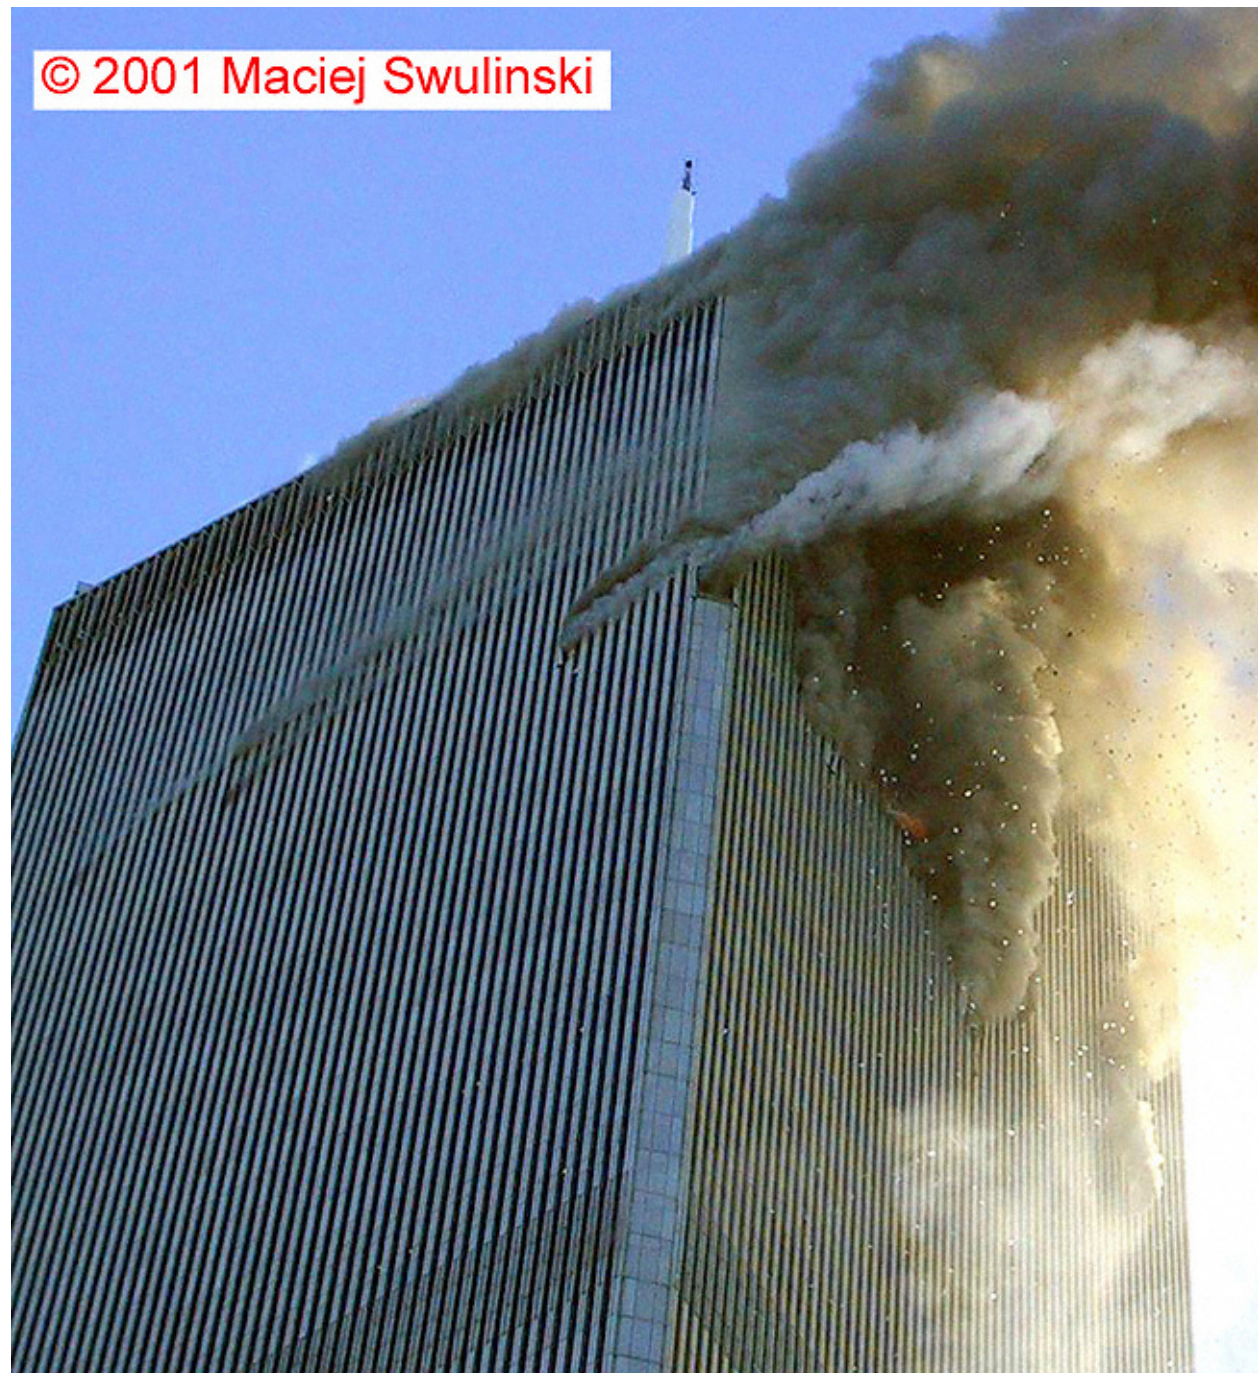
In contrast to the relatively large number of windows missing on the east and south faces of the tower, the number of windows initially opened on the west face was considerably less. This can be seen in Figure 6–12, which shows the west face shortly after the aircraft impact. The façade maps for window condition on the west face shown in Figure 6–9 is based on a number of photographs and videos and indicates that nine windows were broken open on this face by the aircraft impact and fireballs. The only obvious damage to the aluminum facing occurred on columns 410 and 411 at the 96th and 97th floors. The covers for column 410 were removed on both floors, while those on column 411 were partially dislodged.

**Figure 6-12. A cropped photograph shows the west and south faces of WTC 1 shortly after the aircraft impact. The image has been enhanced by adjusting the intensity levels. The exact time of the image is unknown, but the appearance suggests that it was taken within two minutes of the aircraft impact.**

Several windows were opened on the 101st floor on the east side of the south face (presumably by people), and smoke was flowing from these locations (see Figure 6-12). Images suggest that additional windows may have been open higher up on the east side, but the quality of the images and the amount of smoke coming from other locations did not allow this to be confirmed.

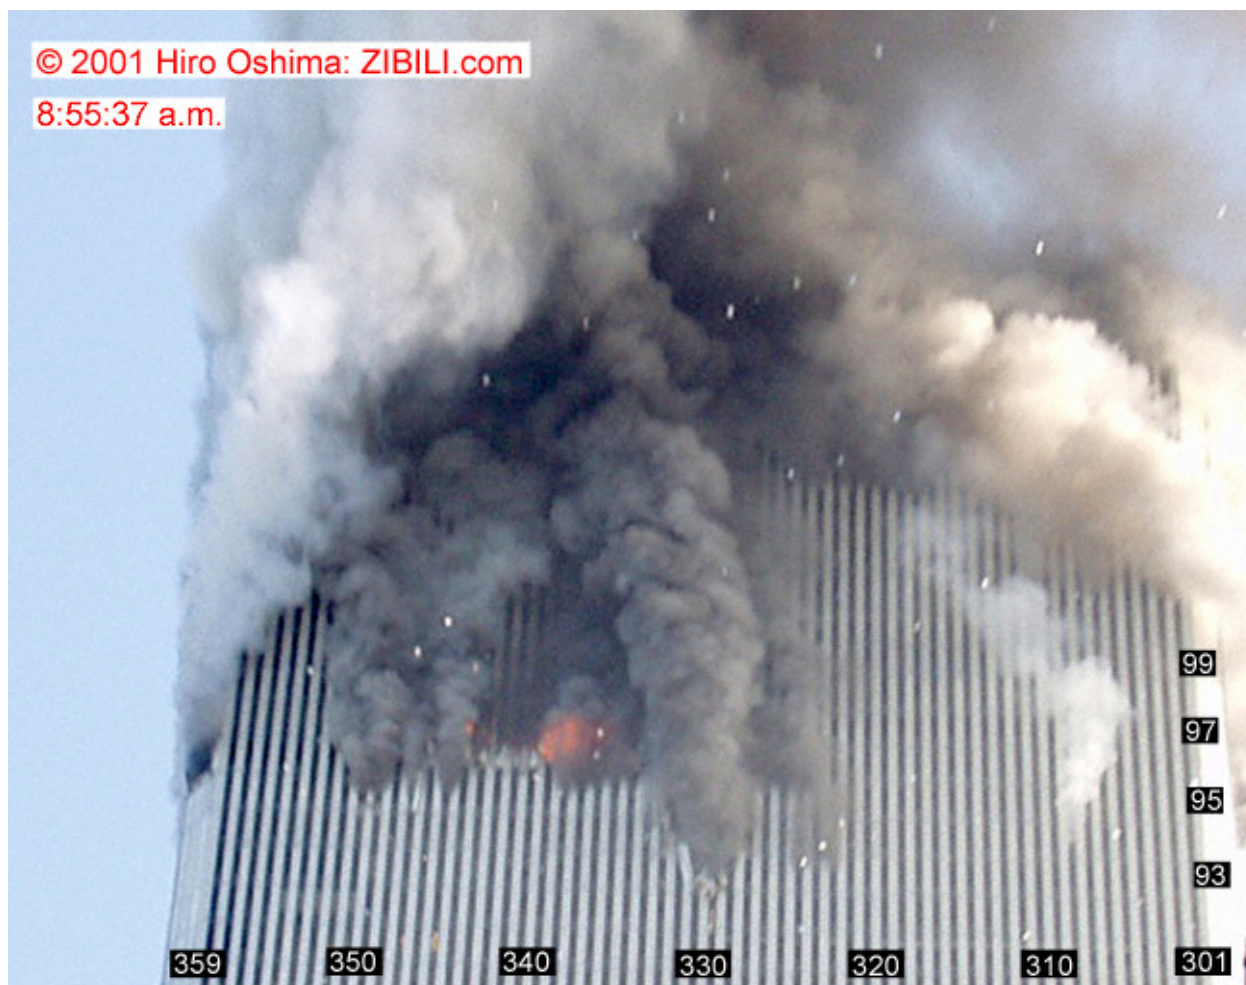
**Figure 6-13.** This enhanced and cropped photograph shows the south face of WTC 1 at 8:55:37 a.m. Column and floor numbers have been added.

The fires seen on the 96th floor of the south face continued to grow during this time, and by 8:56 a.m. covered at least ten windows from windows 96-334 to 96-343, with significant flame extension. These fires can be seen in Figure 6-13, which was taken at roughly this time. There is little evidence for fires on other floors of this face.

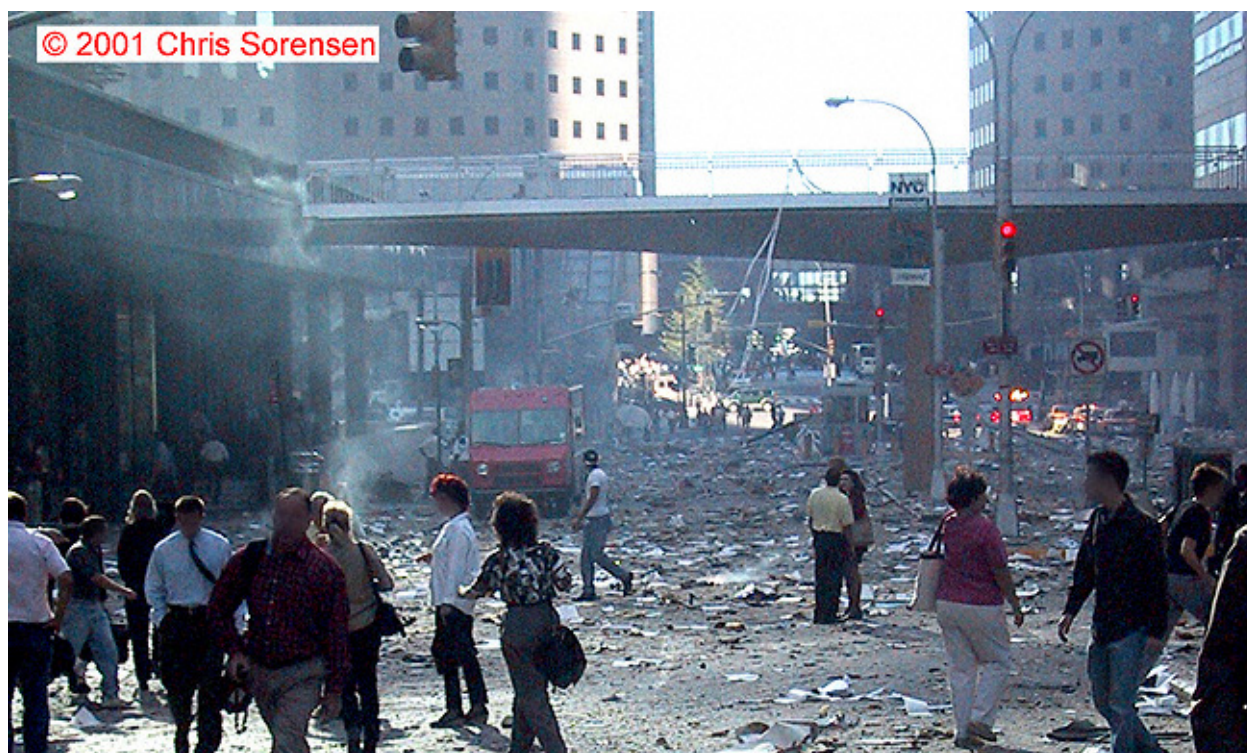
Figure 6-15 shows another view of the streets around the WTC shortly after the aircraft struck WTC 1. This shot was taken from the corner of Liberty Street and Church Street looking west down Liberty Street. It was taken before WTC 2 was struck, so the debris has come from WTC 1. The bridge across Liberty Street connected the southwest corner of WTC 4 to the Bankers Trust Building. The building visible on the right side beyond WTC 4 is WTC 3 (Marriott Hotel), which was located on the corner of West Street. A deep layer of debris is seen strewn across much of the visible length of Liberty Street. Most of this debris is lying to the south of WTC 2. The only possible way for it to have reached this location is by being blown by the prevailing wind from the south face of WTC 1. It is likely that it was dropped from the dust cloud seen to the south of WTC 2 in Figure 6-2. This image, along with several others, shows that, in addition to a lot of paper, the debris in the street consisted of a number of aluminum column covers and what appeared to be small chunks of concrete. The amount and nature of the debris

indicates that the aircraft impact and fireballs must have caused significant damage close to and on the south face of WTC 1. There were also a number of small fires burning on Liberty Street immediately following the aircraft impact (not visible in Figure 6–15).

**Figure 6-15. This photograph was taken from the corner of Liberty Street and Church Street looking west down Liberty Street after WTC 1 was struck by American Airlines Flight 11 but before WTC 2 was hit by United Airlines Flight 175. Some faces are blurred.**

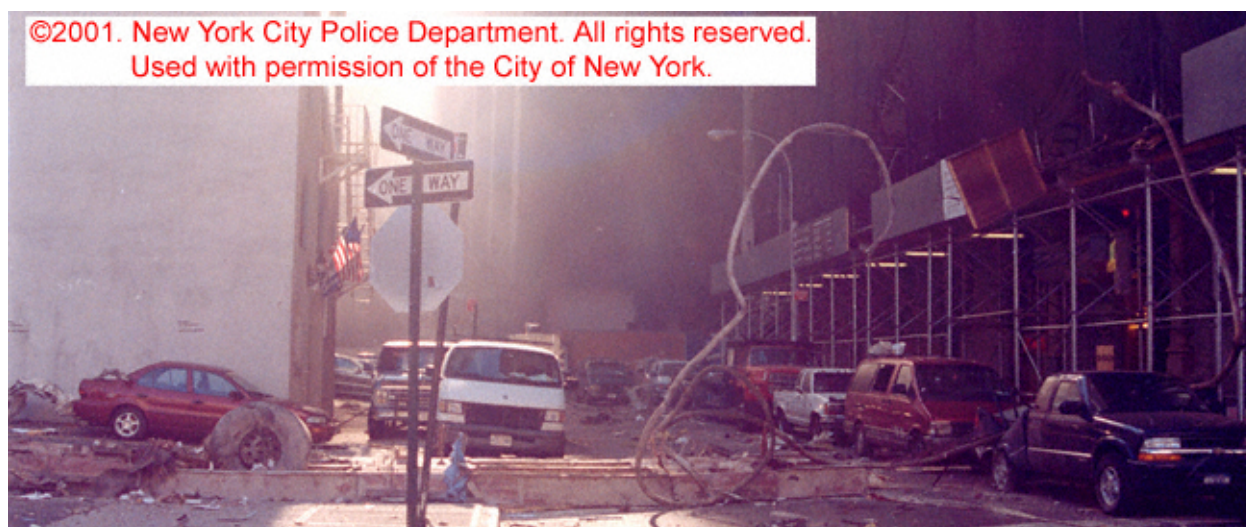
A curious aspect of Figure 6-16 is the large pipe that can be seen twisted about and rising above the panel section. A different view of the pipe is available in Figure 6-17, where it can be seen that it extends from well above the panel section across the pickup truck to the right and then up into the air. The force of the collision of the pipe with the pickup has crushed the cargo bay. The pipe section length is considerably longer than the panel section, which is 36 ft. The pipe diameter has been estimated as 1.5 in., based on its size relative to the panel section.

**Figure 6-17. This cropped and enhanced photograph shows another view of the three-story steel panel section included in Figure 6-16. A long pipe section attached to the steel rises above both the panel section and the pickup truck to the right. The building on the left is Saint Nicholas Greek Orthodox Church, and the building on the right is 90 West Street.**

Review of building plans and consultation with The Port Authority of New York and New Jersey staff and consultants have provided a plausible explanation for the source of this pipe. Cooling at the perimeter of the towers was accomplished by means of cold-water induction units located along the outer wall at the base of the windows. These units were fed cooled water by a series of vertical risers (pipes) that extended either up or down from the mechanical equipment rooms. Water was returned by parallel risers. The pipe in the figures seems to be attached to the bottom of the steel panel section on the center column, i.e., column 130 at the 93rd floor. Induction units on the 92nd floor and higher were connected to the mechanical equipment room on the 106th floor. Building plans indicate that supply and return risers were located just to the inside of column 130. The supply riser was 1.5 in. pipe and the return riser was 2 in. pipe. The appearance and location of the pipe in the figures indicate that it is mostly likely part of a supply riser that fed the induction coolers at this location.

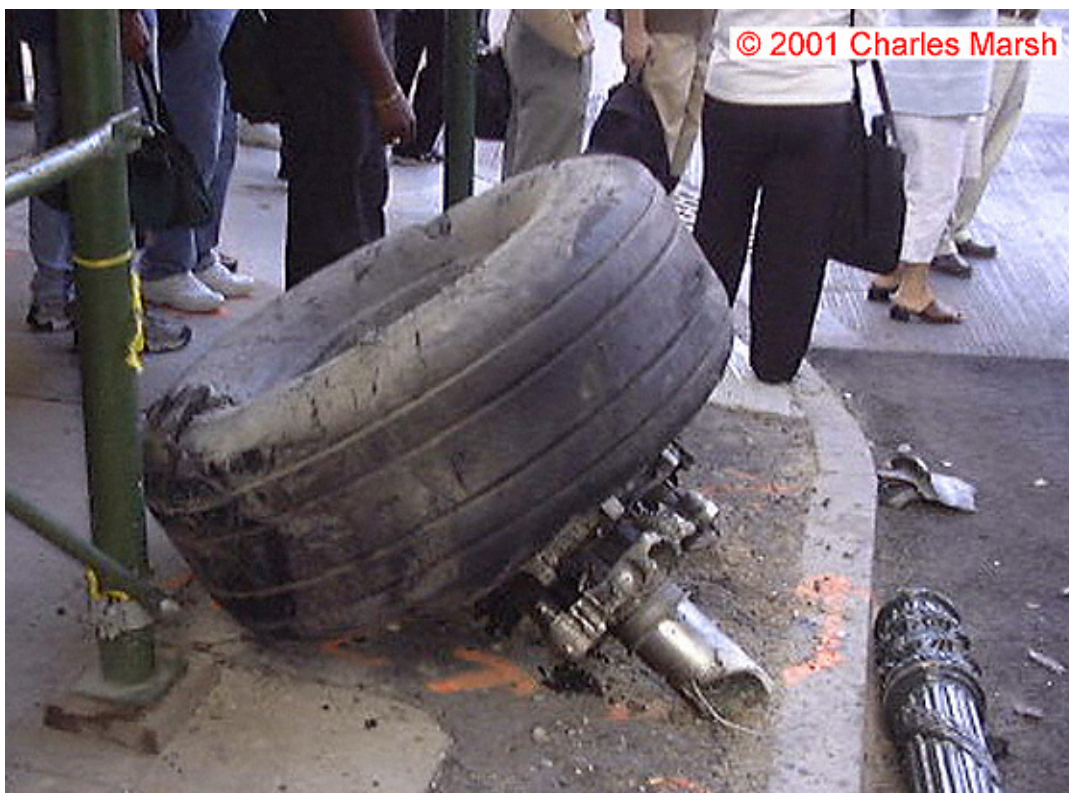
A second wheel from a landing gear, shown in Figure 6-18, was found much further south at the corner of Rector Street and West Street. This is a distance of roughly 1,385 ft from the base of the south face of WTC 1. The presence of a braking system indicates that this wheel also came from one of the two main landing gears.

**Figure 6-18. The photograph shows a wheel from the aircraft that struck WTC 1 lying at the southeast corner of the intersection of Rector and West Streets.**

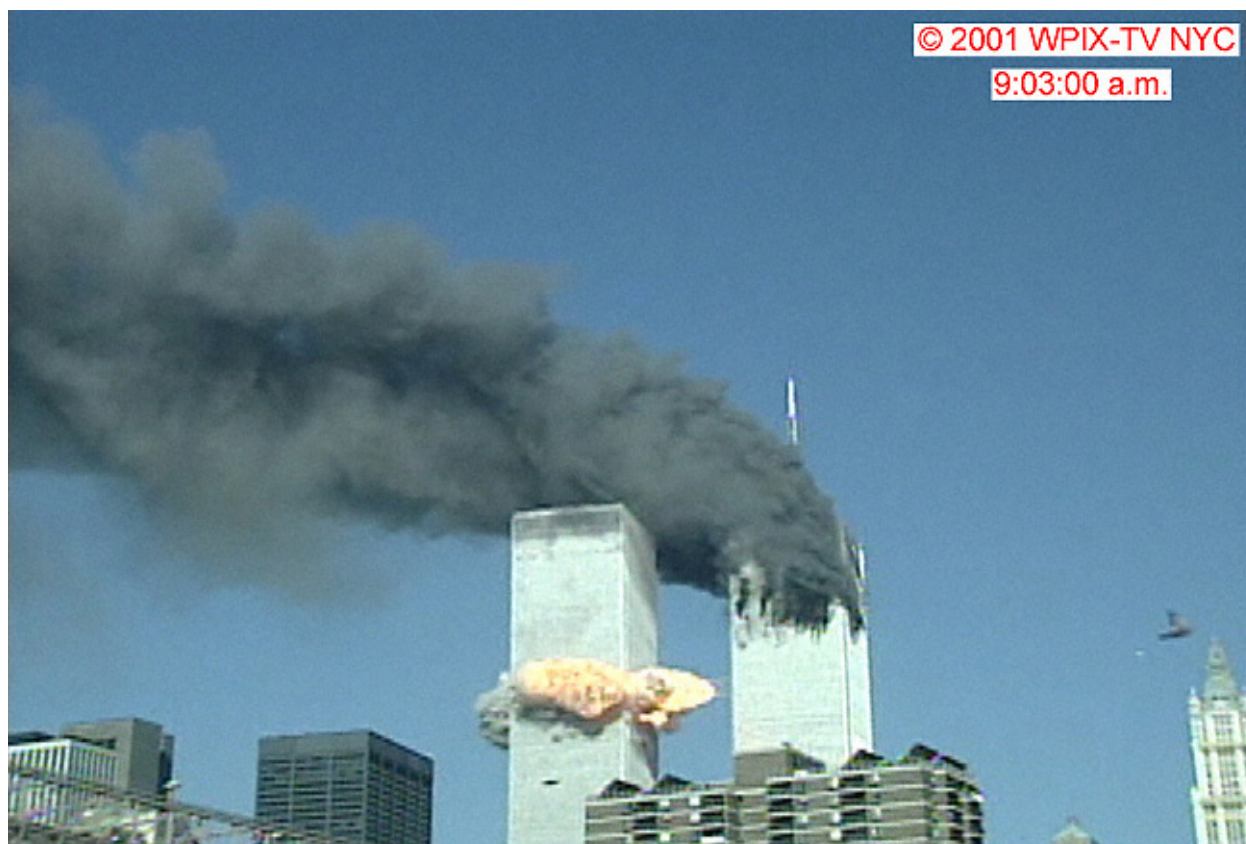
Close inspection of Figure 7-1 shows that there are three distinct fireballs present on the north face. Videos shot from the north indicate that the largest of these grew from the area of fire that originally

appeared on the 80th, 81st, and 82nd floors in the vicinity of windows 239 to 249 (see Table 7–1). The second, somewhat smaller, of the fireballs is at roughly the same height and emanates from near the northeast corner. The third fireball is the smallest and is located below the other two. Northern views show that this fireball was formed from fire exiting from windows 79-233 to 79-240 on the 79th floor (see Table 7–1).

**Figure 7-1. The nascent fireballs and dust clouds formed on WTC 2 1.2 s after the aircraft impact on the tower are shown. The image is a frame from a video.**

A large cloud of dust is evident in Figure 7–1 on the south face that does not appear to be burning despite the fact that ignition was observed on this face (see Table 7–1). It appears as if there was much less fuel in the material that was expelled from this face than observed on the east and north faces. Other regions of dust can be seen below the fireball on the east face and in the vicinity of the mechanical equipment room on the 75th and 76th floors on the east and north faces.
