**NIST NCSTAR 1-5A**

**Federal Building and Fire Safety Investigation of the  
World Trade Center Disaster**

**Visual Evidence, Damage Estimates,  
and Timeline Analysis**

September 2005

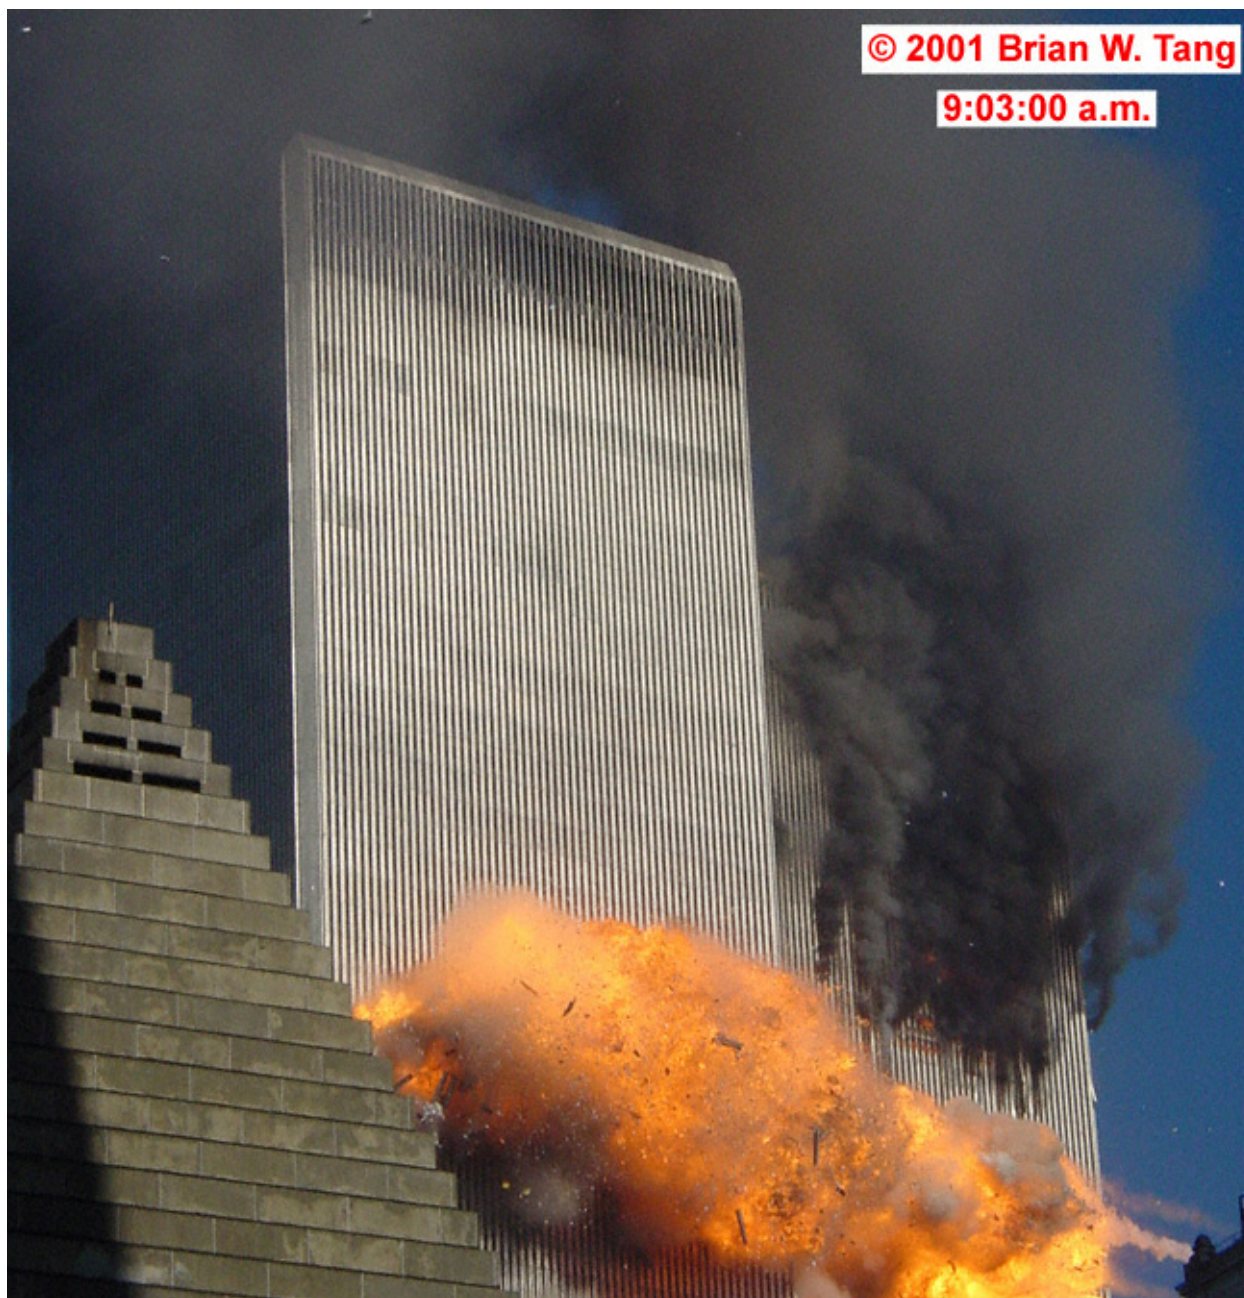
**Figure 7-2. This cropped photograph shows the fireball formed on the east face of WTC 2 following the aircraft impact that took place 1.1 s earlier. The east face of WTC 1 is visible in the background**

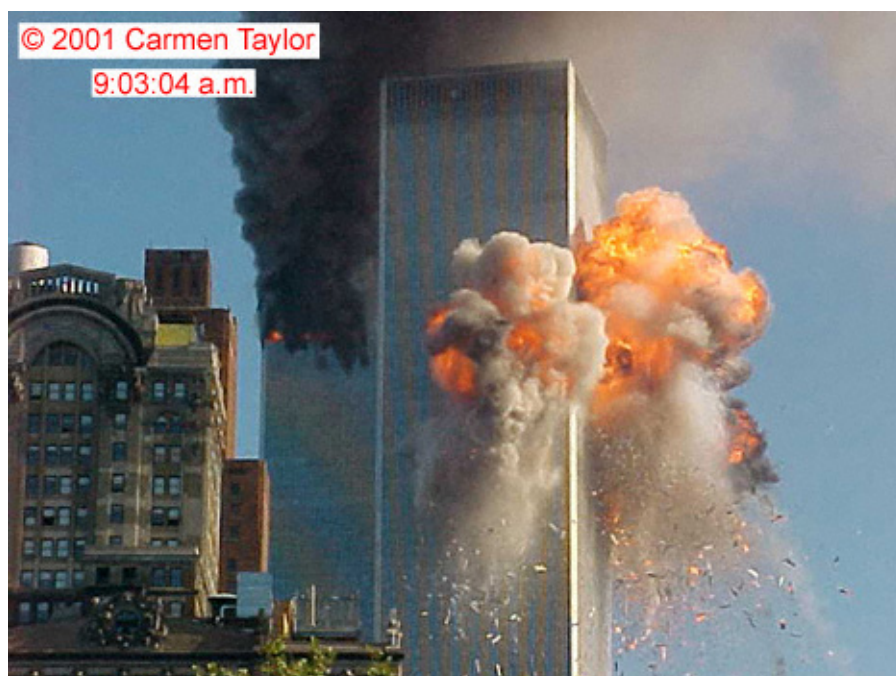
As the fireballs continued to burn, buoyancy forces due to the heated gases began to dominate, and the fireballs were carried upward. Figure 7–3 shows the fireballs on the south and east faces of WTC 2 observed 4.3 s after the aircraft impact. Their appearances are very much changed from those in Figure 7–1 and Figure 7–2. Burning is now observed at heights well above where the aircraft impacted, and both fireballs have become more spherical in shape. Large amounts of dust and larger debris are seen falling downward below the fireballs. The fireball on the east face is considerably larger than that on the south.

**Figure 7-3. An image of WTC 2 recorded from the southeast is shown. The photograph was taken 4.3 s after the aircraft impact on the tower. The south face of WTC 1 can be seen burning in the background.**

Burning on the south face seems to be concentrated more on the west side, with little flame evident in the dust cloud toward the east.

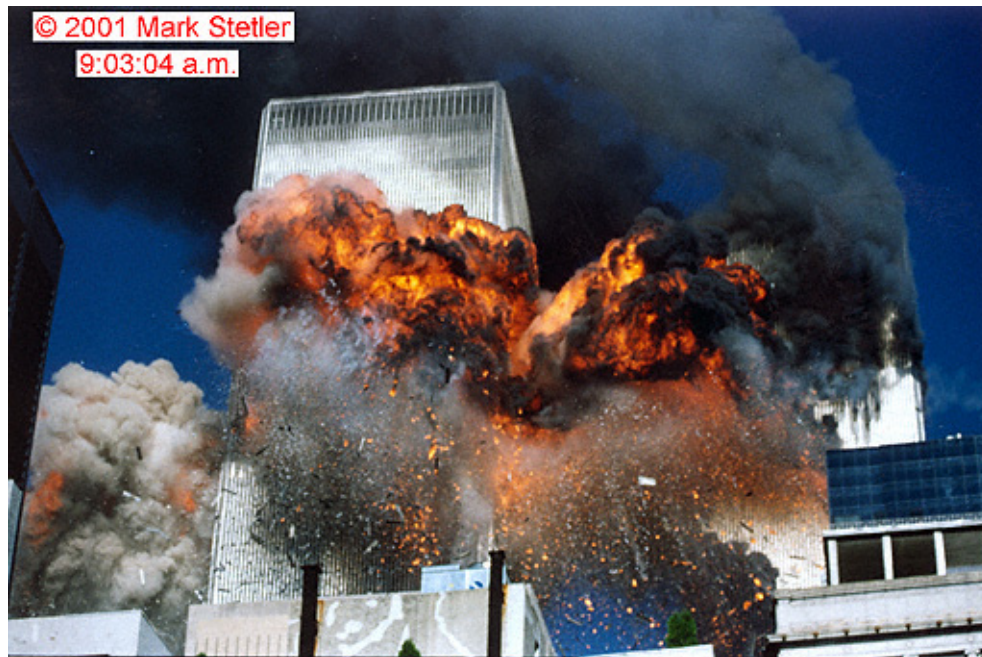
Figure 7-4 shows a photograph of the fireballs taken from just north of due east 4.6 s after the aircraft impact. The features of the fireballs are similar to those already described. The large extent of the fireball on the north face is apparent by noting that the width of each tower is 209 ft. The large amount of dust and larger debris (some flaming) generated by the collision and fireballs can be seen falling below the fireballs. Some isolated regions of fire are evident in the dust cloud on the south face.

**Figure 7-4.** An image of the fireball on WTC 2 recorded from just north of due east is shown. The photograph was taken 4.6 s after the aircraft impact on the tower.

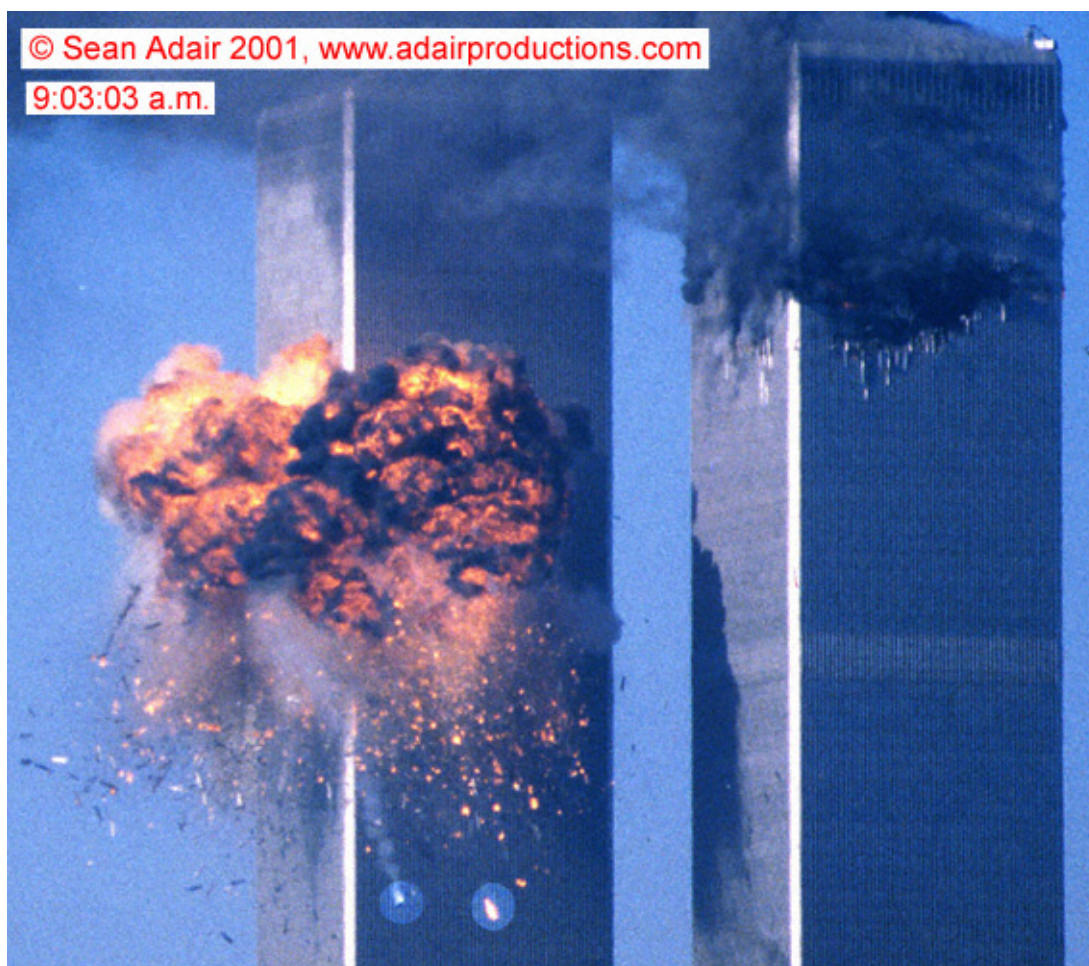
**Figure 7-5. An image of the towers recorded from the north northeast is shown. The photograph was taken 4.3 s after the aircraft impact on WTC 2. Highlighted areas show two large pieces of aircraft debris that passed through the building and landed in the vicinity of the Church and Murray Streets intersection.**

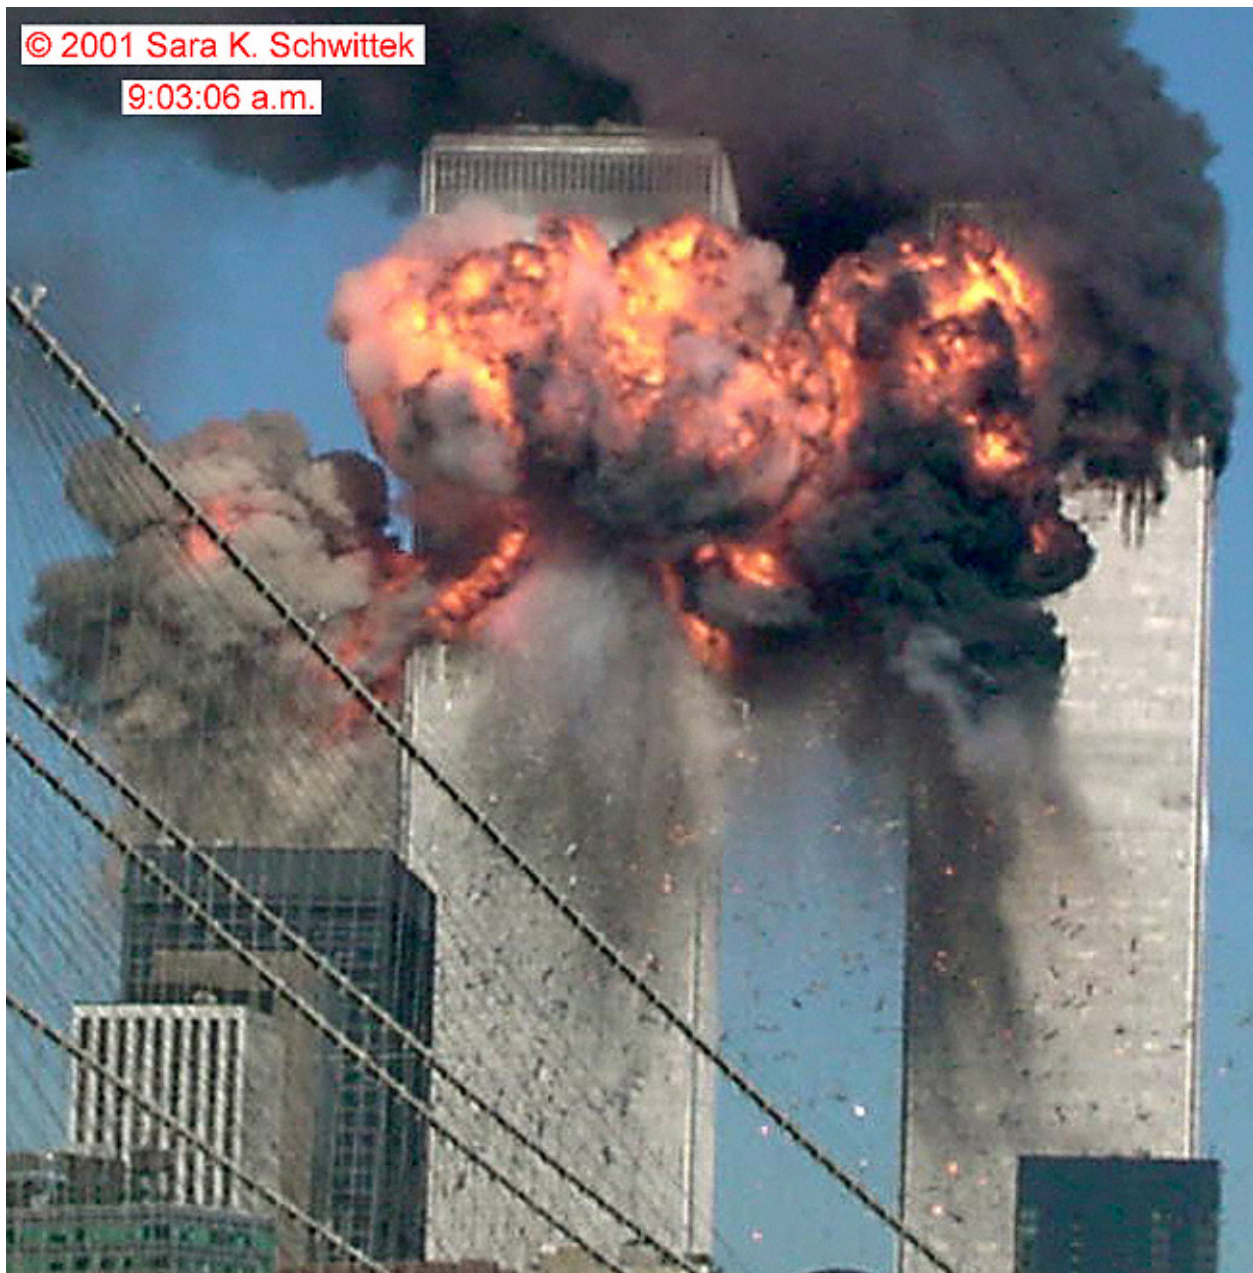
**Figure 7-6.** This cropped image of the towers recorded 6.5 s after the aircraft impact on WTC 2 was shot from the east on the opposite side of the East River in Brooklyn.

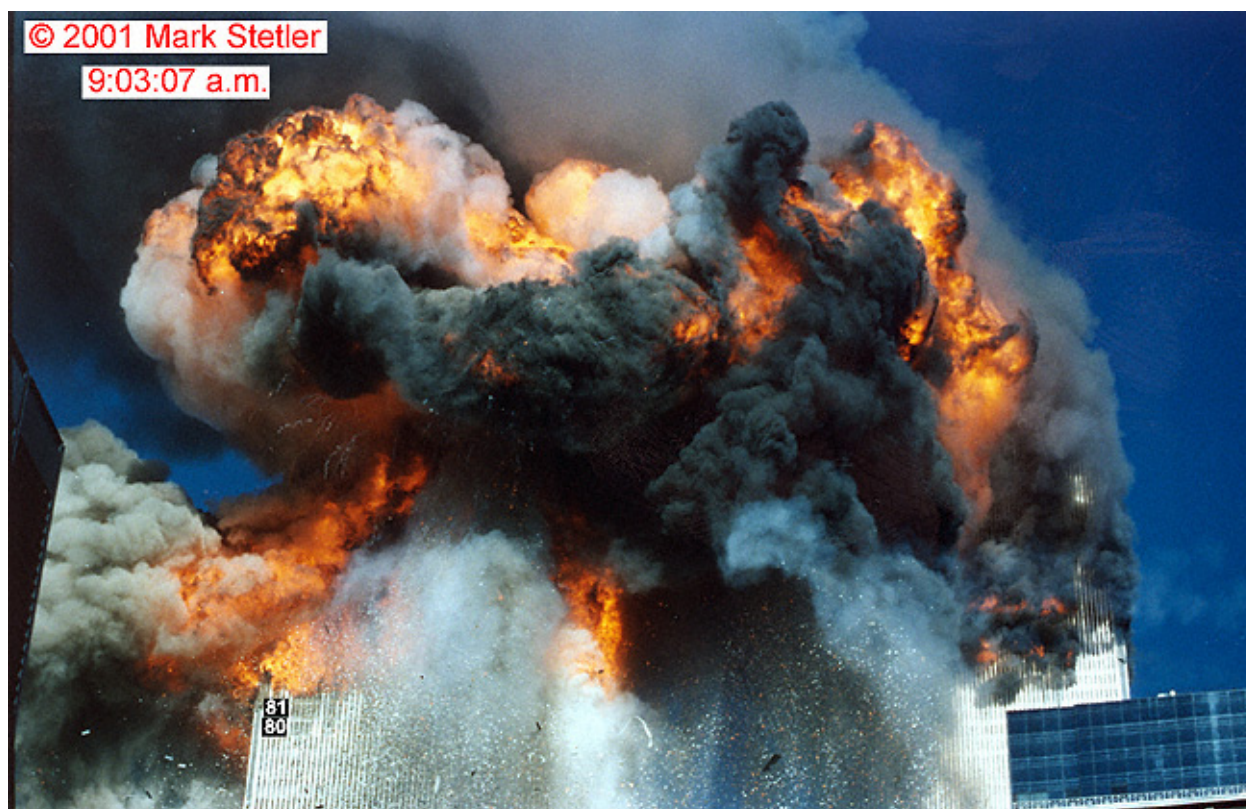
Figure 7-7 is an image recorded 7.9 s following the aircraft impact from the same perspective as Figure 7-4. The large fireball formed by the rapid expulsion of aviation fuel from the tower immediately following the aircraft impact has continued to rise and has begun to separate from the release point. Intense flaming is still seen in the vicinity of the building where the aircraft impact occurred. Even though significant façade damage is evident on the south side of the east face over three floors (80th, 81st, and 82nd), flames are emanating primarily from the 82nd floor windows. It is possible that flaming from higher windows is also occurring, but is hidden. Similar flaming is evident on the south and north faces.

**Figure 7-7. An image of WTC 2 recorded from just north of due east is shown. The photograph was taken 7.9 s after the aircraft impact on the tower. The locations of the 80th and 81st floors are identified**

Large amounts of debris and dust are falling from the central region of the east face. Some of this debris is higher than the aircraft impact floors. This indicates that a portion of the debris that was expelled from the building was initially carried upward by the fireball. Since the debris is heavier than air, it eventually loses its upward momentum and drops from the bottom of the fireball.

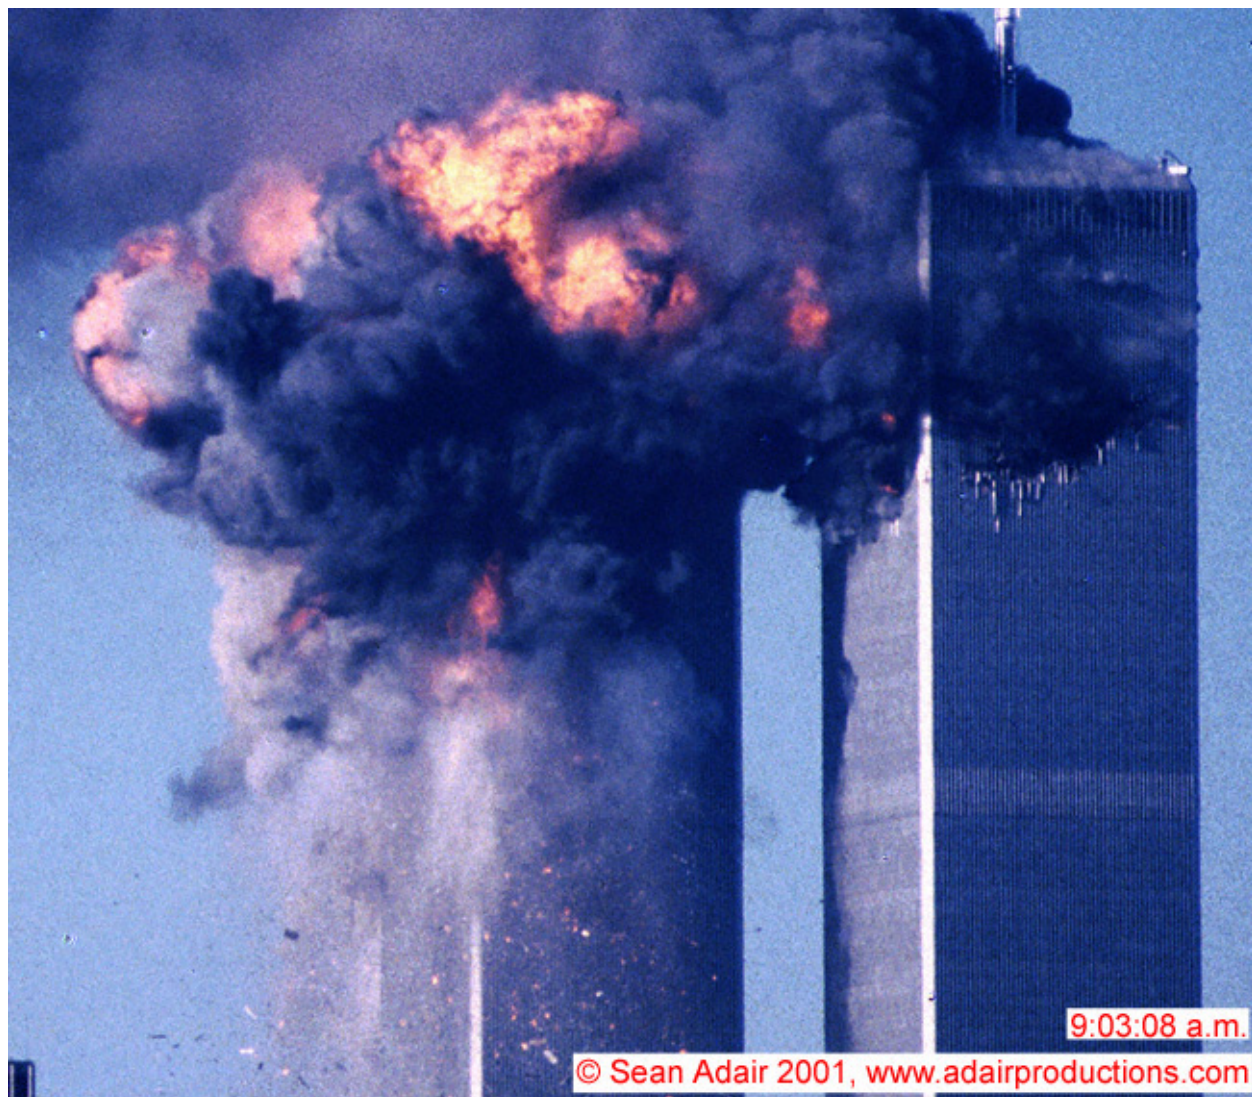
Figure 7-8 shows a northern view of the fireball taken 8.7 s after the aircraft impact. The perspective is the same as in Figure 7-5. The appearance of the fireball is consistent with that described for Figure 7-7, but the amount of visible flame in the fireball appears to be significantly reduced, indicating that it is beginning to burn out. There appears to be a large amount of debris falling on the northeast corner of the tower and considerably less from regions of the north face more toward the center. The falling debris on the northeast corner is evident in Figure 7-7 as well. Similar to the east face photographs shown in Figure 7-6 and Figure 7-7, which were taken at roughly the same time, significant flaming from the tower is evident below the fireball in the vicinity of the aircraft impact location.

**Figure 7-8. An image of the towers recorded from the north northeast is shown. The photograph was taken 8.7 s after the aircraft struck WTC 2.**

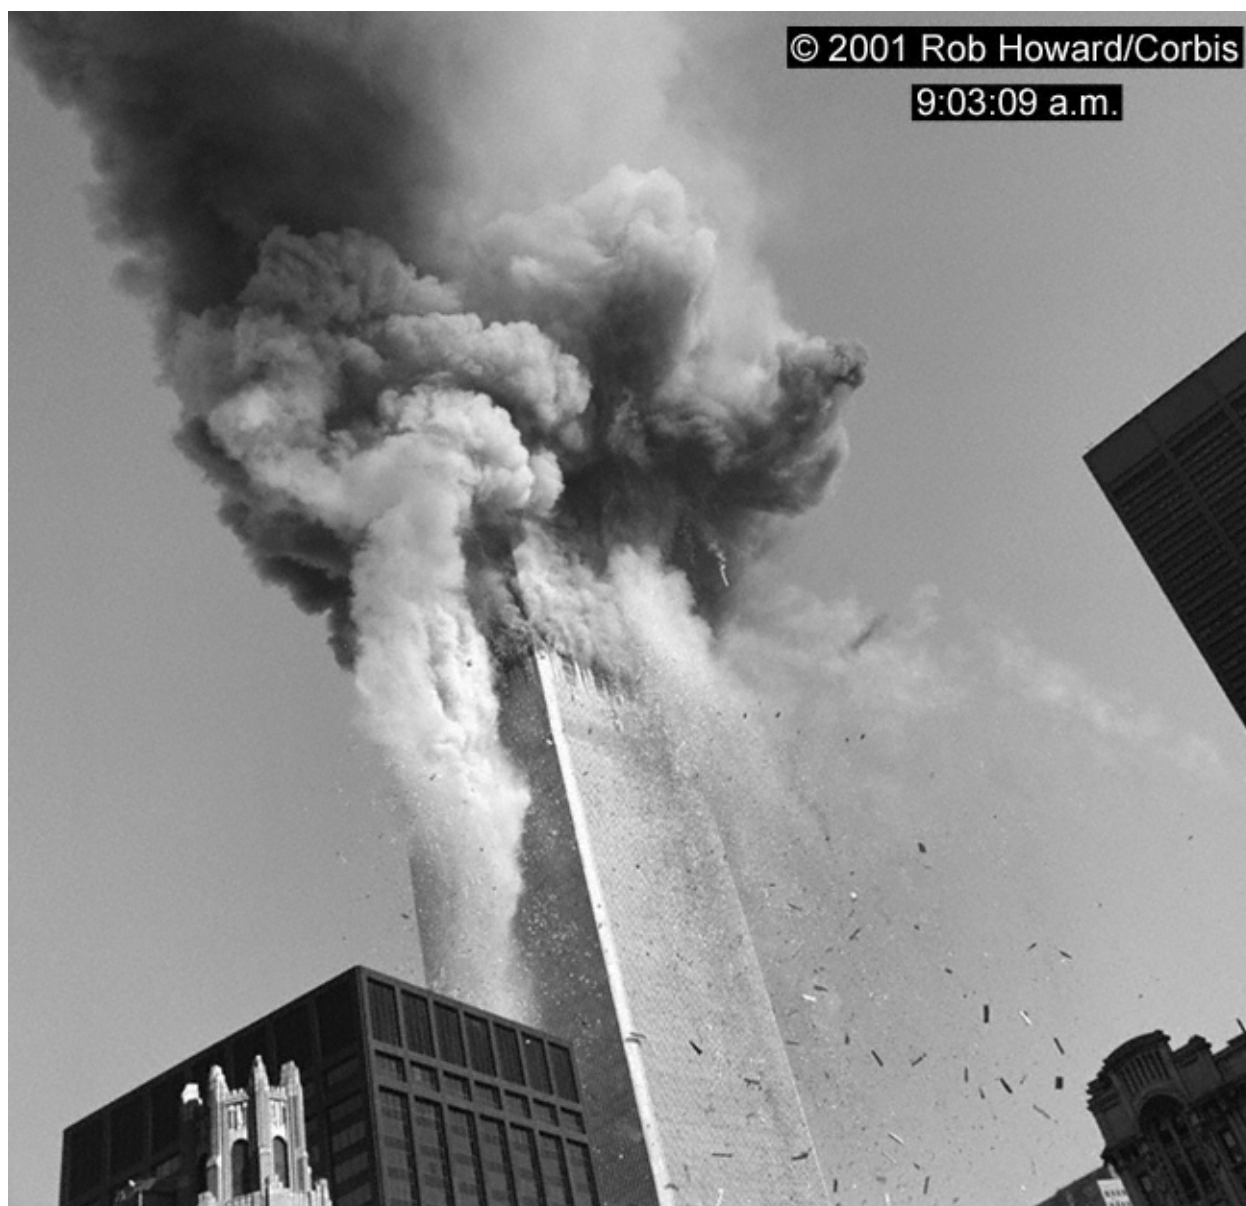
Figure 7-9, taken 10 s after the second aircraft struck WTC 2, shows the debris and dust clouds on the south and east faces of WTC 2. The cloud on the south face is much larger than that on the east face. This is consistent with the conclusion that more debris was expelled from the south face than from either the east face or north face. The observation of a smaller, shorter-lived fireball on the south face suggests that less fuel was consumed by this fireball than those on the east face and north face.

**Figure 7-9. This cropped black and white photograph was recorded from the southeast of WTC 2 10 s after the second aircraft impact.**

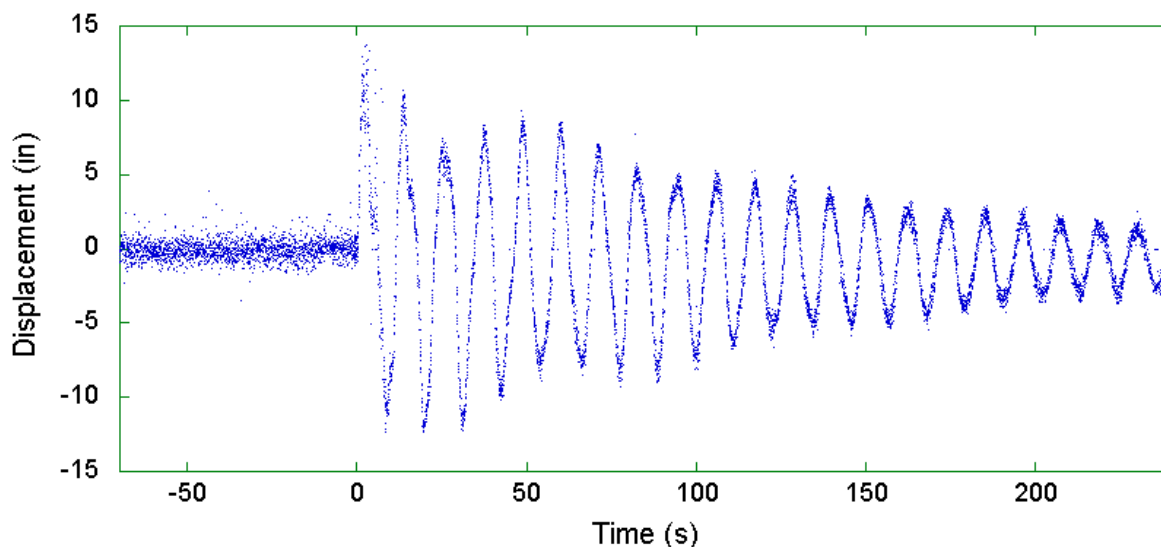
**Figure 7-18. The displacement of the first (left-most) window line on the 70th floor of WTC 2 determined using moiré analysis is shown as a function of time.**

Detailed frequency analysis of the displacement data shown in Figure 7–18 revealed the fundamental north-south mode with a period of 11.4 s, a torsional mode with a period of 5.3 s, and two higher frequency modes with periods of 3.9 s and 2.2 s. All periods are accurate to better than  $\pm 0.1$  s. The period of the fundamental mode is comparable to the computational value for WTC 2 and within normal expected variations as evidenced by measurements on WTC 1 (NIST NCSTAR 1-2). The torsional mode dominates the window spacing variation, as twisting of the building makes the camera's viewing angle of the east face alternatively more and less perpendicular. The highest frequency mode causes some jerkiness in the motion over the first few oscillations.

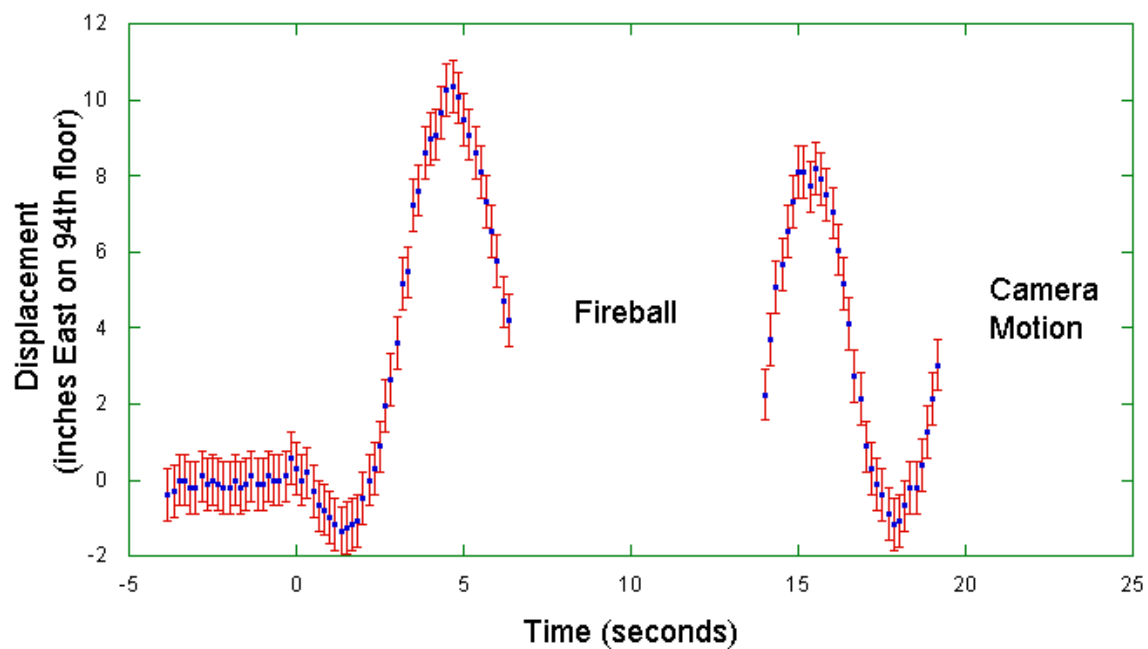
Although the motion of WTC 2 in this video covers less than a pixel width horizontally, the moiré pattern for the nearly vertical lines of windows greatly amplifies this motion. Figure 7-20 shows the calculated east-west displacement of the 94th floor of WTC 2, with a total apparent sway of 12 in.  $\pm$  2 in. A frequency analysis of this brief set of data yielded a period of 5.3 s. This is consistent with the torsional mode found in the analysis of north-south motion and can be explained as follows. The aircraft struck WTC 2 on the south face off-center toward the east while moving toward the northeast relative to the tower. As a result, the tower was twisted in the counter-clockwise direction as seen from above, i.e., the aircraft impact imparted a brief angular momentum as seen from above. To an observer from the north, points on the north face appeared to suddenly move toward the west. The tower resisted this motion and tried to return to its original position. In doing so, it rotated clockwise, causing the apparent motion to the east evident in Figure 7-20. The torsional motion would have continued until it died down. It is uncertain why the estimated building motion is asymmetric relative to the original undisturbed position.

Figure 7-20. East-west motion of WTC 2 just before and after the aircraft impact. Error bars indicate measurement uncertainty.

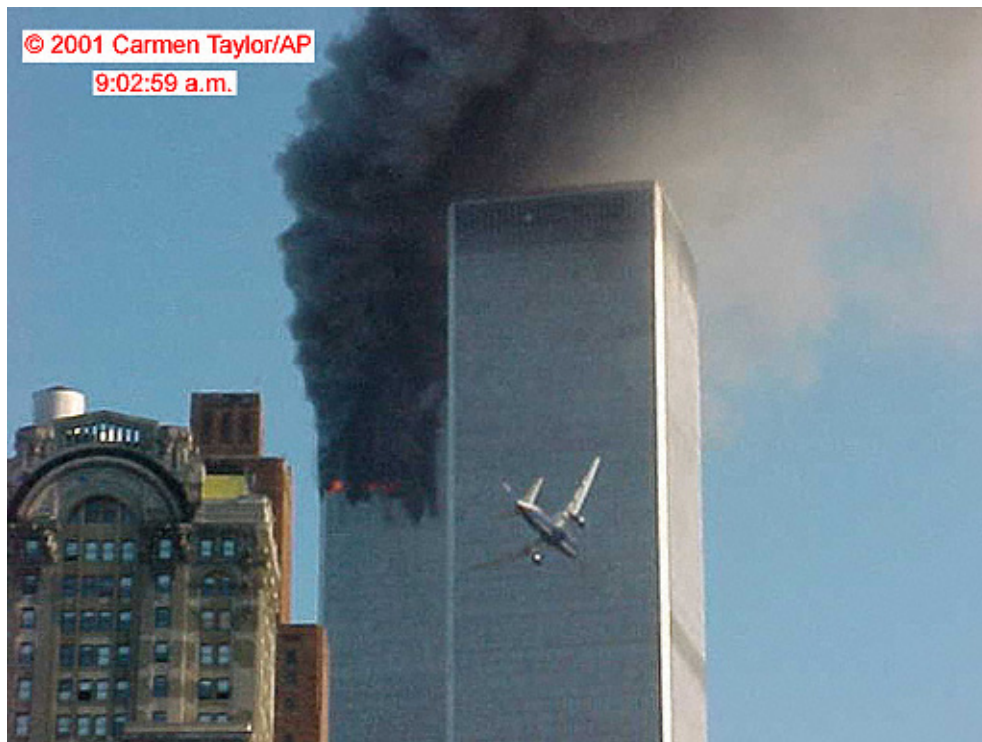
Figure 7–21 shows a photograph that was taken just prior to United Airlines Flight 175 striking WTC 2. The right wing of the aircraft is raised, as if the aircraft was turning to the left. Videos show that when the aircraft struck it appeared to disappear into the tower leaving a hole shaped like the aircraft. Very shortly after the aircraft impact, a large cloud of debris and burning aviation fuel exited the tower from the impact location, obscuring the region. Table 7–1 in Section 7.2 details some of the observations during the period immediately following the aircraft impact. As the fireball rose and the dust cloud cleared, the hole in the building became visible once again.

**Figure 7-21. This photograph shows United Airlines Flight 175 just prior to its collision with the south face of WTC 2 at 9:02:59 a.m.**

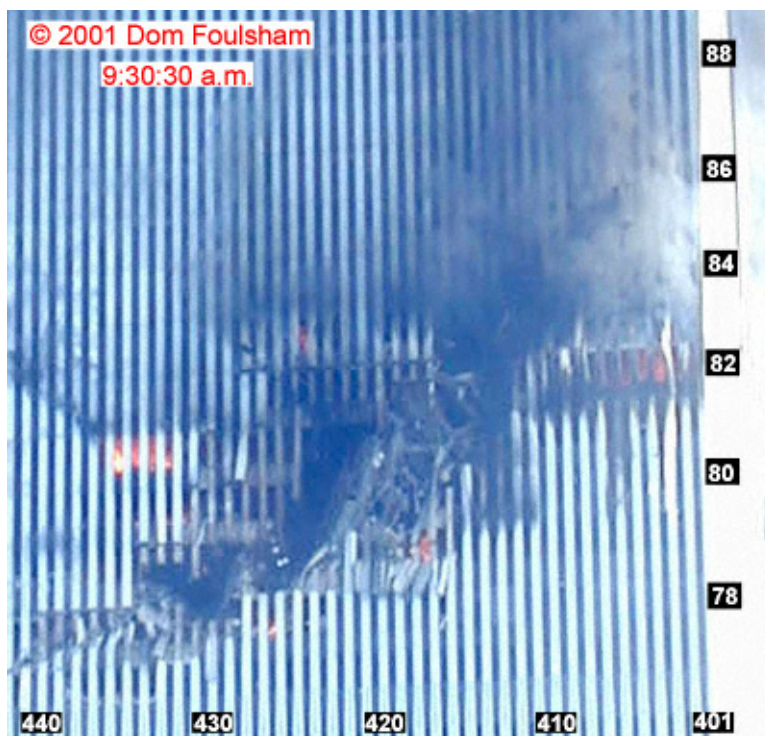
**Figure 7-22.** This cropped photograph shows the damage to the south face of WTC 2 caused by the aircraft impact. The image was enhanced by adjusting the intensity levels. Column and floor number have been added.

Inspection of Figure 7-22, Figure 7-23, and Figure 7-24 shows that portions of the aluminum cladding that formed the curtain wall for the building were partially or completely removed at locations close to where the aircraft impact occurred. This includes areas on the 80th floor extending from column 80-426 to column 80-431, on the 81st floor extending from column 81-425 to column 81-430, and on the 82nd floor extending from column 82-420 to column 82-426. In Figure 7-24 it can be seen that the aluminum cladding covering the southeast corner on the 82nd floor was pushed outward during the event. It is likely that this occurred as a result of the overpressure within the building generated by burning of aviation fuel released from the tanks of the aircraft. This damage provided a convenient marker for identifying the 82nd floor.

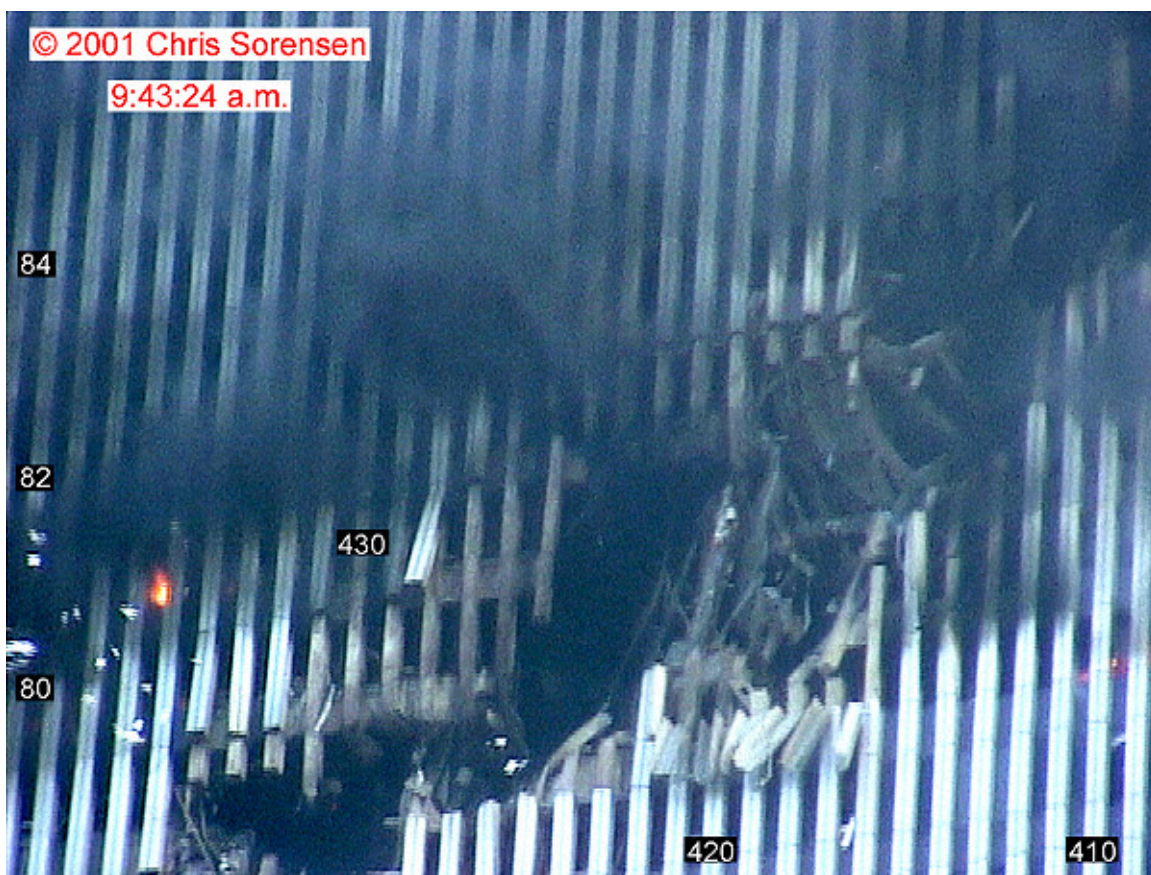
**Figure 7-23. A frame captured from a video recording of the aircraft impact location on the south face of WTC 2 is shown. The image has been enhanced by adjusting the intensity levels. Column numbers and floor numbers have been added.**

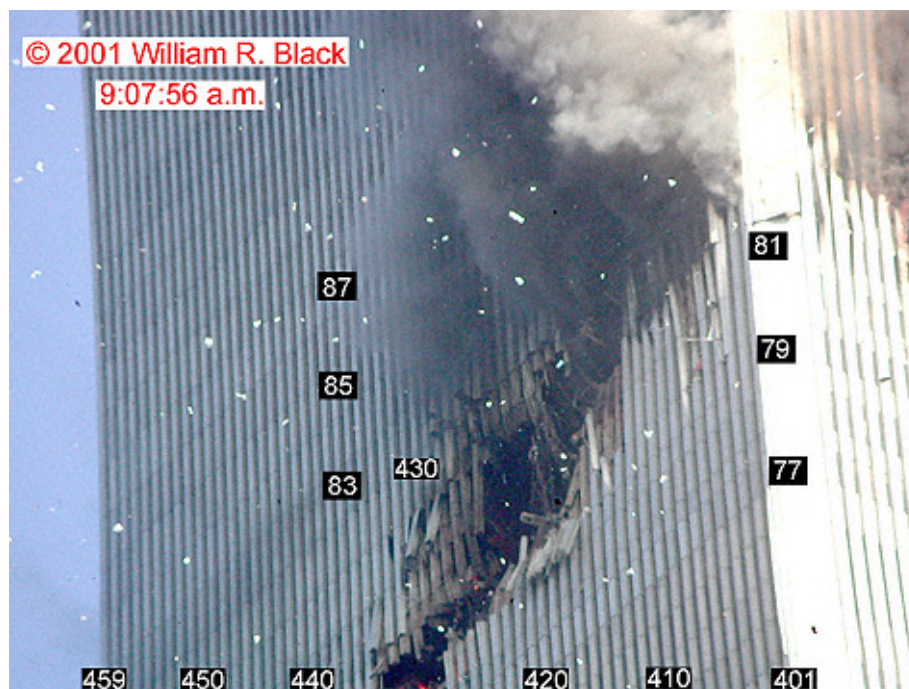
**Figure 7-24. This cropped photograph shows the damage to the south face of WTC 2 caused by the aircraft impact. The original image has been enhanced by adjusting the intensity levels. Column and floor numbers have been added.**

Close inspection of the photographs and videos reveals a great deal of debris piled on the right-hand side of the opening created by the aircraft impact. This debris, along with the depth of the opening, indicates that floor slabs in this area were partially collapsed by the collision. There is insufficient information to determine the exact areas over which the floor slab collapses occurred or the depth of the collapses inside the building. Visual evidence to be discussed in Section 7.4.3 suggests that at least some of the concrete in the floor slabs was pulverized during the collision.

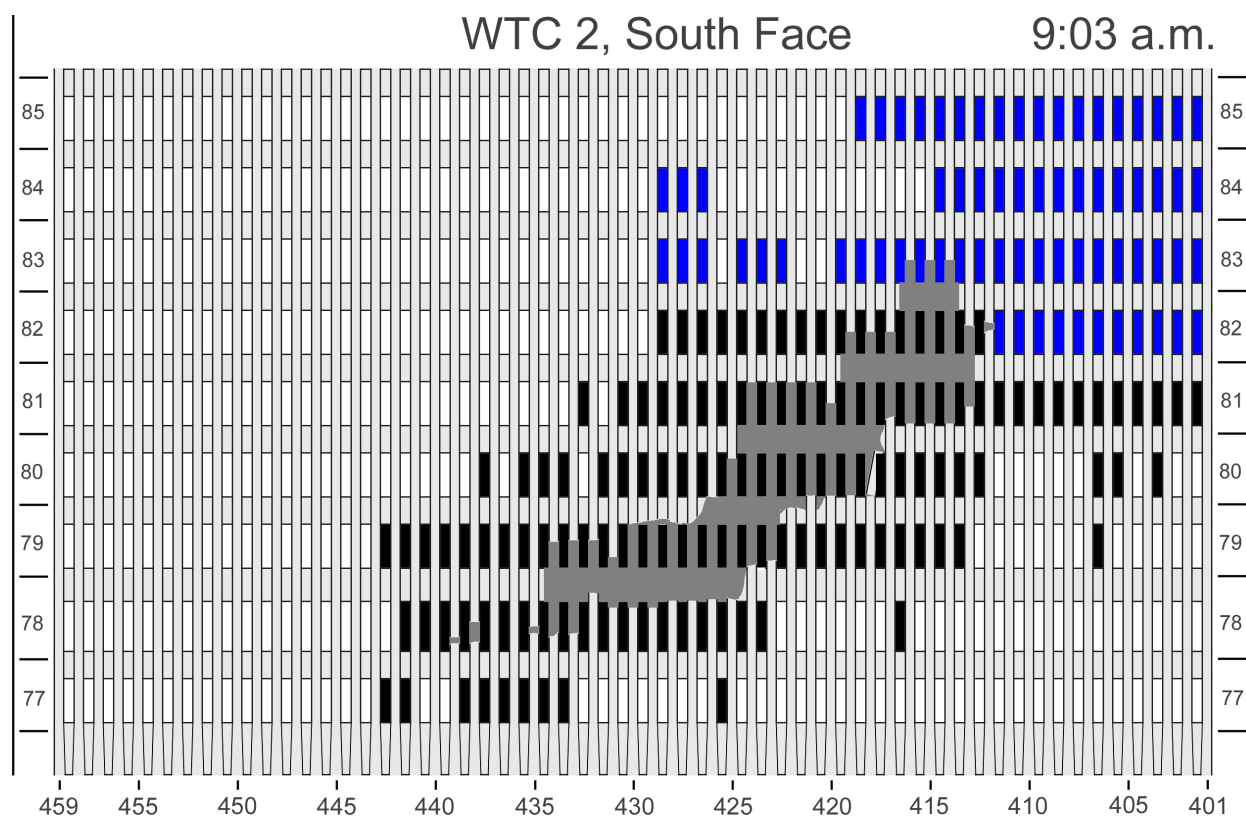
In general, the glass in windows near the aircraft impact location was broken out, while those windows further away tended to remain intact, although some windows were blown open by the overpressure generated by the initial fireball formation within the building. Figure 7-27 is a color-coded representation showing the condition of the windows on the south face in the area immediately following the aircraft impact. Note that a portion of the face was hidden by smoke at this time.

**Figure 7-27. A schematic of observed window conditions on the south face of WTC 2 immediately following the aircraft impact is shown. Window and floor numbers are indicated. The colors represent ■ - window broken open, □ - glass in place, and ■ - not visible.**

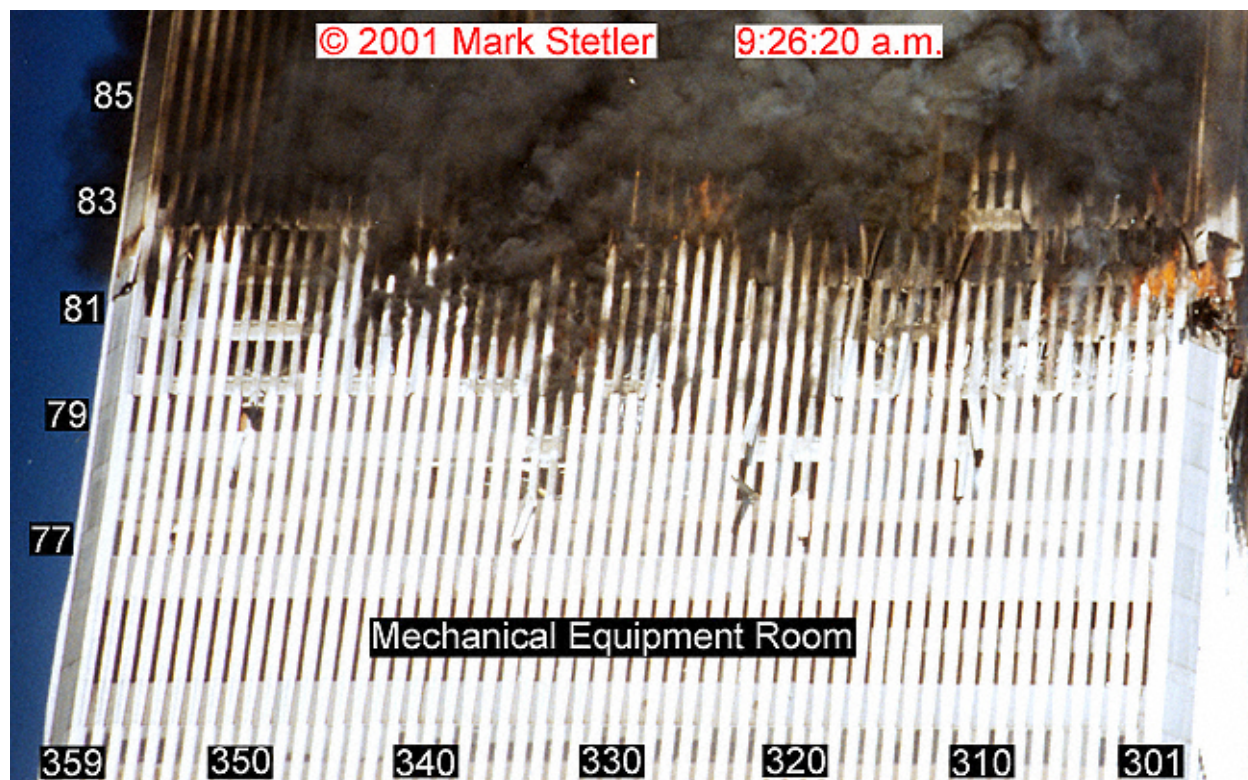
Substantial areas of the aluminum curtain wall have been removed over multiple floors. These areas appear dark due to the color of the underlying column and spandrel steel and fireproofing. In other areas the aluminum column and spandrel covers were disturbed, but remained in place. Video evidence and the wide extent of the damage indicate that much of this damage was due to the overpressures generated within the building by the sudden ignition of atomized aviation fuel and that these overpressures were sufficient to “blow off” numerous sections of the curtain wall. The potential magnitude of the overpressure generated within the tower was discussed in Section 6.5.

**Figure 7-28. A cropped photograph shows the east face of WTC 2 at 9:26:20 a.m. The image has been rotated, and column and floor numbers have been added.**

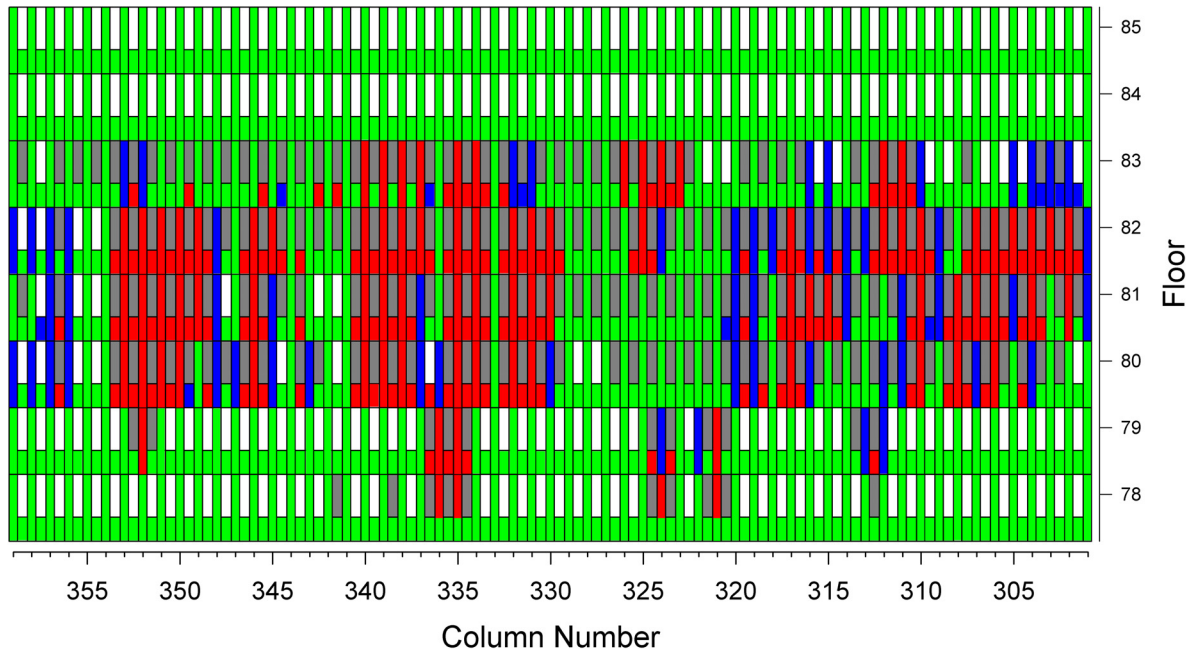
Figure 7-28, along with numerous other photographs and videos, was used as the basis for a detailed assessment of the initial damage to the curtain wall on the east face. Figure 7-29 shows the results. The information displayed includes details about the condition of the aluminum facing and whether or not window glass is missing or is still in place. It is apparent that the largest areas of damage were concentrated on the 80th, 81st, and 82nd floors. Based on Figure 7-26, these correspond to the two floors struck by the body of the aircraft (80th and 81st floors) and the floor where the majority of fuel from the starboard fuel tank was dumped (82nd floor). Interestingly, much less damage is apparent on the 79th floor, which is the floor where most of the fuel from the aircraft's port tank should have been released.

**Figure 7-29. A color-coded map of the damage to the east face of WTC 2 as a result of the aircraft impact and fireball is shown. Details concerning damage to the aluminum curtain wall ( ■ - undisturbed, ■ - disturbed but still in place, and ■ - aluminum facing missing) and windows ( ■ - glass missing and ■ - glass in place) are combined.**

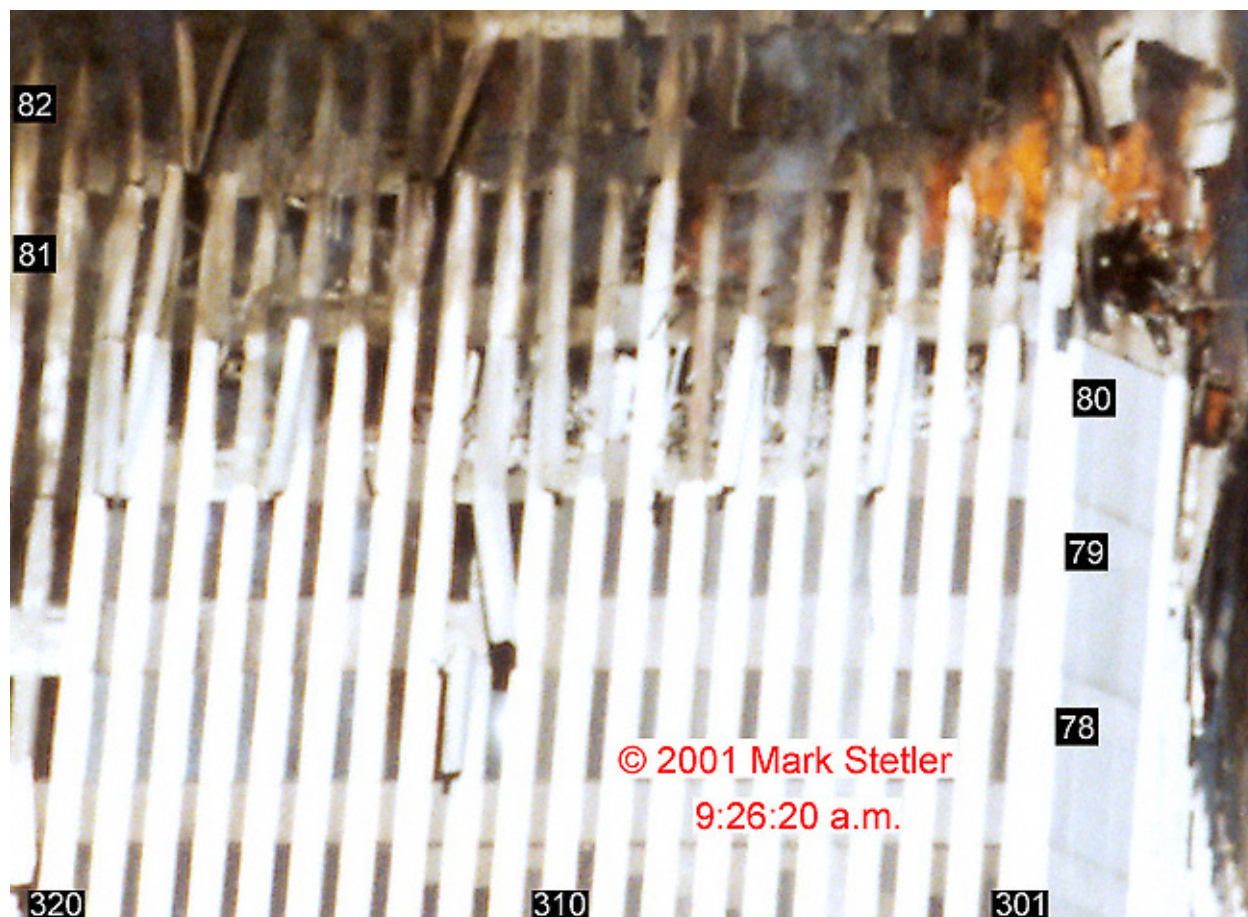
Figure 7-30 shows an enlarged region of the northeast corner of the tower taken from Figure 7-28. Large piles of debris can be seen through the windows near the corner on the 80th and 81st floors. It is likely that a large fraction of this debris was derived from the aircraft, since its body impacted on these two floors (see Figure 7-26). This suggests that either the debris was deflected from the core or that the aircraft was moving toward the east when it struck the tower, since the nose struck near column 422 on the south face.

Figure 7–30 also shows that the aluminum panels on the 80th and 81st floors of the northeast corner have been pushed out and partially removed. This damage was present immediately following the aircraft impact. Observations included in Table 7–1 indicate that the initial damage in this area appeared 0.4 s after the aircraft impact. As discussed below, it is likely that one of the engines of the aircraft passed through this corner. A pile of debris can also be seen jutting from this corner on the 81st floor. The debris in the corner can be seen more clearly in Figure 7–31, which was shot from the northeast. Additional debris extends from windows on either side of the corner.

**Figure 7-30.** This photograph showing a portion of the east face of WTC 2 was cropped from the image shown in Figure 7-28. The image has been rotated, and column and floor numbers have been added. Note the large piles of debris on the 80th and 81st floors.

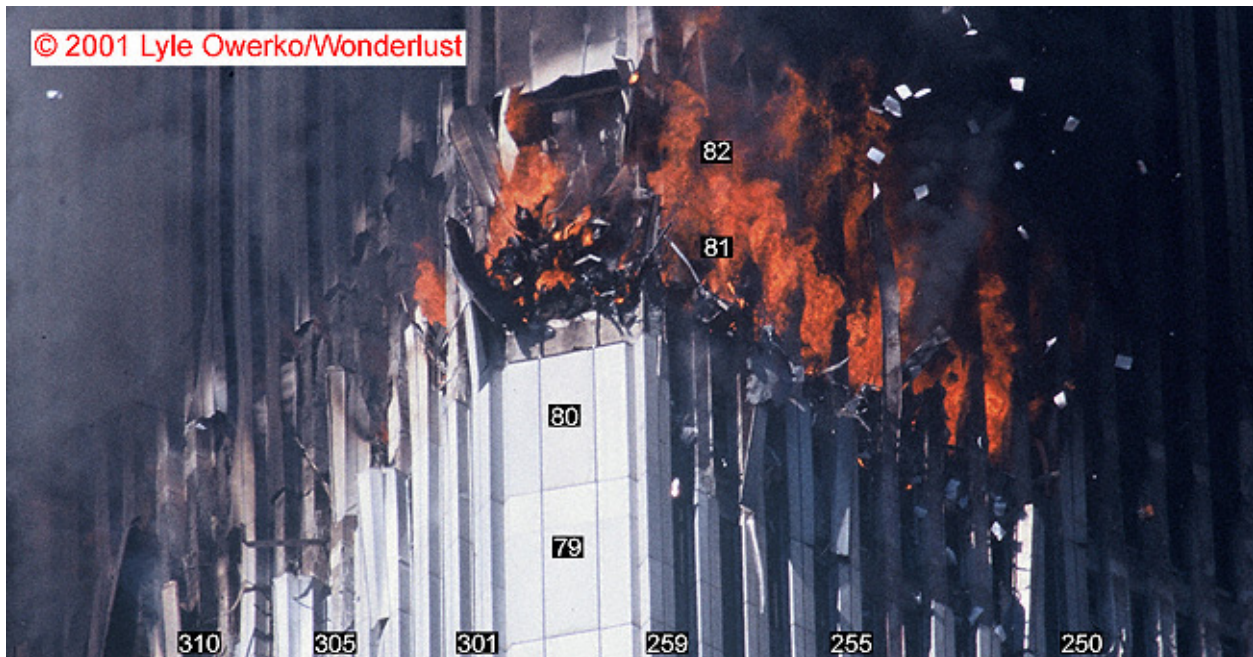
Figure 7-31. This cropped photograph shows the northeast corner of WTC 2. This image was recorded between 9:05 a.m. and 9:19 a.m. Column and floor numbers have been added. The corner aluminum panels on the 81st and 82nd floors have been pushed outward. A large pile of debris is evident in the opening on the 81st floor, and a vertical steel column, numbered 82-300, can be seen on the 82nd floor.
