**NIST NCSTAR 1-5A**

**Federal Building and Fire Safety Investigation of the  
World Trade Center Disaster**

**Visual Evidence, Damage Estimates,  
and Timeline Analysis**

September 2005

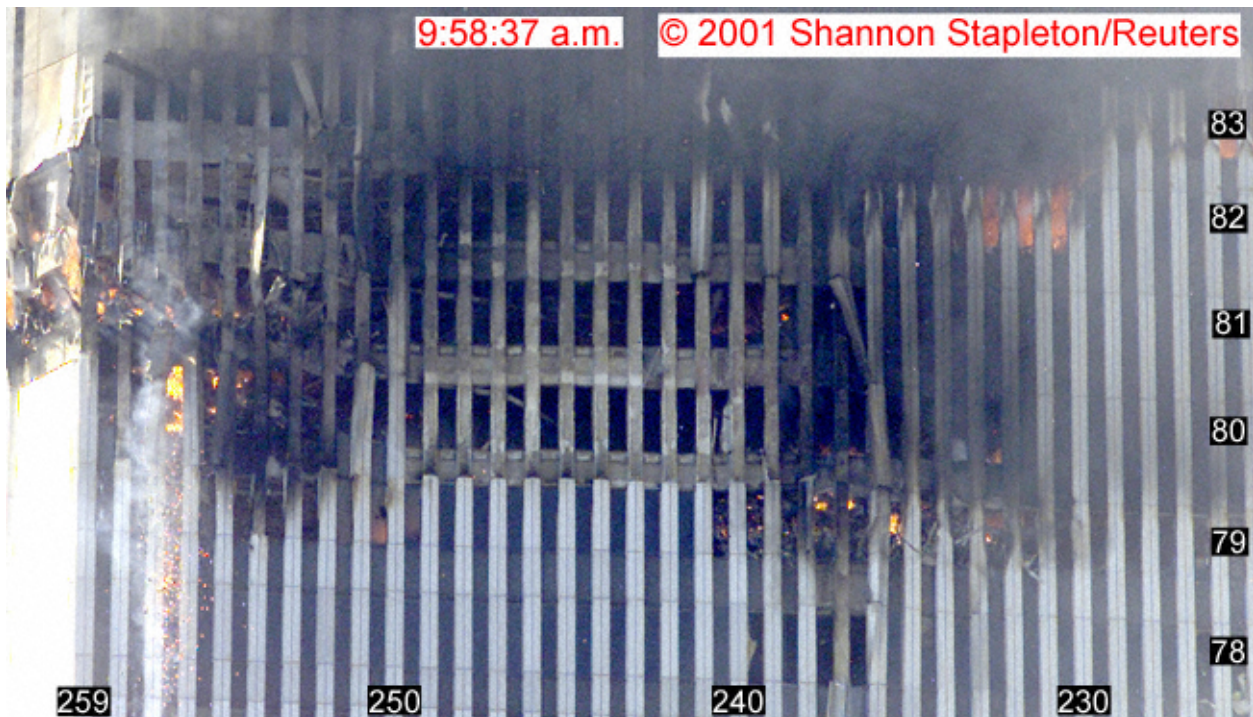
A casual inspection of Figure 7–32 reveals that significant areas of the aluminum curtain wall are missing. Reviews of early photographs and videos indicate the vast majority of this damage was present immediately after the fireball created by the aircraft impact dissipated. The most prominent region of missing curtain wall is a roughly rectangular area extending from column 238 to column 249 and covering the 80th, 81st, and 82nd floors. This area coincides with the locations (see Table 7–1) where the nascent fireball was first observed on this face 0.63 s following the aircraft impact. As will be discussed in more detail in Chapter 9, the observed fire behavior in this area following the fireball and before the

Closer inspection of Figure 7-32 shows that column 253 has been severed just below the spandrel between the 81st and 82nd floors. The adjacent column, 81-254, is bent and split. This damage must be the result of a large part of the aircraft passing through the tower. As indicated in Table 7-1, such an object was observed breaking through the north face at this location 0.5 s after the aircraft impact on the tower.

Figure 7-32. A cropped and enhanced photograph of WTC 2 taken at 9:58:37 a.m. shows the east side of the north face. Piles of debris are evident on the 80th and 81st floors at the northeast corner and on the 79th floor to the right of column 241. The “cold” spot extends over the 80th to 82nd floors from column 238 to 249.

In the photograph the glass for four windows, 78-236 to 78-239, is missing. Again, this observation is consistent with the events listed in Table 7-1, which indicates that this damage first appeared on the north face 0.86 s after the aircraft impact. While not shown in Figure 7-32, the uncropped version of this photograph and numerous earlier photographs and videos indicate that the glass in windows 78-224 to 78-226 was broken out during the aircraft impact. The time line in Table 7-1 indicates that façade damage and dust appeared at this location 0.56 s after the aircraft impact. It is interesting that even though aircraft and/or parts of the building exited the north face on the 78th floor at two locations, no fire was observed emanating from windows on this floor.

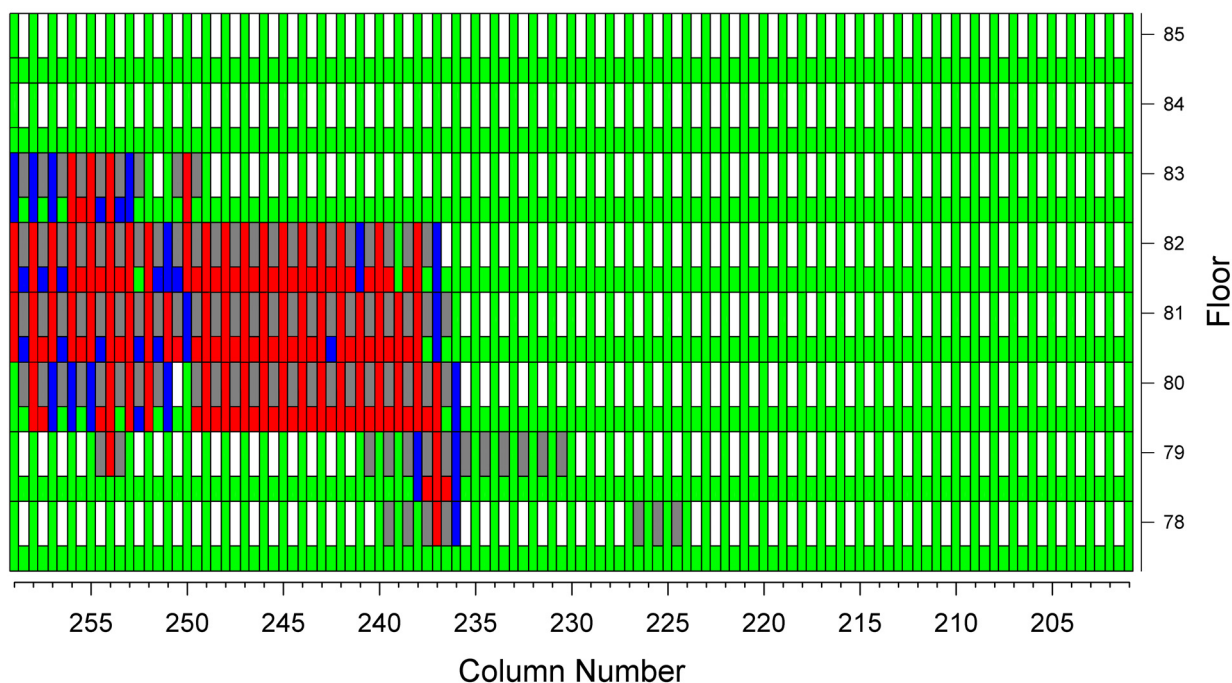
Figure 7-32, along with other photographs and videos, was used to develop the map for exterior damage shown in Figure 7-33 for the north face of WTC 2 that combines damage to the aluminum facing and window glass that make up the curtain wall. Damage on this face is inclined at an angle which roughly matches that at which the aircraft struck the tower on the south face on the opposite side of the tower. This suggests that debris from the aircraft tended to pass straight through the tower, perhaps passing between and being guided by the floor slabs.

**Figure 7-33. A color-coded visualization of initial damage to the north face of WTC 2 is shown. Information concerning damage to the aluminum on the curtain wall ( ■ - undisturbed, ■ - disturbed but still in place, and ■ - aluminum facing missing) and windows ( ■ - glass missing and ■ - glass in place) are combined.**

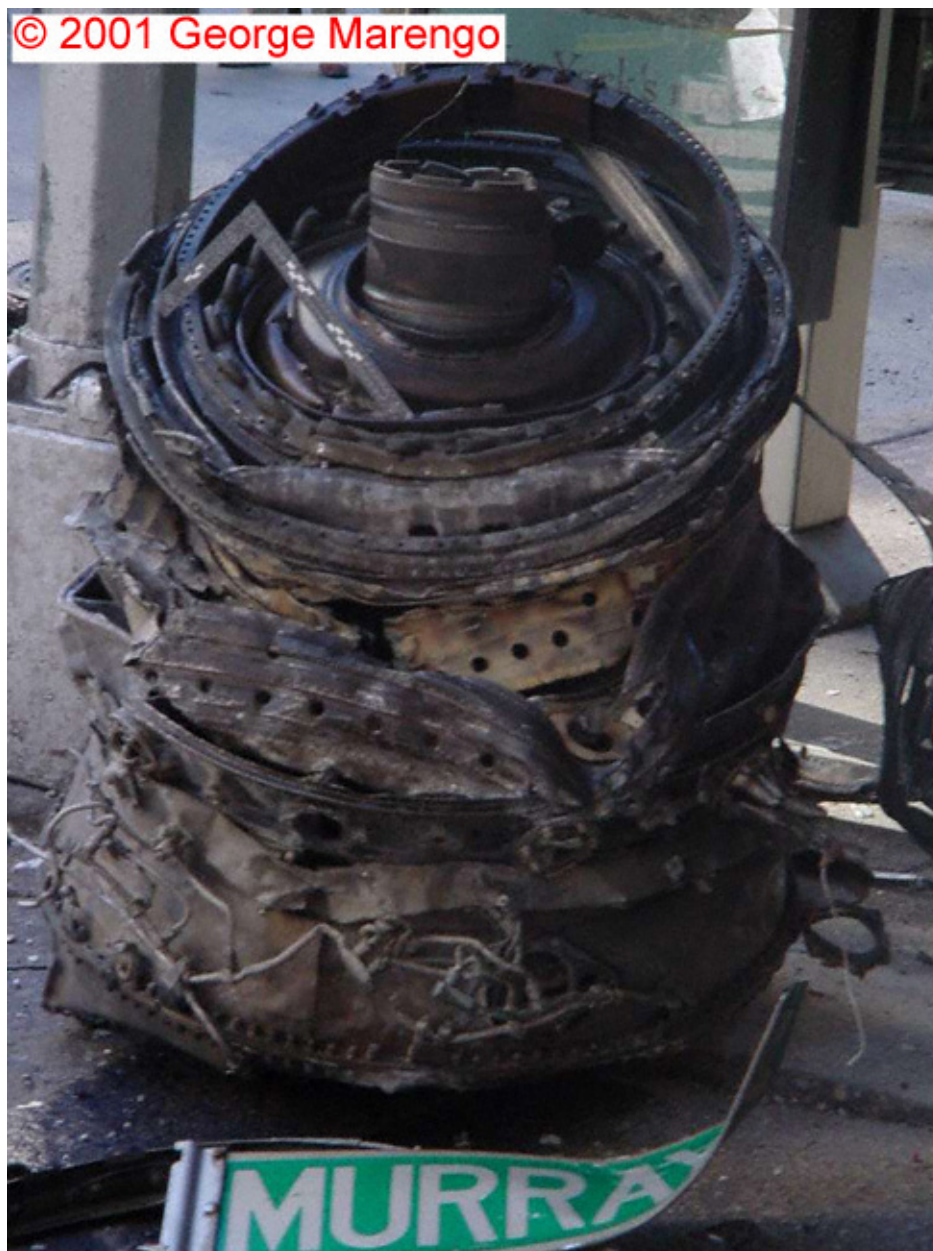
Based on the video evidence summarized in Table 7–1, along with the observed damage pattern, the most likely exit location for the engine component was the northeast corner of the tower at the 81st floor, and for the landing gear it was in the vicinity of window 81-253 on the 81st floor. These locations are consistent with the aircraft impact location indicated in Figure 7–26 if both components came from the starboard side of the aircraft. If the exit locations are identified correctly, the engine component exited

**Figure 7-34. This photograph shows what appears to be part of an aircraft engine lying near the northeast corner of the intersection of Church and Murray Streets. The photograph was taken prior to the collapse of WTC 2.**

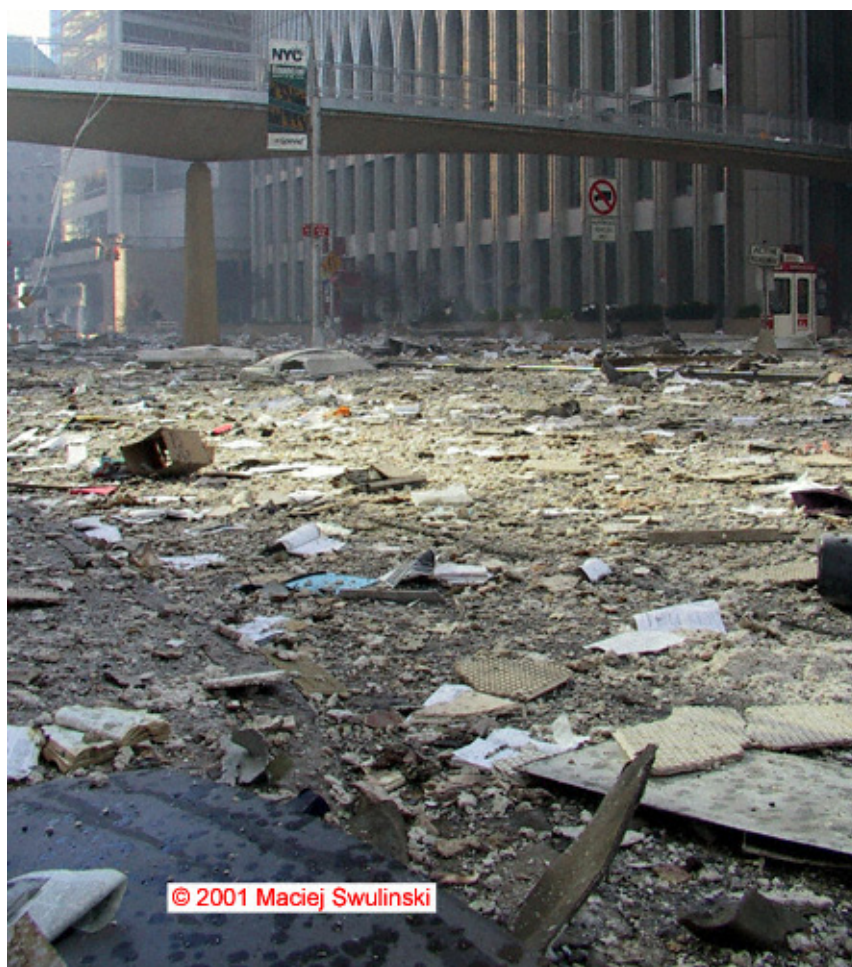
**Figure 7-35.** This cropped photograph taken from near the corner of Greenwich Street and Liberty Street shows debris on Liberty Street following the second aircraft impact on WTC 2. WTC 2 and WTC 3 are located in the background.

The debris in Figure 7-35 and Figure 7-36 most likely made up a portion of the dust cloud evident on the south face of WTC 2 in Figure 7-3 and Figure 7-9. This material was blown backward out of the tower by the overpressure generated by the initial fire inside the building that appeared shortly after the aircraft impact. The relatively large amount of what appears to be concrete, as well as its small size, suggests that the aircraft impact pulverized a significant amount of concrete floor slabs as it entered the tower. This is consistent with the large scooped-out cavity seen in the aircraft impact location (see Figure 7-22 to Figure 7-24). As noted previously, it has not been possible to visually observe the depth of such damage.

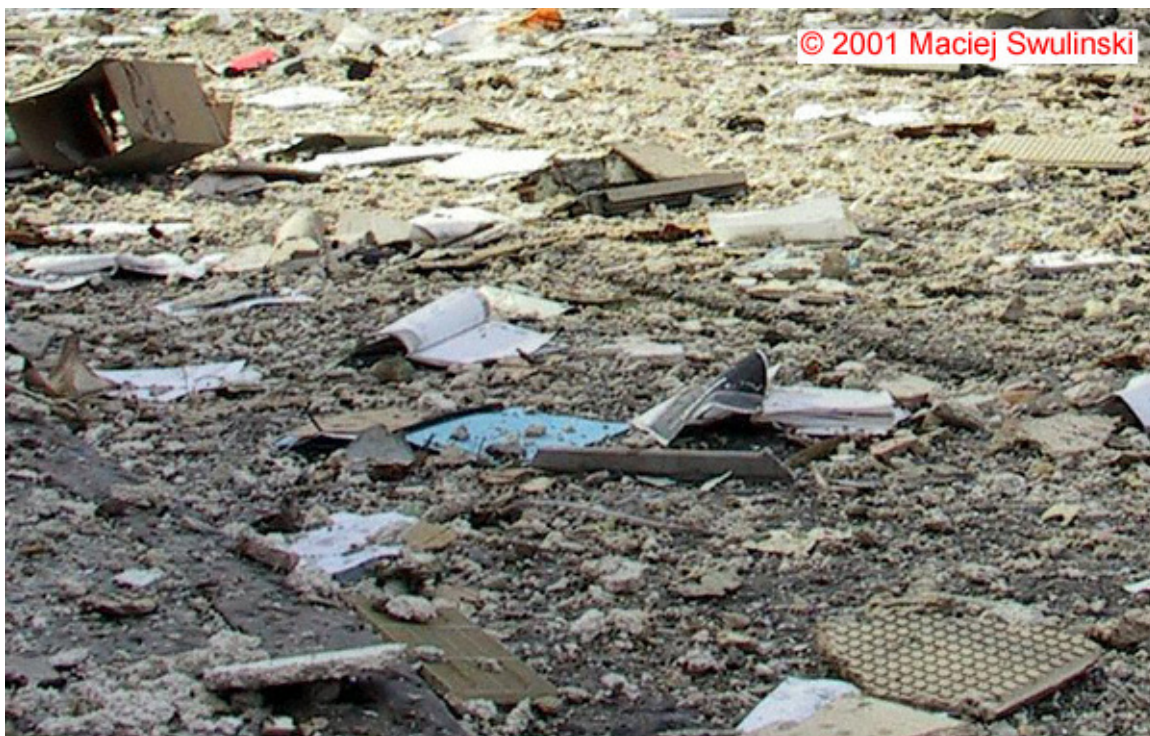
Figure 7-36 shows an enlarged portion of Figure 7-35. This photograph is typical of other photographs of the debris taken in the vicinity. Various types of debris, including papers and cardboard boxes, are identifiable. There is also a great deal of what appears to be crushed concrete. A dimpled material is evident in the foreground. Similar material is seen elsewhere in the street debris. This material is likely a portion of a ceiling tile.

**Figure 7-36. A close-up of the debris on Liberty Street created by the second aircraft impact is shown in an enlarged section from Figure 7-35.**

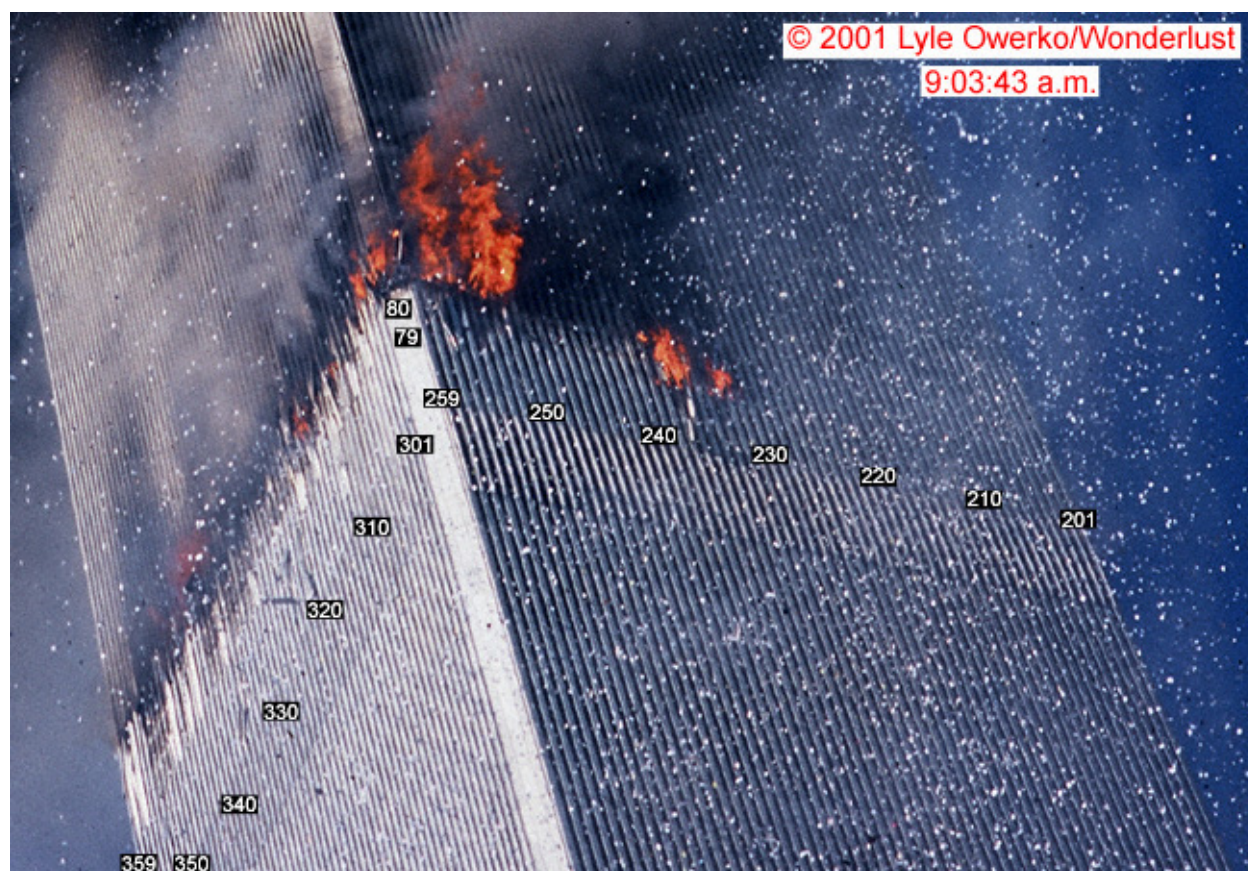
After the initial ten-second period following the aircraft impact, most of the large fires burning around WTC 2 began to decrease in size and to recede back into the building. In many locations fires were no longer visible after about 30 s. Figure 7-37 shows a photograph that was taken 44 s after the aircraft impact. Comparison with Figure 7-6 to Figure 7-8 indicates to what a large extent the flames coming from open windows have died down. Only relatively small fires are now observed on the east face. Substantial flame extension is still present on the north face, with large flames evident on the 81st floor near the northeast corner, and somewhat smaller flames located near the center of the north face on the 79th floor. Both of these flaming regions are in areas where large piles of debris can be seen through the windows. The cold spot discussed earlier stands out between the two fire zones due to the absence of flame. Similar close-up photographs and videos from the south are not available in the database for this early time, but more distant images indicate only a few isolated small fires were present on this face at this time.

**Figure 7-37.** This cropped photograph showing WTC 2 from the northeast was taken from the corner of Vesey Street and Church Street at 9:03:43 a.m., i.e., 44 s after the aircraft impact. The intensity levels have been adjusted, and column and floor numbers have been added.

The lack of significant burning in interior regions in the immediate aftermath of the fireballs is also reflected in the absence of heavy smoke coming from the tower. Some smoke is evident in Figure 7–37, but it does not obscure the faces of the tower. Most of it seems to be emanating from the flaming areas visible near the outer edge of the tower. Figure 7–38 shows the east side of WTC 2 at roughly the same time. Only very light smoke is present, and most of the façade area above the floors with fires is visible.

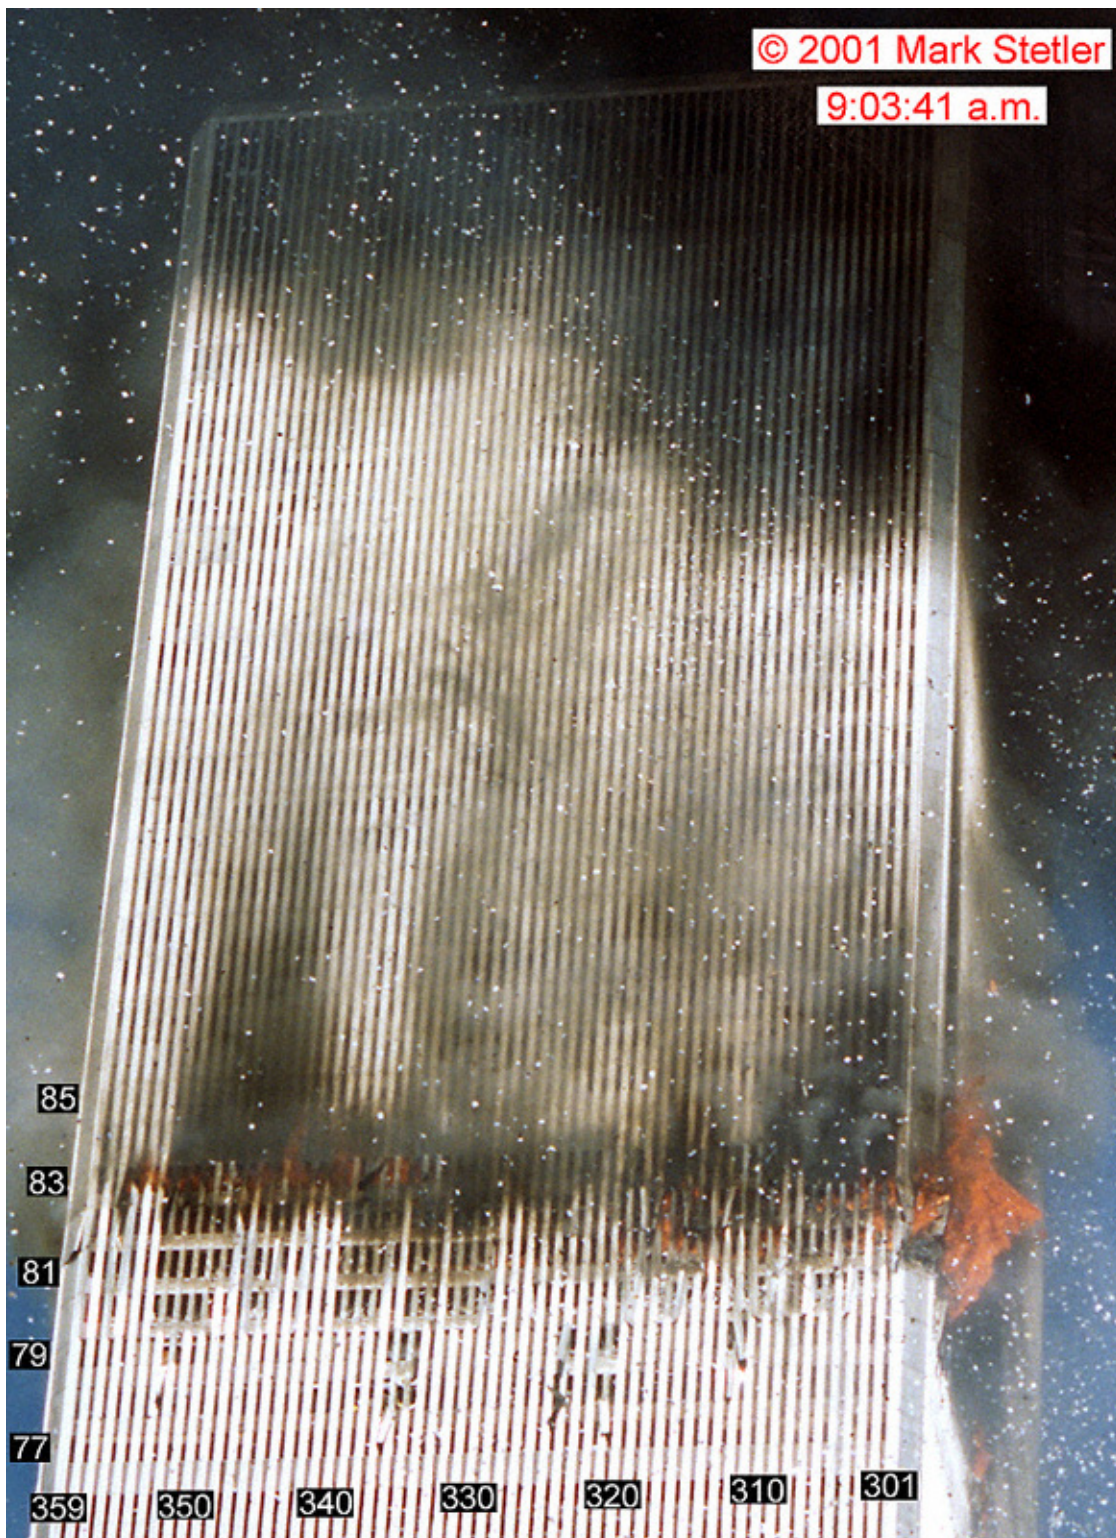
Figure 7-38. This cropped photograph shows the east face of WTC 2 at 9:03:41 a.m. Column and floor numbers have been added.

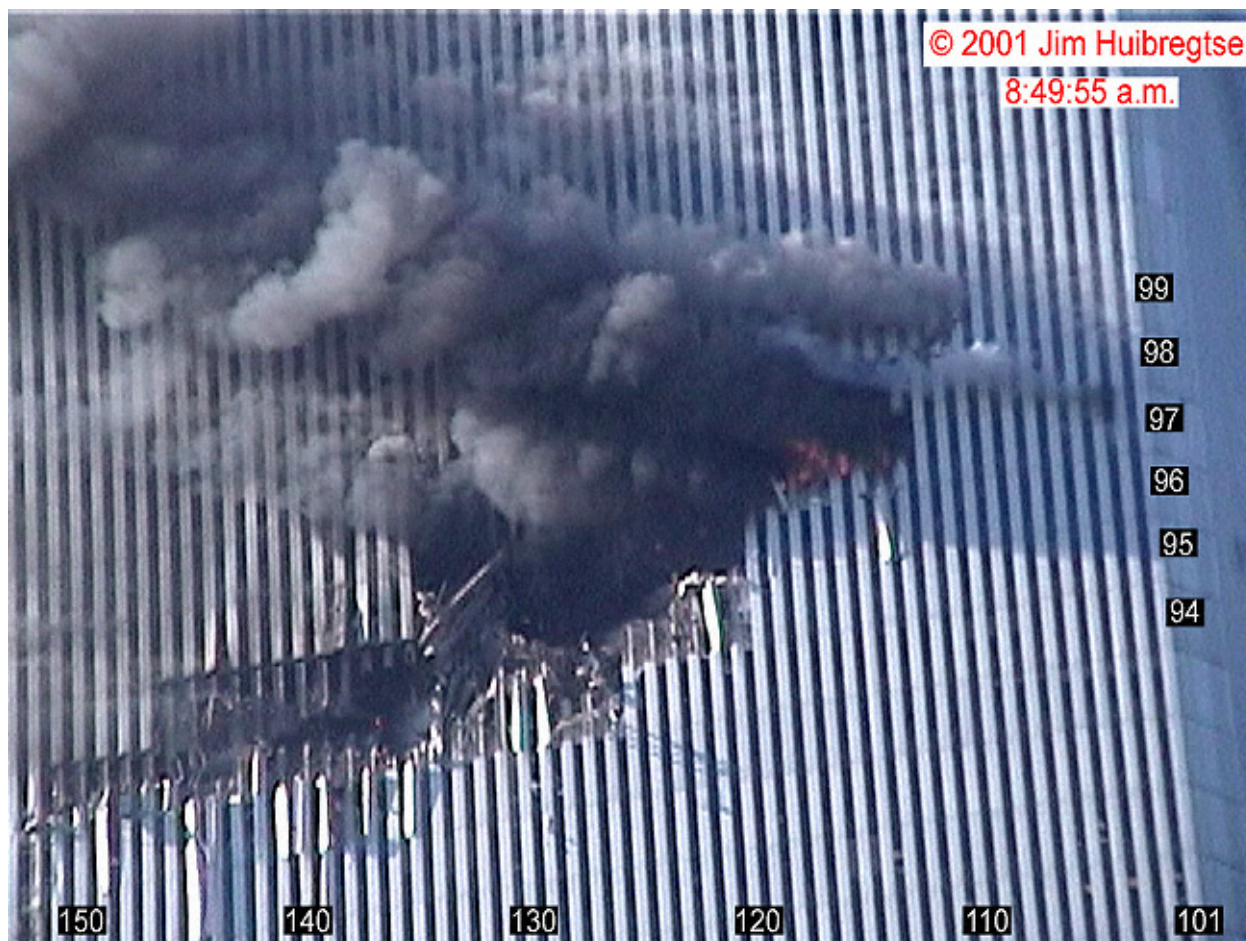
**Figure 8-1. This image is extracted from a video recording that shows the north face of WTC 1 at 8:49:55 a.m. Column and floor numbers have been added.**

At 8:50:55 a.m., light smoke began to come from window 97-144 on the 97th floor, which is located on the north face to the east of the cavity created by the aircraft impact. Fourteen seconds later the smoke suddenly became very dark and heavy. Shortly afterward flames appeared. As evident in Figure 8-1, prior to this time little or no smoke was seen in this region, and the windows in the area appeared to be intact. This developing fire grew rapidly and by 8:52 a.m. fire was visible in windows 97-142 to 97-146, with flames extending from windows 97-144 and 97-145.

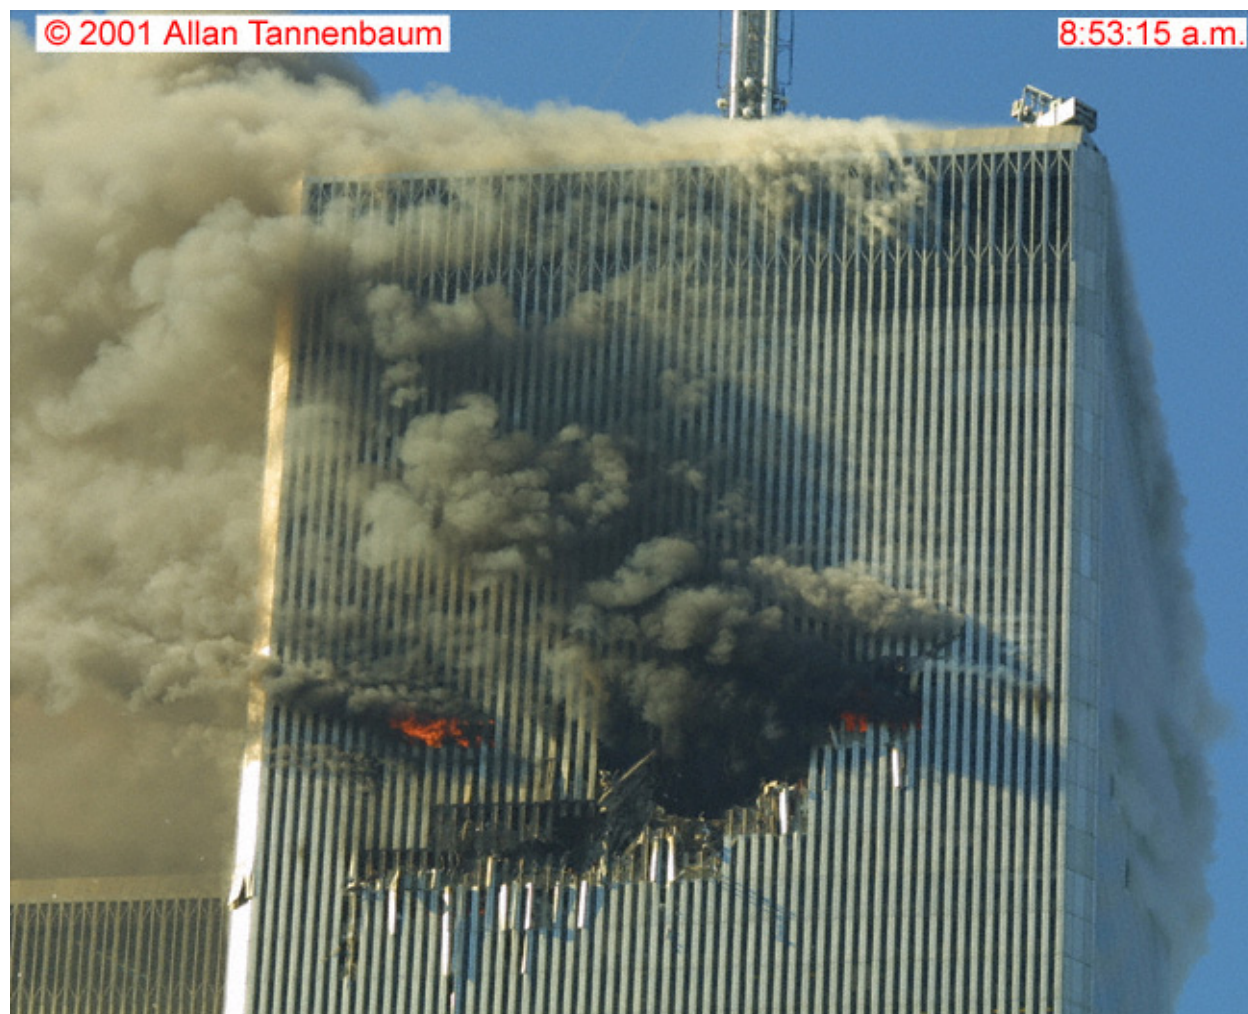
Figure 8-2, showing the north face, was shot at 8:53:15 a.m. An enlarged portion of the image is reproduced as Figure 8-3. The fire to the east of the aircraft impact area has continued to spread, now extending from windows 97-142 to 97-148. In three of the windows (97-142, 97-143, and 97-144) isolated fires are burning at the tops of the open window frames. Videos show that pieces of solid burning fuel from these areas eventually fell and formed the white streamers described in Section 5.2 as the material floated downward. Appendix L summarizes observations of streamers on the four faces of WTC 1. The first streamer from the left of the impact cavity was observed at 8:54:52 a.m., falling from the top of window 97-145, and many additional streamers were observed during the next few minutes.

In Figure 8-2 and Figure 8-3 light smoke is coming from near window 96-150. This smoke is an early indication of a developing fire that will appear shortly and grow rapidly in this area.

Smoke is also flowing from the mechanical equipment rooms at the 108th and 109th floors in Figure 8-2. Smoke and/or dust were observed coming from these floors immediately following the aircraft impact, suggesting that ductwork within the core area had been compromised. Smoke was observed continuously coming from these floors after the impact. As described in Section 4.2.5, the smoke was actually flowing from louvers mounted in an interior wall located nearly 5 feet behind the exterior facade that is visible. The smoke appears to be coming from three distinct locations centered near windows 113, 122, and 132. Figure A-1 in Appendix A shows the locations of the various louvers on these floors and identifies which parts of the ventilation system were serviced by these louvers. On the north face of WTC 1 the louvers were part of the fresh air intake system that serviced the upper portion of the building extending from the 92nd floor to the top. The three locations are close to the three intakes that provided air to the core, interior, and peripheral areas of the lower floors in the northwest quadrant of the building. The ductwork for these ventilation systems extended downward through a shaft located on the northwest corner of the core. Smoke was clearly entering these three sets of ducts at some point. It should be noted that in order for the smoke to backflow through the intakes as observed, it had to pass through an extensive series of fans, preheating and cooling coils, and air filters.

**Figure 8-2. A photograph of the north face of WTC 1 recorded at 8:53:15 a.m. is shown. The original has been cropped.**

At the time that the photograph in Figure 8–2 was taken, there was no indication that any windows on the north face above the 99th floor were missing. This situation changed abruptly 43 s later, i.e., at 8:53:58 a.m., when a light smoke plume appeared from the 104th floor at window 104-116. At the same time an object was seen falling from this location. This observation was the first indication on the north face that people trapped on floors above the aircraft impact area were breaking windows to provide access to outside air. Nine seconds later another object was observed falling from window 104-115, and shortly

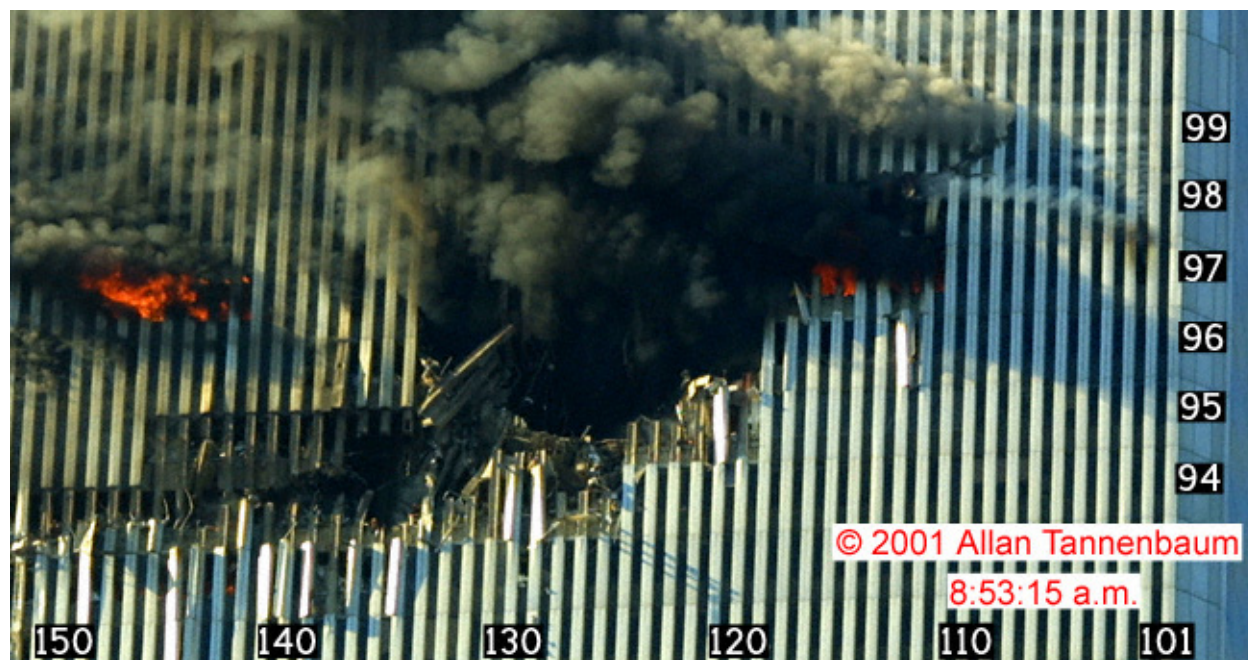
**Figure 8-3. An enlargement of a portion of the photograph reproduced in Figure 8-2 showing the north face of WTC 1 at 8:53:15 a.m. is shown. Labels showing floor and column numbers have been added.**

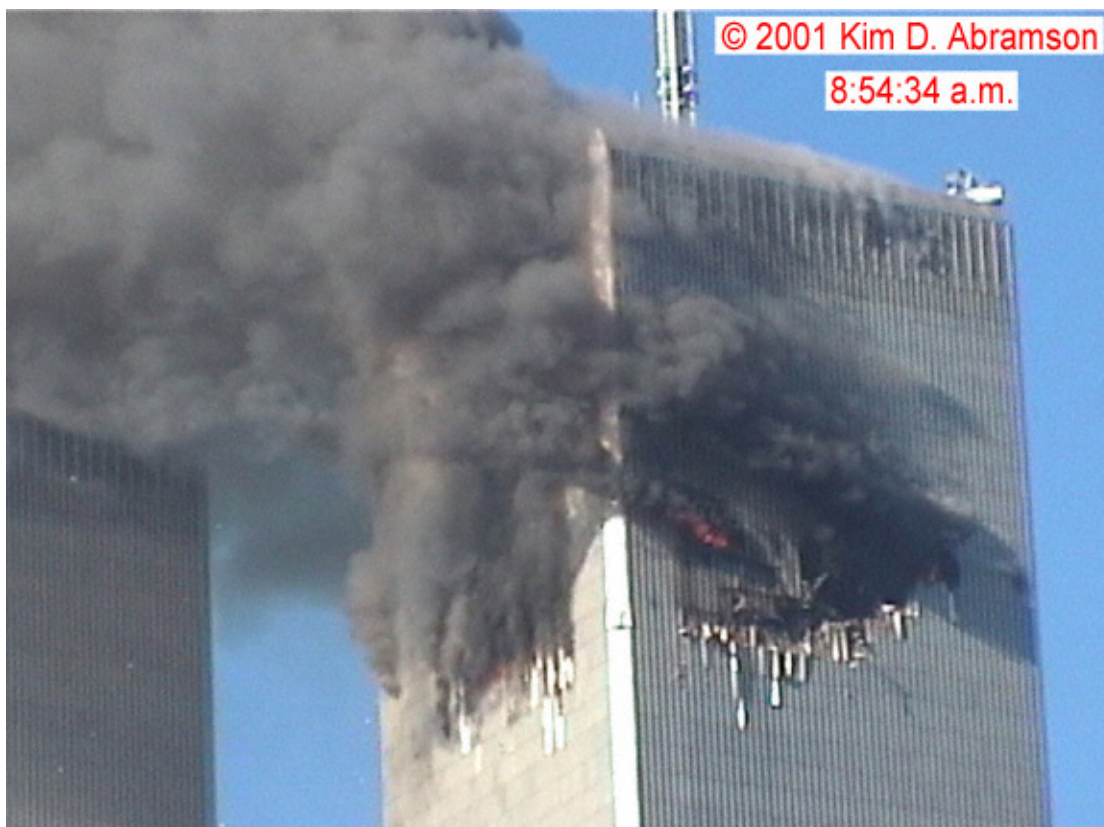
Near the top of the tower in Figure 8-4 there appears to be a heavy flow of smoke from the area of the mechanical equipment room floors near the north edge of the east face. Smoke was present in this region continuously until the tower collapsed over an hour later. This area is close to the exhaust spill louver that served the northeast quadrant of the tower (see Figure A-2), and it is possible that the observed smoke was flowing from this system. However, there is another plausible explanation for these observations based on predictions of smoke movement obtained using the Fire Dynamics Simulator (FDS) (McGrattan 2004). For the simulations, smoke was assumed to come from the 94th floor across

Even though a large amount of smoke hides much of the east face in Figure 8-4, it is still possible to see portions of the façade for floors above the 94th floor where fire is present. This is true for a small region on the lower northern edge and a larger area on the southern side of the face. In these areas smoke was observed coming from windows higher on the face, which indicates that people were also breaking windows on this face at roughly the same time as on the west and north faces. At 8:53:24 a.m. dense smoke plumes appeared at windows 105-245 and 105-246 on the 105th floor. Several additional windows on this floor were broken around this time. The nearly simultaneous decisions by people to break windows on three sides of the tower suggest that smoke had already spread over extensive volumes of the upper floors. Two windows, 99-201 and 99-202, were also broken out on the 99th floor around 8:53 a.m. Light smoke was observed flowing from these windows. Earlier, the windows appeared to be intact.

**Figure 8-4. A frame captured from a video shot from the northeast shows the north and east faces of WTC 1 at 8:54:34 a.m. The undamaged WTC 2 is to the left.**

In Figure 8–4, heavy smoke can be seen on the east face, coming from a few windows on the 93rd floor, located immediately below the 94th floor where significant fires and smoke flow are evident. An area of light smoke is also coming from a section of the open windows on the 92nd floor. Review of visual material around this time indicates that both the number of windows where smoke was observed and the smoke density appeared to be increasing on these floors. These observations suggest that fires, which were not yet visible from the outside, were growing on these two floors.

Meanwhile, between 8:54 a.m. and 9:02 a.m. fires observed on the north face of WTC 1 continued to grow and spread. Figure 8–4 shows the appearance of the face at 8:54:34 a.m. The fires on the 97th floor on either side of the aircraft impact cavity are the dominant features. Figure 8–5 provides a closer view of the face at 8:55:15 a.m. Heavy flames were now coming from window 97-148, which is two windows to the east of window 97-146, where the heaviest flames were present three minutes earlier in Figure 8–3, but have now receded back into the window. The heavy smoke coming from windows 96-137, 96-147,

and 96-150 in Figure 8-4 indicates that an unseen fire was continuing to grow on the 96th floor on this side of the north face.

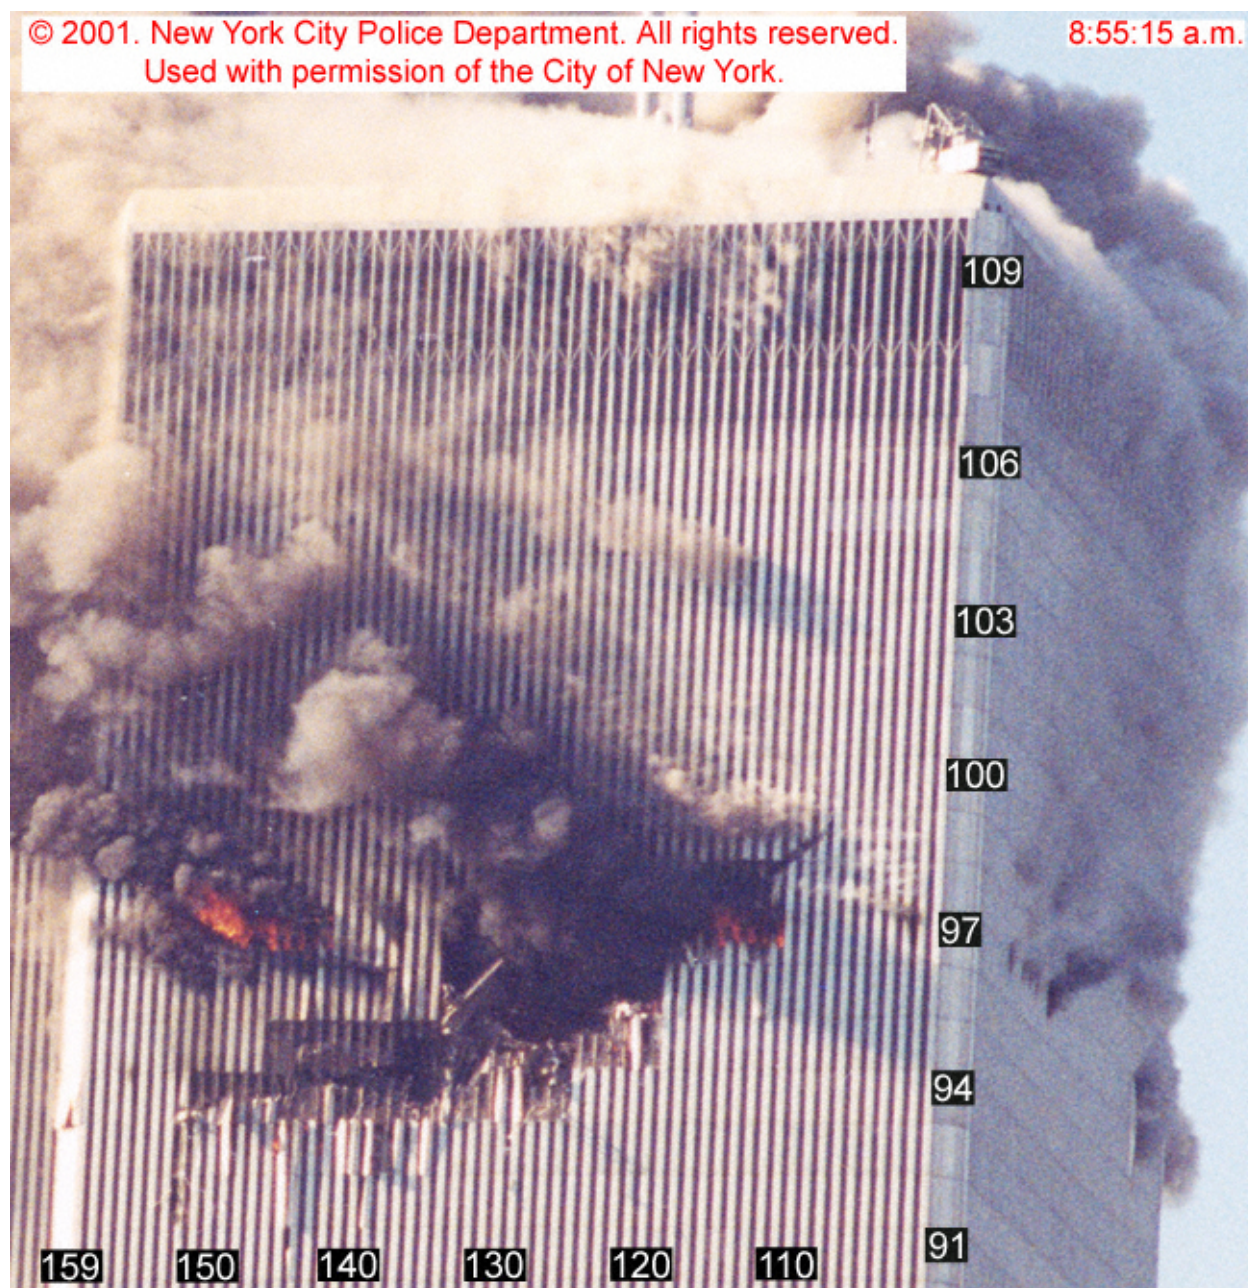
Figure 8–5 was taken just after the beginning of a dramatic change in the fire behavior on the west face of the tower. Videos show that at 8:55:09 a.m. there was a sudden increase in the volume of smoke coming from near window 97-435 on the 97th floor. Almost immediately, smoke began to appear at additional windows, and flames were observed shortly afterwards. The initial stages of this rapid change are indicated by the appearance of smoke at multiple windows on the 97th floor in Figure 8–5. Within a minute following the initial increase in smoke, external flaming was observed from roughly

window 97-430 to window 97-444. The number of windows where heavy smoke was observed was greater, reaching from window 97-425 to window 97-445. In the span of roughly one minute, this fire on the west side of the 97th floor opened windows over a distance of nearly 97 feet.

**Figure 8-5. A photograph of WTC 1 recorded at 8:55:15 a.m. shows the north and west faces. The original image has been rotated and cropped. Numbers indicating column numbers for the north face and floors have been added.**

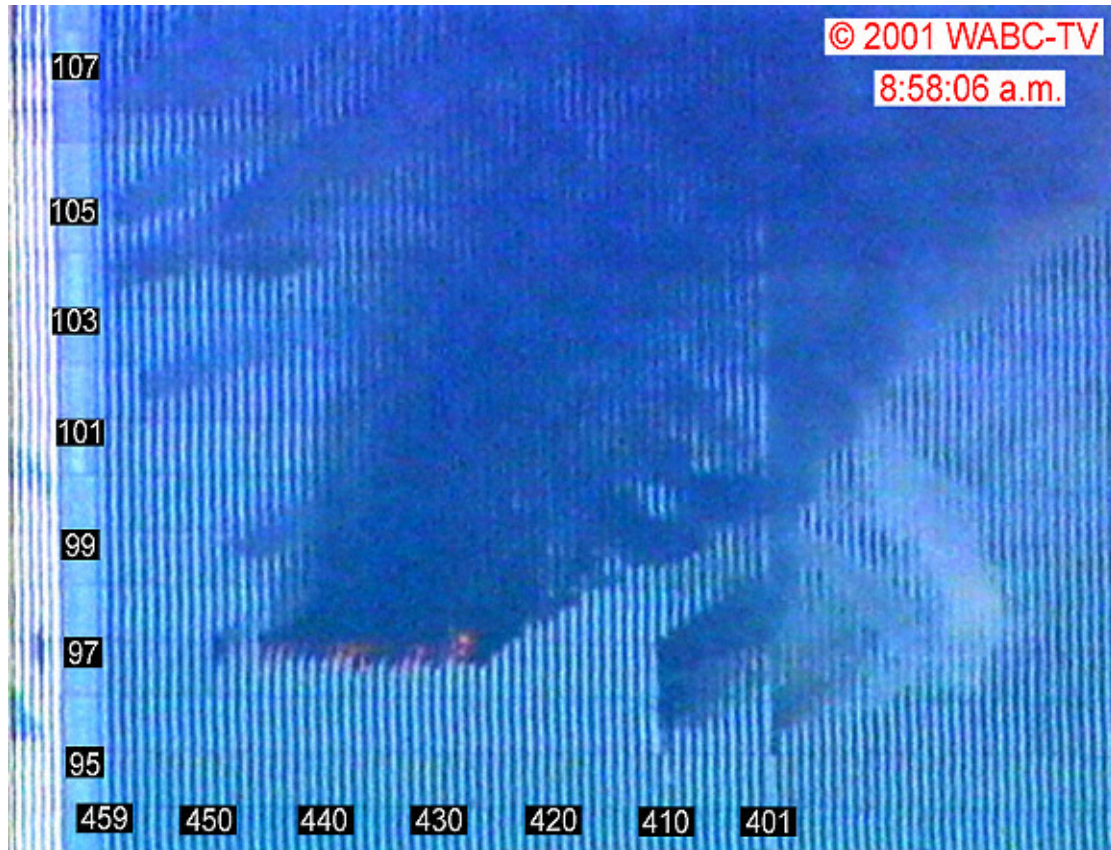
The west face of WTC 1 was filmed from a helicopter around this time. Figure 8–6 shows a frame taken from this video that was recorded at 8:58:06 a.m. Intense fire and heavy smoke are present over the same range of windows observed roughly two minutes earlier. Following the extremely rapid fire spread during the minute that started around 8:55 a.m., the fire appears to have stabilized for a period of time. It

Another feature of the west face around 8:58 a.m. can be seen in Figure 8–6. Numerous plumes of heavy dark smoke are flowing from windows high above the 97th floor on the north side of the face. These plumes are present on the 102nd, 104th, 105th, and 107th floors. People in these areas have broken out the window glass. It is difficult to determine exactly when these windows were opened due to the quality of the imagery during this period, but smoke first appears from the upper regions of the northern side around 8:55:30 a.m. Multiple windows over several floors had been broken by 8:56 a.m., and the number continued to increase during the next two minutes.

**Figure 8-6.** This image shows the west face of WTC 1 at 8:58:06 a.m. It is a frame taken from a video shot from a helicopter. Floor and column numbers have been added for WTC1. WTC 2 is in the background on the right side. Smoke is flowing from the damaged area on the corner of the 96th floor.

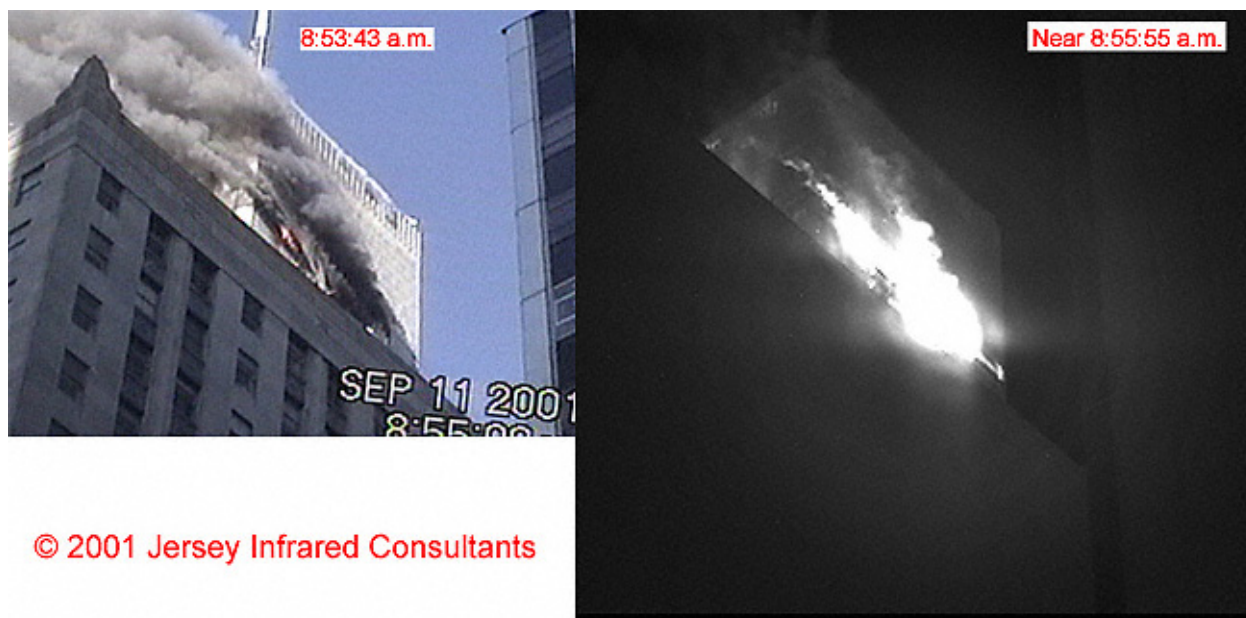
Nonetheless, the infrared images provide unique insights into the heat distribution inside the towers. One of the infrared images showing the north face of WTC 1 around 8:55:55 a.m. (the time uncertainty is estimated to be 15 s) is shown in Figure 8-7. The dimensions of the infrared image are 255 pixels × 240 pixels. It is compared with a frame from a video that was shot from the same location roughly two minutes earlier. The video frame has been rotated and scaled to match the infrared image.

It is immediately clear that large areas of the infrared image are saturated, indicating the presence of strong heating. Even so, there are some interesting features resolved in the image. By comparing the standard and infrared images it is seen that the smoke plumes leaving the aircraft impact cavity and the area of fire on the 97th floor to the east are hot and radiating as they exit the building, but cool rapidly as they move away. There is an isolated bright area near the western edge of the north face, indicating a high temperature region. In Figure 8-5, it can be seen that there is a smoke plume exiting from window 97-102 on the 97th floor. This plume is the source of the high temperature spot. A distinct line connects to the bright spot. This line shows that heat is being radiated from the 97th floor even though, as can be seen in Figure 8-5, the windows are still in place and no smoke and fire are visible in these windows.

The fire on the 97th floor to the immediate right of the aircraft impact cavity has saturated the camera output. Much of the area inside the aircraft impact cavity is also saturated, showing that the smoke flowing from this area was hot. The heat distribution on the east side of the cavity is consistent with the visible fire distribution. There is an extensive length across the face that is saturated. This corresponds to the large fire on the 97th floor that is visible in the video frame and Figure 8-5. This area does not extend all the way to the east edge of the face, and the northern edge of the east face is still relatively unheated. There is a shorter heated length on the floor below that is separated from the aircraft cavity by a cooler

region. This heating is due to the fire that was growing on the 96th floor and had not yet appeared on the face. There is evidence of an isolated fire burning in the eastern half of the 94th floor on the north side.

**Figure 8-7. Images of the north face of WTC 1 recorded using a standard video camera (left) and an infrared camera (right) are shown. The frame from the video camera was recorded at 8:53:43 a.m., and the infrared image was shot around 8:55:55 a.m. (the uncertainty is estimated as 15 s) from roughly the same location. The infrared image intensity levels were adjusted. The video frame has been cropped, rotated and sized to match the infrared image. The building in the foreground is the post office on the corner of Church and Vesey Streets.**

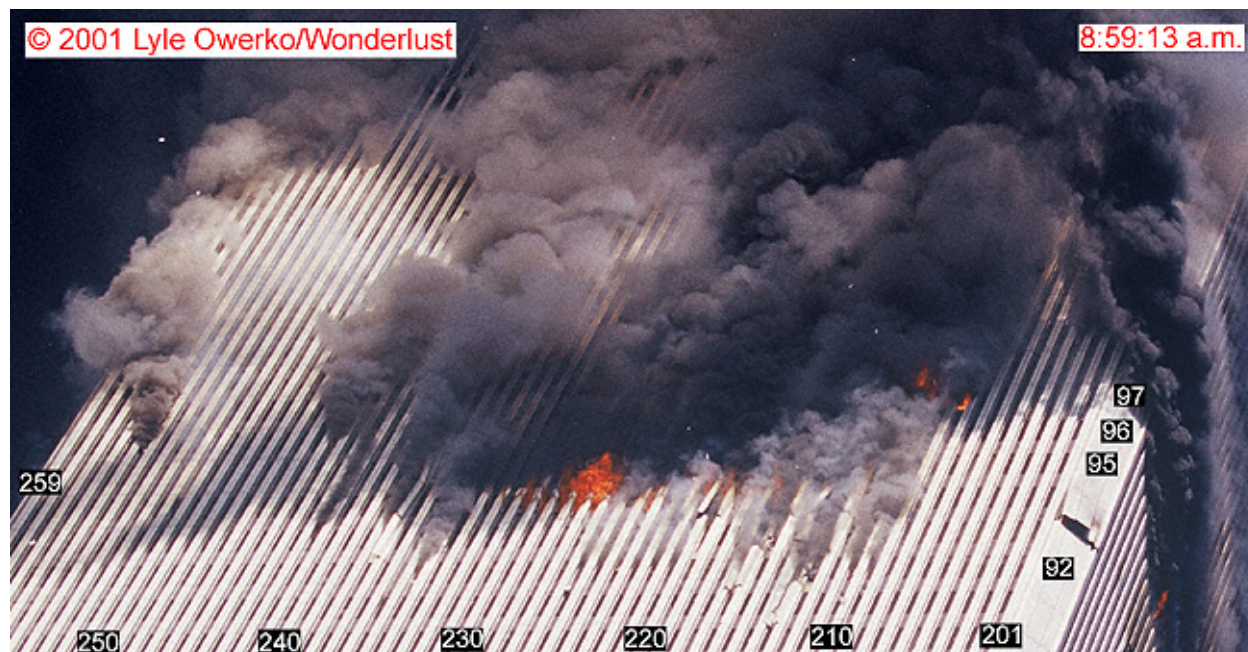
Figure 8-9 shows the east face of WTC 1 at 8:59:13 a.m. As observed earlier, a significant fire continues to burn over a large extent of the 94th floor. Intense burning was particularly evident at windows 94-226 and 94-227. Closer inspection of the photograph shows that distinct “caretts” are present on the column covers next to these windows as well as on the covers for columns 94-229 to 94-232. As discussed in Section 5.2, these caretts indicate that sometime earlier flames were extended out of windows 94-229 to 94-231 and subsequently withdrew back into the windows. These caretts are an additional indicator of the intensity of the fires burning on this floor.

A major change in the east façade fire behavior is also apparent in Figure 8–9. Flames can now be seen at windows 97-208 to 97-210 on the 97th floor. It is difficult to determine exactly when fire growth started at this location due to obscuration by smoke coming from below. However, at least two videos showed flames erupting from these windows at 8:56:45 a.m., while another video showed an intense flame near window 97-211 at 8:58:19 a.m. A close-up photograph showed fire in window 97-114 at 8:57:38 a.m. It seems likely that fire first broke out on the 97th floor on this face around 8:56:45 a.m. and rapidly spread over at least seven windows.

**Figure 8-9. This view of the east face of WTC 1 was recorded at 8:59:13 a.m. The original image has been rotated and cropped. Column and floor numbers have been added.**

The amount of smoke coming from windows on the 92nd and 93rd floors in Figure 8–9 has increased further from earlier times, suggesting that internal fires are continuing to grow on these floors in the vicinity of the windows where smoke is observed (see Figure 8–9). Observations of people falling from the tower support this conclusion. Appendix M summarizes times when and locations where people were observed falling from WTC 1. Very shortly following the aircraft impact (8:51:01 a.m.), a single person was observed falling from window 93-149 on the 93rd floor. Images of the north face indicate that a fire

Starting at 8:58:23 a.m., eight people fell from several locations on the east side of the 92nd floor in less than two minutes. They fell from two separate locations centered near window 92-210 and window 92-220. In Figure 8–9, smoke can be seen flowing from windows at both of these locations. These human behaviors suggest that significant fires were ignited on the east sides of the 92nd and 93rd floors following the aircraft impact. Initially, these fires did not seem to create intolerable conditions at interior locations near the east face. However, the observations suggest that with time they grew until it was no longer possible for the people to stay at these locations or to move away from the fires.
