**NIST NCSTAR 1-5A**

**Federal Building and Fire Safety Investigation of the  
World Trade Center Disaster**

**Visual Evidence, Damage Estimates,  
and Timeline Analysis**

September 2005

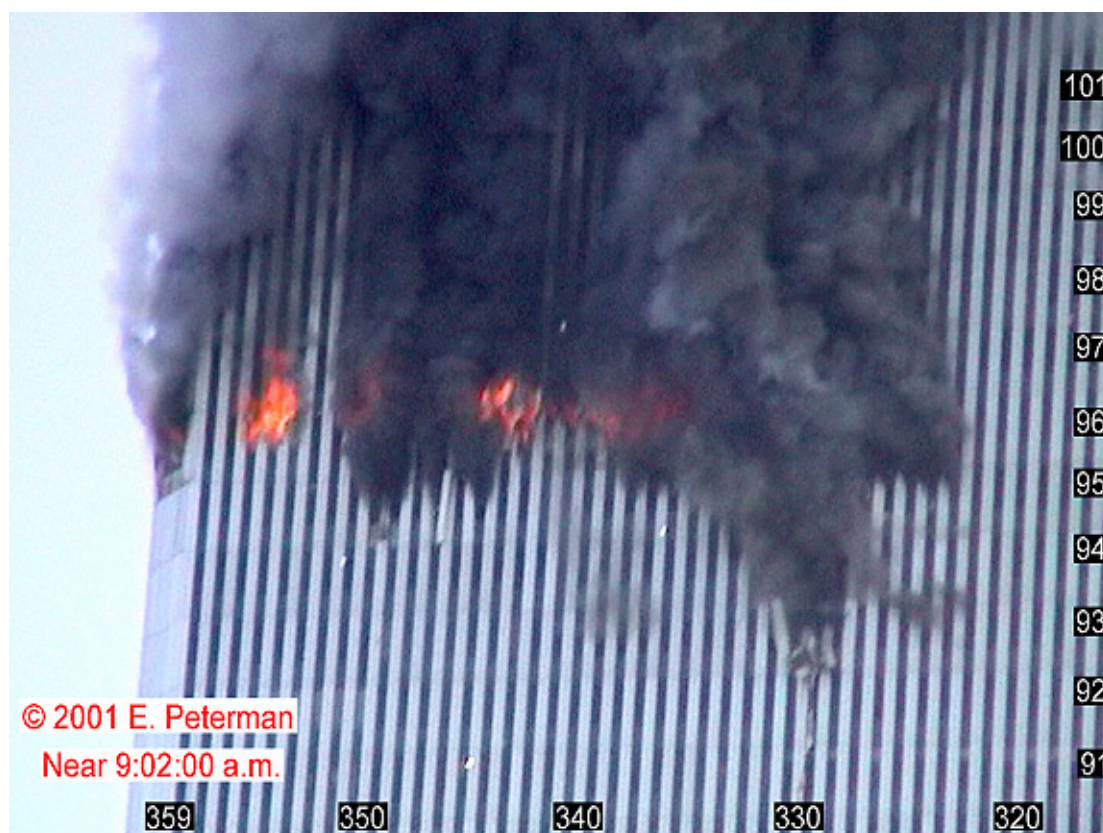
As seen in Figure 8–10, there is a large amount of smoke coming from broken windows on the 95th floor, even though no flames are apparent. This may be an indication that a substantial fire was present somewhere on this floor. The heavy smoke coming from the center of the face at the 93rd floor continues to hide the location where the steel panel section is believed to have been dislodged during the aircraft impact. Lighter smoke is flowing from several other windows on the 93rd floor.

**Figure 8-10. This image showing the south face was captured from a video. It was not possible to time this image exactly, but it was recorded within a minute of 9:02 a.m. Column and floor numbers have been added.**

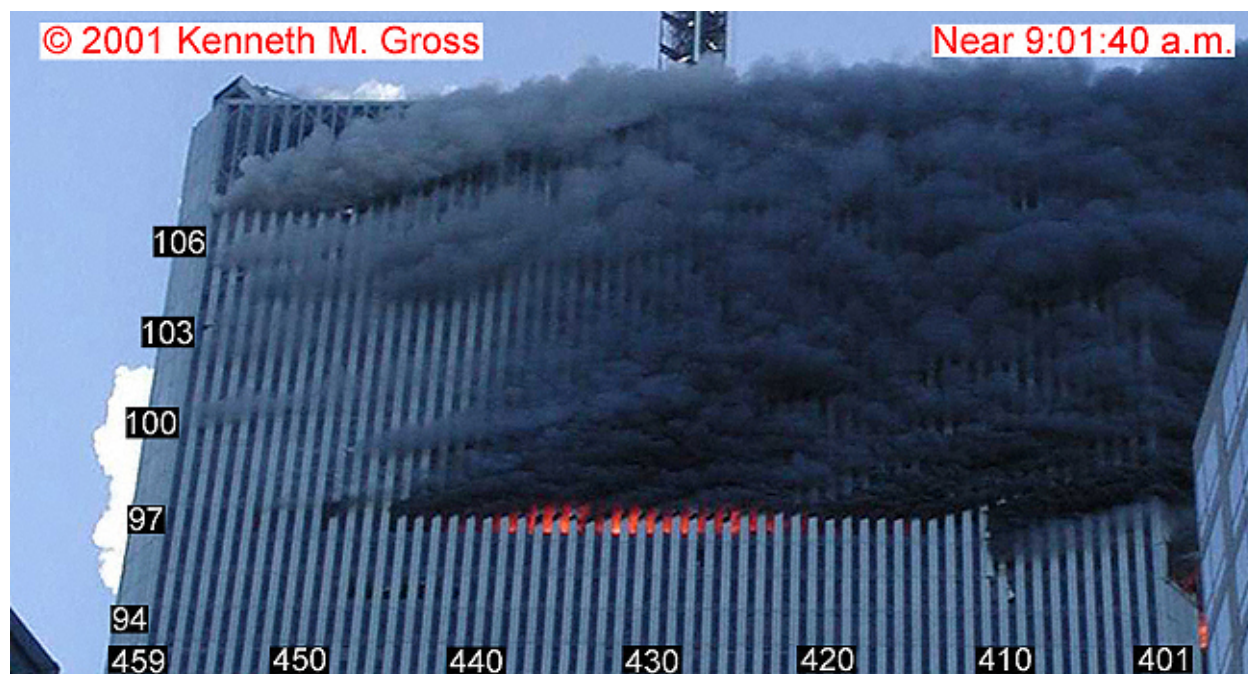
Figure 8–11 is a photograph of the west face of WTC 1 taken shortly after the second rapid fire spread episode. It has not been possible to time this image exactly, but based on observed fire behaviors on this face, it was taken between 9:01:09 a.m. and 9:02:17 a.m., or roughly around 9:01:40 a.m. Intense fires are present in the windows where the initial rapid fire spread took place, and heavy smoke is coming from

windows where the second took place. In the area with flames, carets are present at the tops of the columns, indicating the past presence of flames coming out of these windows.

The figure shows large amounts of smoke continuing to pour from windows well above the 97th floor on the north side of the face. The smoke is particularly heavy from window 107-458. A row of open windows is also present on the 95th floor extending from window 95-441 to window 95-447, with window 95-442 still in place. It is not known exactly when these windows were broken since they were not observed until around 9:00 a.m. They may have been broken during the aircraft impact or by people, who were observed in the open windows. The absence of any smoke or dust coming from the area may indicate that the latter explanation is more likely. The same is true for two windows (windows 92-424 and 92-434) on the 92nd floor that appear to be open in the uncropped version of Figure 8-11.

**Figure 8-11. Image of the west face of WTC 1 recorded between 9:01:09 a.m. and 9:02:17 a.m. The image has been cropped and rotated, and column and floor numbers have been added.**

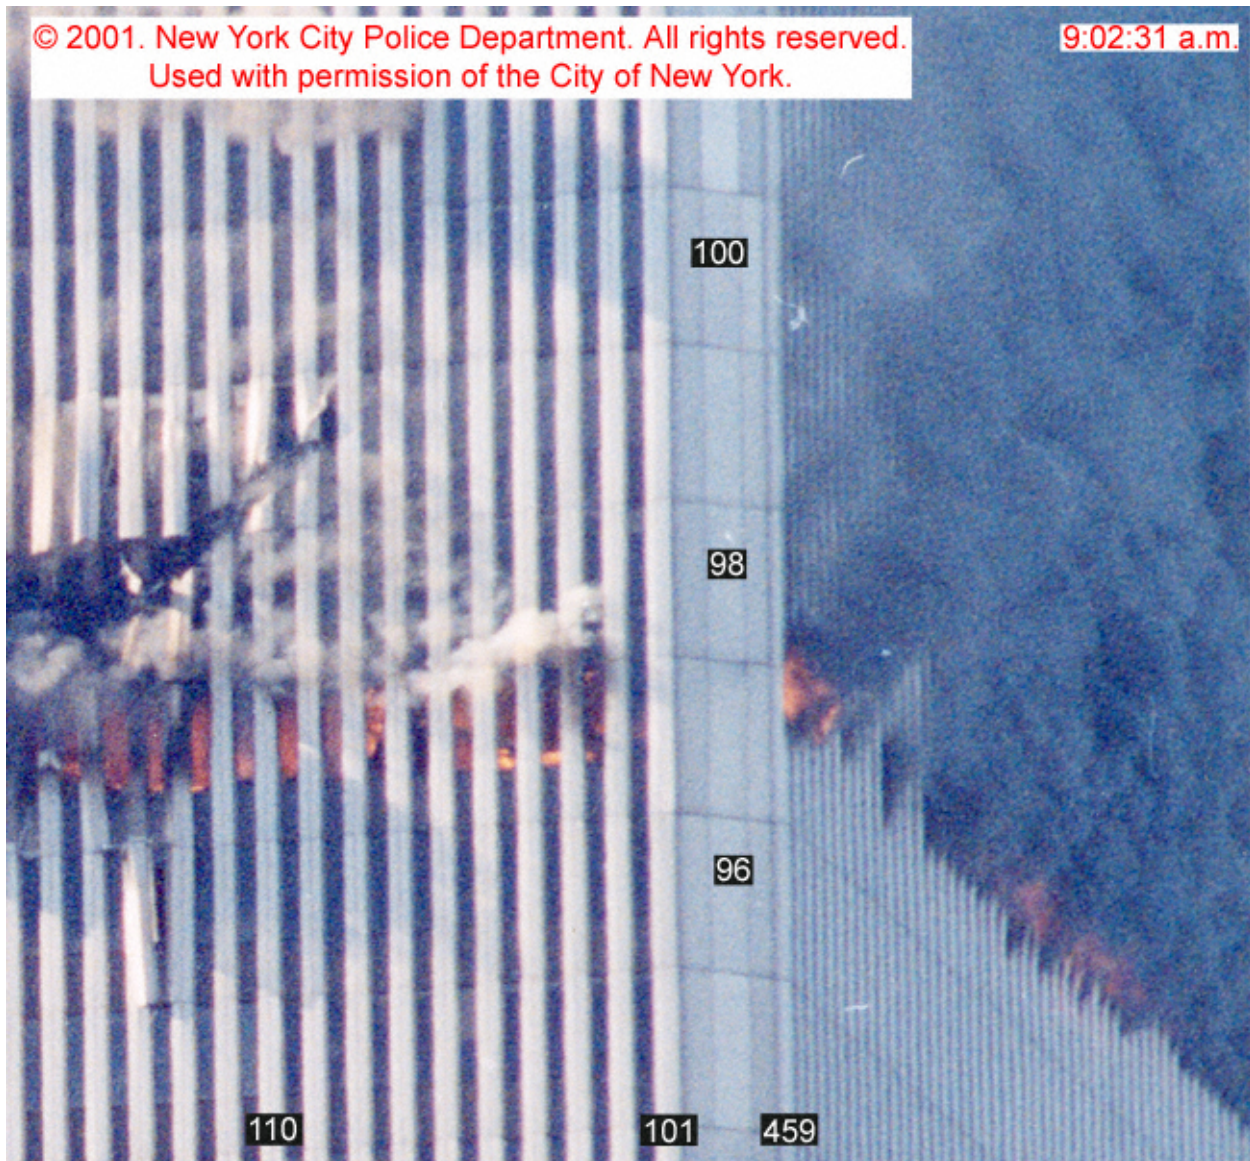
The fire behavior described above suggests that the fire that erupted from window 97-458 at 9:02:17 a.m. was a continuation of the fire spread observed on the north face. It is interesting to consider why the intense fire that grew rapidly over windows 97-110 to 97-116 around 8:50 a.m. did not spread westward for the next ten minutes. A review of the floor plan layouts for the 97th floor (see Figure B-6) shows that

there was a group of three rooms located at the northwest corner of the floor. One of these rooms had a rectangular shape, with one interior wall that abutted column 97-108 and a second that terminated at column 97-456, with the remaining two walls formed by the exterior walls. Based on visual observations, it can be concluded that these walls were able to appreciably slow the fire spread into these rooms. This conclusion requires that these walls remained essentially intact despite the aircraft impact only a short distance away. The sudden appearance of flame and smoke on the west face suggests that flashover occurred in the enclosed space at this time, even though fire seems to have entered the space somewhat earlier.

**Figure 8-12. This photograph was shot from the northwest and shows the north and west faces of WTC 1 at 9:02 31 a.m. The image has been cropped and the intensity levels have been adjusted. Column and floor numbers have been added.**

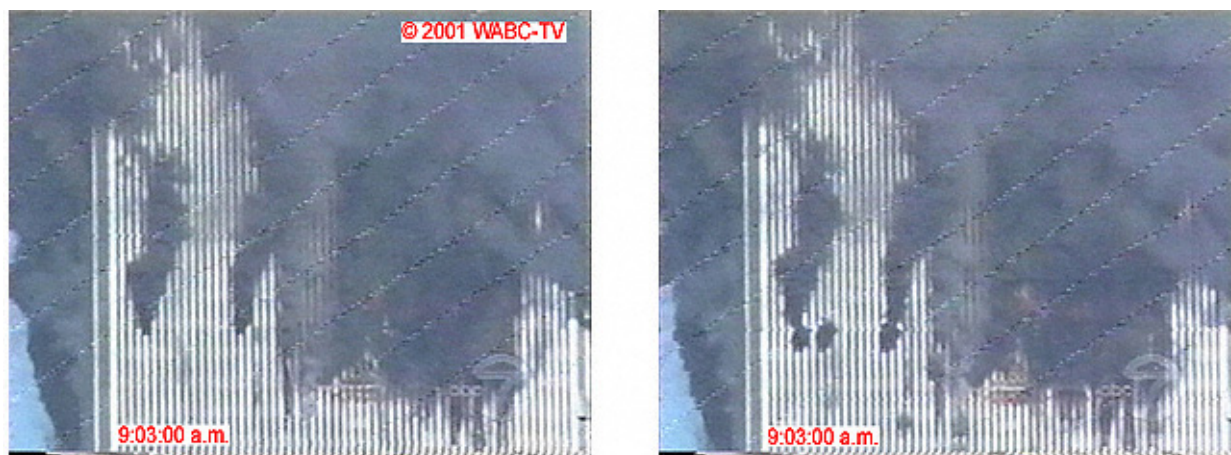
The impact of United Airlines Flight 175 on WTC 2 resulted in some interesting short-term effects in WTC 1. Almost exactly one second after the nose of the aircraft entered WTC 2, a pressure pulse passed through WTC 1 that pushed smoke, and in a few cases fire, from windows located throughout the upper portion of the tower. Figure 8–15 shows the results of this pressure pulse on the east face of WTC 1. The two images are separated by 0.4 s and were recorded roughly one second after the aircraft struck. In the image on the right, puffs of smoke have been pushed out of several windows on the south side of the 96th floor (the floor with smoke coming from a window near the south edge) as well as windows on the 92nd

through 95th floors. Other videos show that almost simultaneously similar puffs of smoke appeared from broken windows on the 92nd, 93rd, 94th, 96th, 97th, 101st, 103rd, 104th, 105th, and 107th floors, as well as from the mechanical equipment room on the 108th and 109th floors. A large burst of flame was ejected by the fire burning on the 97th floor at the north edge of the west face. These observations suggest that a pressure pulse created either by the entry of the aircraft into WTC 2 or the resulting ignition of aviation fuel within the tower was transmitted to WTC 1. The widespread observation of ejected gases suggests that low resistance pathways existed that allowed pressure pulses to be transmitted throughout the upper regions of WTC 1.

**Figure 8-15.** This figure shows two frames taken from a video that were recorded 12 frames apart, i.e., 0.4 s. The images show the east face of WTC 1 at 9:03:00 a.m.

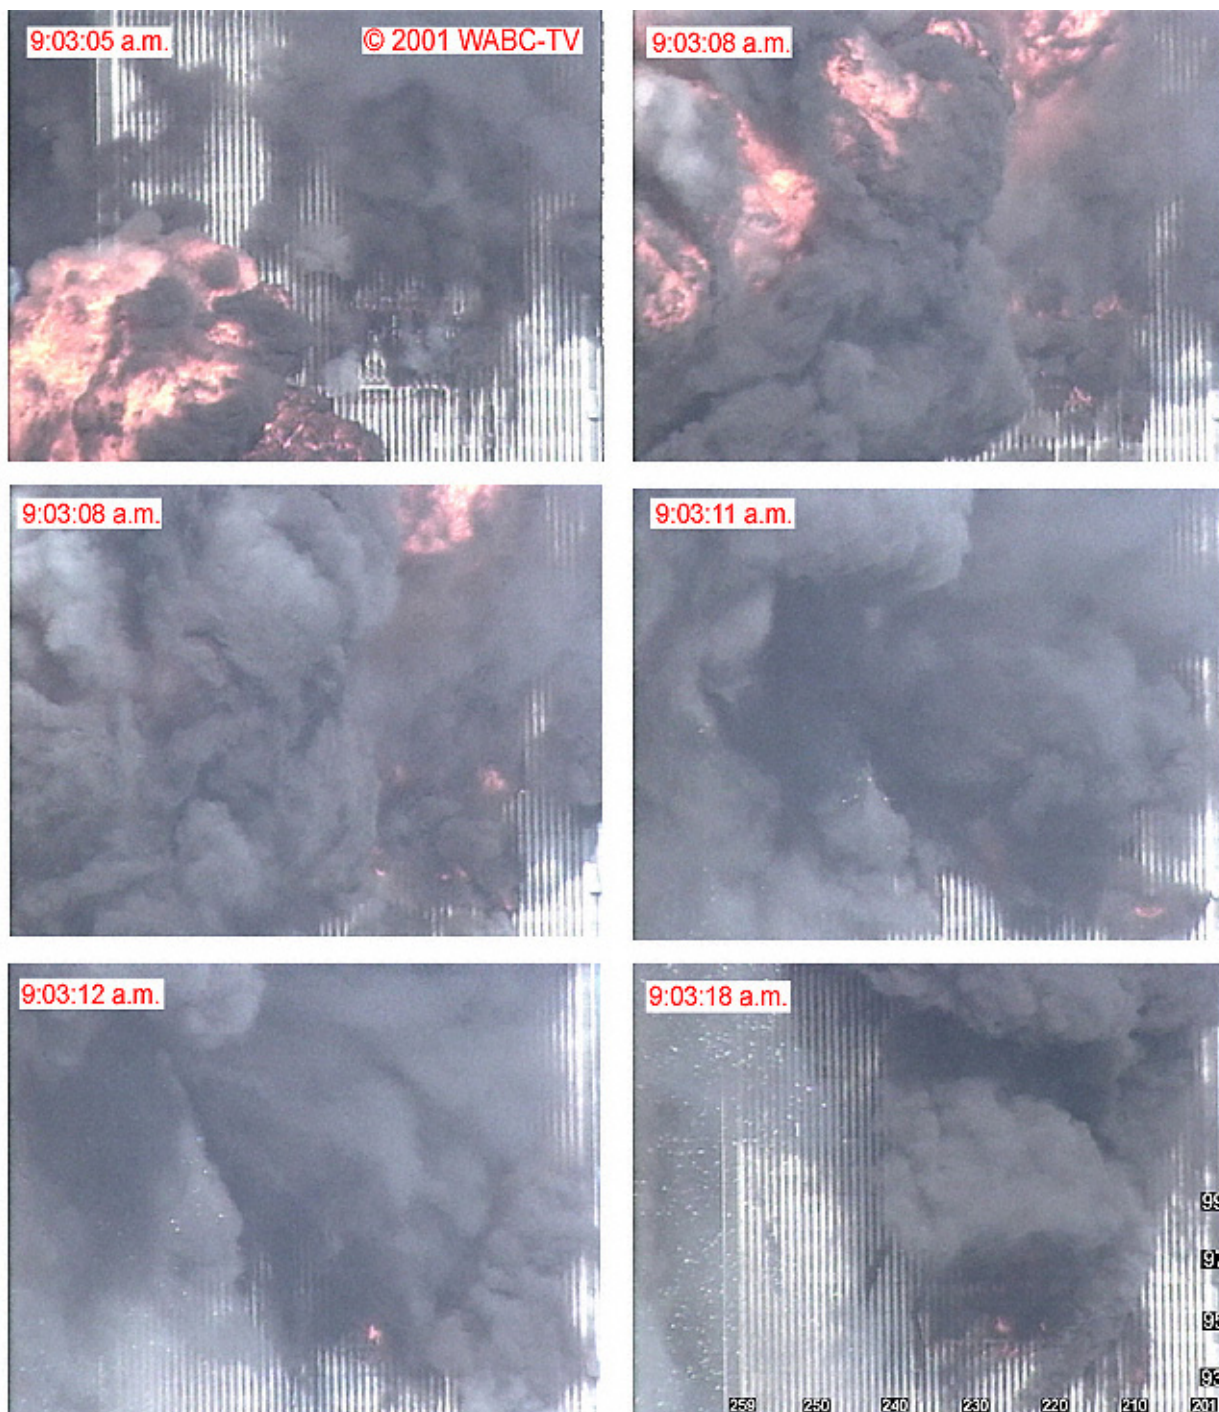
Figure 8–16 shows six frames taken from a video of the east face of WTC 1 during the period when the fireball was forming and rising away from the north face of WTC 2. The fireball itself is visible at the sides of the two earliest images and at the top of the third. In the image at 9:03:05 a.m., much of the smoke has been drawn away from the face of the tower, and it is possible to see the area near the right center of the face where fires have been burning. It is interesting that there are no external flames present at this time. While it still difficult to determine with certainty, it appears as if windows are open on the 94th floor from windows 94-212 to 94-233, on the 95th floor from windows 95-222 to 95-227, on the 96th floor at window 96-224, and on the 97th floor from windows 97-212 to 97-227.

**Figure 8-16.** Six frames taken from a video of the east face of WTC 1 are shown. These images were recorded during and just after a fireball formed on the north face of WTC 2 following the aircraft impact. Column and floor numbers have been added to the lower right-hand image.

The appearance of the face changed dramatically during the next three seconds. At 9:03:08 a.m. more of the face is hidden by the fireball, but most significantly, flames now appear to have been drawn out of windows 94-216 to 94-218 on the 94th floor, window 95-221 on the 95th floor, and a range of windows on the 97th floor extending from window 97-208 to window 97-227. This is the first image that shows a fire burning on the 95th floor. The next image was recorded 0.6 s later. Flames can now be seen coming from window 93-210 as well as from windows 94-225 and 95-226. At 9:03:11 a.m. the flame extending from around window 93-210 was particularly evident, and at 9:03:12 a.m. the same was true for the flames near windows 95-226 and 95-227. At 9:03:18 a.m. a small flame was observed burning at the top of window 92-212. In this image the flames extending from window 93-209 on the 93rd floor are distinct. Flames are also present on the 94th floor at windows 94-225 and 94-226 and on the 95th floor at two locations around windows 95-220 and 95-226. Even though not easily seen in the captured images, there appeared to be a small fire on the 96th floor near window 96-216 during the sequence.

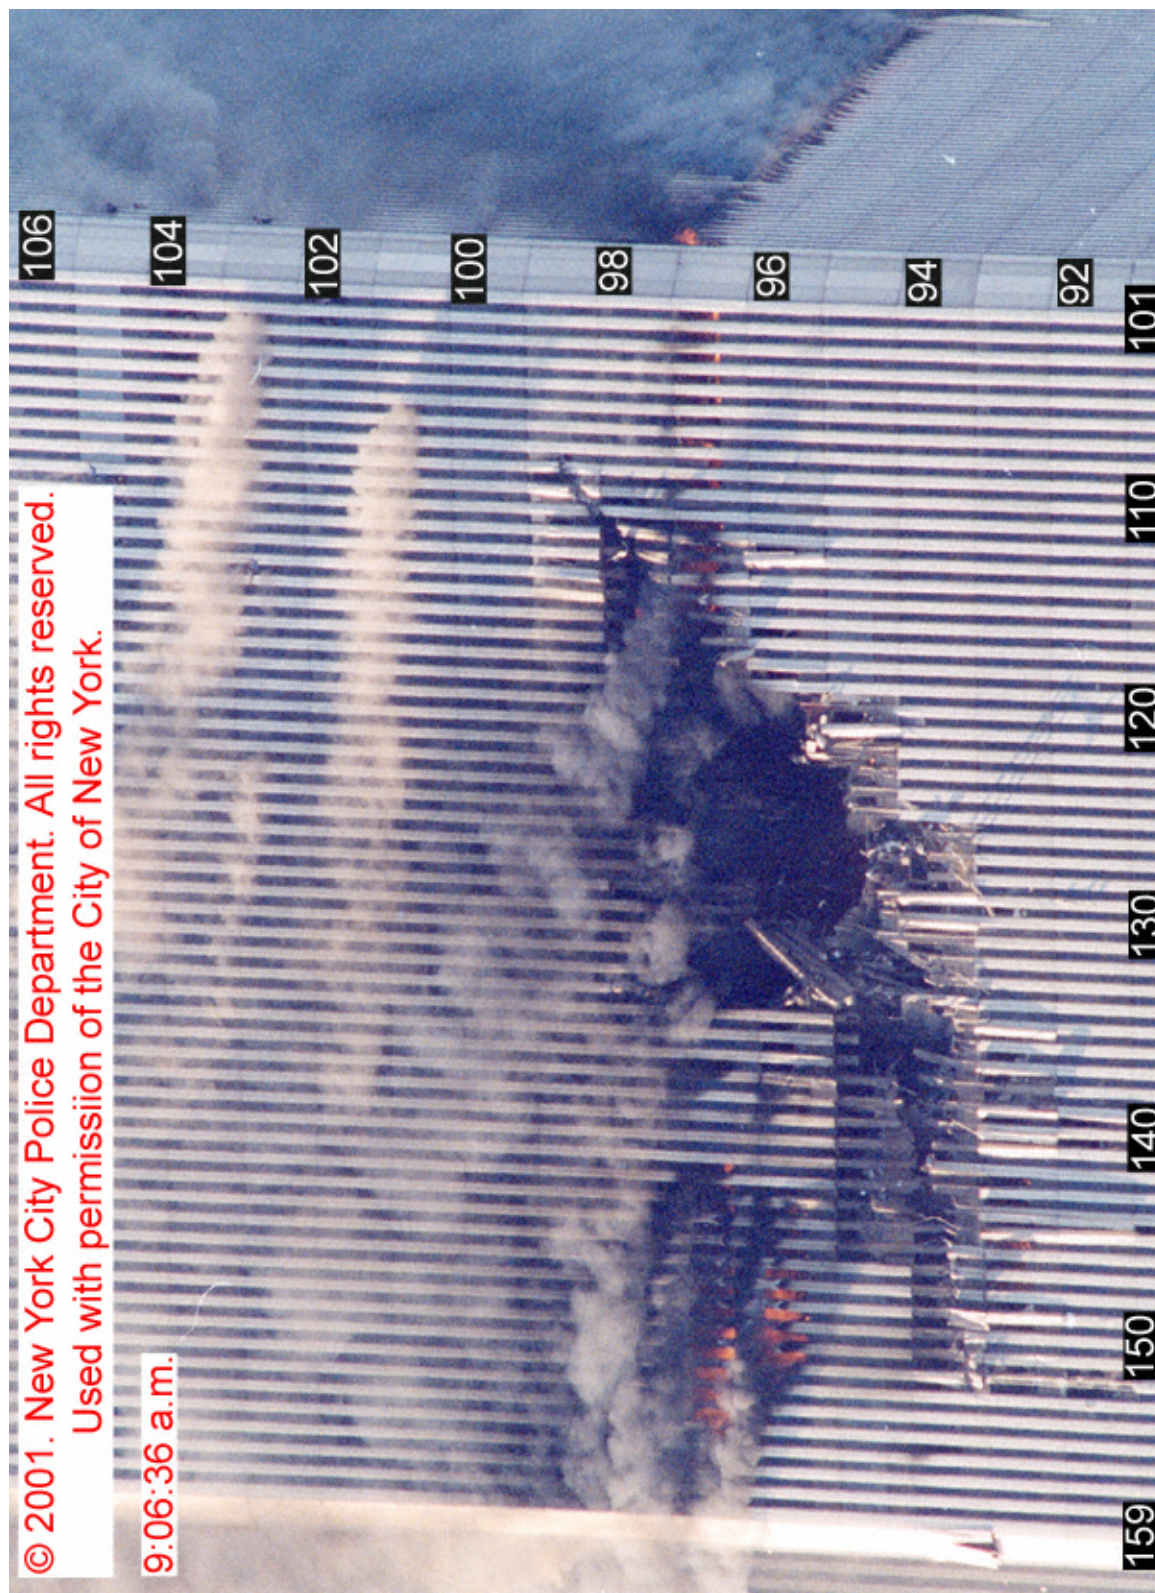
Compared to the rapid fire growth on the north face of WTC 1 during the first fifteen minutes of the event, fire spread during the following fifteen minutes was much reduced. The intense fires that grew on the 96th and 97th floors retreated into the building and began to die down. Figure 8–17 shows a photograph of the north face that was shot at 9:06:36 a.m. Even though the fire on the west side of the 97th floor had spread all the way to the west wall somewhat earlier, the two fires burning eastward on the 96th and 97th floors appear to have stopped spreading. The last window with fire present on the 97th floor is window 97-154. Flames are also evident at the other end of the area, starting at window 97-141. On the 96th floor fire is present at window 96-151, and from window 96-152 on to the east end of the floor, windows appear to be intact. This is clearer in Figure 8–18, which shows a blowup of the area taken from Figure 8–17.

Figure 8-17. A photograph of the north face of WTC 1 recorded at 9:06:36 a.m. is shown. The image has been cropped, rotated, and enhanced. Column and floor numbers have been added.

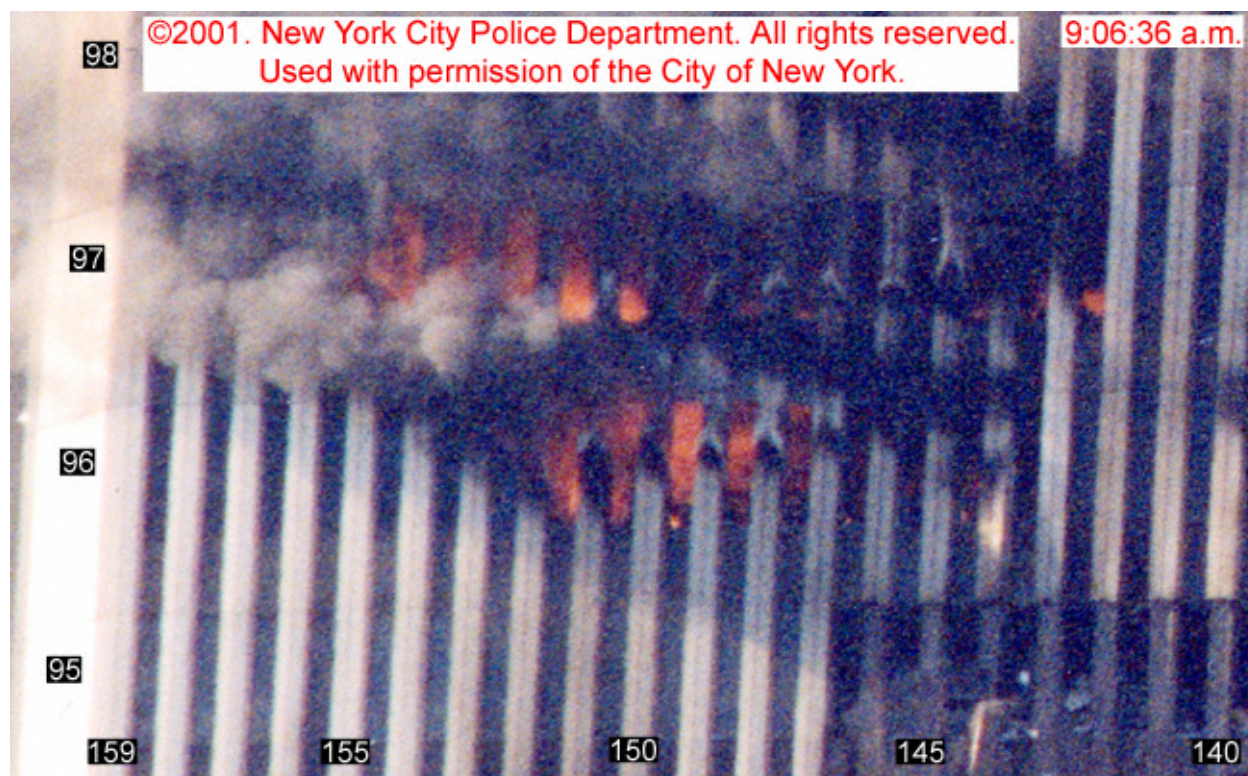
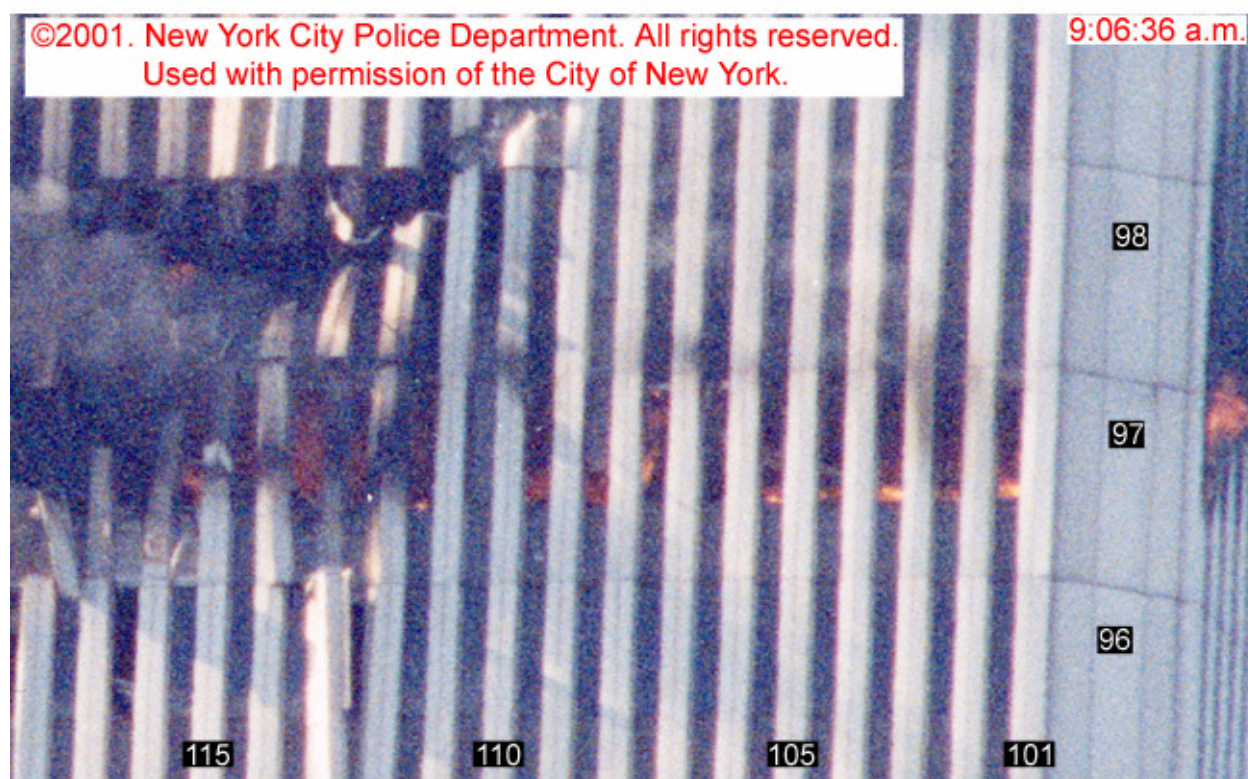
Another prominent feature in Figure 8–18 is the row of carets running across the tops of the column covers. These provide a clear visual indication of how intense the earlier fires in these windows were. It is interesting to compare the appearance of the column covers in this area with those on the 97th floor to the west of the aircraft impact cavity. A blowup of this area is also included in Figure 8–18. The columns are barely marked despite the presence of an active fire in the area for many minutes. This suggests that this fire must be venting somewhere other than through the open windows on the north face. As already discussed, and can be seen in the figure, flames and smoke were coming from this area on the west face of the tower. The smoke issuing from the right side of the aircraft impact cavity may also be due to effluent from this fire. Comparison of Figure 8–17 with earlier images of the north face shows that the flow of smoke from the cavity had also decreased with time. The pathways of venting are expected to influence the local heating of the exterior columns since the imposed heat flux will vary with changes in the flow direction through the opening. Exhausting fire gases will tend to heat the columns, while in-flowing outside air will cool the columns.

**Figure 8-18.** Two close-ups of the north face of WTC 1 taken from the photograph in Figure 8-17 show the east and west sides of the face around the 97th floor. The photos have been rotated, enhanced, and column and floor number have been added.

A small fire continues to burn on the 93rd floor around window 93-145. There is also a small spot fire present in window 98-115 on the 98th floor. This window is immediately above the location where an intense fire initially grew on the 97th floor. Since the windows immediately above on the 98th floor were broken out by the aircraft impact, it is reasonable to assume that flames from below ignited this fire.

In-place windows can be seen in Figure 8–18. On the east side of the building window panes are in their frames on the 95th floor as well as on either side of the fire areas on the 96th and 97th floors. On the west side most windows are still in place on the 96th floor and on the 98th and 99th floors at locations removed from the immediate vicinity of the aircraft impact. These observations suggest that windows are only removed when active burning is present in the immediate area of the window.

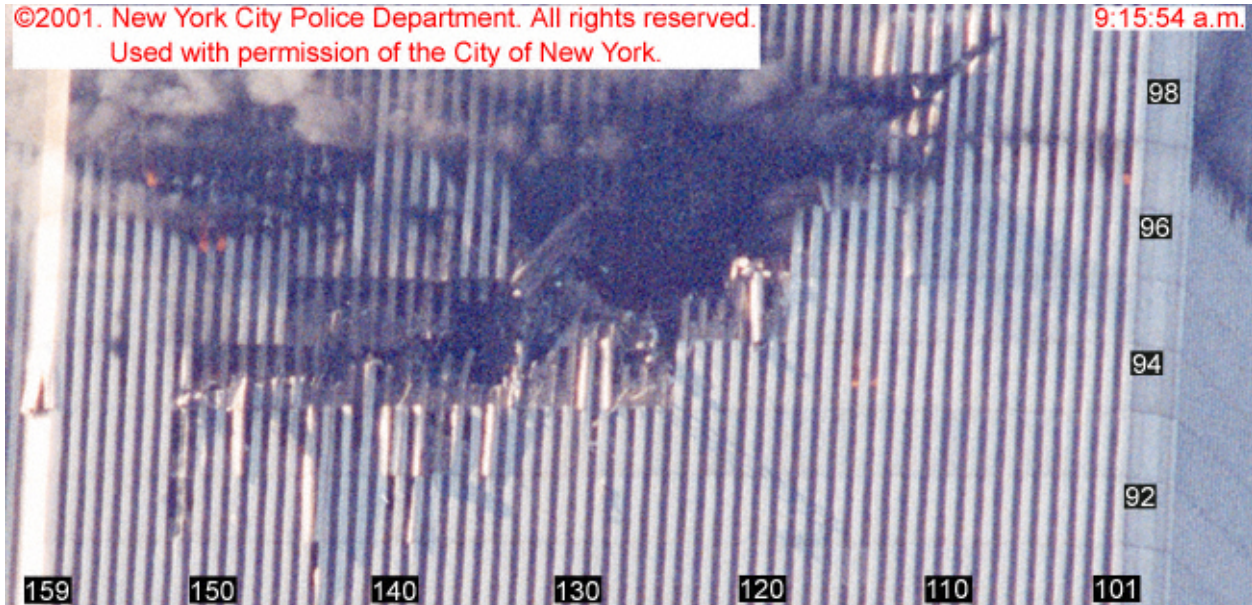
**Figure 8-19.** An image recorded at 9:15:54 a.m. shows the north face of WTC 1. The original has been cropped, rotated, and enhanced. Column and floor numbers have been added.

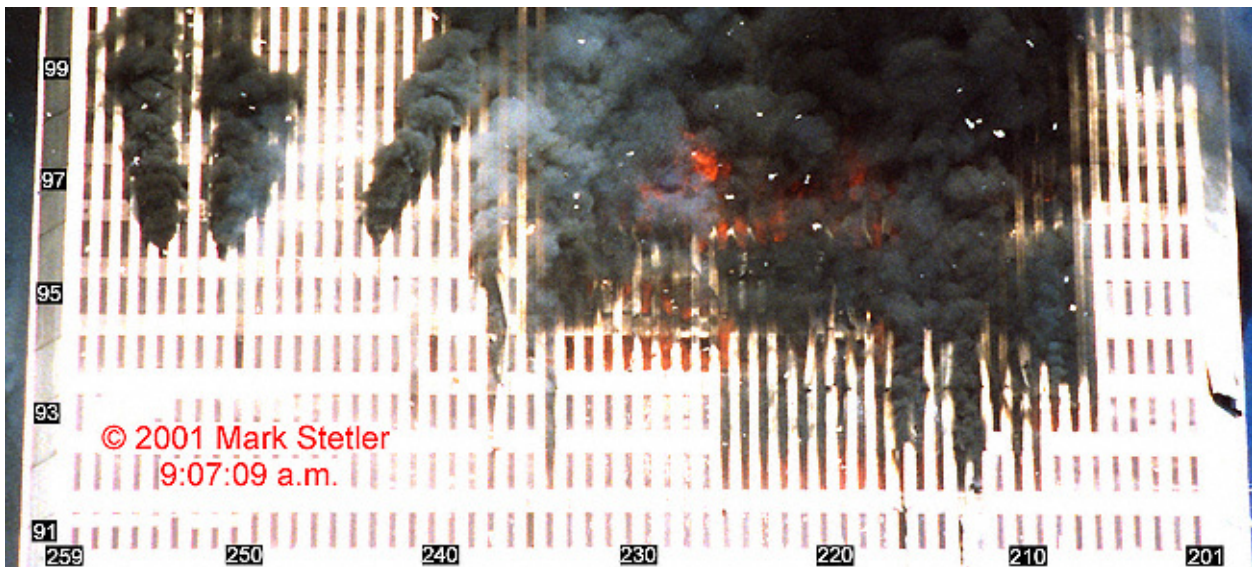
In contrast to the north face of WTC 1, the fires burning on the periphery of the east side of the tower continued to spread during this time period, initiating new areas of intense burning, while areas ignited somewhat earlier were dying down. Figure 8–20 shows the east face at 9:07:09 a.m. The appearance has changed considerably in the four minutes since 9:03 a.m. (see Figure 8–15 and Figure 8–16) and even more so from earlier times. Two important changes are the appearance of extensive areas of flame on the 92nd floor (extending roughly from window 92-216 to window 92-225) and on the 96th floor (visible over at least windows 96-217 to 96-227). Several distinct carets can already be seen on column covers on the 96th floor, indicating that strong external flaming had already taken place from windows adjacent to these columns. At the earlier time there had only been indications of small fires on both of these floors.

**Figure 8-20.** This cropped photograph shows the east face of WTC 1 at 9:07:09 a.m. It has been rotated slightly and enhanced to emphasize the presence of fire. Column and floor numbers have been added.

The intense fires on the 94th and 97th floors, which developed earliest on this face, have died down considerably in the windows where they were first observed. For an example of the earlier fire distribution, see Figure 8–9, which shows fire locations around 8:59 a.m. At this earlier time, intense burning with flame extension was seen over windows 94-214 to 94-228 on the 94th floor and windows 97-208 to 97-228 on the 97th floor. In Figure 8–20, a region of intense flaming is evident on the 94th floor, extending from window 94-225 to at least window 94-233, with some flame extension in the area, while windows further to the north appear to have little fire present. This shows that the fires on this

floor were spreading to the south at the same time they were dying down in areas that were ignited earlier. The same was true for the 97th floor. At 9:07 a.m., the most intense burning was located near windows 97-218 to 97-229. The largest flame extension was from window 97-226 at this time. At the time the photograph in Figure 8-9 was taken, flames were coming from window 97-208.

Around 9:03 a.m. there was a fire near column 95-225 on the 95th floor. In Figure 8-20, the fire on this floor now extends to window 95-231. The extended flames observed on the 93rd floor near column 93-210 around 9:03 a.m. have receded back into the building and are not obvious in the photograph. In their wake they left a dark caret at the top of the aluminum cover for column 93-210.

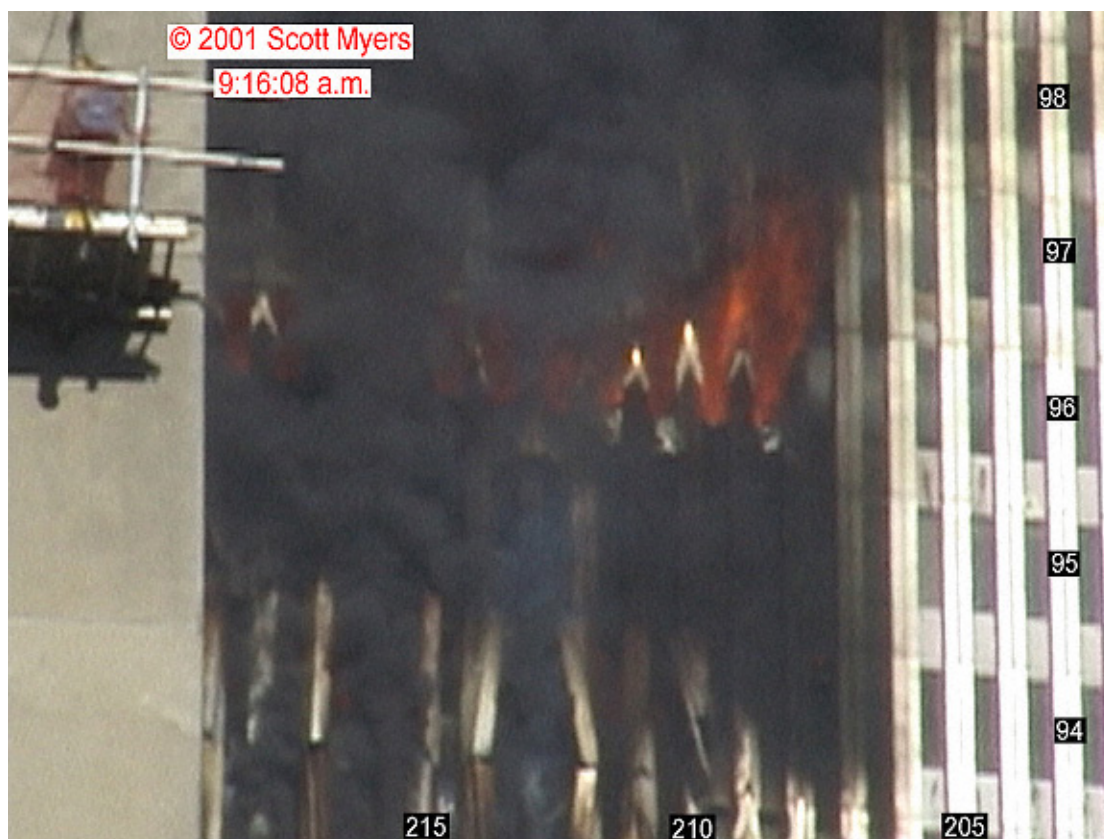
Figure 8-21 shows a close-up frame from a video of a portion of the east face recorded at 9:16:08 a.m. Intense flames are coming from windows 96-208 and 96-209. In the video it is clear that flames are exiting from across the entire burning region that is visible on this floor. A series of carets are seen at the tops of the column covers. The carets appear to be glowing near the center. The physical mechanism responsible for this glow is not known, but it does suggest that significant heating was taking place at this time. Recall that flames were observed on the 97th floor immediately above this location around 8:59 a.m. (see Figure 8-9). These flames are no longer visible, providing additional evidence that flames are growing and then decaying in relatively short period of times.

**Figure 8-21.** A close up of a portion of the east face of WTC 1 is shown. The image is a frame taken from a video recorded at 9:16:08 a.m. Column and floor numbers have been added. The area to the left with the scaffolding is another building in the foreground.

Even though flames have been observed extending from windows 96-208 and 97-208 on the 96th and 97th floors, the adjacent windows to the north, window 96-207 and window 97-207, are still intact. In fact, the entire area to the east of column 208 on floors 94 through 98 appears to be unaffected by the fires, except for soot deposited on the left side of the area. The sharp demarcation line for the fires on the 96th and 97th floors suggests that fire spread is being inhibited in a manner similar to that already described for the north face. The plan layouts for these floors shown in Appendix B (Figure B-5 and Figure B-6) indicate that both floors had rooms in the northeast corners, with walls that terminated at column 208.

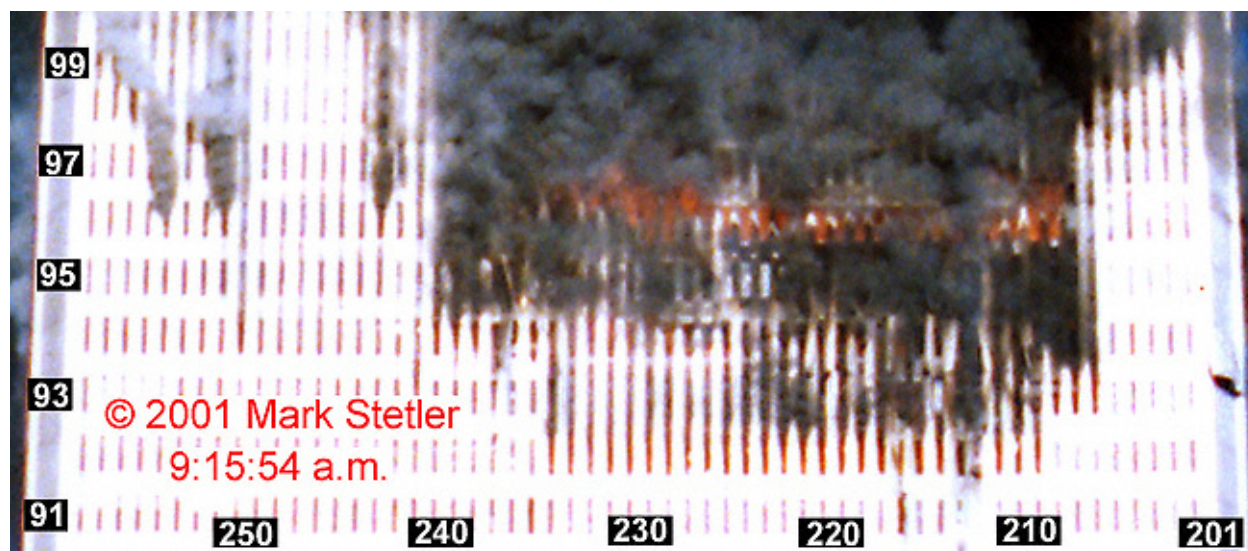
These general trends in the observed fire behavior for the east face continued over the next several minutes. Figure 8–22 shows a photograph that was taken at 9:15:54 a.m. There are regions of extensive fire. Flames can be seen on the 92nd floor from window 92-209 to window 92-235. One curious aspect of these flames is that there is little, if any, flame extension, and there is only heavy smoke coming from windows on the right side of the area. As a result of these characteristics, in many images of the east face recorded around this time, the fire on the 92nd floor is not readily apparent, and the smoke flow from these windows appears to be light. Fire is only observed in images taken nearly perpendicular to the face from relatively long distances. As discussed in Section 4.2.7, such observations are due to the geometry of the building and either suggest the fires are located near the floor or are set back from the windows.

**Figure 8-22.** This cropped photograph shows the east face of WTC 1 at 9:15:54 a.m. The image has been rotated and enhanced to improve the dynamic range. Column and floor numbers have been added.

On the 93rd floor, there appears to a small fire covering several windows starting at window 93-206. There is some smoke coming from the area.

Unlike earlier, at this moment, only limited flame extension is observed from windows on the 94th floor. Flames can be seen inside the windows starting near window 94-224, and they have now spread as far south as window 94-240. Even though smoke is still coming from some windows, there is little flame evident in windows to the north of window 94-223.

The fire observed earlier on the 95th floor in windows 95-225 to 95-231 has died down. Interestingly, intact windows can be seen to the immediate right of this area. Images recorded much later show that many windows to the north remained intact.

The fire on the 96th floor continues to burn fiercely. A continuous region of flames extends from windows 96-208 to 96-234. There is significant flame extension from around windows 96-208 and 96-209 and from windows 96-227 to 96-234. A distinct row of carets at the tops of the column covers is visible over much of the fire length, providing an indication of the maximum depths of the layer of flaming gases that flowed earlier from the adjacent windows. The layer depth is related to the local intensity of burning, with a deeper depth indicating a more intense fire.

Some of the 97th floor is hidden by smoke. This is especially true near the center of the face, where a substantial fire may still be present. Many open windows can be seen to the north of this area in which there does not appear to be fire present. In other places, e.g., near window 97-211, relatively low-level burning is taking place. Similar to part of the 94th floor, the fires on the 97th floor that grew the earliest on this face now appear to have died down.

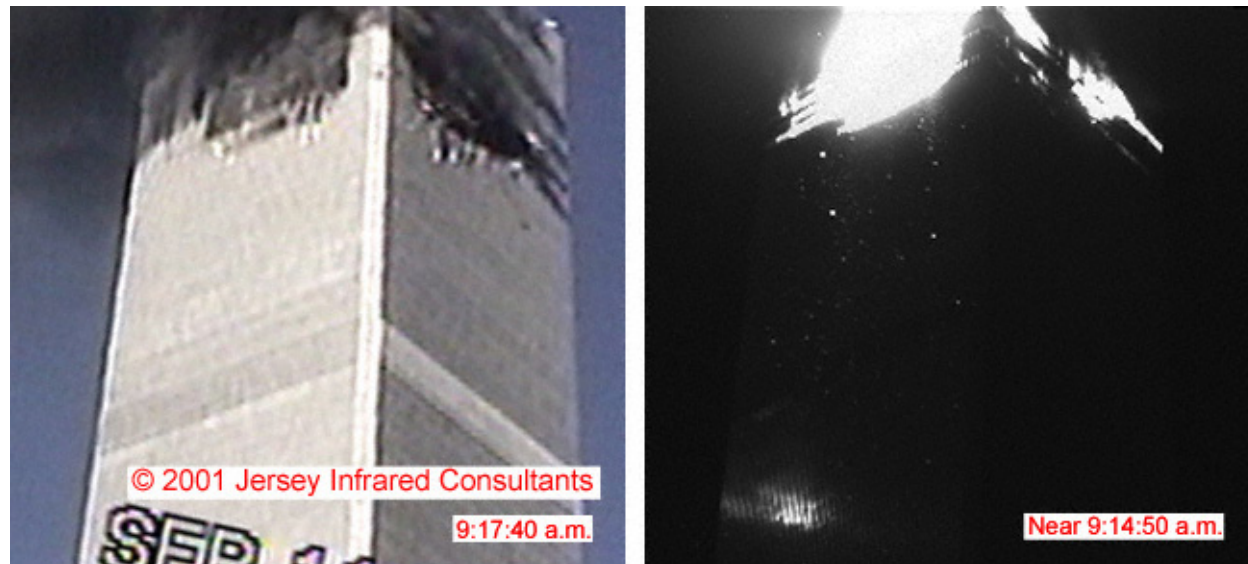
An infrared image showing the north and east faces of WTC 1 that was taken around 9:14:50 a.m. is compared in Figure 8–23 with a standard video frame recorded shortly afterward from the same location. These images were recorded at roughly the same times as Figure 8–19 (9:18:17 a.m.) and Figure 8–22 (9:15:54 a.m.), which show the north and east faces of WTC 1, respectively. Recall from the earlier discussion that the infrared photographs provide only a qualitative indication of where heating of the building façade is taking place.

**Figure 8-23. A frame from a standard video camera (left) and an image from an infrared camera (right) showing the north and east faces of WTC 1 are compared. The video frame was shot at 9:17:40 a.m., and the infrared image was taken around 9:14:50 a.m. (an uncertainty of 15 s has been assigned). The infrared image intensity levels were adjusted. The video frame has been rotated and sized to match the infrared image.**

There is considerable heating in the immediate vicinity of the aircraft impact cavity. This is most likely associated with the heavy smoke (presumably heated) that is still flowing from the area. The two bright lines on the east side of the north face are due to heating by the fires that have been burning on the 96th and 97th floors. It is interesting that there is a region between the aircraft impact cavity and these heated regions that has remained relatively cool. This means that this area had neither burned nor been heated by fire gases from nearby fires.

In Figure 8–23 there appears to be a heated area on the east face many floors below the fire floors. There are no other indications of a fire burning in this area, and it is believed that this apparent heating results from a reflection of the fires burning in WTC 2.

Despite this strong heating, there are parts of the east face in Figure 8–23 where individual floors and windows can be identified. On the south side of the face heat has migrated along the 94th through 97th floors, resulting in the bright lines that are visible in the infrared image. Individual windows are barely resolved. Figure 8–22 shows that smoke was flowing from only a few of the windows in this area and that most of the windows were still closed around this time. Heavy smoke can be seen coming from two windows (96-251 and 96-254) on the southern side of the 96th floor in Figure 8–22. In Figure 8–23 these two windows stand out as two larger bright spots near the southern edge of the tower. Using these windows for reference, it can be seen that the heated sections of the 95th, 96th, and 97th floors do not extend beyond column 250, while the heating on the 94th floor seems to have reached the south end of the

floor. The southern portion of the east side of the 92nd floor appears unheated despite the presence of a substantial fire near the center of this floor.

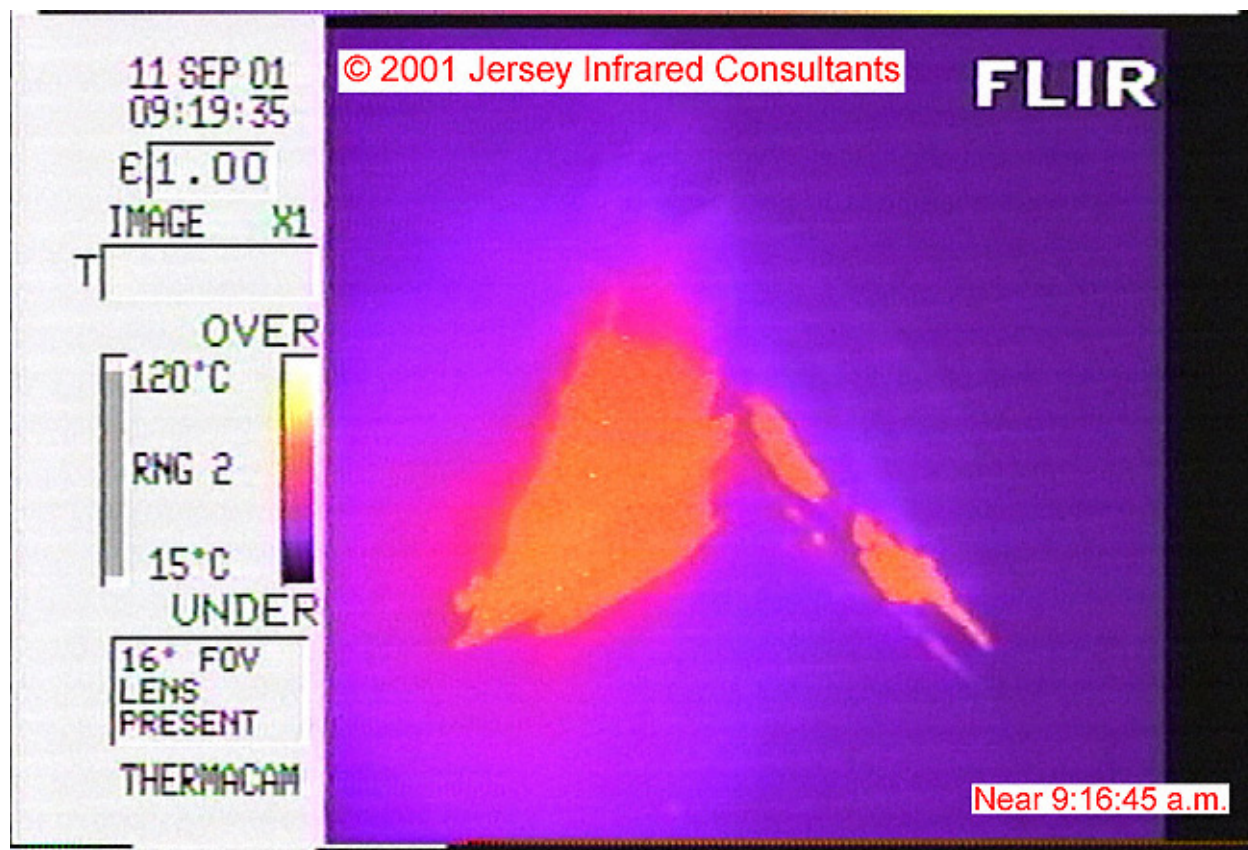
The difference in the amount of heating on the north and east faces in Figure 8–23 and Figure 8–24 is striking. Much of the area above the fires on the 92nd floor at the center of the east face is saturated, i.e., strongly heated. This is likely due to the large amounts of smoke and heat flowing from open windows near the intense fires burning on multiple floors of this face.

**Figure 8-24.** This frame from a standard video recording of the display from an infrared camera shows the north and east faces of WTC 1. It was shot around 9:16:45 a.m. (an uncertainty of 15 s is assigned) using a false-color scale for intensity. The output is strongly saturated.

On the northern side of the east face there are heated areas that reach as far as the northeast corner on the 96th and 97th floors. This is clearer in Figure 8–24, which shows more of the tower. Recall that at the times these images were taken the glass for all of the windows inside the northeast corner rooms was still in place on these floors despite the presence of nearby intense fires. On the lower floors there appears to be mild heating at the northern edges of the 92nd and 94th floors, while the 93rd and 95th floors are close to the ambient temperature.

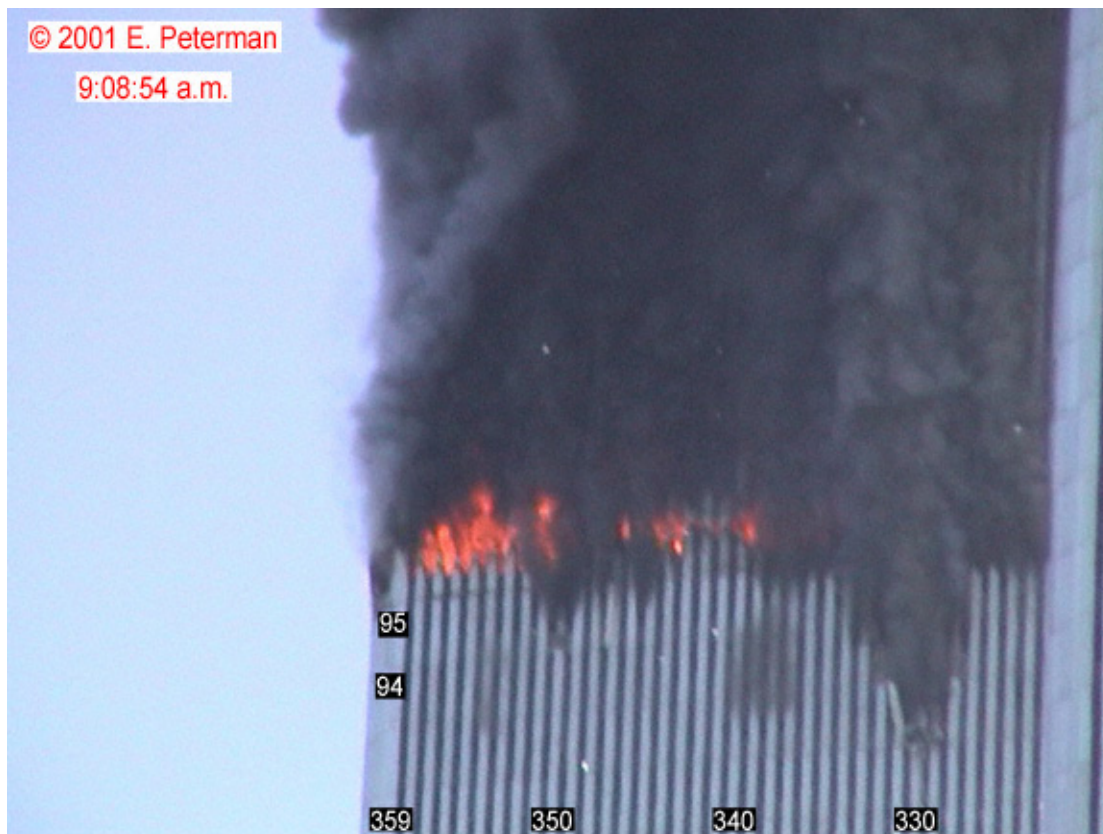
During the initial part of this time period, the fires on the west side of the 96th floor on the south face continued to spread and grow. Distant images indicate that fire fully covered the area near the west wall shortly after 9:03 a.m. Figure 8–25 shows the west side of the south face as it appeared at 9:08:54 a.m. The image was captured from a video recording. On the 96th floor, flames now extended from at least

window 96-335 all the way west to window 96-358. The flames were particularly heavy on the west edge from windows 96-350 to 96-358. At this time, flames are not visible on other floors.

**Figure 8-25. This image showing the south face of WTC 1 at 9:08:54 a.m. is a frame taken from a video. Column and floor numbers have been added.**
