**NIST NCSTAR 1-5A**

**Federal Building and Fire Safety Investigation of the  
World Trade Center Disaster**

**Visual Evidence, Damage Estimates,  
and Timeline Analysis**

September 2005

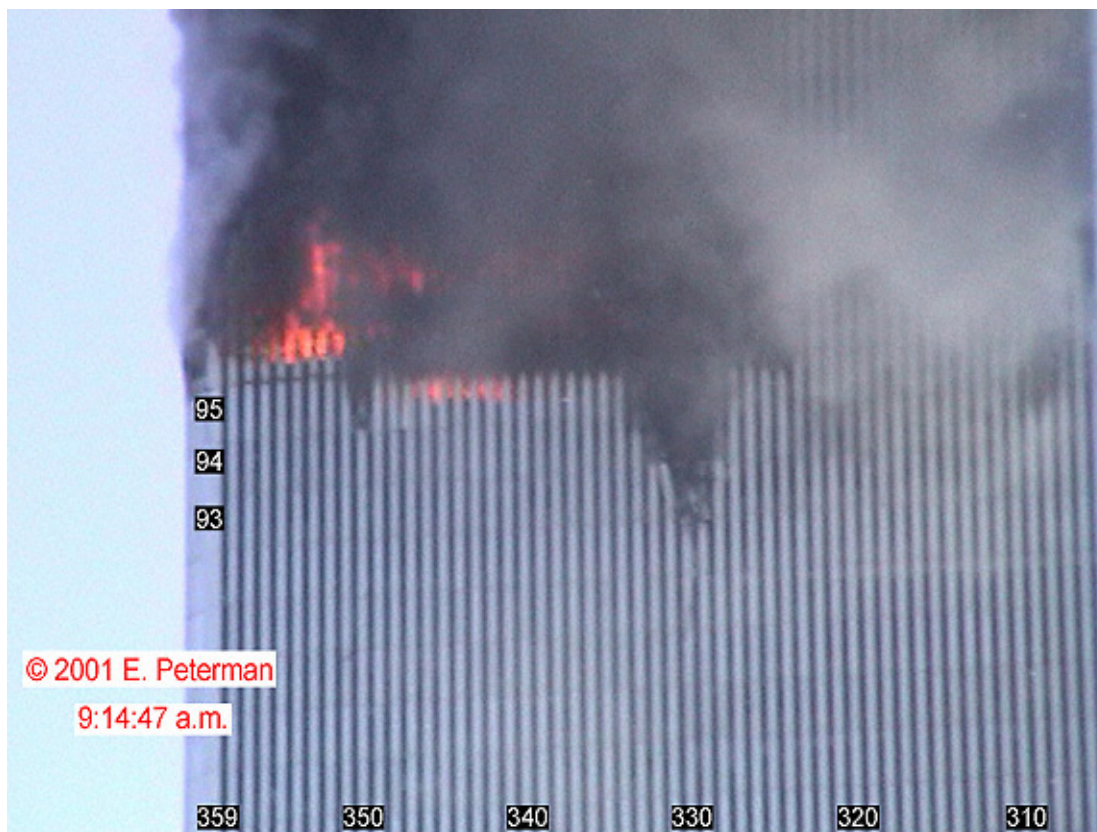
During the next five minutes, the appearance of the south face changed dramatically as can be seen by comparing Figure 8-25 with another captured video frame shown in Figure 8-26. While the fires on the 96th floor were beginning to die down and recede back into the tower, extensive areas of flame were now apparent on both the 95th and 97th floors. The fire on the 95th floor can be seen in windows 95-340 to 95-346, while flames are visible extending from windows 97-336 to 97-354 on the 97th floor. The fire on the 97th floor may actually extend to the west face, but this cannot be confirmed since the area was hidden by heavy smoke coming from below.

Even though the west side of the south face is heavily involved in flames, there has been no apparent fire spread toward the east beyond the initially damaged area near the center of the face.

**Figure 8-26. This image showing the south face of WTC 1 at 9:14:47 a.m. is a frame taken from a video. Column and floor numbers have been added.**

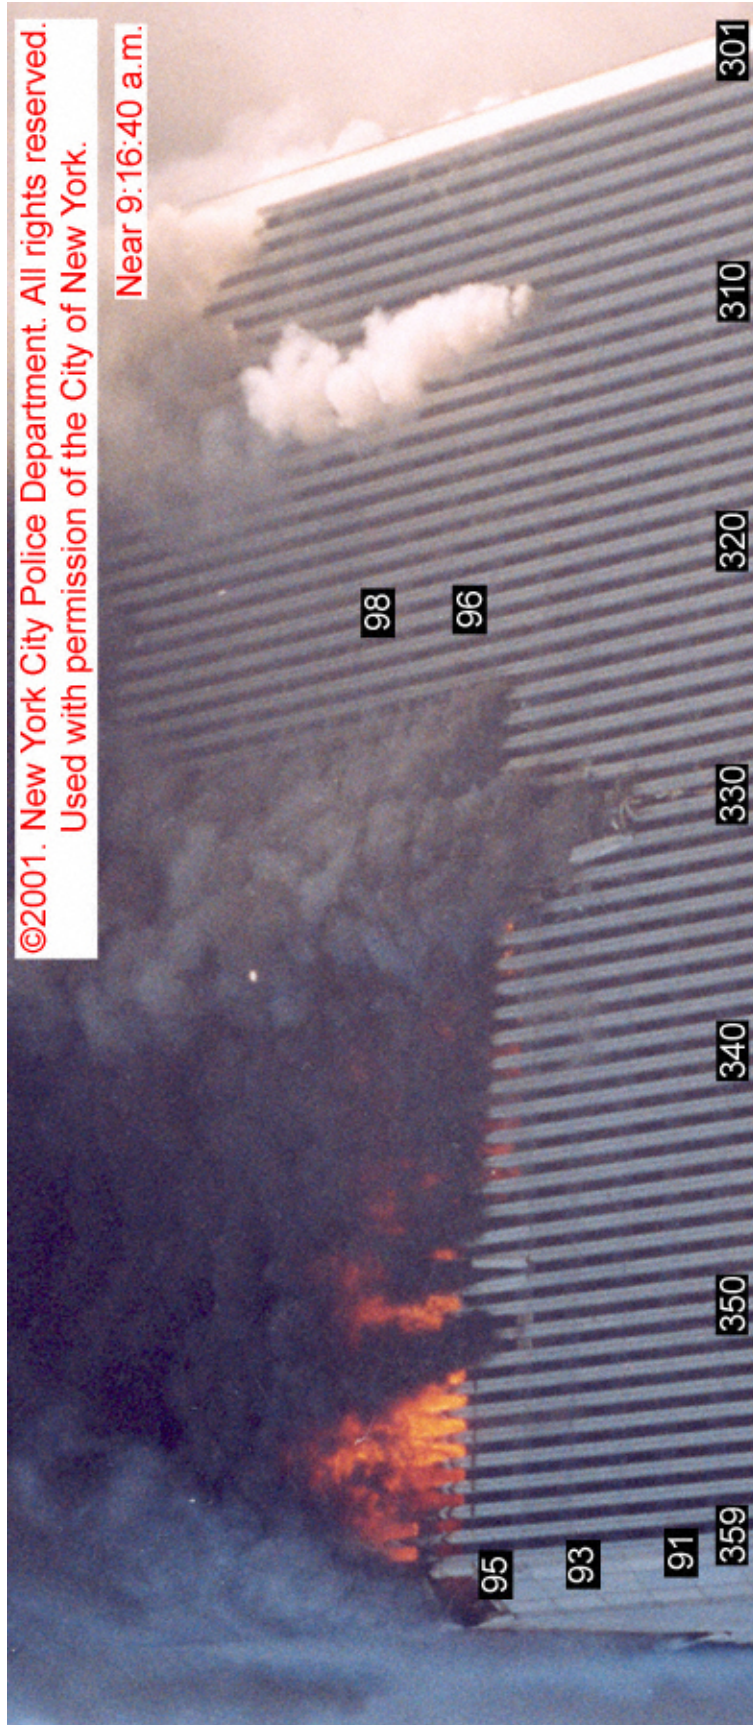
The fire intensity on the south face appears to have gone through several cycles, alternating between periods during which flames extended large distances from multiple windows and those where the flames receded back into the building. Figure 8-27, a photograph shot at around 9:16:40 a.m., i.e., roughly two minutes later than Figure 8-26, shows an example of one of the intense burning periods. The fire on the 95th floor has spread to the east and now extends to at least window 95-333. Flames are coming from several windows to the left of window 95-340. Heavy smoke, which partially obscures the areas above, is pouring from the openings. Bright yellow flames, which appear to reach down to the bases of the

Figure 8-27. This image of the south face has been cropped from a high-resolution photograph. There is a 35 s uncertainty in the assigned time of 9:16:40 a.m. The image has been enhanced and rotated. Column and floor numbers have been added.

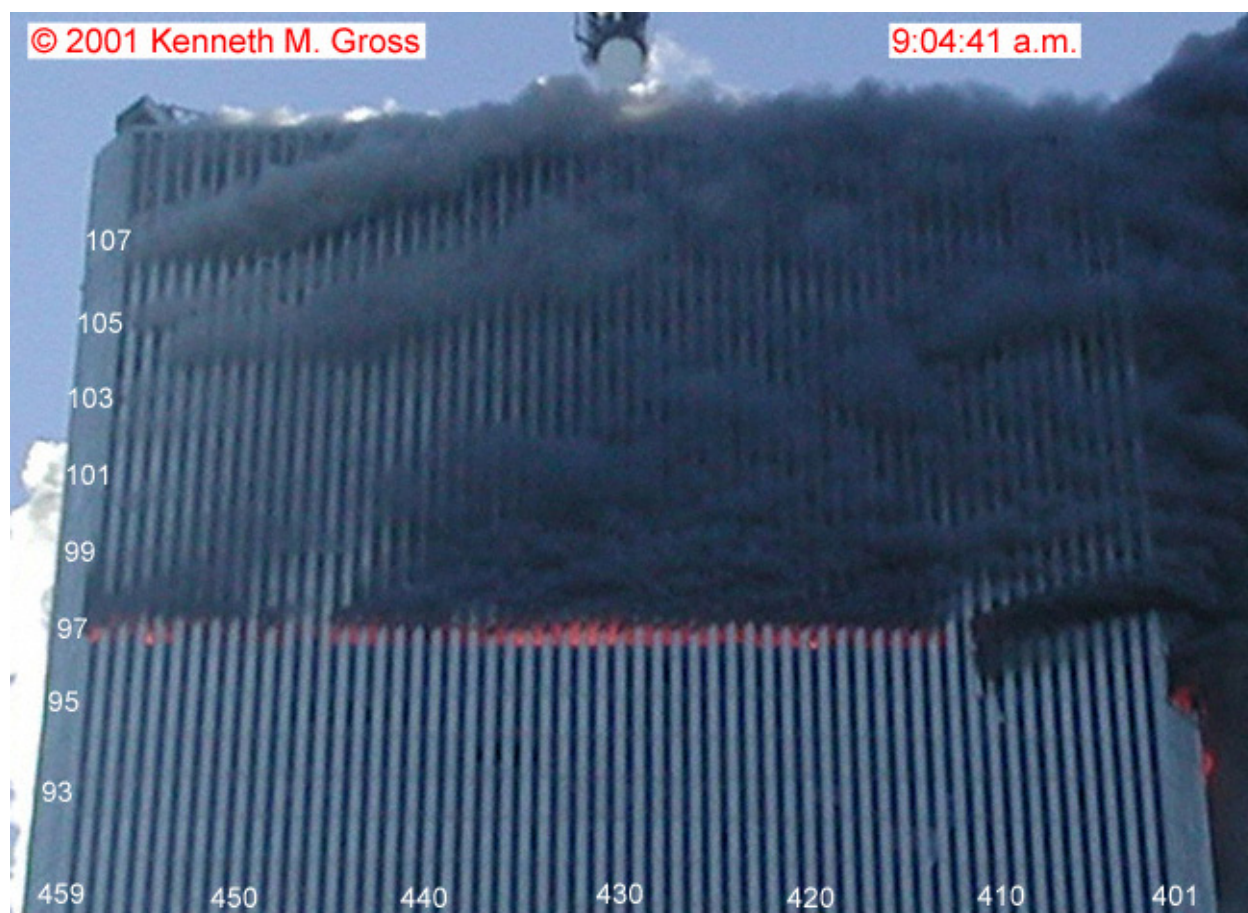
The fires on the west face during this time period continued to undergo unusual and dramatic changes in behavior. But first, following the two periods of rapid fire spread prior to 9:03 a.m., the fires again underwent another pause during which further fire spread was not evident. Figure 8–28 shows the west face as it appeared at 9:04:41 a.m. Flames, with a couple of breaks, can be seen in or extending from window 97-412 to window 97-458. This is roughly the same area that was burning just prior to 9:03 a.m., although the flames in the southern part of the area are more evident than earlier. Heavy smoke is pouring from multiple windows on this floor. Other features present in Figure 8–28 include heavy smoke flow from windows 96-409, 96-410, 97-409, and 97-410 on the 96th and 97th floors, the heavy smoke coming from broken windows in the upper northern portion of the face, and the fire coming from the southwest corner of the 96th floor where the aluminum panel was dislodged during the aircraft impact and subsequent fireball. A streamer can be seen near column 414 at the bottom of the photograph.

The open windows on the 95th floor, visible in Figure 8–11, can also be seen in Figure 8–28. There are also four windows, 94-434 to 94-437, on the 94th floor that are now open, but were in place in the earlier photograph taken at 9:01:40 a.m. These windows are believed to have been broken out by people. At this time there is no smoke coming from either set of open windows despite the presence of fires elsewhere on both floors.

**Figure 8-28. A cropped photograph of the west face of WTC 1 taken at 9:04:41 a.m. is shown. The image has been enhanced and rotated. Window and floor numbers have been added. A streamer can be seen falling near the bottom of the image at column 414.**

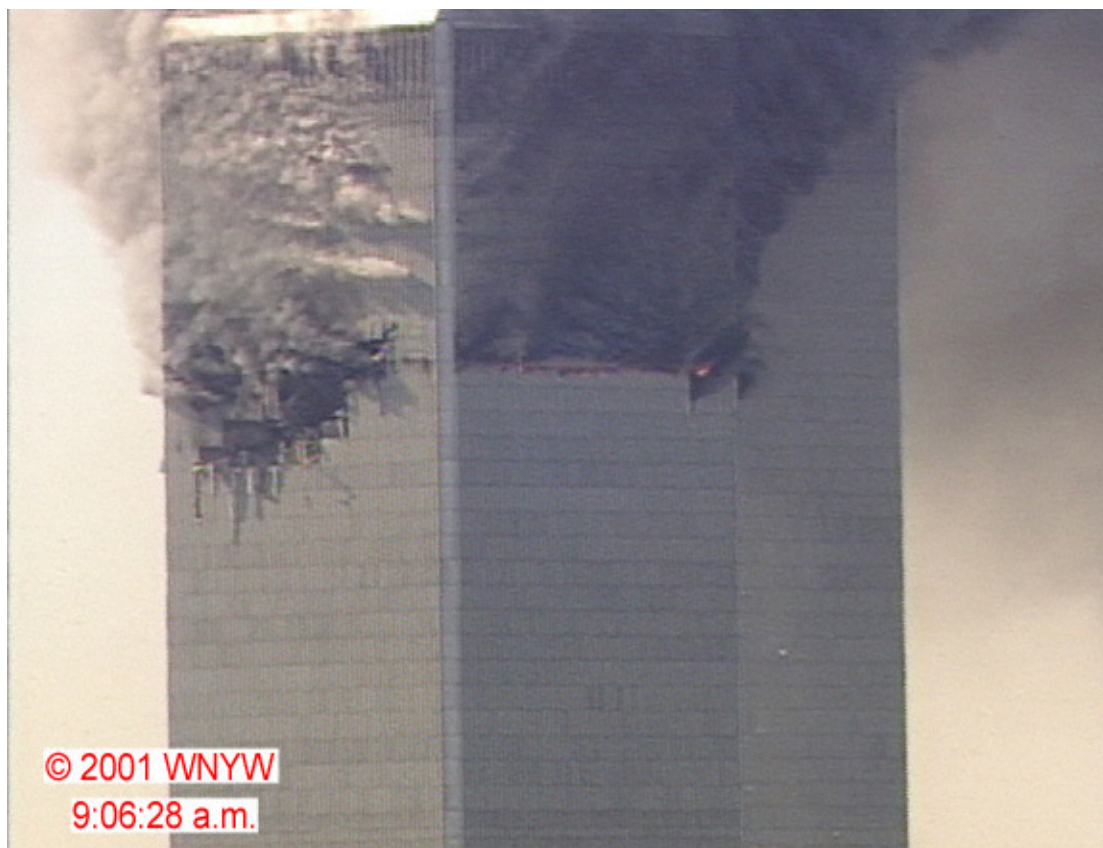
Mostly long-distance photographs and videos show that the conditions present in Figure 8–28 did not change appreciably until 9:06:27 a.m. At this time a short-lived, but intense, burst of flame appeared near the top of window 97-408, as can be seen in Figure 8–29. Very shortly after this flame appeared, the amount of smoke coming from open windows on the 97th floor decreased dramatically, and it was possible to see parts of the west façade that had been hidden just before. The heavy smoke is still evident in Figure 8–29.

**Figure 8-29. This image of the north and west faces of WTC 1 is a frame from a video recorded by a news helicopter at 9:06:28 a.m. WTC 2 can be seen behind WTC 1. Note the burst of flame from near window 97-408 at the southwest corner of WTC 1.**

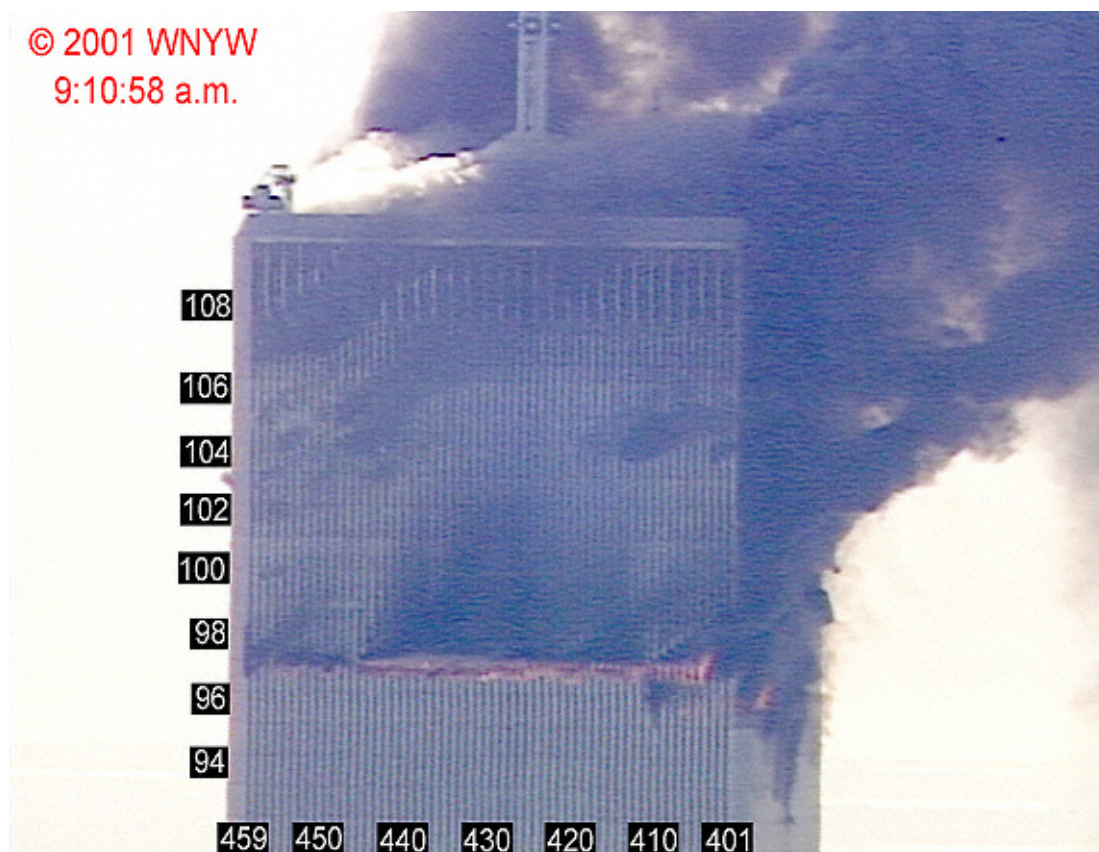
Another frame taken from a video shot by a news helicopter is shown in Figure 8–30. This image was taken four and a half minutes later than Figure 8–29. An extensive area of flame is still present on the 97th floor, but the flames toward the center of the face appear to have receded deep inside the building. There is very little smoke coming from the region. Most of the west face is now visible. In particular, the smoke coming from two areas on the south side of the face at the 104th floor can now be seen clearly. On the north side of the face the heaviest smoke flow from the upper floors is coming from the 107th floor, with strong smoke plumes also issuing from open windows on the 104th and 105th floors.

There appears to be a small fire on the 96th floor at window 96-406. Small fires such as this one were not observed on the west face of the 96<sup>th</sup> floor until around 9:08 a.m. This was the case despite the fact that an intense fire had been burning just around the southwest corner on this floor for over 20 minutes. Several windows did open near the corner during this time period, suggesting that heating was taking place in the area. There is a remarkable difference in the fire growth and spread on the western

**Figure 8-30. This image of the west face of WTC 1 and an oblique view of the south face is a frame from a video recorded by a news helicopter at 9:10:58 a.m. Column and floor numbers have been added.**

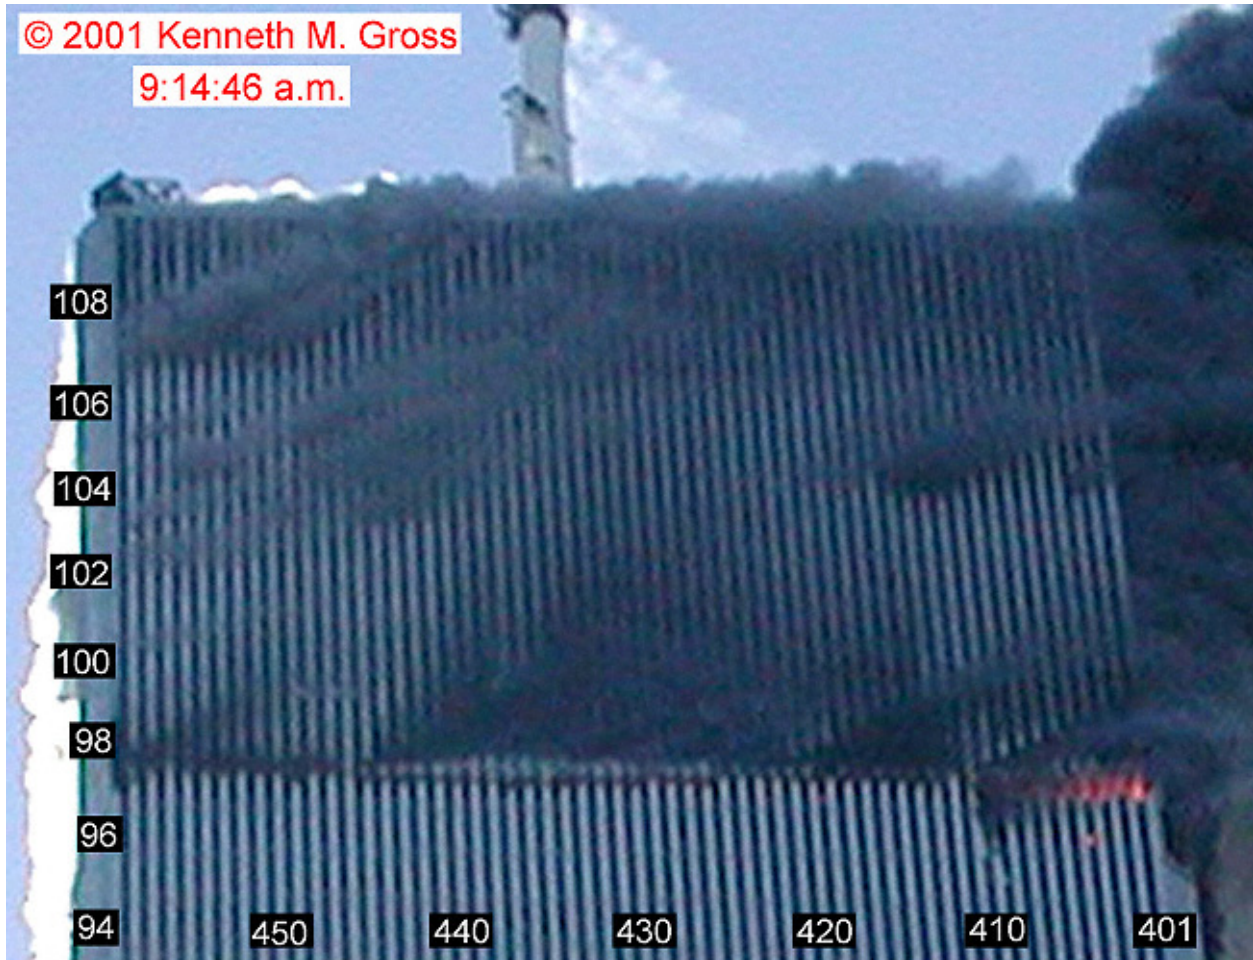
A higher resolution photograph of the west face taken at 9:14:46 a.m. is shown in Figure 8-31. The photographer was located just to the west of the WTC site and was, therefore, shooting up at the building from a steep angle. The only area in which fire is evident in this photograph is on the 97th floor at the south edge in windows 97-401 to 97-406. While the flame lengths are fairly short, there does appear to be some flame extension from these windows. The smoke plumes from higher floors described above are also visible, and a spot fire is present in window 96-404. There are still no indications of smoke or fire on floors below the 96th.

**Figure 8-31. This cropped photograph shows the west face of WTC 1 at 9:14:46 a.m. It was shot from the ground a short distance from the WTC site. Column and floor numbers have been added.**

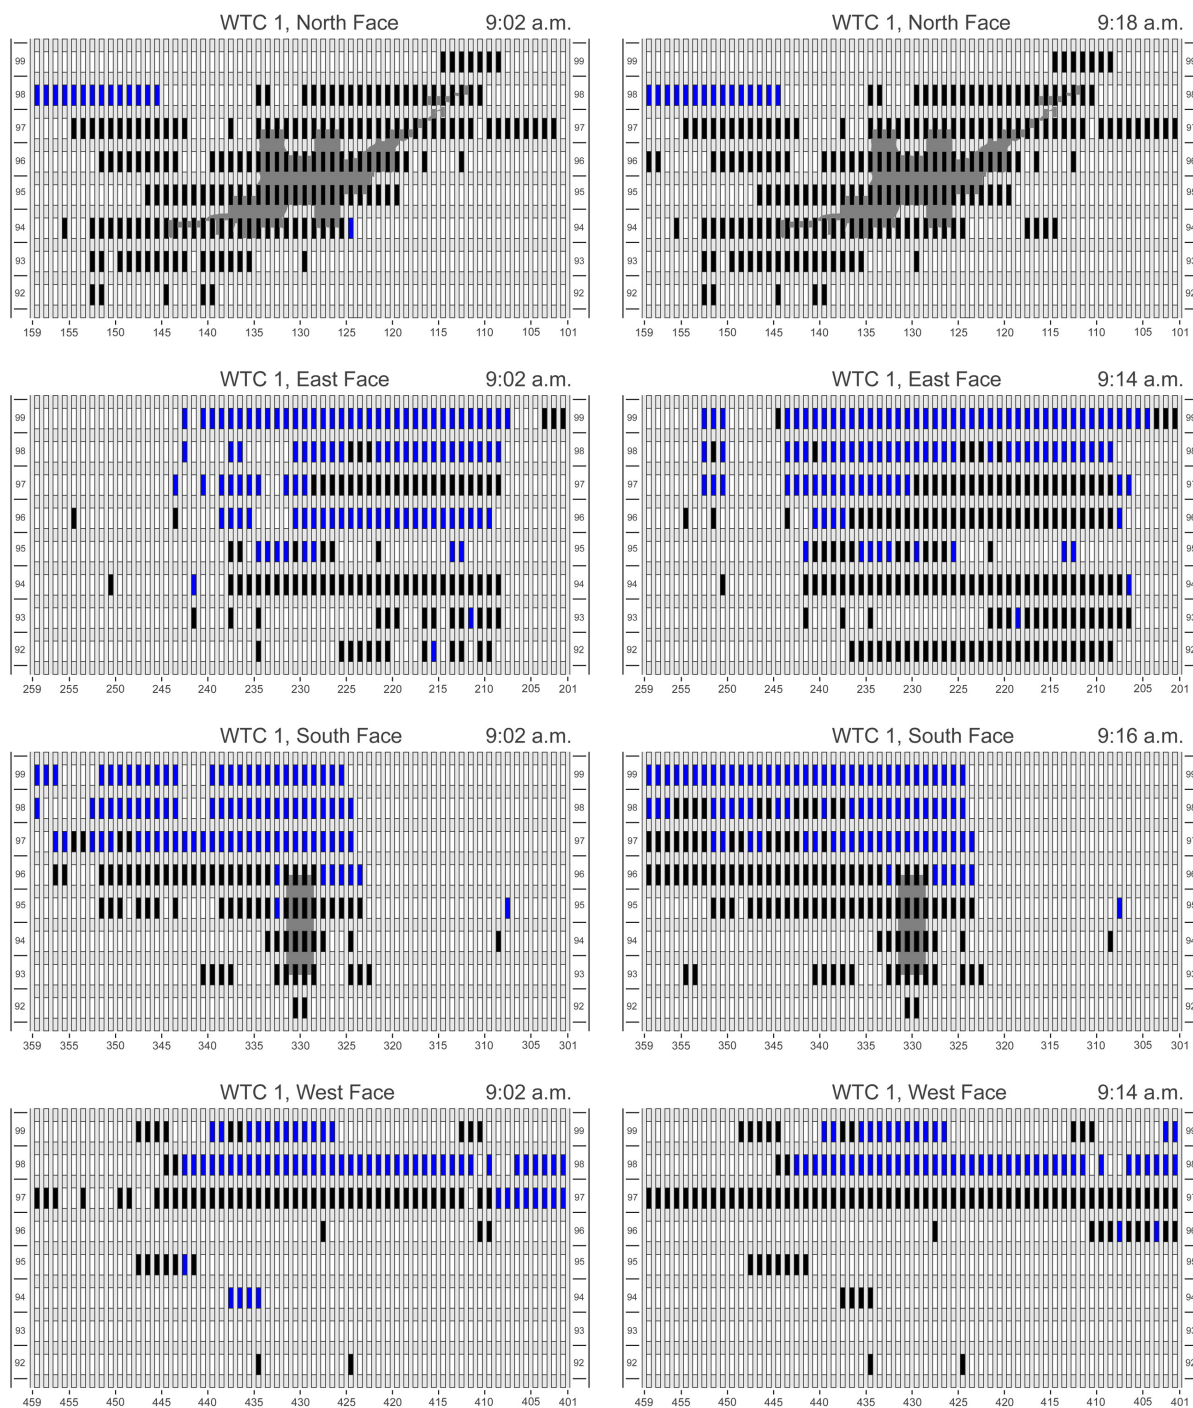
In Figure 8–32, window breakage is used as a surrogate for fire spread to provide a visual indication for fire growth during the period covering roughly 9:03 a.m. to 9:18 a.m. It should be kept in mind that open windows do not provide a perfect history of fire locations since many windows were broken during the aircraft impact and accompanying fireballs. It is also likely that some of the windows that were open at this time were broken by people. This is particularly the case on the 94th and 95th floors on the west face.

**Figure 8-32. Maps for the 92nd through the 99th floors compare missing window glass for the four faces of WTC 1 at two times, around 9:02 a.m. and roughly 15 minutes later. The color coding used for the maps is indicated in Figure 5-1.**

In Section 6.4.2 it was pointed out that the aircraft and fireball damage to the tower was asymmetrical and that the southeast quadrant appeared to be relatively undamaged. Figure 8–32 and Figure 8–33 show quite distinctly that major fire development has not yet occurred at the periphery of this quadrant. This is further evidence that aircraft debris and/or fuel did not reach the periphery of this quadrant to any great extent.

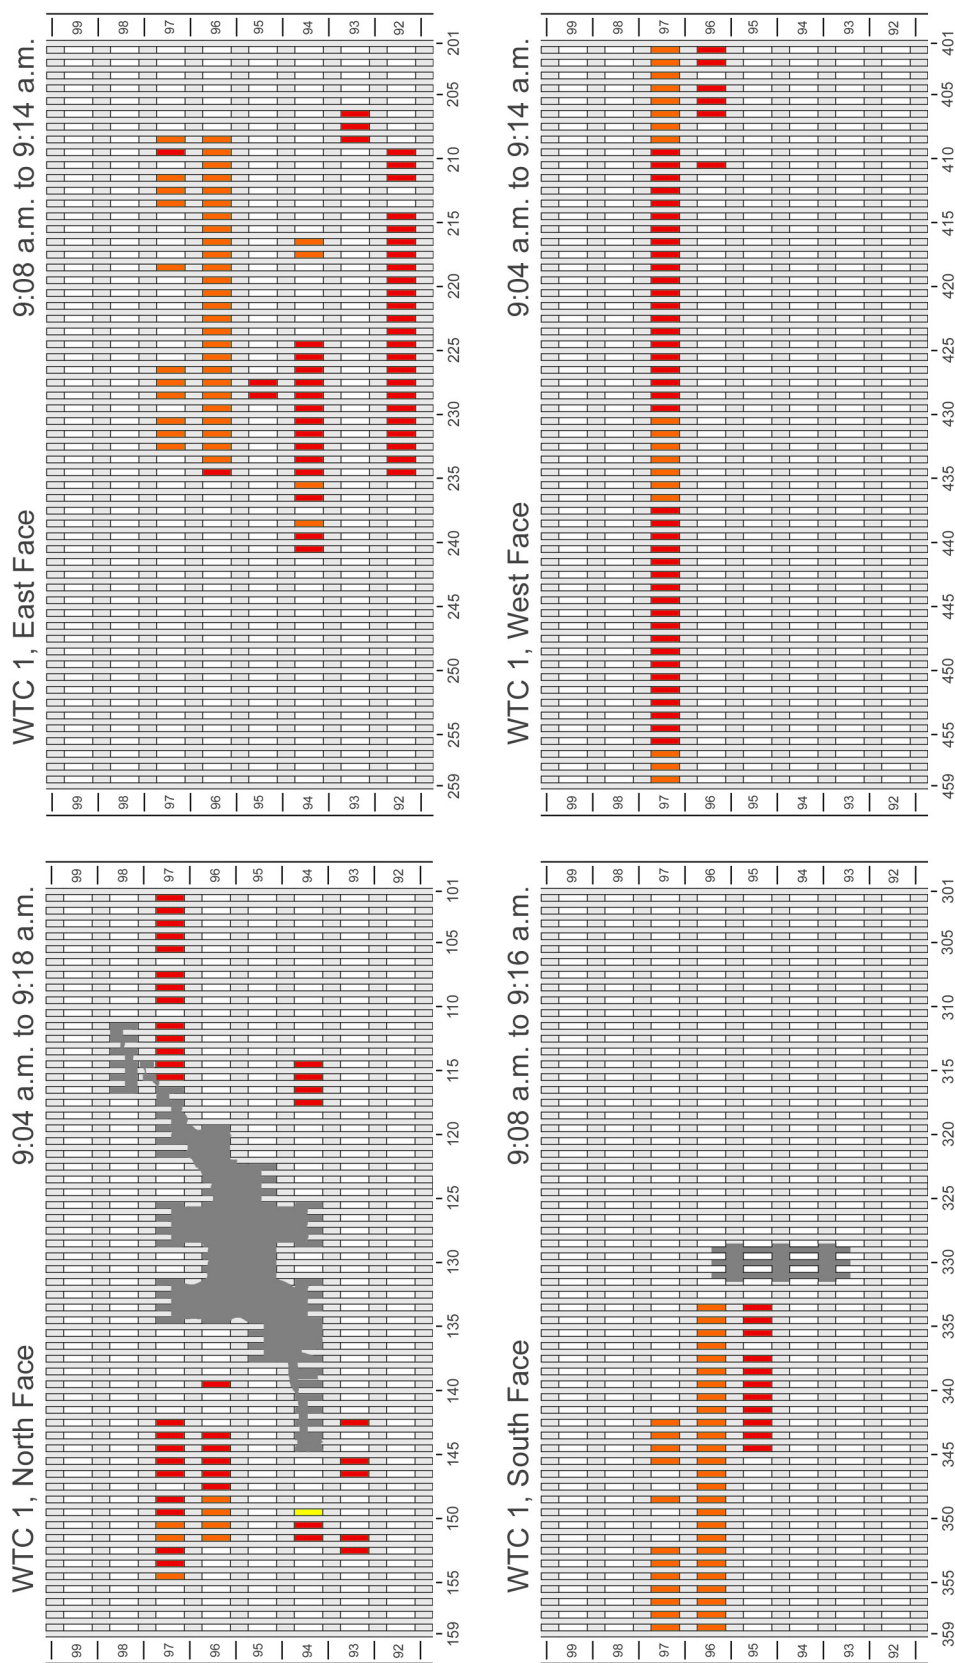
Integrated maps for fire intensity for the period, similar to those shown in Figure 8–14, are included in Figure 8–33. Comparison of these two figures confirms the general trends in fire spread described above. Such a comparison also shows that some of the fires observed during the initial period have died down and are not apparent during the second time period. Examples include fires on the 97th floor on the north face and areas on the 94th and 97th floors on the east face.

From Figure 8–33 it appears as if the most intense and widespread fires during the period from 9:03 a.m. to 9:18 a.m. were on the 96th and 97th floors. The east side of the tower had the most widespread fires, with flames visible from the 92nd floor to the 97th floor. The absence of burning in the southwest quadrant of the tower is evident from the maps.

**Figure 8-33. Maps of integrated fire observations between 9:03 a.m. and 9:18 a.m. are shown for the four faces of WTC 1. Colors represent the highest intensity fire observed in a window using the color scale defined in Figure 5-1.**

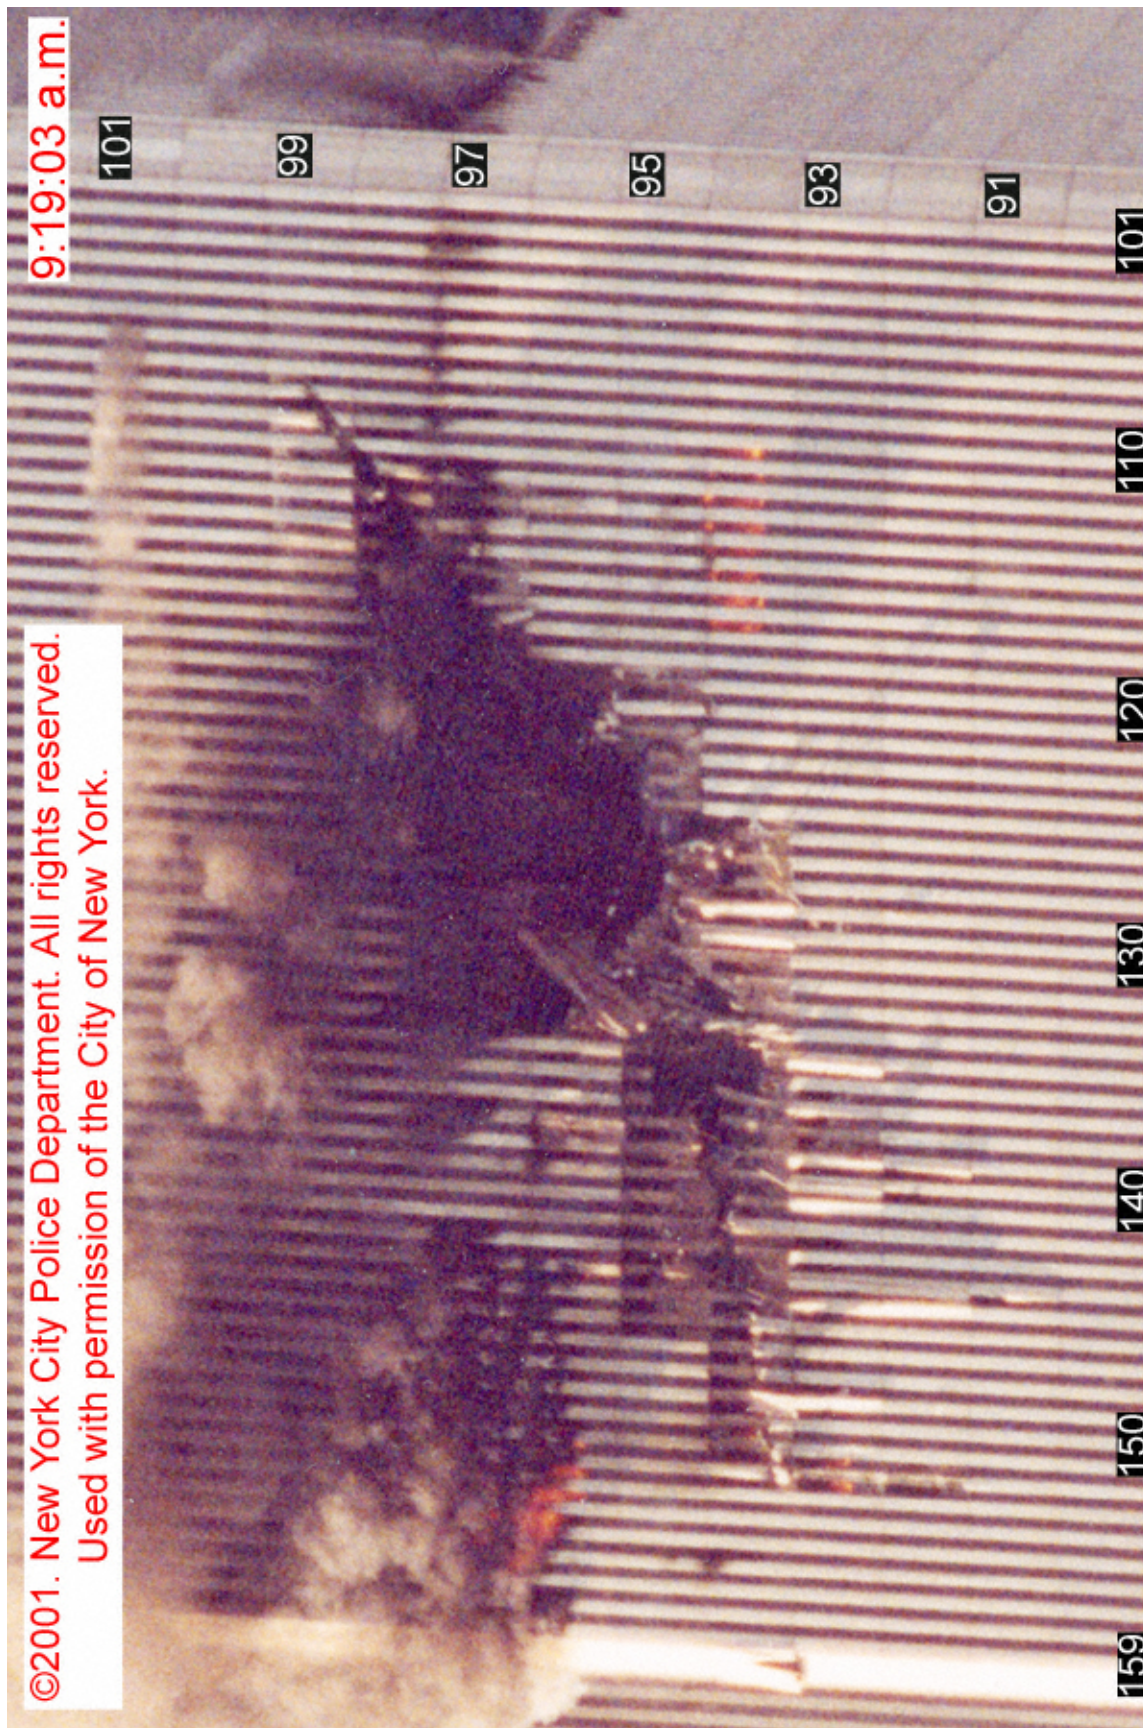
A close-up photograph taken at 9:20:51 a.m. shows that the appearance of the fires on the 96th and 97th floors was somewhat changed from that seen in Figure 8–34. Heavy flames were present in all of the north side windows that were originally within the corner rooms. Flames were extended primarily from the two windows nearest the east face on both floors. The fire on the 94th floor had a similar appearance to that in Figure 8–34, with extensive flames present inside the building, numerous areas burning at the tops of window openings, and only light smoke coming from the windows. This fire had continued to spread to the east and now extended from windows 94-106 to 94-117.

Figure 8-34. An image recorded at 9:19:03 a.m. shows the north face of WTC 1. The original has been cropped, rotated, and enhanced. Column and floor numbers have been added.

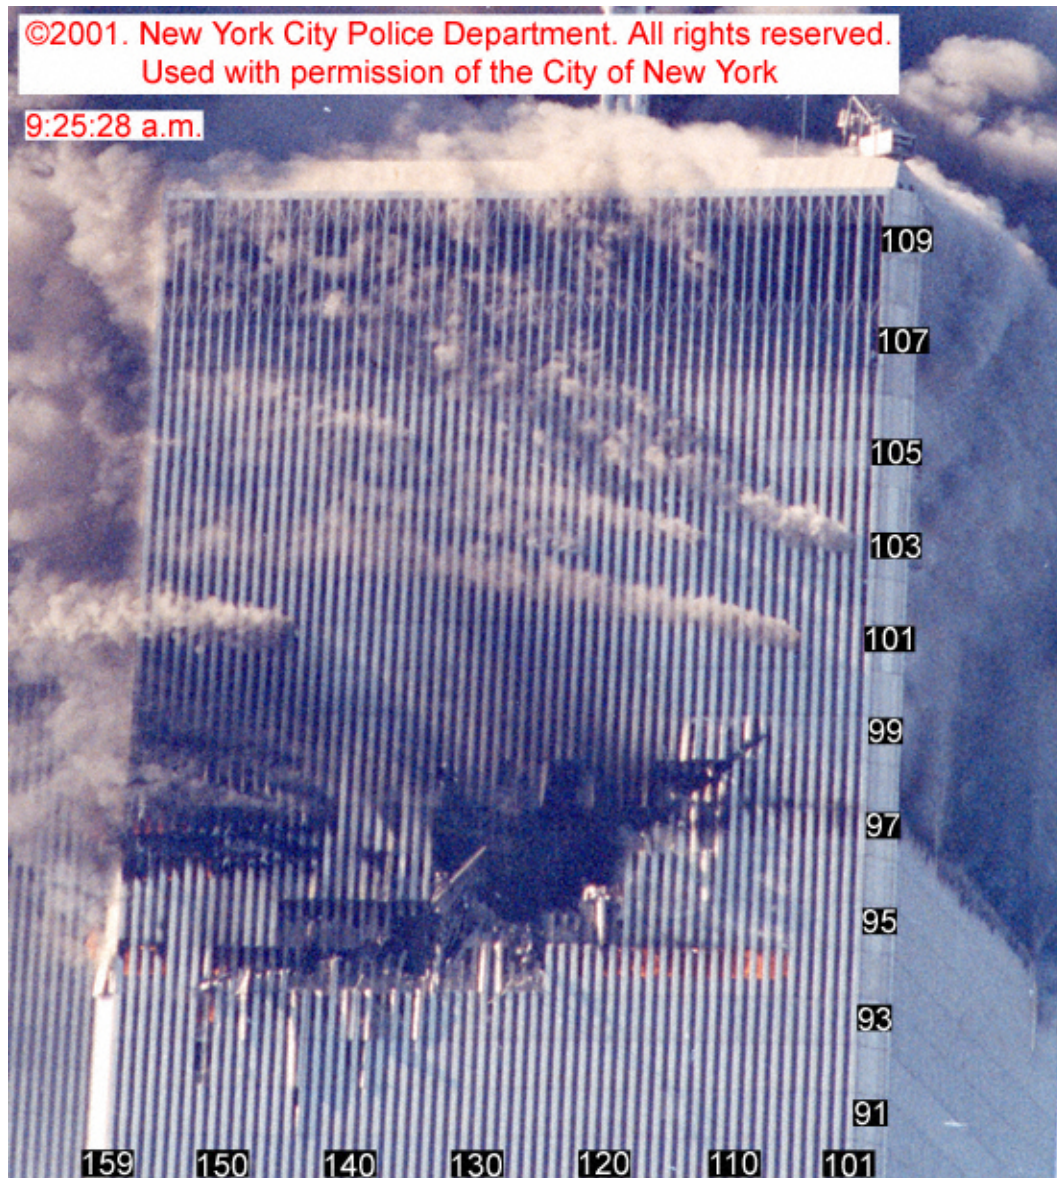
Figure 8–35 shows the north face of WTC 1 as it appeared at 9:25:28 a.m. The amount of smoke coming from the north face, particularly the aircraft impact cavity, has decreased markedly as compared to images taken earlier. There are fires visible on multiple floors, but the amount of smoke coming from these floors is very low. In fact, the densest smoke appears to be coming from open windows that are well above the fire floors. This observation indicates that smoke is still moving upward inside the building and following flow pathways to windows opened by people trapped above the aircraft impact floors. Smoke is still flowing from the air intakes on the 108th and 109th floors.

**Figure 8-35.** An image recorded at 9:25:28 a.m. shows the north face and an oblique view of the west face of WTC 1. The original has been cropped, rotated, and enhanced. Column and floor numbers have been added.

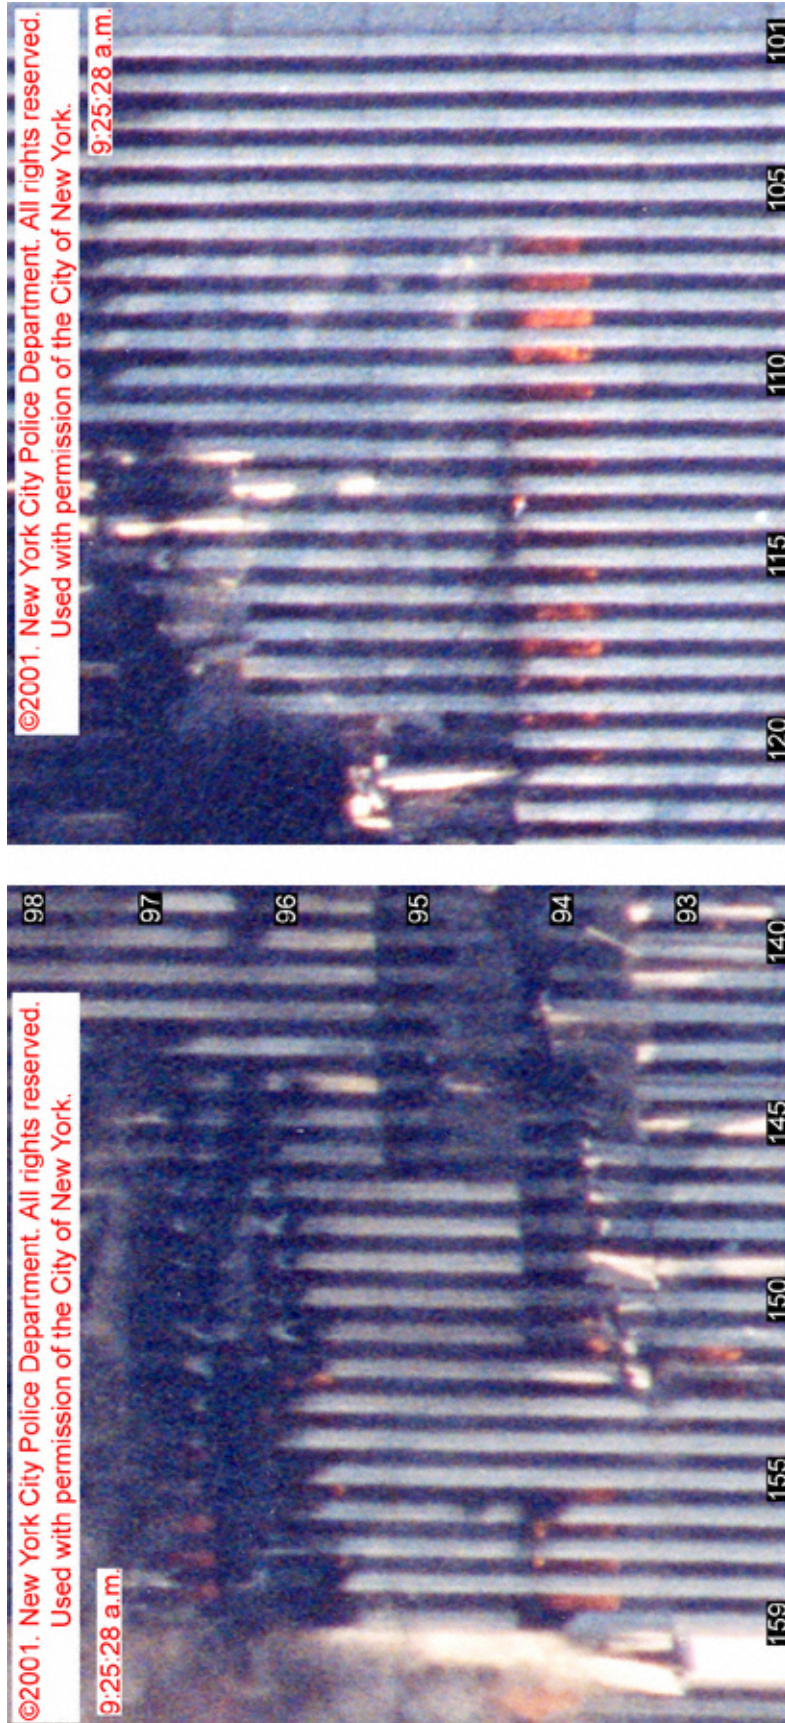
In Figure 8–36 two areas on either side of the aircraft impact cavity in Figure 8–35 have been blown up in order to provide a better view of the active fires. On the east side, fires can be seen on the 93rd, 94th, 96th, and 97th floors. Fires that appear to be relatively small and isolated are present at two locations centered near windows 93-139 and 93-151 on the 93rd floor. On the 94th floor an isolated fire is also present near window 94-151, but the major change from earlier times is that the glass in windows 94-155 to 94-158 is now missing, and an intense fire is evident burning within the building behind the four open windows. Isolated fires are present at the tops of the two windows in the center of the group. Note that the two adjacent windows, 94-153 and 94-154, are still in place. Flames can be seen through multiple open windows on the 96th and 97th floors. There is now no flame extension from the north face windows, and the fires have died down considerably from their levels of a few minutes earlier (e.g., compare with Figure 8–34 recorded at 9:19:03 a.m.).

On the west side of the north face, fire is only visible on the 94th floor. The apparent intensity of this fire has also died down somewhat from a few minutes earlier. The fire has broken into two sections on either side of a central region running from roughly windows 94-109 to 94-113, where only small fires near the bases or tops of the windows are evident. The fire spread to the west has paused at window 94-106, and the five windows to the west have glass in place. This suggests that the fire spread to the west had been slowed down by an internal wall located at column 94-106. The floor plan layout in Figure B-3 indicates that there was indeed an internal wall that terminated on this column.

The areas of the north face of WTC 1 included in Figure 8–36 provide good examples of the correlation of local fire behavior with the column cover marks observed next to windows where fire is present. On the 96th and 97th floors the fires created conditions in which flames extended from the windows. A series of carets are present at the tops of the windows running across these two floors. The heights of the carets vary over the region providing an indication of the local maximum burning intensity. In contrast, fires on the 93rd and 94th floors did not generally extend from windows and did not generate a great deal of smoke flow from the windows. For these windows there were sometimes narrow, dark lines at the tops of the adjacent aluminum column covers, and for others very little marking of the column covers occurred.

An enlarged image of the fires on the west side of the north face is also included in Figure 8–36. The marks on the column covers on the 97th floor show evidence for both types of fires. Those nearest the airplane strike point are marked with carets. Flame extension was observed in this area shortly following the aircraft impact. Further to the west there are black marks above the windows, except for the column covers on either side of window 97-102, which are marked with carets. As discussed earlier, fires on this part of the 97th floor did not extend from these windows for any significant period of time. The same types of narrow black bands are observed at the tops of the columns above the burning region on the 94th floor. Recall that this was a region of heavy burning, but without flame extension.

**Figure 8-36. Two blowups from Figure 8-35 of areas on the north face of WTC1 are shown. The photograph was taken at 9:25:28 a.m. The images have been enhanced, and column and floor numbers have been added.**

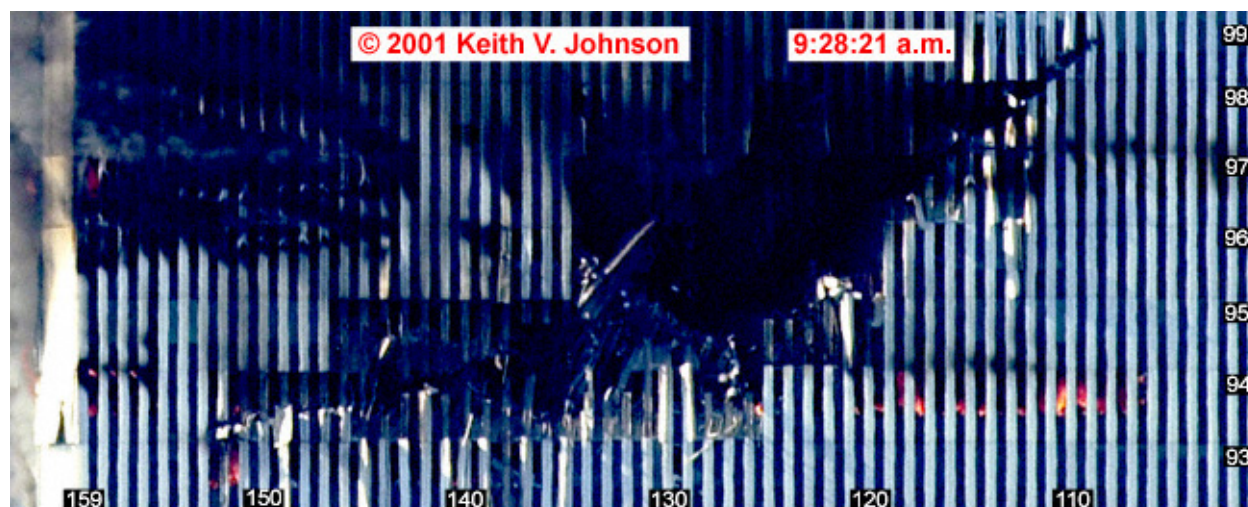
**Figure 8-37. This cropped photograph shows the north face of WTC 1 at 9:28:21 a.m. The image has been rotated and enhanced. Column and floor numbers have been added.**

Figure 8-37 shows a photograph of the fire floors on the north face taken at 9:28:21 a.m. The fires which grew rapidly at the start of the period are continuing to die down. In particular, the large fires that appeared within the rooms on the northeast corners of the 96th and 97th floors are now barely visible. The fires on either side of the aircraft impact cavity on the 94th floor are also decreasing in size. On the east side there are still fires burning at the window head casings of windows 94-156 to 94-158. An isolated fire can still be seen on the 93rd floor through open windows 93-152 and 93-153.

While it is difficult to make out in Figure 8-37, close inspection shows that there is a small spot fire visible in window 98-123 on the 98th floor. Recall that a similar fire was observed on this floor in window 98-115 around 9:06 a.m. Most windows were still in place on this floor around the time Figure 8-37 was taken.

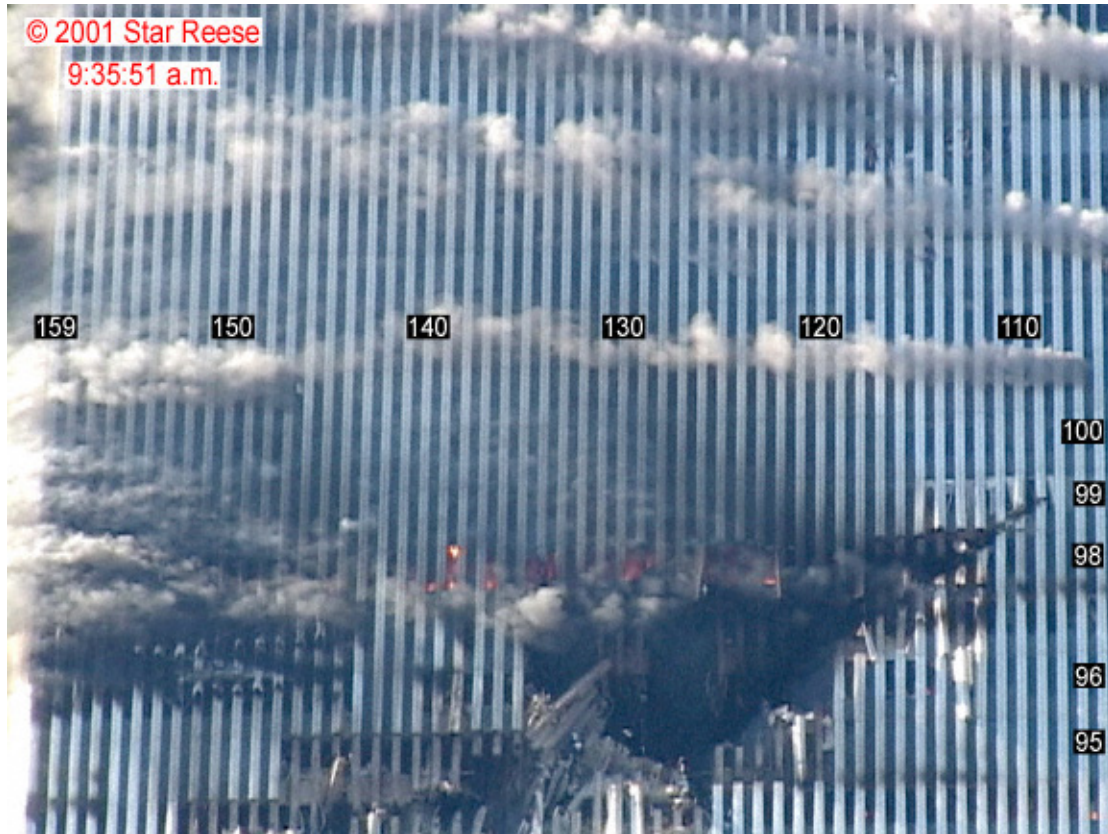
During the next several minutes, the older fires on the north face of WTC 1 continued to die down, but on the 98th floor the fires were growing and appearing at new locations. Around 9:29:10 a.m. a video shows a sudden increase in the brightness of the flame at window 98-124. Near 9:31:40 a.m. the amount of smoke coming from the aircraft impact cavity increased dramatically. Figure 8-38 is an image of the face captured from a video recording shortly after 9:35 a.m. Flames are visible in many windows, ranging from at least window 98-122 to window 98-139. There is a bright flame at the head casing of window 98-138. Most of the imagery of the north face during the period from around 9:29 a.m. to 9:35 a.m. was shot at a longer distance than Figure 8-38, and it has not been possible to follow the growth of the fires seen in this image in detail. It does appear that much of this fire growth occurred around 9:35 a.m. At this time very little north face flame is visible on other floors.

**Figure 8-38. A frame taken from a video shows the north face of WTC 1 at 9:35:51 a.m. The image has been enhanced. Column and floor number have been added.**

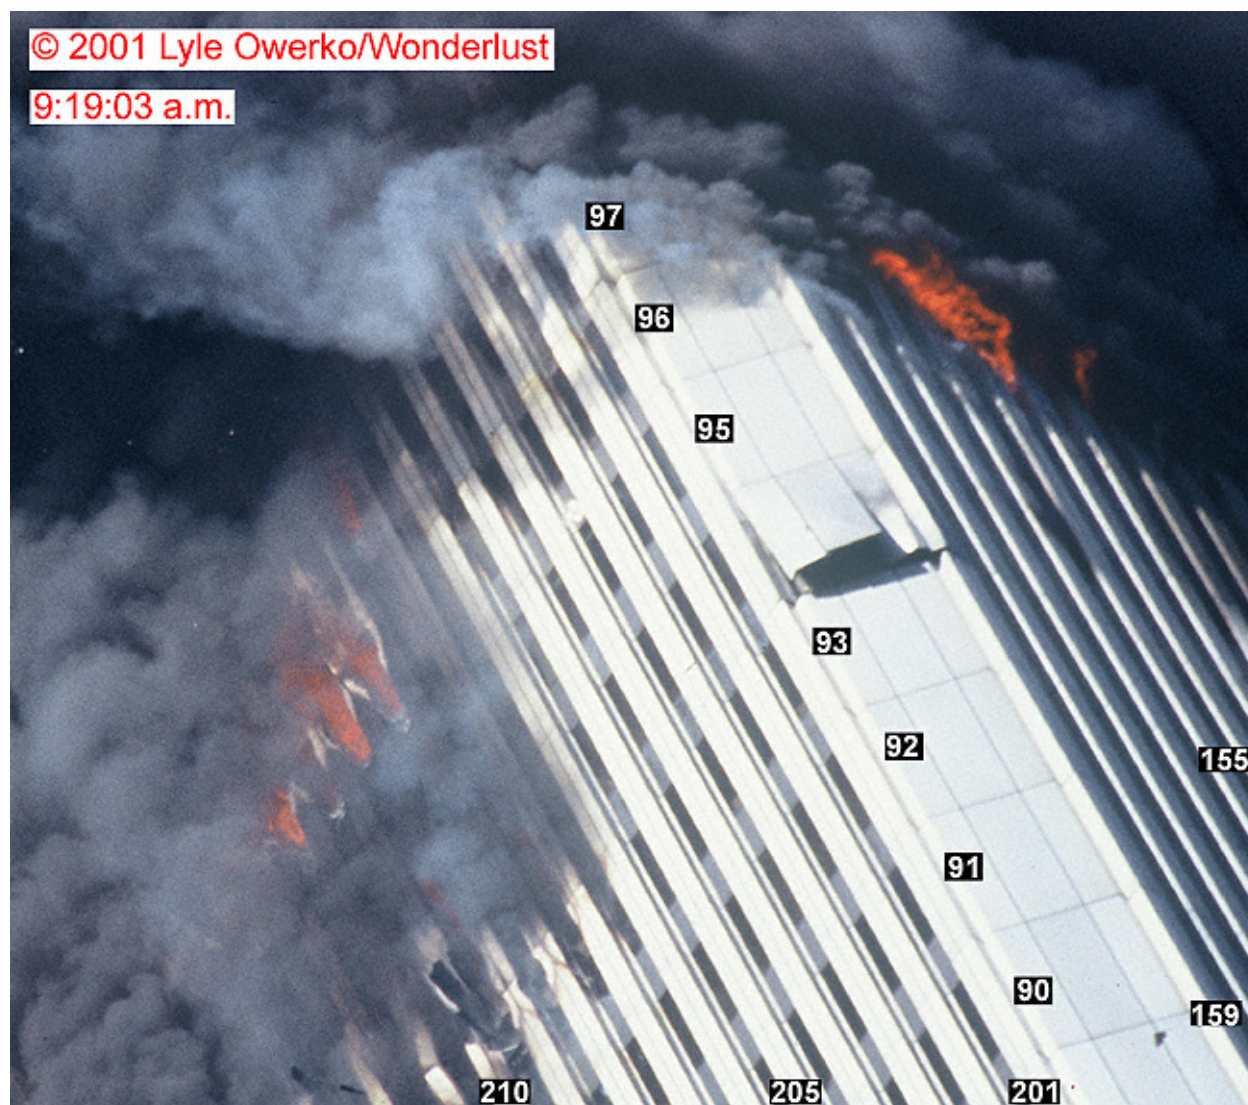
The close-up photograph in Figure 8-39 shows the northeast corner of WTC 1 at 9:19:03 a.m. On the north face, the flames that first emerged from windows on the 96th floor at 9:19:00 a.m. are evident. At the time of Figure 8-39, the largest flame jet was coming from window 96-154. On the east face heavy flames were present in windows 96-208 to 96-211. The distinct carets on the column covers attest to the intensity of the fires that have been burning in the area. The window glass on the inside of the internal wall at column 96-208 is still in place. This is not the case on the 97th floor. Flames are evident through a partially opened window 97-207, indicating that fire had penetrated the wall at column 97-208 by this

On the 95th floor, windows from the north edge out to window 95-207 appear intact. It looks as if there was a small fire in window 94-207, and the window may be partially broken out. This is not clear. Carets on the covers of columns 93-206 to 93-208 are telltale signs of the extended flames that came from windows 93-206 to 93-208 at an earlier time. Glass for windows to the north of column 93-205 is still intact. These observations suggest that a wall at column 93-205 may have slowed the spread of this fire. However, it is not possible to confirm this since the plan layout for this floor shown in Figure B-2 does not cover this section of the floor. For the 92nd floor, glass is intact in windows extending from the north edge to at least window 92-207. The floor plan layout in Figure B-1 indicates that there was a room in the northeast corner of this floor with walls that extended to columns 92-155 and 92-204. The interior wall on the south side of this room was glass.

**Figure 8-39.** This cropped close-up photograph showing the northeast corner of WTC 1 was taken at 9:19:03 a.m. It has been enhanced, and column and floor numbers have been added.
