**NIST NCSTAR 1-5A**

**Federal Building and Fire Safety Investigation of the  
World Trade Center Disaster**

**Visual Evidence, Damage Estimates,  
and Timeline Analysis**

September 2005

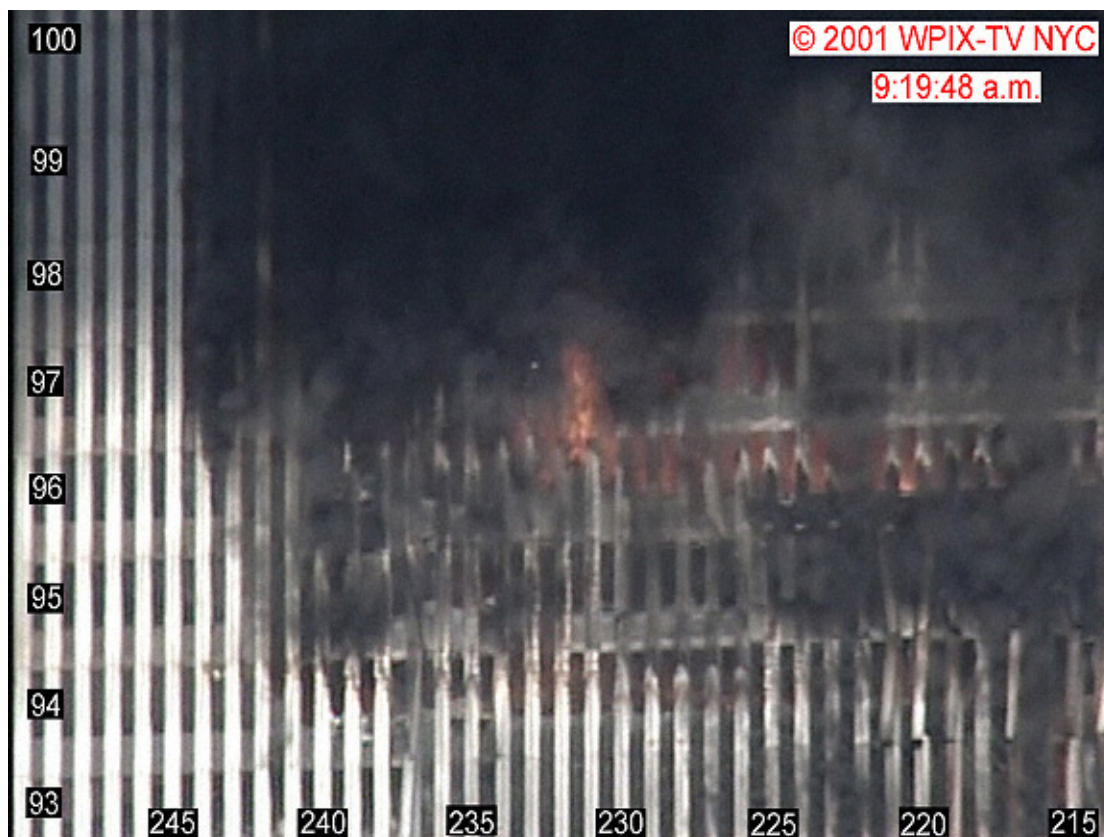
Extended flames are coming from window 96-231 in Figure 8-40. The presence of carets indicates that flames had earlier been present at least as far south as window 96-238, but at this time these flames were not visible. The floor plan layout for this floor (see Figure B-5 in Appendix B) does not provide an explanation for this fire distribution, since there are no walls or rooms indicated in this area of the floor.

A region of flame is also evident on the 97th floor, starting near window 97-225 and going west. The full extent of this flaming region is not known, since fire and smoke from the 96th floor hides a portion of these windows. The flames visible on the 97th floor do not extend from windows and appear to be dying down.

There are no extensive flame regions evident on the 93rd or 94th floors. A review of videos recorded around this time indicates that the fires on these floors had indeed died down. Smoke is visible coming from below in Figure 8-40. This smoke is coming from the 92nd floor.

**Figure 8-40. A frame taken from a video shows a portion of the east face of WTC 1 at 9:19:48 a.m. The image has been enhanced, column and floor numbers added.**

There are some interesting variations in the column smoke markings in Figure 8–40. In particular, consider the 94th floor. Many of the column covers have distinct carets that are characteristic of locations next to windows that have experienced extended flames. Clear examples of carets can be seen on the covers for columns 94-226 to 94-230. On other column covers the smoke marks take the form of alternating horizontal bands of light and dark areas. The marks on the covers for columns 94-231 to 94-234 show good examples of this type. By comparing the markings with the local fire behavior, it has been possible to correlate the formation of this type of smoke mark with windows from which there had been a heavy smoke flow, but for which external flaming was not observed. In contrast to the mixed fire behavior seen on the 94th floor, carets are present on nearly all of the columns on the 96th floor visible in Figure 8–40.

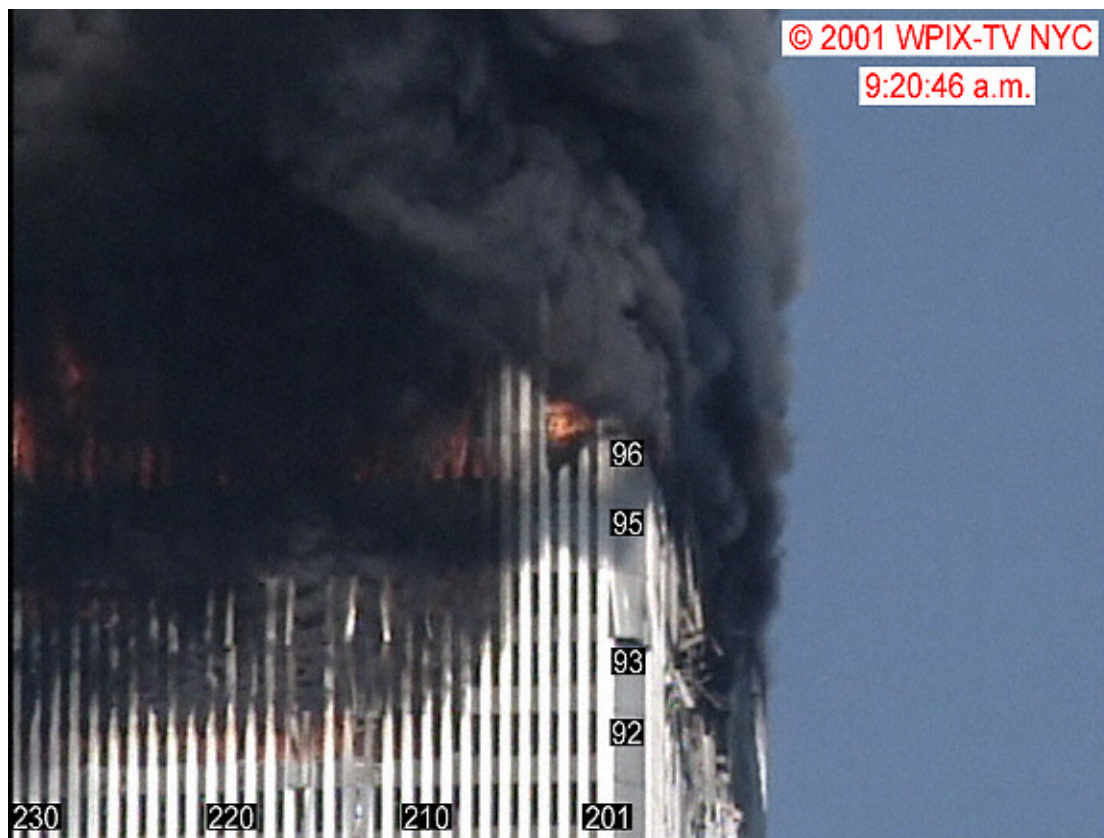
**Figure 8-41. A frame taken from a video shows a portion of the east face of WTC 1 at 9:20:46 a.m. The image has been enhanced. Column and floor numbers have been added.**

In Figure 8-41 heavy smoke is flowing from a number of windows on the 92nd floor, starting at window 92-208 and running to the last visible window, 92-230. A dull orange glow is evident in the vicinity of windows 92-214 to 92-218, but the remaining open windows appear to be dark. Shortly after Figure 8-41 was shot, the video zoomed out, revealing that internal fires were present inside the tower at least as far south as window 92-234, with open windows as far as window 92-237. Figure 8-22, which was taken at 9:15:54 a.m., showed internal fires in this same area. During the intervening period, the fire had moved north one window, having opened window 92-208. There is no obvious reason for the fire spread to slow down at this location, since the floor plan layout in Figure B-2 in Appendix B indicates there was not a wall at column 92-208. At 9:15:54 a.m. the fire had already moved as far south as window 92-234. During the next five minutes, three additional windows were opened. Fire spread in this direction also appears to have been retarded. The floor plan layout for this floor does indicate that there was a wall located at column 92-238, i.e., right next to open window 92-237. Detailed drawings for this floor show

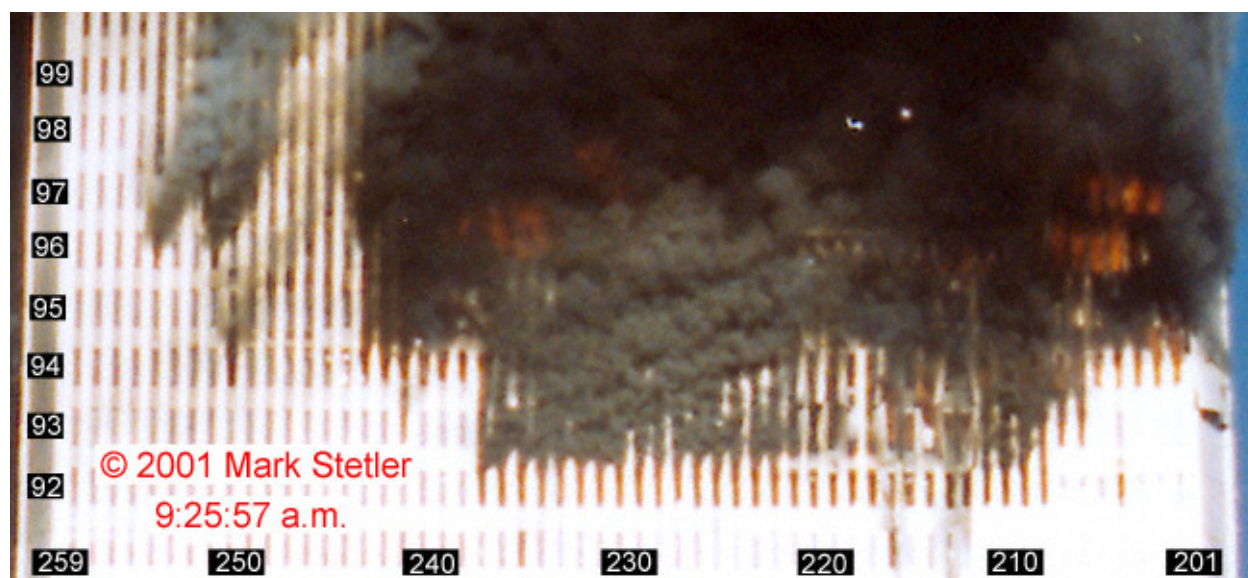
Figure 8-42 is a photograph of the east face taken at 9:25:57 a.m. The flames which had earlier spread into rooms located on the northeast corners of the 94th and 96th floors are still burning intensely. There is also now a large fire burning in the northeast corner room on the 97th floor. It has not been possible to identify exactly when this fire appeared because smoke and fire from the 96th floor hid its development from view. However, a video taken near 9:23:30 a.m. shows that flames were coming from window 97-203 at that time, so it must have appeared between 9:20:45 a.m., when fire was first visible in the area on the 96th floor, and this time.

**Figure 8-42. This cropped photograph shows the east face of WTC 1 at 9:25:57 a.m. The image has been rotated slightly and column and floor numbers have been added.**

Fire is evident at a couple of locations on the 93rd floor. It appears as if flames are present inside window 93-206, while adjacent windows to the north still have glass in place. Recall that window 93-206 was already open at 9:19:03 a.m. (see Figure 8-39) and that fire spread to the north had seemed to pause at this location prior to this. The observations continue to suggest the presence of a room in the northeast corner of this floor with a wall at column 93-206, even though the incomplete floor plan layout in Figure B-2 does not allow this to be confirmed.

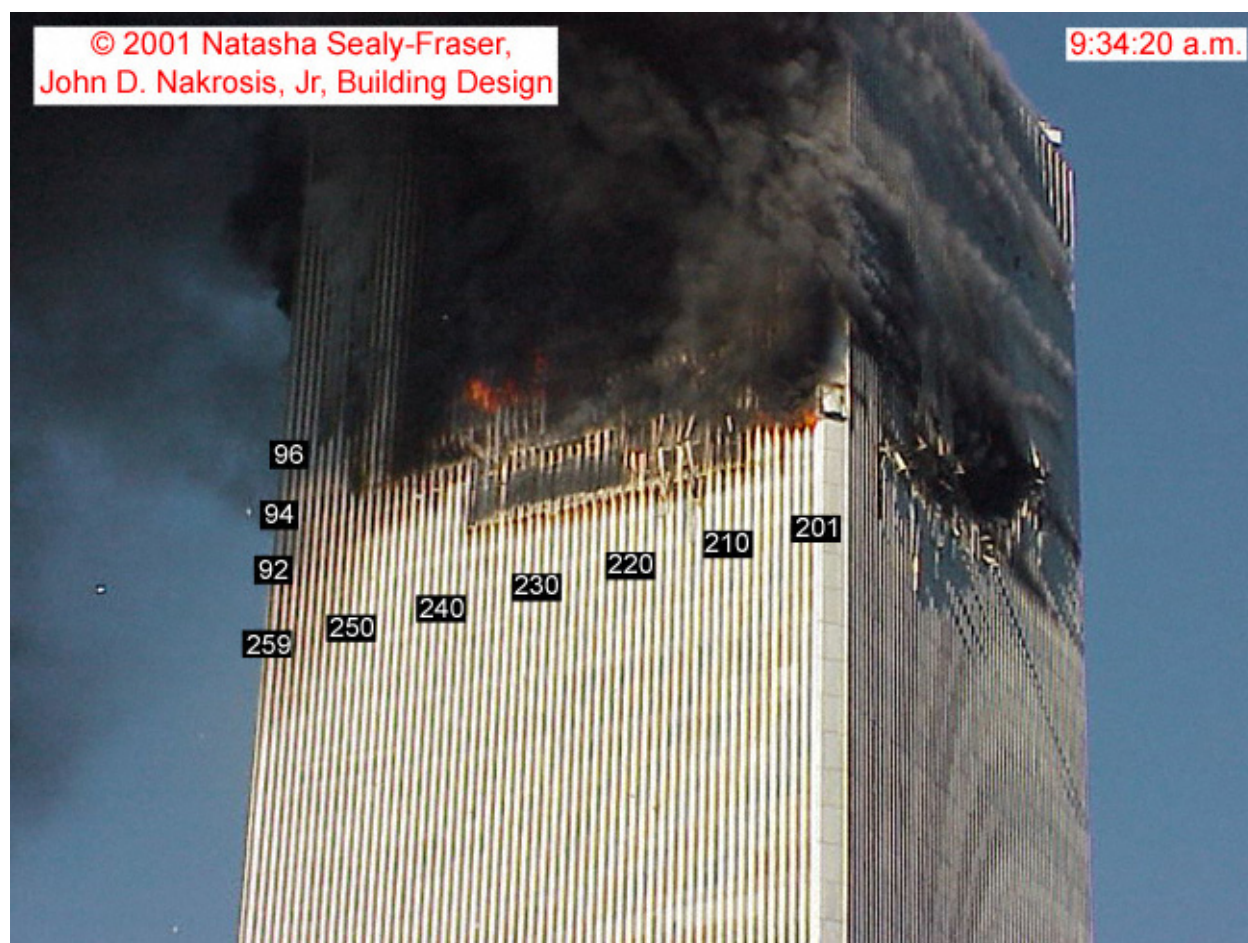
At 9:32:58 a.m., smoke emerged from the northeast corner of the 93rd floor at window 93-205. During the next 31 s, the successive windows toward the north opened, reaching window 93-201. At this time, 9:33:29 a.m., flames appeared in the area. Figure 8–43 shows a photograph of the east face recorded at 9:34:20 a.m. From this angle and distance, only flames extending from windows are apparent. Flames are coming out of windows 93-201 to 93-205. The sudden fire development and flame extension from windows is a strong indication that flashover has occurred within an enclosed space located around windows 93-201 to 93-205. The evidence for an enclosed space with walls that hindered fire spread into the northeast corner of the 93rd floor is quite strong even though the presence of such a room cannot be confirmed from the incomplete floor plan layout shown in Figure B-2.

Intense flaming was also taking place on the 96th floor near windows 96-236 and 96-237. Much more of the façade is now visible through the smoke than earlier. In particular, this is an indication that fires on the 92nd floor and 94th floor, which were generating large quantities of smoke at earlier times, have largely died down.

**Figure 8-43. Photograph of the east face of WTC 1 recorded at 9:34:20 a.m. Column and floor numbers have been added.**

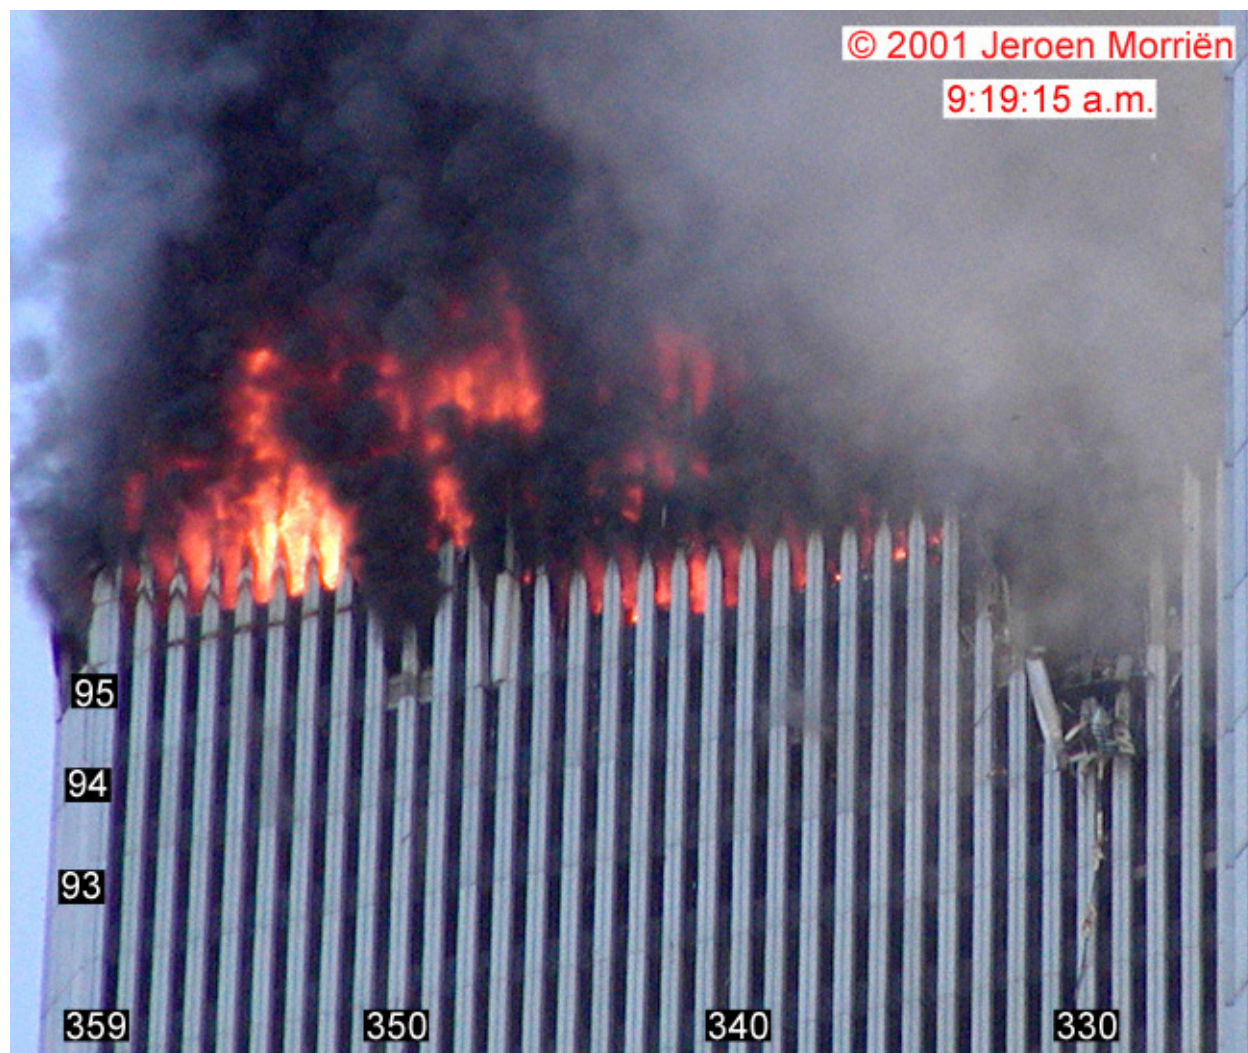
Figure 8-44 provides a view of the south face at 9:19:15 a.m. The general appearance of the fires is little changed from that in Figure 8-27, which was recorded near 9:16:40 a.m. The intense jets of flames coming from windows 96-352, 96-353, and 96-354 on the 96th floor remain a prominent feature. This image provides a particularly good view of the area on the 93rd floor, near column 330, where the steel panel section, which was found near the corner of Cedar and West Streets, is believed to have originated. Extensive damage is evident in the vicinity, but it is not possible to visually confirm that the section is actually missing. There is a long section of what appears to be a pipe hanging below the suspected opening that appears to be attached to a cylindrical object. Recall that a long section of pipe was seen in photographs of the detached panel section lying in the street (see Figure 6-16 and Figure 6-17). The presence of piping near the suspected origin for the panel section provides further support that the panel section actually did come from this spot.

**Figure 8-44. This cropped image shows a portion of the south face of WTC 1 at 9:19:15 a.m. The photograph has been enhanced and column and floor numbers have been added. The corner of WTC 2 is visible at the far right side of the image.**

A line of deposited soot is visible at the top of columns 95-351 to 95-357 at the western side of the 95th floor. These markings can be seen more clearly in Figure 8–44. No smoke is apparent coming from the windows, and it appears likely that the glass is still in place for these windows. The formation of these marks may be an indication that fire gases and smoke were leaking from the tower at locations where windows still had intact glass. Presumably, the leaks took place through the expansion joints located between column covers on different floors.

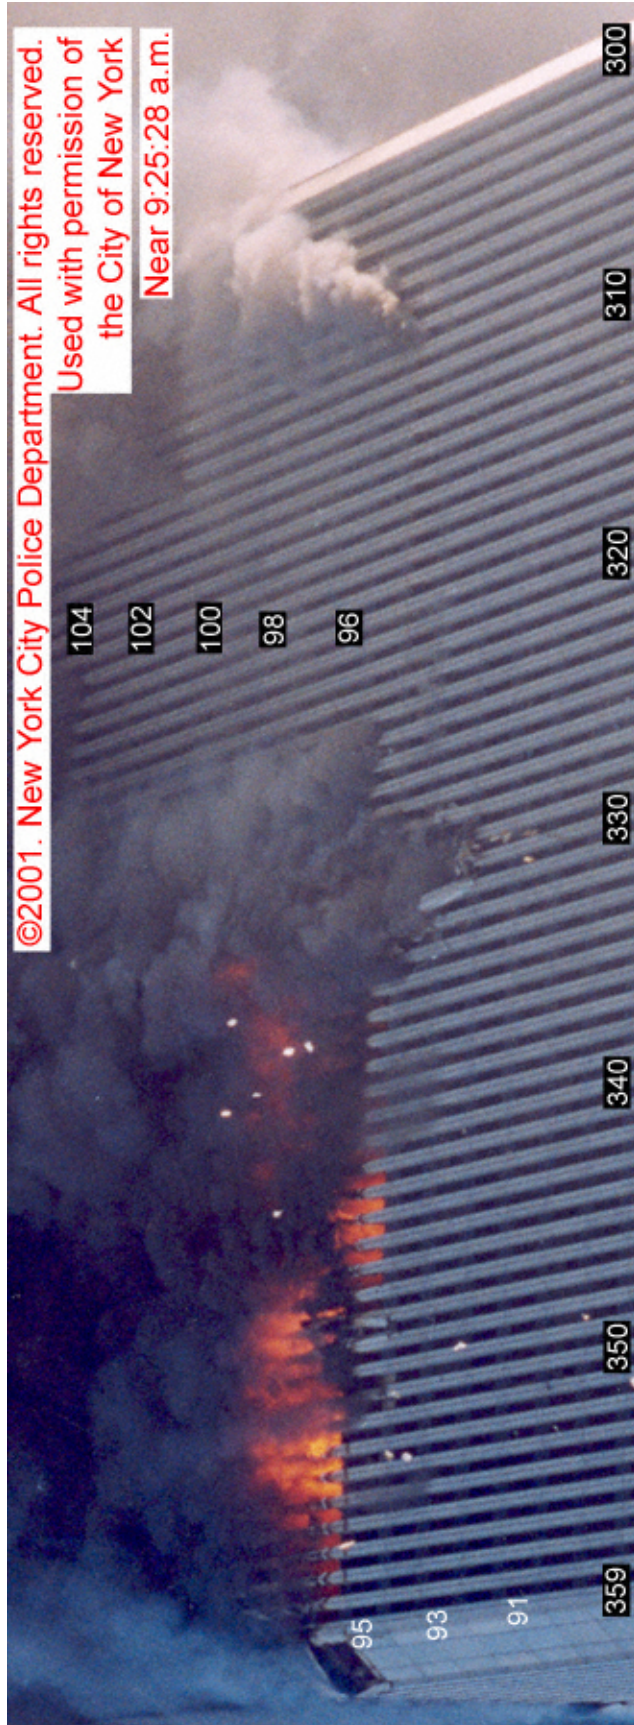
A later view of the burning area on the south face is shown in Figure 8-45, which was recorded around 9:25:28 a.m. There are a large number of pages of paper visible in the photograph. A video of the west face showed that these pages had traveled from the west face of the tower, where they had been released from an upper window. The fires present at this time remain quite intense and extensive, but there have been some changes since 9:19:15 a.m. The fires at the western edge of the 96th floor appear to be dying down and have receded back into the windows, while the strong jets of flame evident in Figure 8-44 on this floor are not as distinct. The fires on the 95th floor appear to have grown stronger. There is now flame extension from windows 95-340 to 95-343. The flames near the center of the face indicate that the fires on either the 96th floor or 97th floor, or both, extend continuously from the west edge of the south face to very near the center, i.e., column 330.

Figure 8-45. This cropped photograph shows the south face of WTC 1. It was taken around 9:25:28 a.m. with an assigned time uncertainty of 15 seconds. The original image has been enhanced and rotated. Column and floor number have been added. A number of pages of paper are present in the photograph.

Even though fires have been burning on the south face for well over a half hour, there is no indication in Figure 8–45 that the flames have begun to spread toward the east. With the exception of broken windows on floors well above the fire, the appearance of the east side of the façade has not changed since the aircraft impact.

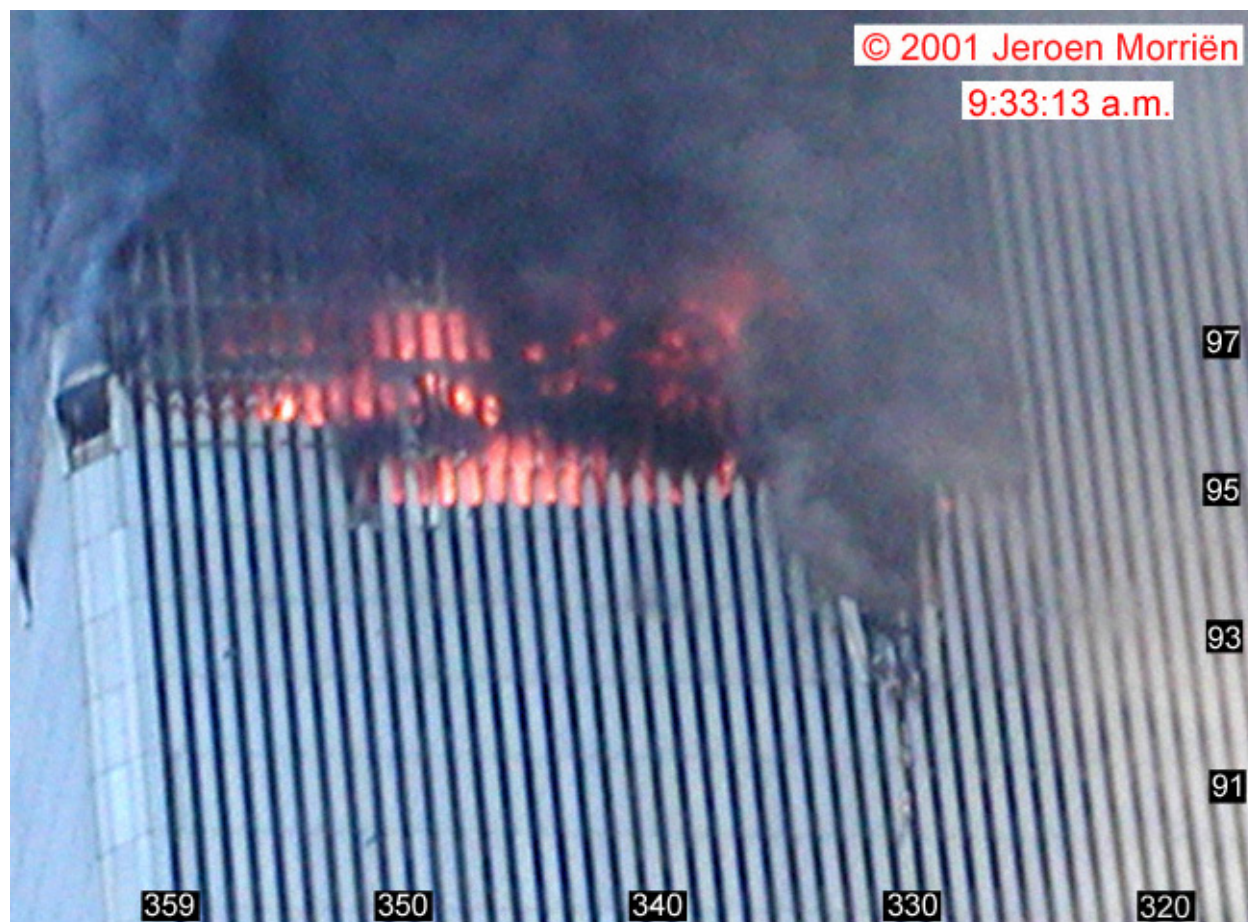
Figure 8–46 shows a view of the south face taken at 9:33:13 a.m. By this time, the intense fires on the 96th and 97th floors near the western edge of the face have diminished greatly, and flames are no longer prominent in the windows nearest the edge, while flames closer to the center have receded back into the windows. It is now possible to observe individual windows on the 96th, 97th, and 98th floors all the way from the western edge to windows 96-344, 97-344, and 98-344. Note that it appears as if these windows on the 98th floor are missing. It is not possible to conclude this definitely, since it is possible that smoke has been deposited on the windows, which would make them dark and thus appear to be missing. In either case, there are no obvious flames present in this area of the 98th floor.

**Figure 8-46.** This cropped image shows a portion of the south face of WTC 1 at 9:33:13 a.m. The photograph has been enhanced, and column and floor numbers have been added.

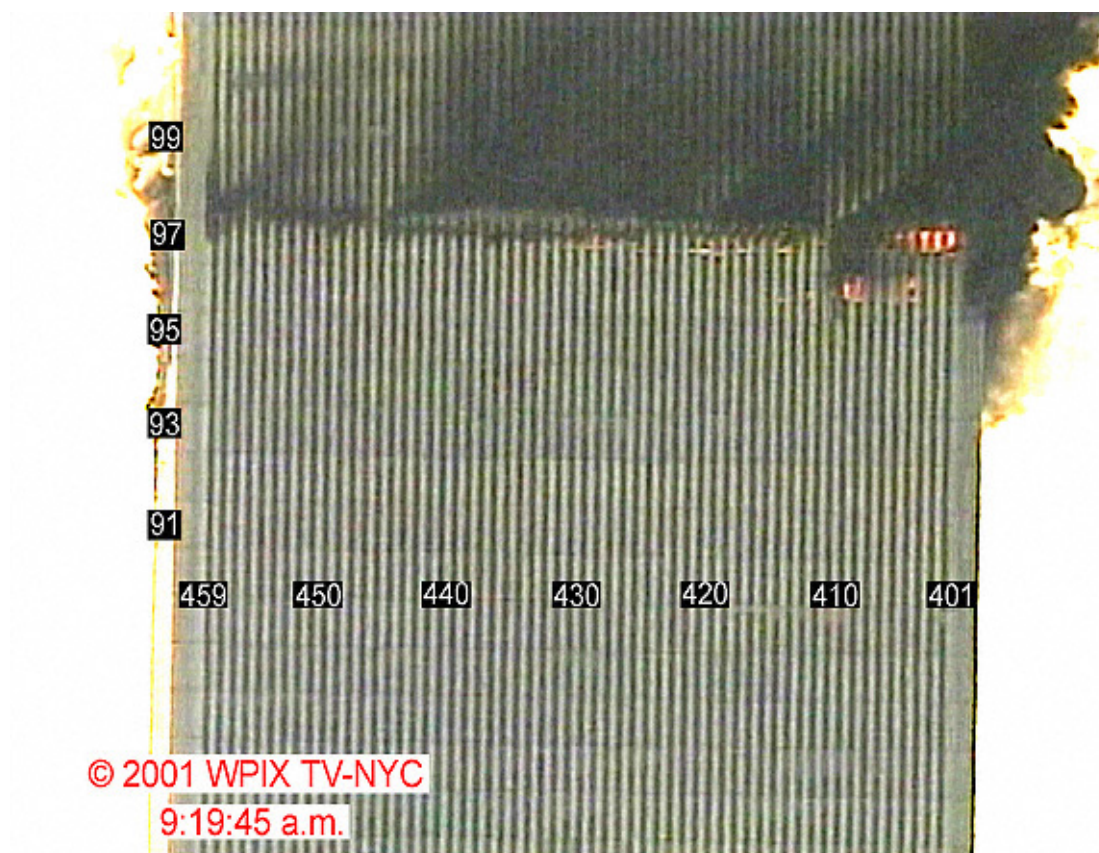
One such image taken from a video recorded at 9:19:45 a.m. is shown in Figure 8-47. The fire distribution is consistent with that observed from the ground at 9:14:46 a.m. in Figure 8-31. A flaming region is prominent at the south edge of the 97th floor over windows 97-401 to 97-405. While these flames appear to fill the windows, they do not seem to extend out of them. Further toward the north on the 97th floor, a number of relatively small fires are visible through the lowest portions of the window openings. Most of these flames are observed between the intensely burning corner and the center of the face. When viewing the video, it appears as if this gentle burning is relatively continuous across this length. The only location on the face where flames are apparent even further to the north is in window 97-455. Keeping in mind that the bases of the windows are raised 15 in. from the floor, it is clear that most of the intense fires that were burning earlier on the west side of the 97th floor have died down to a condition in which widely distributed flames are gently burning near the floor on the remaining fuel. A comparison of Figure 8-47 with Figure 8-30, which was recorded at 9:10:58 a.m., provides a good visual measure of how much the fire intensity on this floor has decreased over this nearly 9 min period.

The only other floor on which flames are apparent in Figure 8-47 is the 96th. A region of fire, which fills the window openings, runs from window 96-404 to perhaps window 96-410. The flames in windows 96-408 and 96-409 extend from these windows. As discussed above, fire was present in the

same general location around 9:11 a.m. (see Figure 8–30). Two regions of small flames around windows 96-412 and 96-414 are visible just to the north of the flaming area. Even though these flames are similar in appearance to the dying flames just above on the 97th floor, there is a major difference. Based on the visual evidence, there has not yet been an intense burning phase in this region of the 96th floor. The absence of smoke marks on the nearby aluminum cladding is consistent with this conclusion.

**Figure 8-47.** This image of the west face of WTC 1 is a frame captured from a video recorded by a news helicopter at 9:19:45 a.m. The image has been enhanced by adjusting the intensity range, and areas to the left and right of the tower are saturated. Column and floor numbers have been added.

It is interesting to compare Figure 8–47 with the view of the south face shown in Figure 8–44. These images were taken approximately 30 s apart. While there are intense flames issuing from numerous windows on the 95th, 96th, and 97th floors on the west side of the south face, from the west flames are only observed near the south corners of the 96th and 97th floors, and they do not appear to be nearly as intense. These observations indicate that either the flames on the south face are isolated near the outer wall or that interior portions of these floors are actually hidden from view by obscuring smoke or walls. There is no indication of fire on the 95th floor from the west. Figure B-4 in Appendix B shows that there were a group of rooms in the southwest corner of this floor with a wall extending to column 95-350. The walls associated with these rooms may still be in place, protecting the west side of the floor from the fire raging on the south face. One piece of visual evidence argues against this conclusion. In Figure 8–44, smoke is observed coming from windows 95-349 and 95-350 on the south face, and there is evidence of façade damage below both of these windows. This suggests that both windows were removed during the

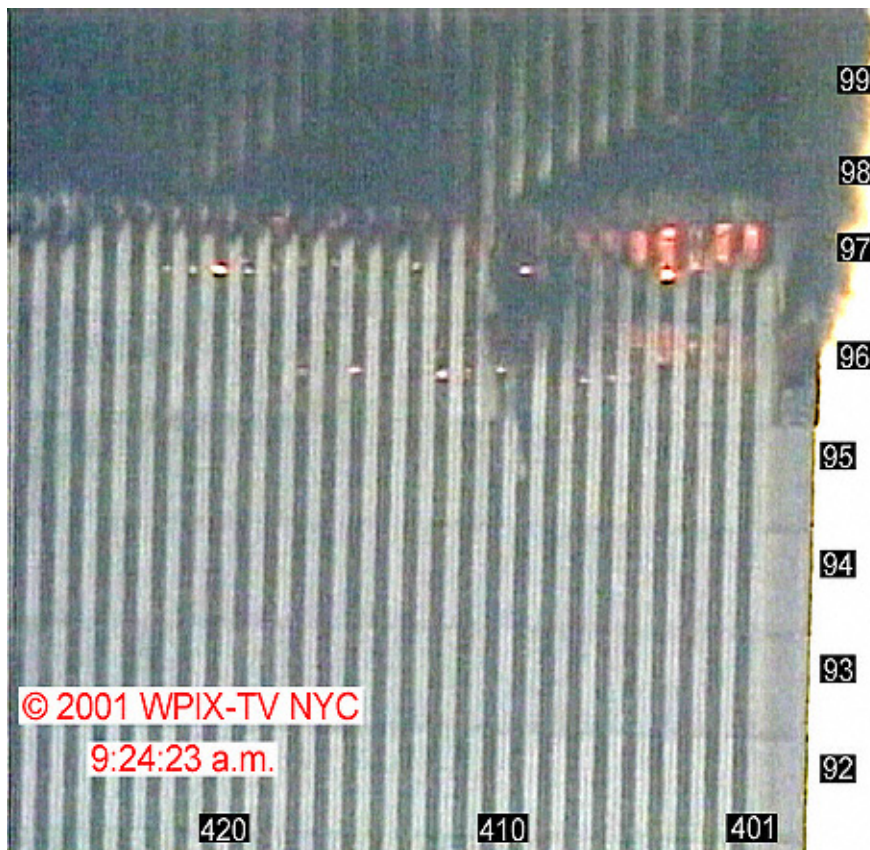
Figure 8–48 shows a closer view of the south side of the west face captured from a news helicopter video recording at 9:24:23 a.m. The general appearance is very similar to that of Figure 8–47. The relatively intense fires burning at the south edges of the 96th and 97th floors are still present. A number of small, apparently isolated, fires can be seen on both of these floors. On the 96th floor there are now indications of fires as far north as window 96-417. This is slightly farther than observed at 9:19:45 a.m. and suggests that these low-level fires are slowly moving toward the north along the outer west wall of the 96th floor. The image has sufficient resolution to just identify, albeit with some uncertainty, whether window glass is still in place. It appears that the glass is missing from those windows where the small fires are visible and is intact in windows at the intervening locations.

**Figure 8-48.** This image of a portion of the west face of WTC 1 is a frame captured from a video recorded by a news helicopter at 9:24:23 a.m. The image has been enhanced by adjusting the intensity range, and the area to the right of the tower is saturated. Column and floor numbers have been added.

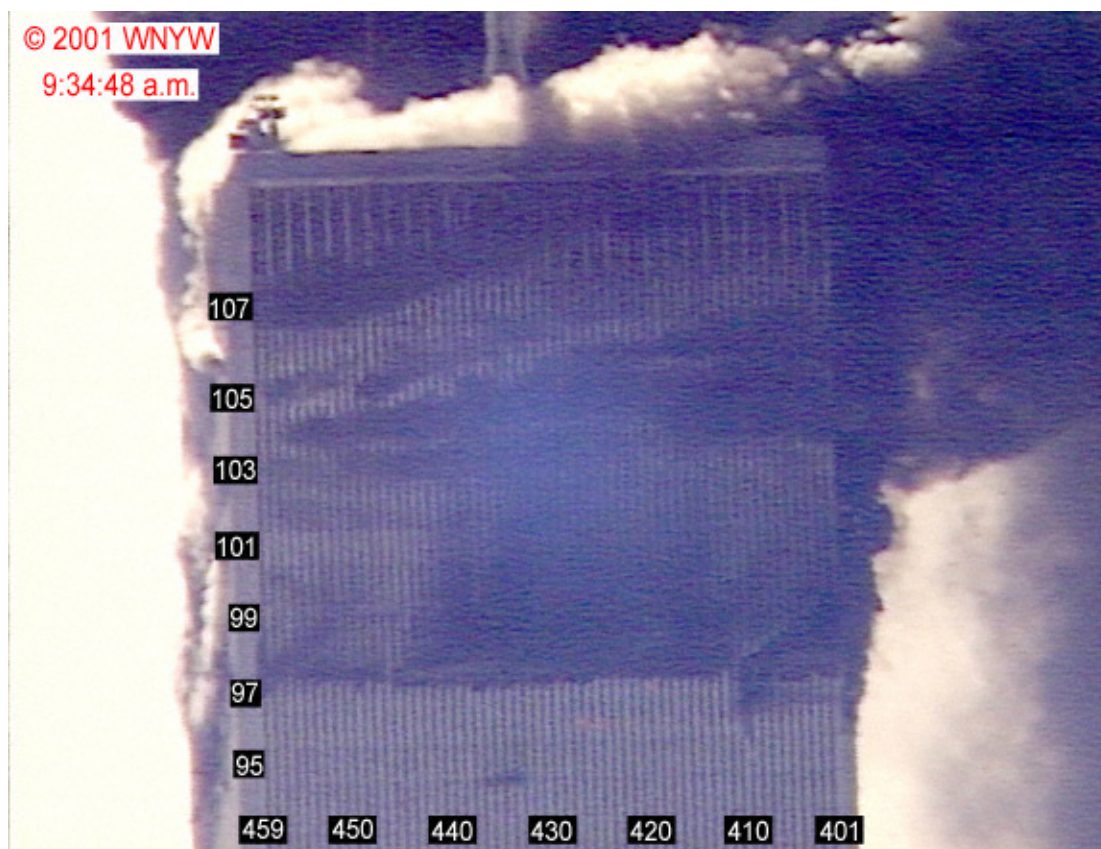
Figure 8–49 shows another view of the west face of WTC 1 taken from a video that was recorded from a helicopter at 9:34:48 a.m. The fires on the south ends of the 96th and 97th floors are no longer as prominent as they were earlier. In fact, at this distance and clarity it is difficult to identify fires in these locations. There is evidence of low-intensity fires further to the north on both the 96th and 97th floors. The most visible flames on the 96th floor are in windows 96-224 to 96-226. This area is north of where flames were observed earlier, indicating that the fires are continuing to spread slowly toward the north.

**Figure 8-49.** This image of the west face of WTC 1 is a frame captured from a video recorded by a news helicopter at 9:34:48 a.m. The image has been enhanced by adjusting the intensity range, and some areas to the left and right of the tower are saturated. Column and floor numbers have been added.

Even at the distance from which Figure 8-49 was taken, a black mark is visible running across the tops of windows 94-433 to 94-436 on the 94th floor. These marks are not evident in Figure 8-47, which was taken at 9:19:45 a.m. This suggests that smoke began to flow from these windows at some point between these two times. A review of video recordings shows that visible smoke was apparent coming from these windows starting around 9:26 a.m. As discussed earlier, windows had been opened in this general area as early as 9:04 a.m. Recall also that several windows are open just to the north on the 95th floor. There is still no indication of smoke coming from these windows.

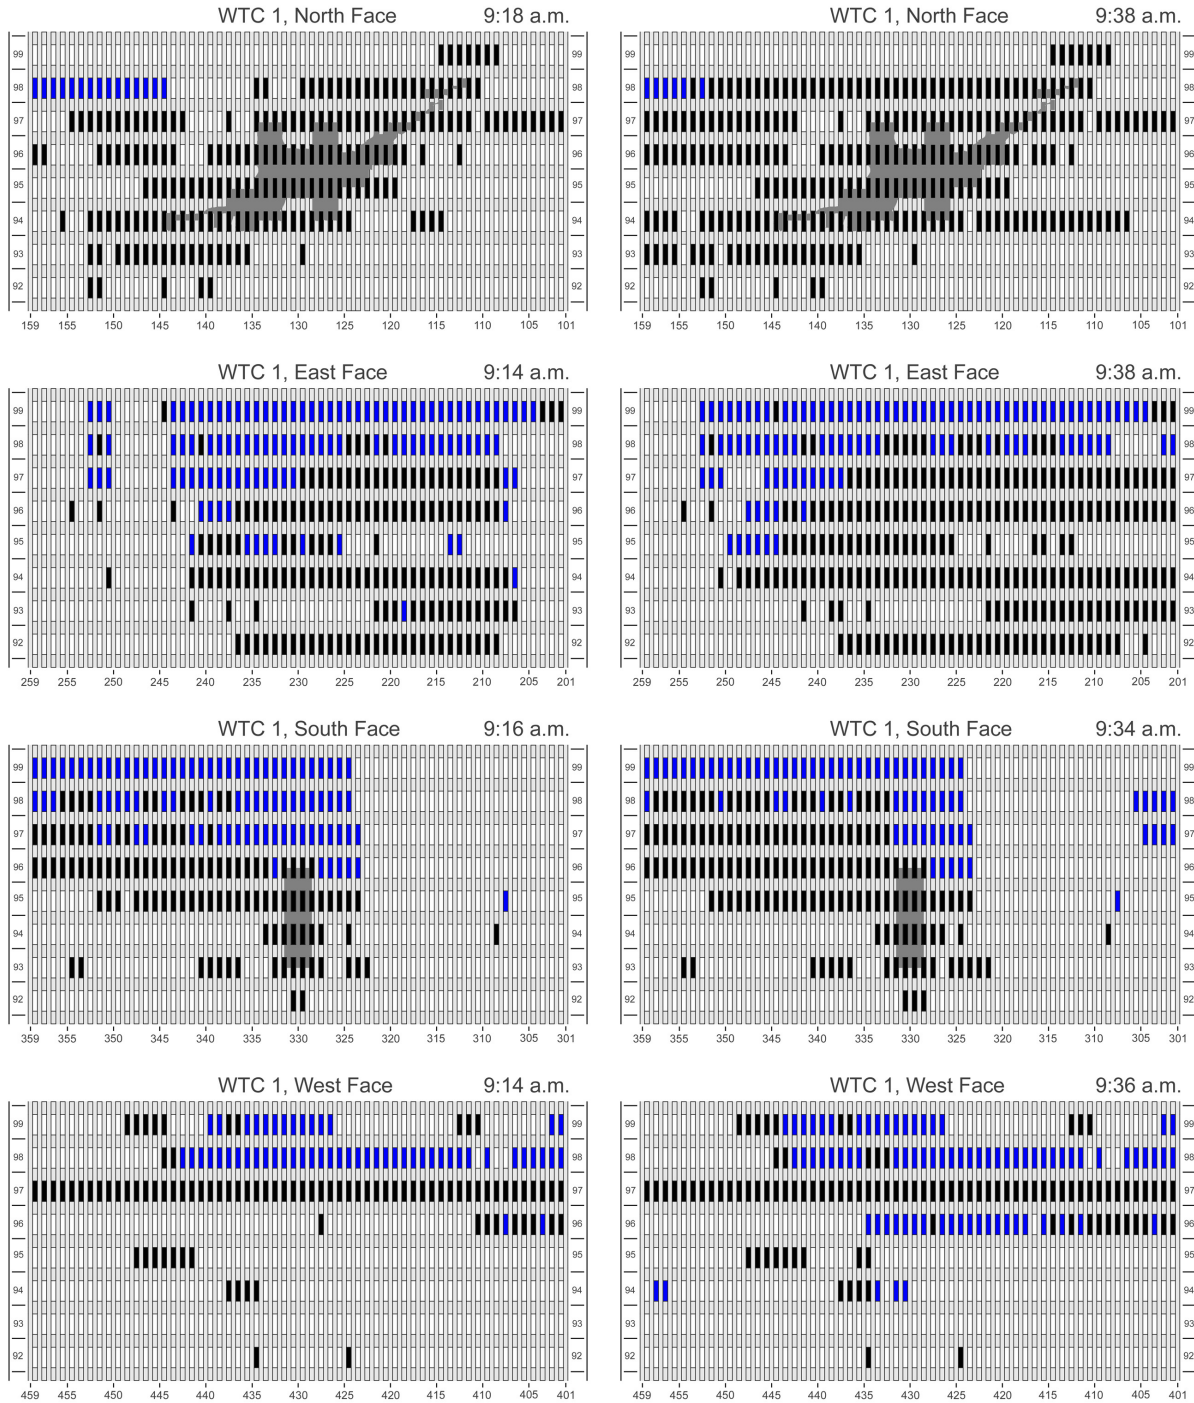
Figure 8-50 compares maps for open windows on the four faces of WTC 1 for times near the start and end of the current time period. These maps capture the general trends that emerge from the detailed discussion of fire behavior during the period. In particular, on the north face fires on the 93rd, 94th, 96th, and 97th floors breeched walls and entered northeast corner rooms, and the contents inside began burning. A new region of fire grew along the north face on the 94th floor to the west side of the aircraft impact

**Figure 8-50. Maps for the 92nd through the 99th floors compare missing window glass for the four faces of WTC 1 at two times, around 9:18 a.m. and roughly 17 minutes later. The color coding used for the maps is indicated in Figure 5-1.**

cavity. The changes in window conditions on the east face reveal that the fires that entered rooms at the northeast corners of the 93rd, 94th, 96th, and 97th floors also removed windows on the east faces of the rooms. It is also clear that fires that were originally present near the center of the face on the 94th, 95th, 96th, and 97th floors had begun to slowly spread toward the south. On the south face there was very little fire spread during the period. The same is true for the west face, but there are indications that fires on the 96th floor had begun to spread from the southwest corner back toward the north face.

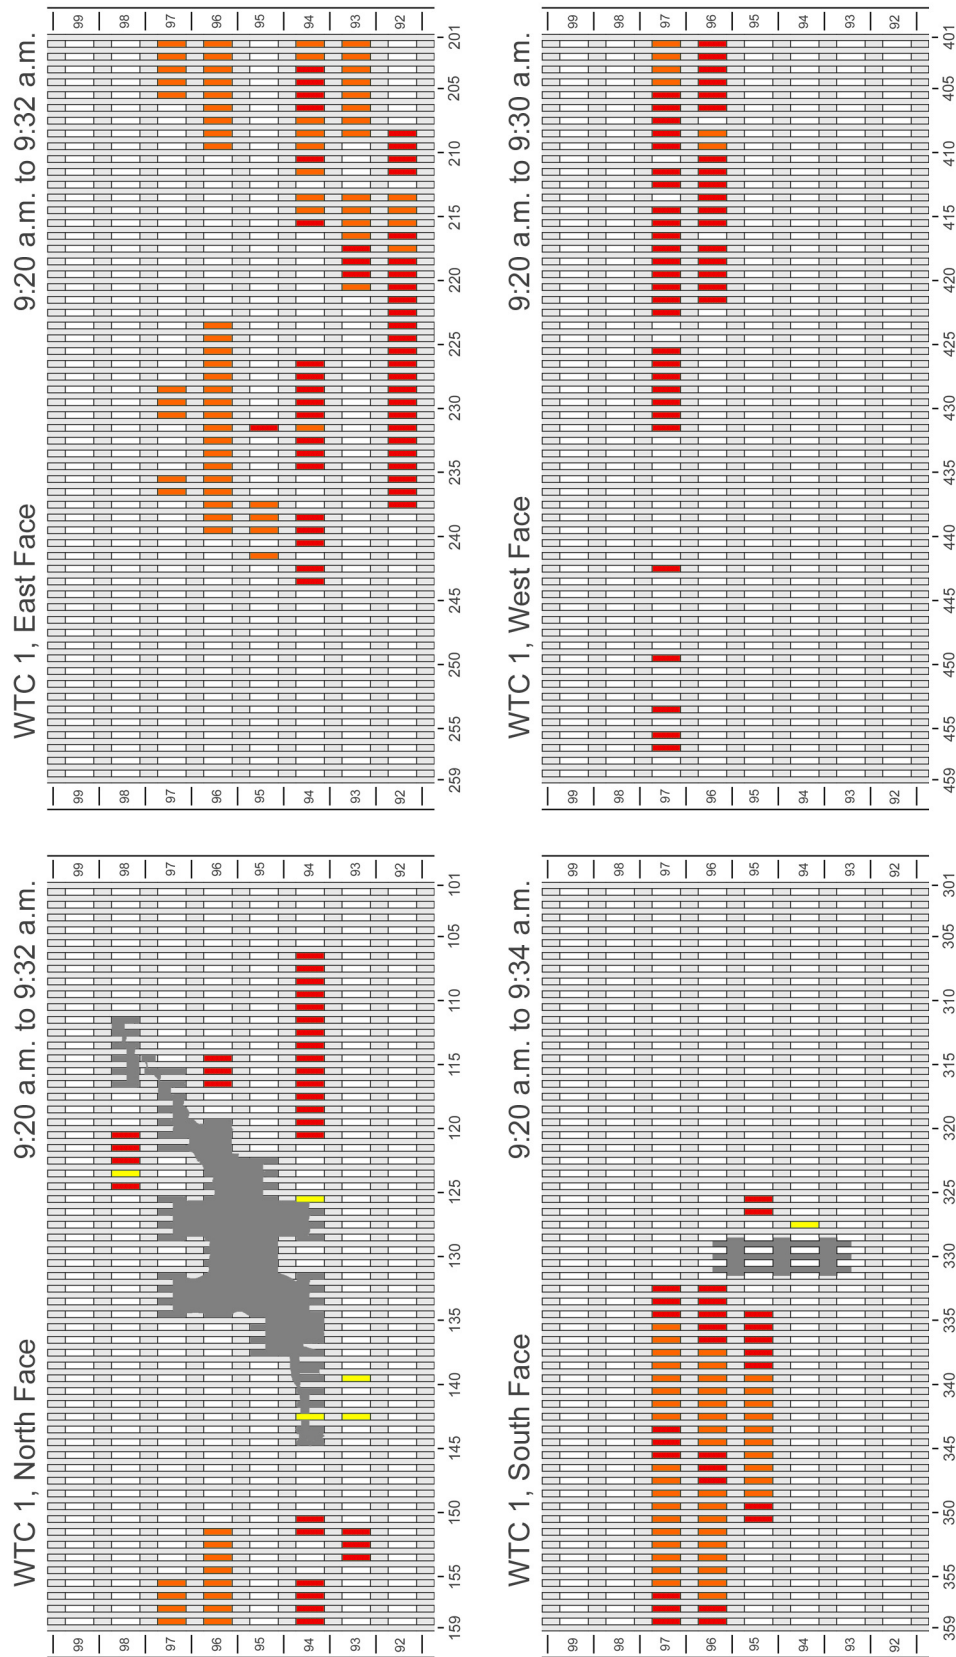
The effects of the life cycle of the fires are also apparent in comparisons of the integrated fire maps prepared for the different time periods. Figure 8–51 shows integrated fire maps on the four faces for the current period from 9:18 a.m. to 9:35 a.m. These maps can be compared with the maps for the two earlier periods shown in Figure 8–33 and Figure 8–14. Such a comparison indicates that there are many windows where fire was observed during the earlier periods where it is no longer visible. These include windows near the aircraft impact area on several floors of the north face, windows on multiple floors around the center of the east face, and many windows on the 97th floor on the west face.

On the north and east faces the windows with observed fire appear to surround areas near the centers of the faces where the fires had already died or were dying down. This suggests that fire spread along the north and east peripheries of these floors has occurred primarily by horizontal fire movement in both directions away from regions initially ignited near the centers of the faces. The fire distribution on the south face indicates that fire spread and growth had occurred differently than on the north and east, with large fires growing and spreading nearly simultaneously on multiple floors at the western side of the face. The integrated fire distribution on the west face reflects both the very rapid fire spread that was observed earlier across the 97th floor and the much slower fire spread from west to east that was observed on the 96th floor.

**Figure 8-51. Maps of integrated fire observations between 9:19 a.m. and 9:35 a.m. are shown for the four faces of WTC 1. Colors represent the highest intensity fire observed in a window using the color scale defined in Figure 5-1.**

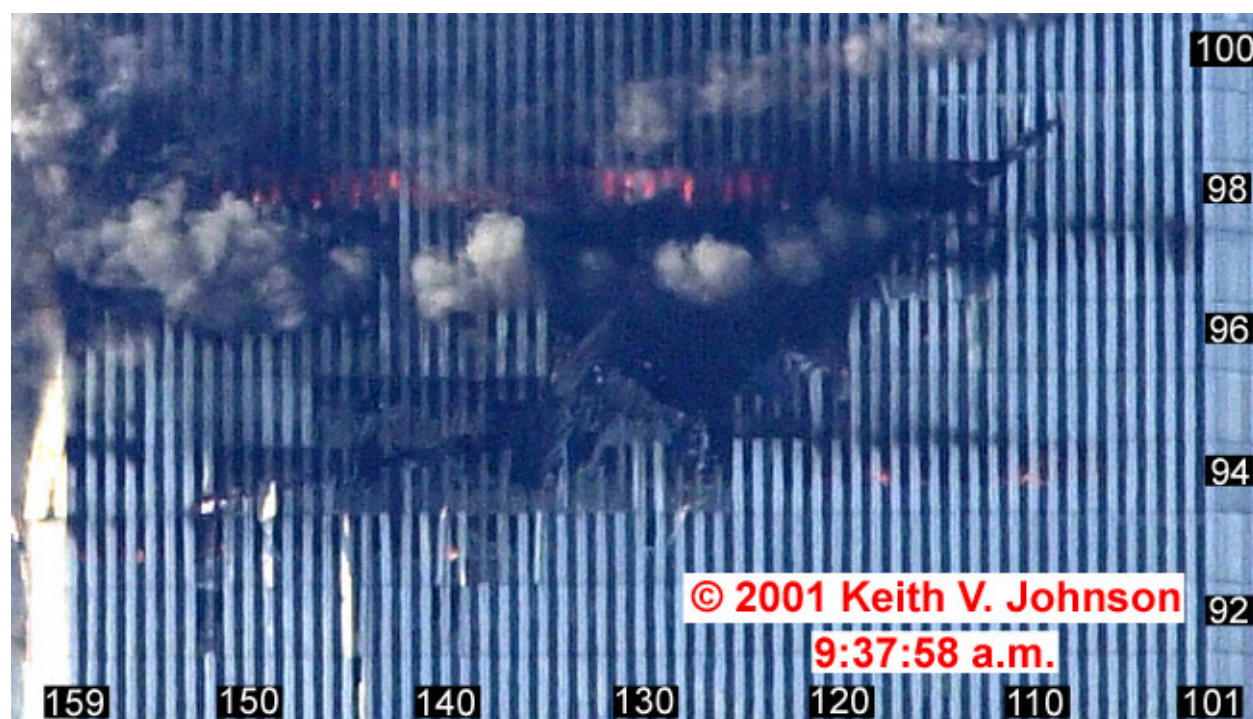
A portion of a photograph showing the fire floors on the north face of WTC 1 at 9:37:58 a.m. is reproduced as Figure 8–52. This photograph was taken just over two minutes later than the image shown in Figure 8–38. The fire on the 98th floor has spread over a wider area and has grown in intensity during this time. Fires are observed (not continuously) from window 98-122 to window 98-150. Even though the flames extend over roughly half the length of the floor, and in some locations appear to fill the volume behind the windows, there is very little smoke and flame evident coming from the 98th floor windows. This is likely another case where the fire gases are exhausting elsewhere than through nearby windows.

**Figure 8-52. This enhanced and cropped photograph shows the north face of WTC 1 at 9:37:58 a.m. Column and floor numbers have been added.**

On the 93rd floor there are two isolated regions of flame visible. One of these is at window 93-139 and the second is at windows 93-151 and 93-152. Many of the windows on this floor are open. The only fire evident on the 94th floor is a small spot fire in the cavity created by the aircraft. The fire on the northeast corner, which developed rapidly around 9:25 a.m. (see Figure 8-36) and filled windows 94-155 to 94-158 with flames, has already died down to a level where it not visible from this vantage point. The image provides sufficient detail to determine that the glass for windows 94-153 and 94-155 is still in place. This is an example where the apparent flame movement does not align with the wall placement indicated by the floor plan layout. The layout in Figure B-3 indicates that the wall for the room in this corner terminated at column 94-154. It is surprising that window 94-154 is not broken. No flames are visible on the 95th to 97th floors.

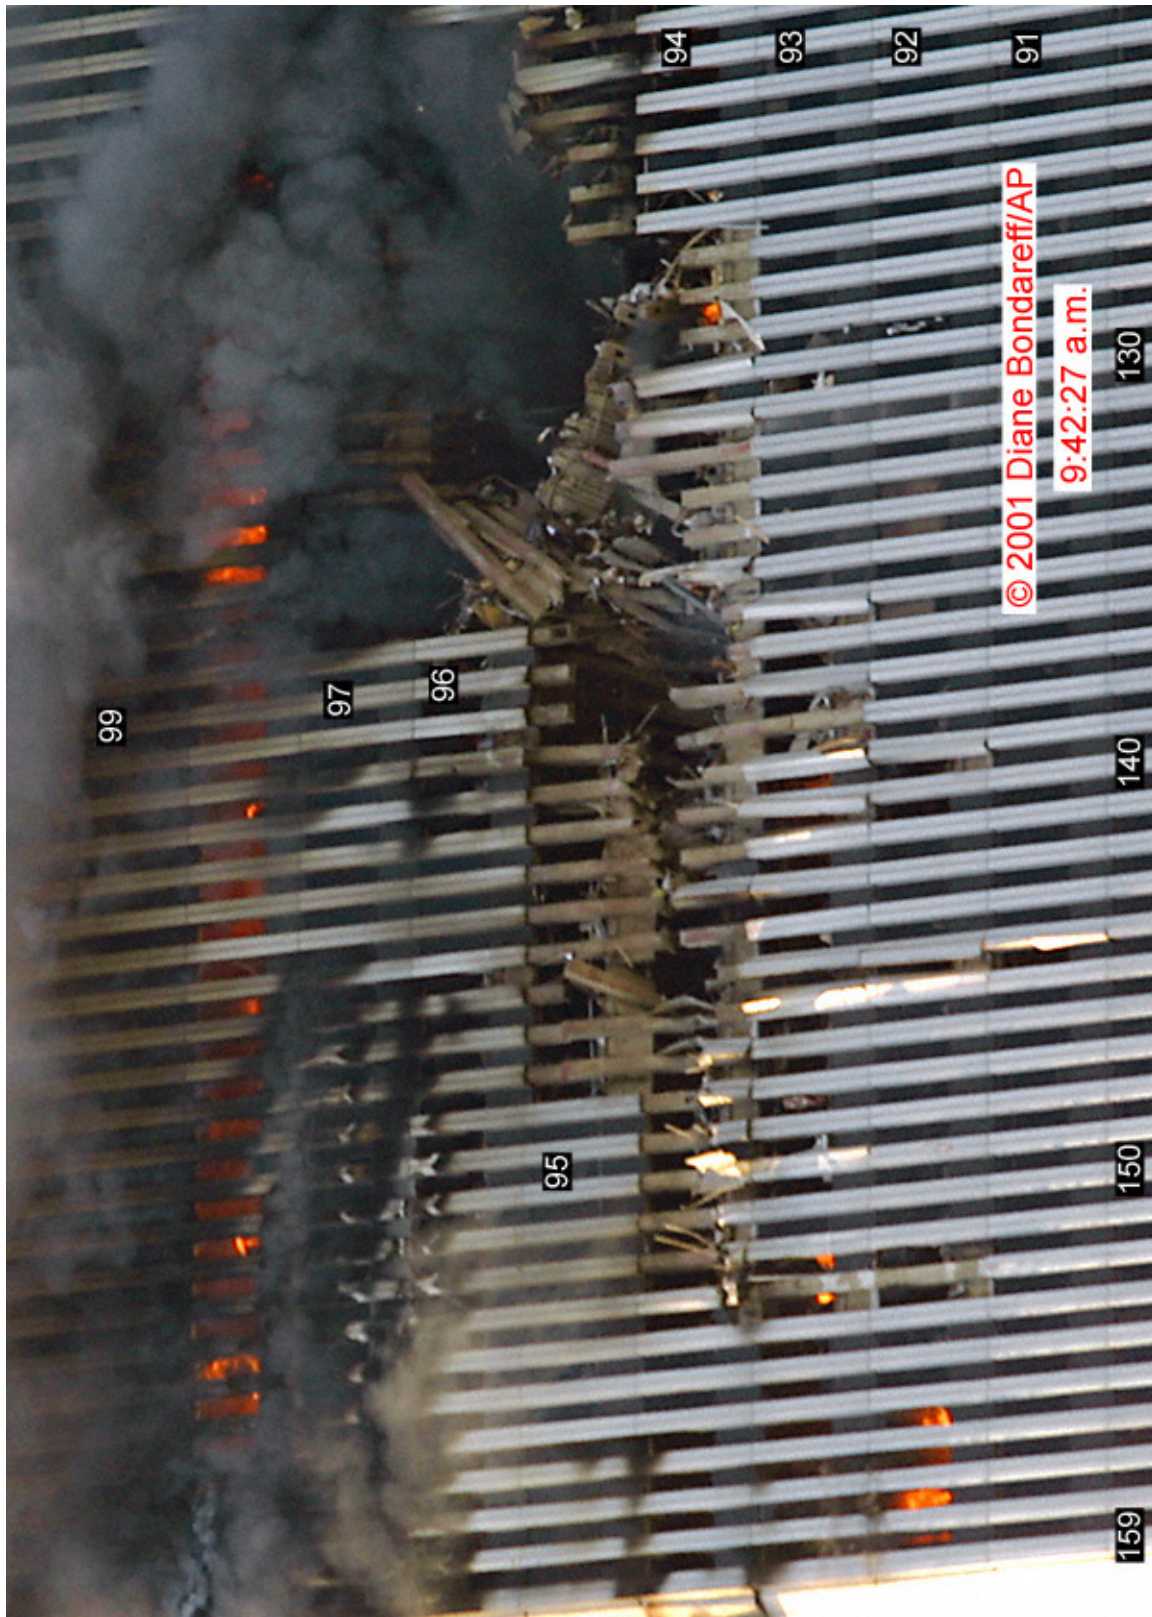
Figure 8-53 provides a clear view of the fires on the 98th floor, which extend from beyond the center of the floor on the west side to at least window 98-154 on the east. Even though the flames appear to be continuous, close inspection shows that in many windows there is simply an orange glow, suggesting that the fires are burning away from the windows at interior locations. The number of windows where flames are directly visible is limited. The only areas where flames appear to fill the windows are near the center of the face and around window 98-153.

Figure 8-53. This sharp photograph shows the eastern portion of the north face of WTC 1 at 9:42:27 a.m. The original version has been cropped and enhanced. Column and floor numbers have been added.

The fires on the north side of the 98th floor do not appear to be as intense as those observed at many other locations on the tower faces. Even so, they were large enough to break out the glass in multiple windows. Windows that were closed prior to the fire are now open. A review of the streamer observations summarized in Appendix L shows that numerous streamers were observed on the north face coming from the 98th floor during the early part of this time period when the fires were growing. Their source locations were spread out across the floor. This provides additional evidence that the streamers formed in regions where fires were breaking window glass.
