**NIST NCSTAR 1-5A**

**Federal Building and Fire Safety Investigation of the  
World Trade Center Disaster**

**Visual Evidence, Damage Estimates,  
and Timeline Analysis**

September 2005

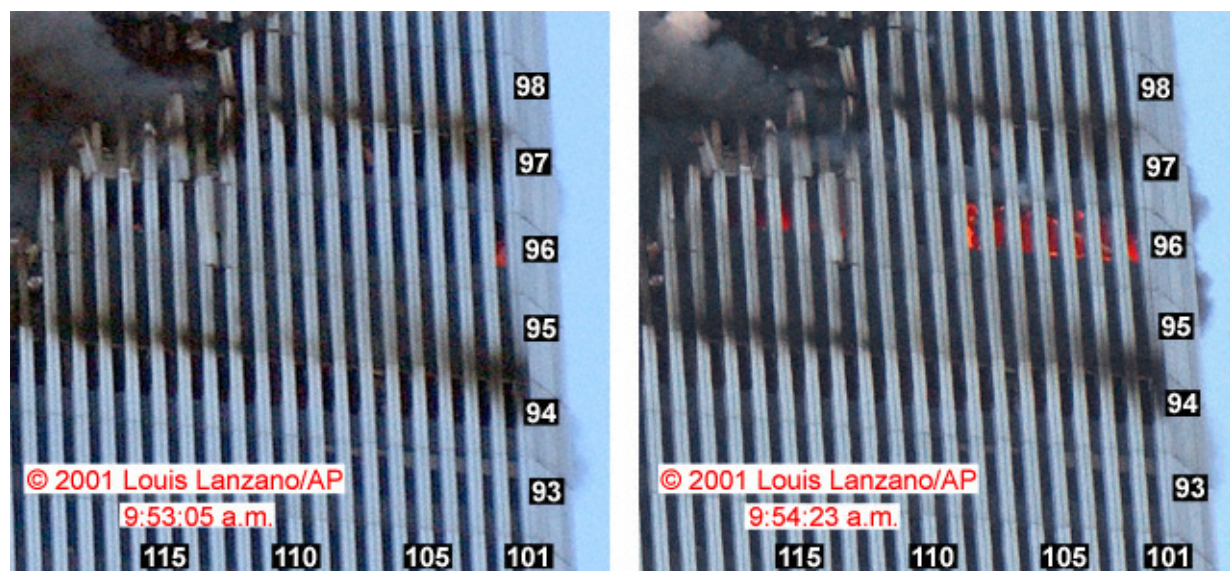
Figure 8-54 includes a photograph of this area taken at 9:53:05 a.m. Windows 94-101 to 94-105 are clearly open. The fires in the corner room have already died down to the point where they are no longer visible from this vantage point. All of the windows on the 94th floor within the view of the image are missing. At the same time, windows on the 92nd, 93rd and 95th floors and windows 98-101 to 98-108 on the 98th floor still have glass panes in place.

**Figure 8-54. Two photographs of the west side of the north face of WTC1 taken at 9:53:05 a.m. and 9:54:23 a.m. are compared. The original photographs were cropped and enhanced. Column and floor numbers have been added.**

In the photograph taken at 9:53:05 a.m., a small fire can be seen at the western edge of the 96th floor in window 96-101, while the glass for windows 96-102 to 96-110 is still in place. Videos show that there was a flash of light at window 96-101 at 9:53:00 a.m., which was likely associated with this window opening. At 9:53:20 a.m. the fire in window 96-101 grew visibly larger. During the following 13 s, fire appeared, moving from west to east over windows 96-102 to 96-107. This fire is evident in the second photograph included in Figure 8-54, which was taken at 9:54:23 a.m. The adjacent window, 96-108, was still in place at this time. According to the floor plan layout shown in Figure B-5, one of the walls for the room at this corner was located at column 96-108.

Even though the glass panes for windows 96-108 to 96-111 are still in place, a fire is visible growing rapidly further to the west in windows 96-112 to 96-115. The fire seen in window 96-113 is one of the few examples where flames are observed through a closed window. As discussed below, a significant fire was observed on the west face near the northwest corner prior to the rapid fire growth in the northwest corner room. This suggests that the fire broke into this corner room through the south wall located at column 96-456 (see Figure B-5). Note that there were two adjacent rooms attached to the south side of this wall. Fire movement from the south is also the likely source for the fire seen in windows 96-112 to 96-115.

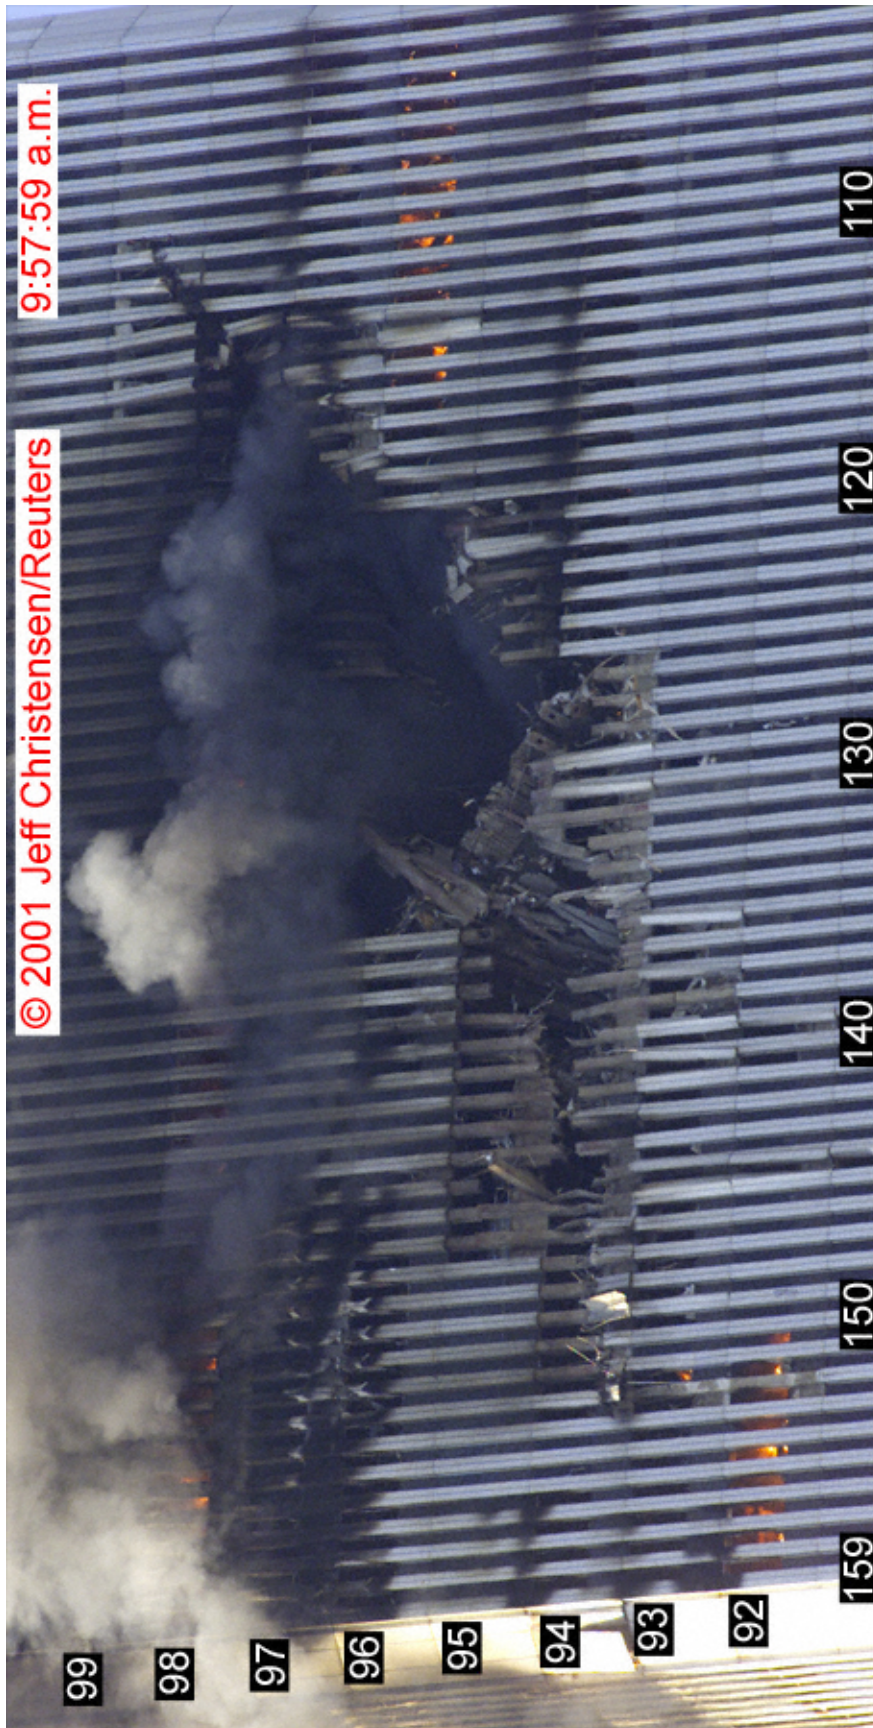
A photograph of the north face of WTC 1 taken at 9:57:59 a.m., i.e., one minute prior to the collapse of WTC 2, is shown in Figure 8-55. Several changes have taken place since the photographs in Figure 8-53 and Figure 8-54 were taken. The fires on the 98th floor have died down considerably, with fire primarily evident on the east side of the north face. The fires on the 92nd and 96th floors have also spread a little further. On the 96th floor, windows 96-108 to 96-111 are now open, and flames are visible in these windows. On the 92nd floor, the panes for windows 92-153 and 92-154 are missing, and flames are visible through these windows, as well as windows 92-151 and 92-152. Recall that walls for rooms in this area were located at columns 92-152 and 92-155 (see Figure B-1). This photograph has sufficient resolution to identify details inside the windows. It appears as if both of these walls are still present.

Figure 8-55. This image shows the north face of WTC 1 at 9:57:59 a.m. The original has been rotated, cropped, and enhanced. Column and floor numbers have been added.

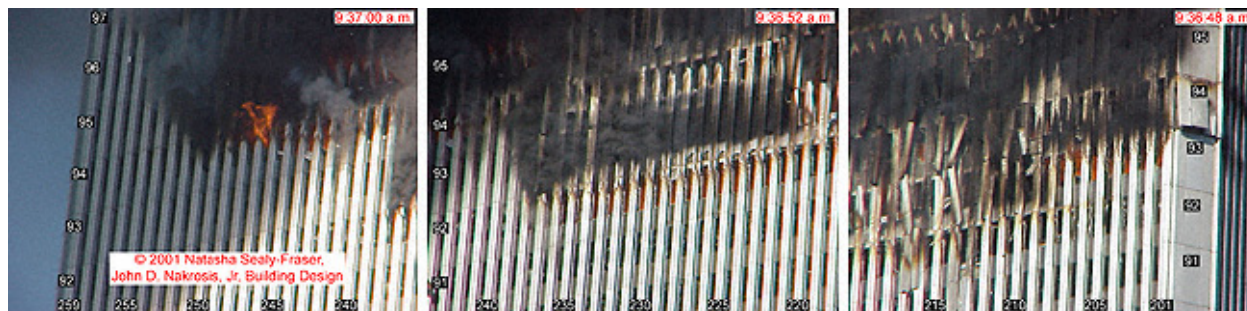
A number of close-up photographs and videos that provide views of the east face are available during the current time period. Figure 8-56 shows a series of three photographs that were taken around 9:37 a.m. They show the lower floors where fires have been burning. Note that the fires that are present on the 96th and 97th floors are not visible. In the right-most photograph fire is visible near the northeast corner of the

**Figure 8-56. This series of three photographs shows various locations along the east face of WTC 1 around 9:37 a.m. Column and floor numbers have been added.**

92nd floor in windows 92-201 to 92-207. Flames first appeared in this area around 9:33 a.m., and at 9:34:20 a.m. flames were coming from these windows. These flames had already begun to die down two and a half minutes later. The smoke markings on the adjacent column covers are interesting. They are a combination of carets and horizontal bands. There is also a smoke band above these windows. These markings suggest that while flames did extend from the windows, they were not intense enough or sustained for a long enough time to create well-defined carets. Well-defined carets are present just above on the 94th floor, as well as on numerous column covers on the 96th floor.

The same photograph provides an indication of the degree to which the flames that were present earlier on the 94th and 96th floors have died down. Only a couple of isolated fires are observed on the 94th floor, and no flames are obvious in windows 96-201 to 96-220.

In the center photograph of Figure 8–56, the fires that were present earlier on the 93rd, 94th, and 95th floors near the center of the east face have also died down and are no longer evident. There is still considerable evidence of interior fires on the 92nd floor, but the flames still do not seem to have progressed beyond window 92-237. As discussed earlier, flames were observed at window 92-237 at 9:21:01 a.m. The fires on the 92nd floor have caused some interesting effects on the surrounding façade. The variations in the types of smoke marks on the column covers adjacent to the windows have already been mentioned. Inspection shows that in the area immediately above windows 92-223 to 92-228, the aluminum spandrel covers have partially disappeared. The shapes of the missing areas indicate that they mostly likely melted due to heating from the hot fire gases flowing from below. In fact, spots of what appear to be solidified drops of aluminum can be seen on windows below this floor. Based on the melting temperature of aluminum, the fire gases leaving these windows must have been well in excess of 600 °C. Even though these gases were quite hot, they have not broken out the glass in the windows immediately above on the 93rd floor, which are heavily coated with soot, but remain in place.

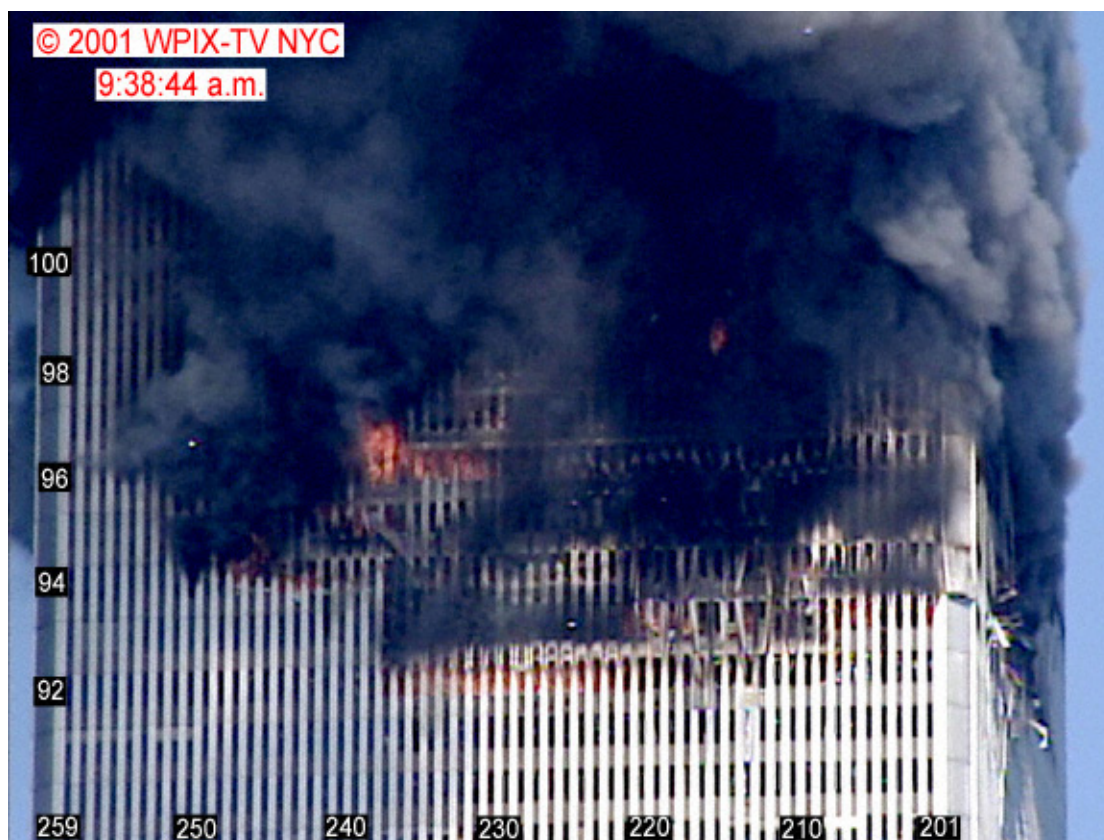
Figure 8–57 is a frame from a video of the east face taken at 9:38:44 a.m., which shows all of the floors with fires. This photograph was taken more directly from the east than Figure 8–56 and, therefore, provides a better indication of fire locations. Starting at the lower part of the figure, the fire on the

92nd floor is visible over a length from near window 92-223 to window 92-238. Despite the extent of the flames, visible smoke is only coming from near window 92-237. On the 93rd floor, flames are evident at the northeast corner and also in a region running from approximately window 93-213 to window 93-221. Flames are coming from the several windows on the 94th floor, centered near window 94-248, and flames extend over at least seven windows. A short flaming region is present on the 95th floor, centered near window 95-239.

**Figure 8-57. This image of the east face of WTC 1 was captured from a video recorded at 9:38:44 a.m. It has been enhanced by adjusting the intensity levels. Column and floor numbers have been added.**

There is an intense flaming region on the 96th floor, with flames extending a large distance from windows 96-237 and 96-238. Videos of this face around this time show that this intense flaming lasted several minutes. The intense region of burning has only moved a few windows to the south since 9:25:27 a.m. (see Figure 8-42). In contrast, very little flame is visible on the 97th floor, directly above, even though fires have burned to roughly the same location as on the 96th floor. Videos recorded at around the same time also indicate there was very little fire on this floor.

On the 98th floor, there is a localized jet of flame coming from window 98-215. A review of photographs and videos recorded around this time reveals that this flame was not apparent in close-up shots taken around 9:37 a.m. and that it is seen for the first time in more distant videos around 9:37:57 a.m. Recall that by this time a wide-spread fire had been observed on the north face of this floor for around 10 minutes. Unlike the fire that has just appeared on the east face, the flames did not extend from the north face and appeared to be of relatively low intensity. It is interesting that the first appearance of

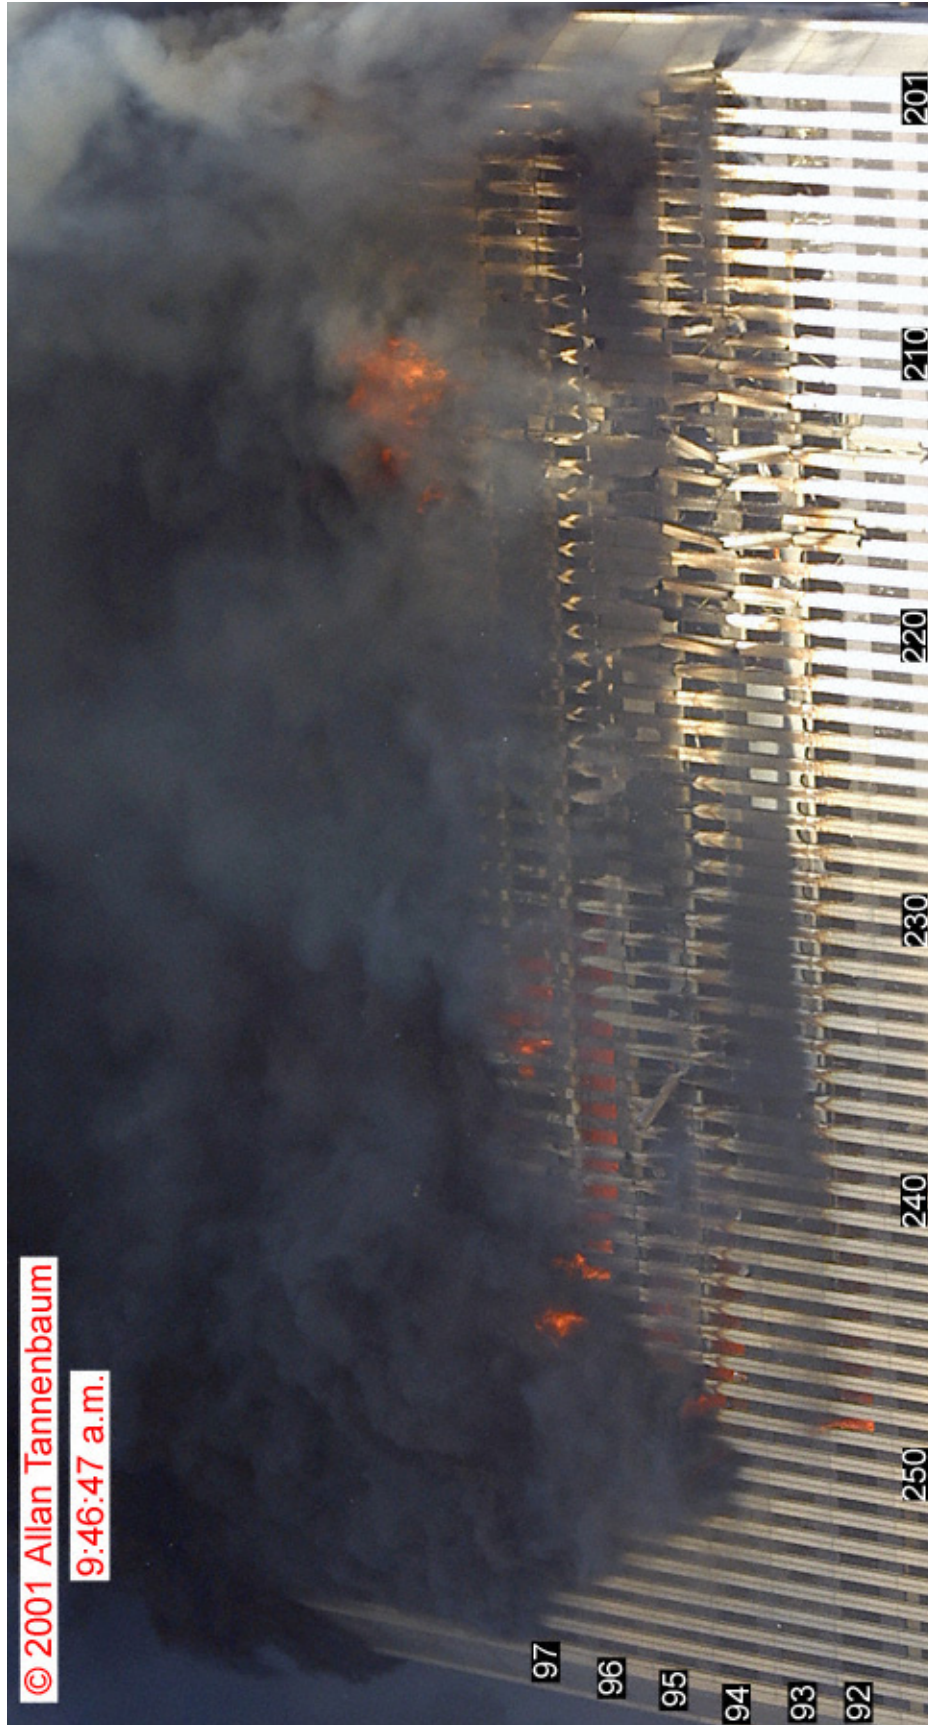
In areas of the face below and to the north of the current active fire areas there is little visual evidence of smoke or flames in the open windows. This indicates that fires observed earlier at these locations have either gone out or are now burning at very low levels. Figure 8–58 provides a good view of the various markings on the face described earlier, including the smoke marks on the column covers and partially melted spandrel covers.

Figure 8-58. This image shows the east face of WTC 1 at 9:46:47 a.m. The original image has been cropped, rotated, and enhanced. Column and floor numbers have been added.

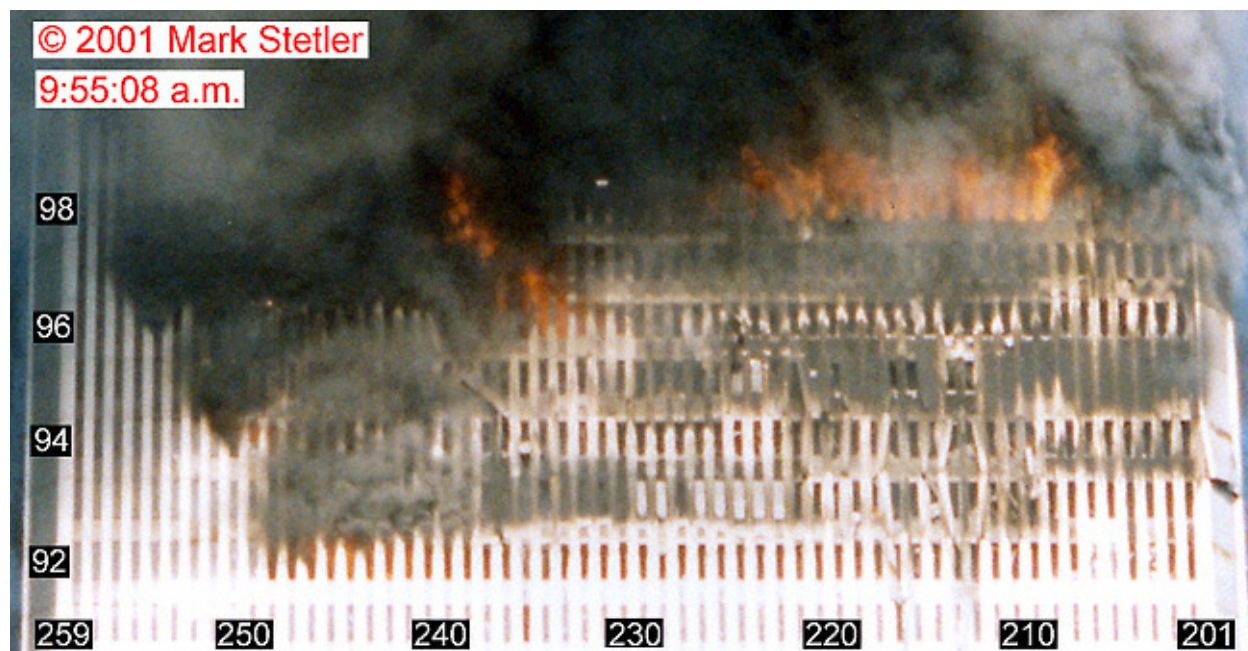
Figure 8–59 includes a photograph of the east face that was taken roughly eight and one half minutes (at 9:55:08 a.m.) after that shown in Figure 8–59. The fire burning on the 98th floor has continued to spread. It now extends from window 98-225 on the south to window 98-201 on the north. There is flame extension from windows 98-208 to 98-223. The fire has clearly moved into the room on the northeast corner, but the fire inside the room is burning at a lower intensity than the main fire region to the south.

**Figure 8-59.** This photograph shows the east face of WTC 1 at 9:55:08 a.m. The original has been rotated, cropped, and enhanced. Column and floor number have been added.

The fire on the 92nd floor has not moved further south than window 92-248 during the interval, but it has grown larger in the immediate area. The windows from window 92-240 to window 92-248 appear to be filled with flames, and there is some flame extension in the area. The fire on the 94th floor also seems to have remained in place, but it has decreased in intensity. The appearance of the fire on the 95th floor is little changed from the earlier photograph.

The changes in the appearance of the fire burning on the 96th floor are somewhat surprising. At 9:46:47 a.m. flames were evident all the way to window 96-249, with flame extension from window 96-248. At 9:55:08 a.m. the major flame region has apparently moved back to the north and is centered near window 96-235. Flames extend out of windows 96-234 and 96-235. The floor plan layout in Figure B-5 indicates that the space in this general area was open with no walls that could provide an explanation for this behavior. On the 97th floor there is a long flame coming from near window 97-237. This is roughly the same location where less vigorous flames were observed earlier.

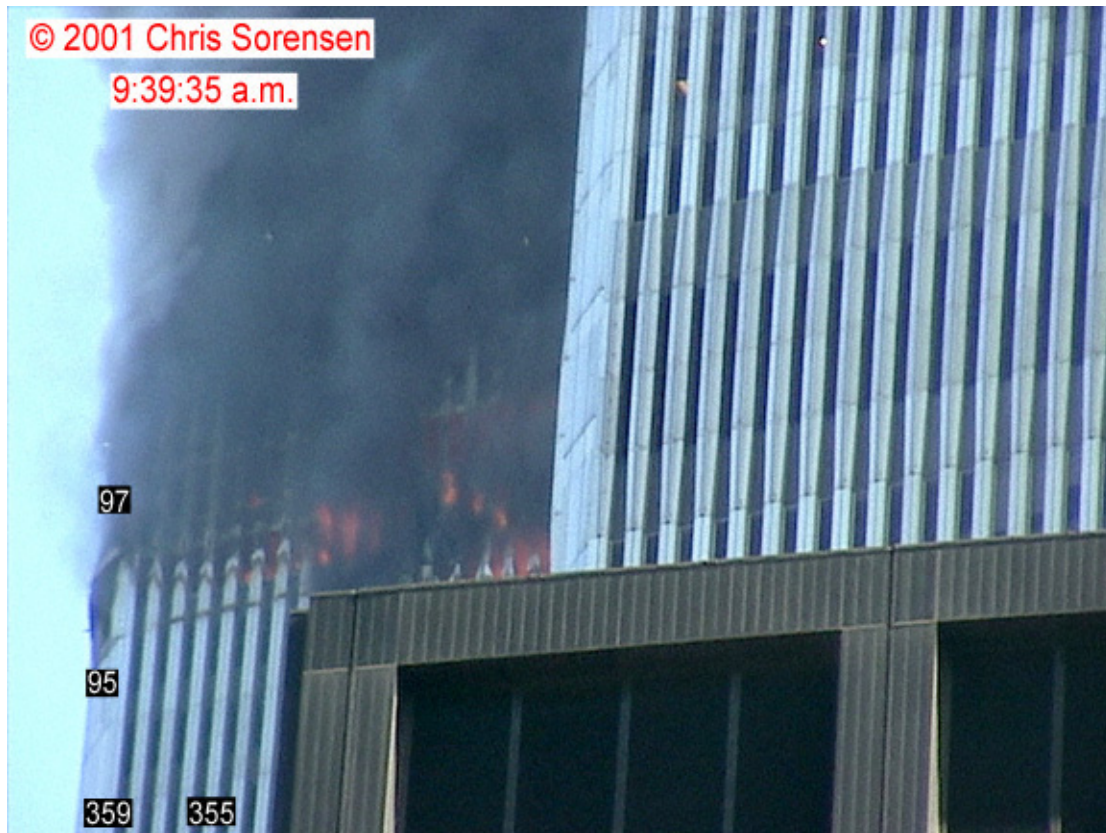
Figure 8–60 shows a partial view of the south face of WTC 1 taken from a video recorded at 9:39:35 a.m. WTC 1 is behind WTC 2, which appears to the right in the image. The first column that is visible on WTC 1 is column 343. The top of the 95th and higher floors are visible. Flames are visible on the 95th, 96th, and 97th floors, but the fire intensity appears to have decreased from that observed in Figure 8–46, which was taken at 9:33:13 a.m. Note that it is possible to see parts of the 98th floor through the smoke, and no flames are apparent.

**Figure 8-60.** This image of the south face of WTC 1 was captured from a video recorded at 9:39:35 a.m. It has been enhanced by adjusting the intensity levels. WTC 1 is on the left behind WTC 2. Another building appears in the foreground. Column and floor numbers have been added.

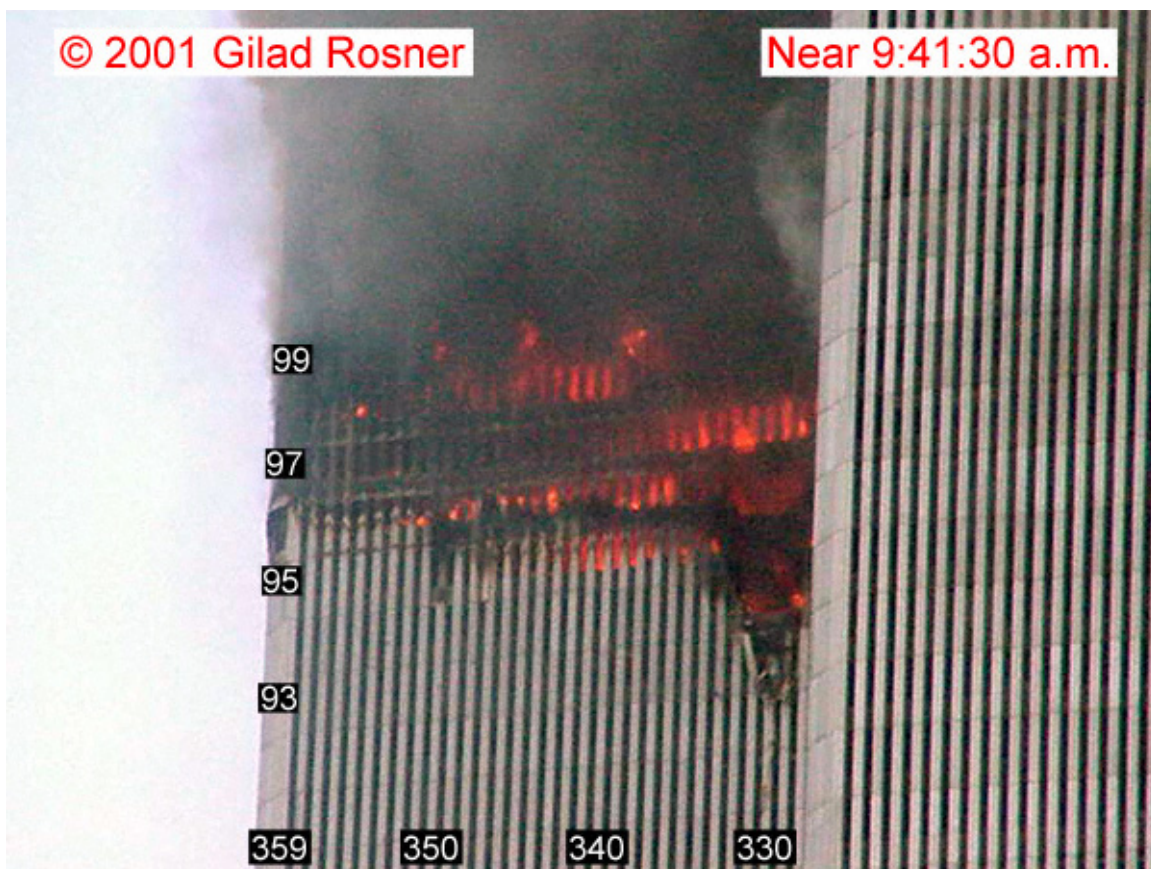
The photograph in Figure 8–61 was taken shortly after the initial rapid fire growth on the south face took place on the 98th floor. The exact time of the photograph is unknown. The assigned time of 9:41:30 a.m. has an uncertainty of just over one minute. The fire on the 98th floor has already covered a number of windows, and flames are extended from many of these. Significant fires are also evident on the 95th, 96th, and 97th floors. The intensities of these fires have continued to decrease relative to earlier times. Burning is also present on the 94th floor near the center of the face, where the panel section is believed to have been displaced during the aircraft impact. Flames were not evident at this location in Figure 8–46, which was taken at 9:33:13 a.m.

**Figure 8-61. This untimed photograph shows the south face of WTC 1. It is estimated that it was taken between 9:40:40 a.m. and 9:42 a.m. Column and floor numbers have been added.**

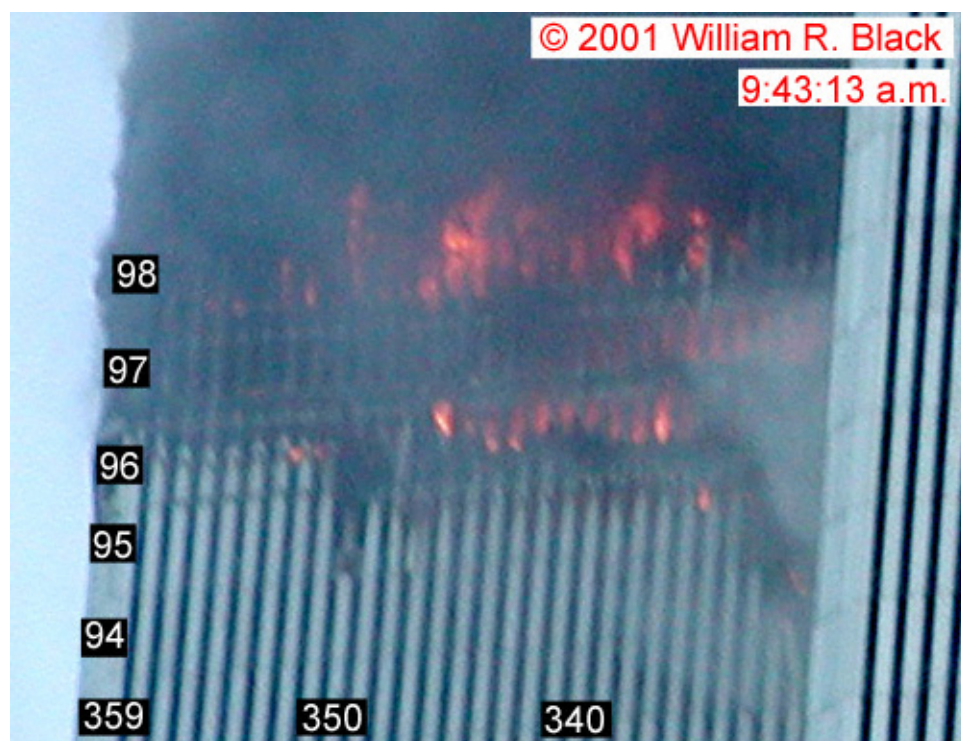
Figure 8–62 shows a partial view of the south face recorded at 9:43:13 a.m. The intensity of the fire on the 98th floor has increased markedly from that seen in Figure 8–61. Fire is now evident from at least window 98-335 to window 98-356. Well over ten of the windows on this floor have large extended flames. Forty seconds later the fire on the 98th floor had grown still more intense as shown in the somewhat closer view of the area reproduced in Figure 8–63. Flames are evident as far west as window 98-357. It is clear from this photograph that, while the intensities of the fires on the 95th, 96th, and 97th floors have decreased from earlier times, vigorous burning is still taking place on each of these floors. A small fire is burning on the 94th floor in window 94-332.

**Figure 8-62.** This cropped photograph of the south face of WTC 1 was recorded at 9:43:13 a.m. The image has been rotated and enhanced. WTC 2 appears at the right. Column and floor numbers have been added.

Comparison of Figure 8–60 to Figure 8–62 verifies the observation from the video that an intense fire appeared on the south face of the 98th floor shortly after 9:40 a.m. and very rapidly covered most of the western half of the face.

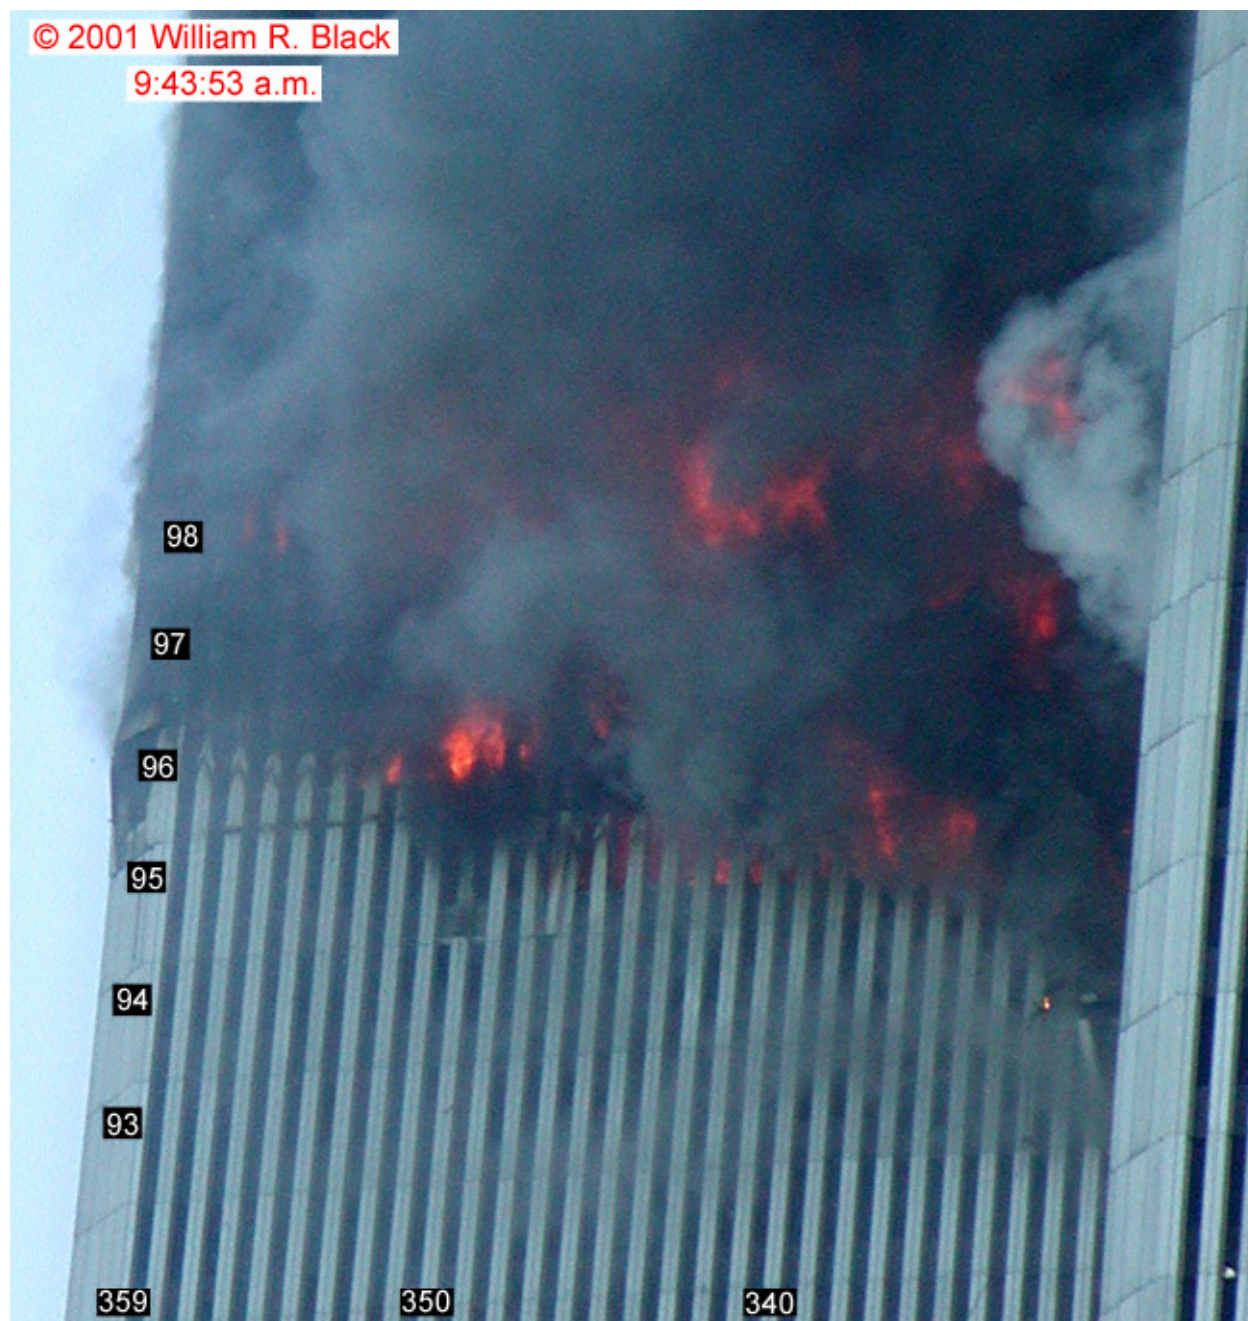
**Figure 8-63.** This cropped photograph of the south face of WTC 1 was recorded at 9:43:53 a.m. The image has been rotated and enhanced. WTC 2 appears at the right. Column and floor numbers have been added.

Even though it has been over an hour since the aircraft struck WTC 1, the majority of flames observed on the south face are still present to the left, i.e., west, of column 330. However, unlike earlier times, there are indications that fires have begun to burn in the southeast quadrant of the tower. There appears to be a small fire visible near window 94-315 in Figure 8-64. In another photograph, taken at roughly the same time, flames with a similar intensity are visible at window 94-314. Figure 8-65 provides a view of the south face at 9:53:47 a.m. taken from the southwest. While flames are not apparent in this area of the 94th floor from this angle, smoke is visible coming from at least two locations on the 94th floor to the

east of the center. Window glass appears to be missing in other nearby windows. Taken together, these observations suggest that a relatively low intensity fire is present at this time on the 94th floor on the east side of the south face.

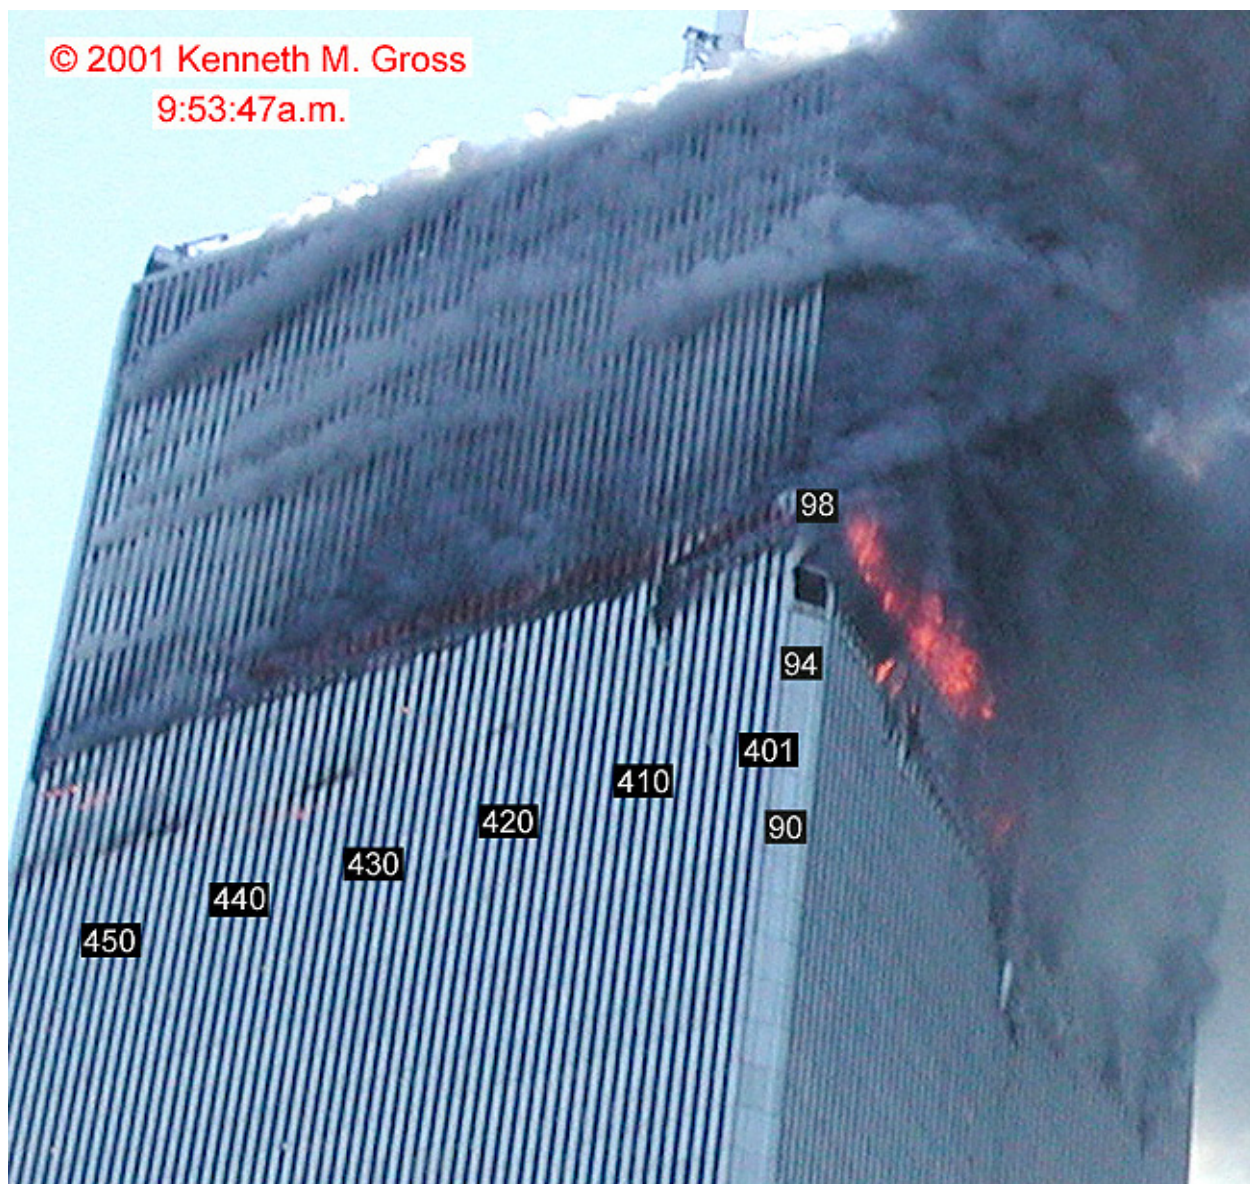
In Figure 8–65 there are indications of smoke coming from windows on the 93rd floor just to the right of the area where the panel section is believed to be missing. Higher floors on the east side are partially obscured by smoke, but there are no indications of intense fires or heavy smoke on this side for levels above the 94th floor. This figure provides a good qualitative indication of the relative intensity of the recently developed fire on the 98th floor as compared to the fires that had been burning longer on the 95th to 97th floors.

As seen by comparing Figure 8–65 and Figure 8–66, which was taken at 9:55:56 a.m., the intensity of the fire on the west side of the 98th floor decreased rapidly over the next two minutes. Even though bright fires are still evident, the flames have receded back into the building at most windows. In Figure 8–66, it

is clear that intense flames are present over several floors in the area at the center of the face where the panel section is likely missing.

**Figure 8-65.** A photograph shot from the southwest shows the west and south faces of WTC 1 at 9:53:47 a.m. The original image has been cropped and enhanced. Column numbers for the west face and floor numbers have been added.

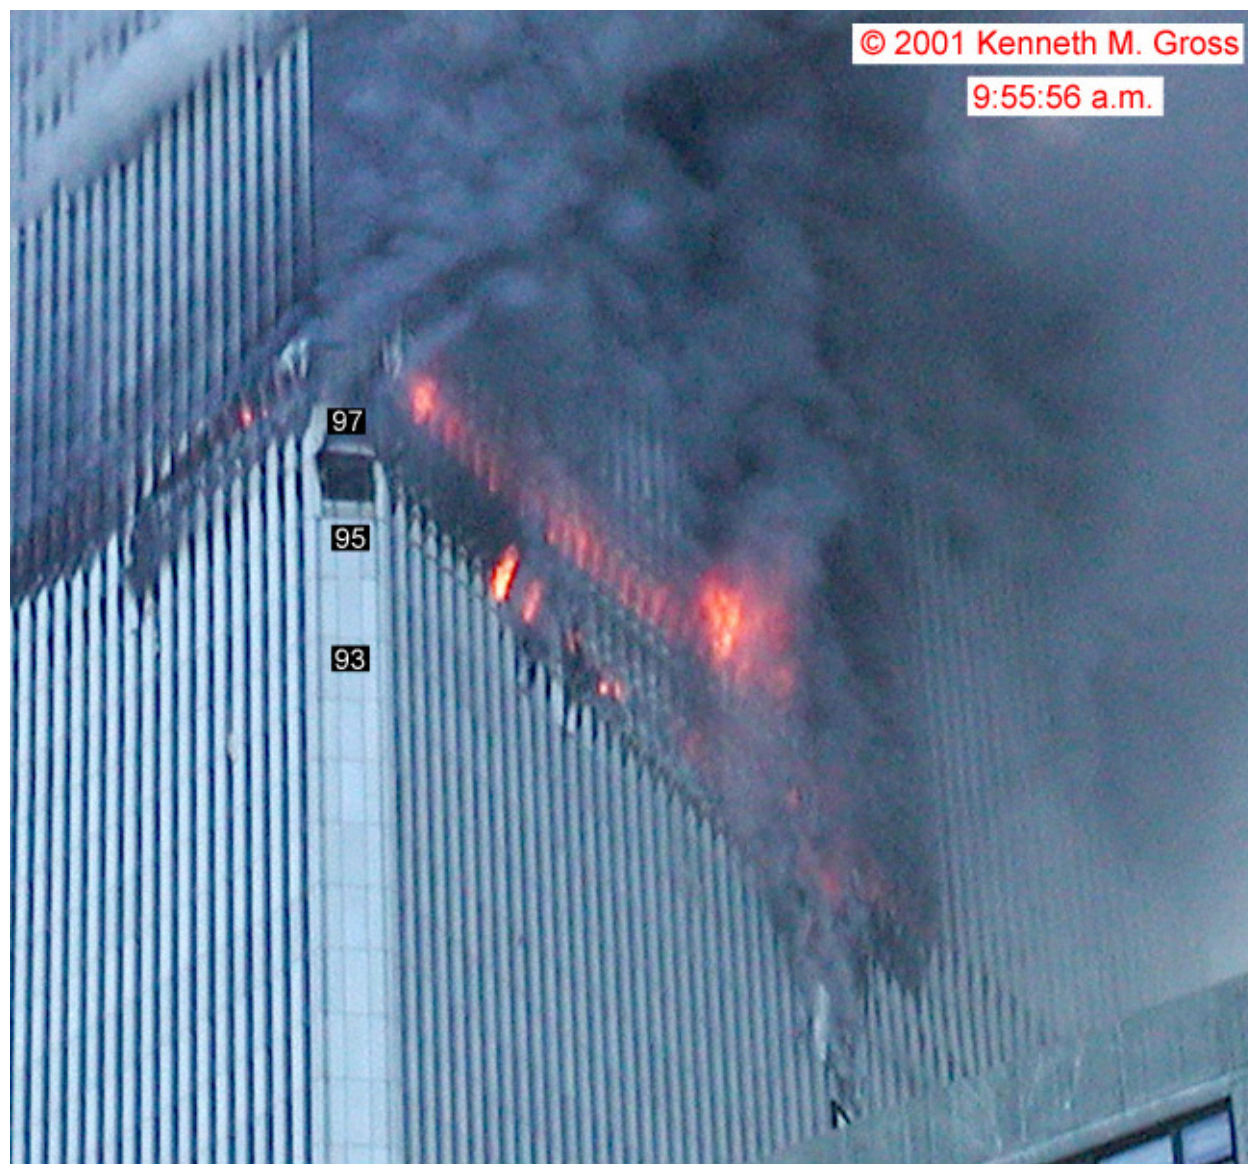
**Figure 8-66. A photograph shot from the southwest shows the west and south faces of WTC 1 at 9:55:56 a.m. The original image has been cropped and enhanced. Floor numbers have been added.**

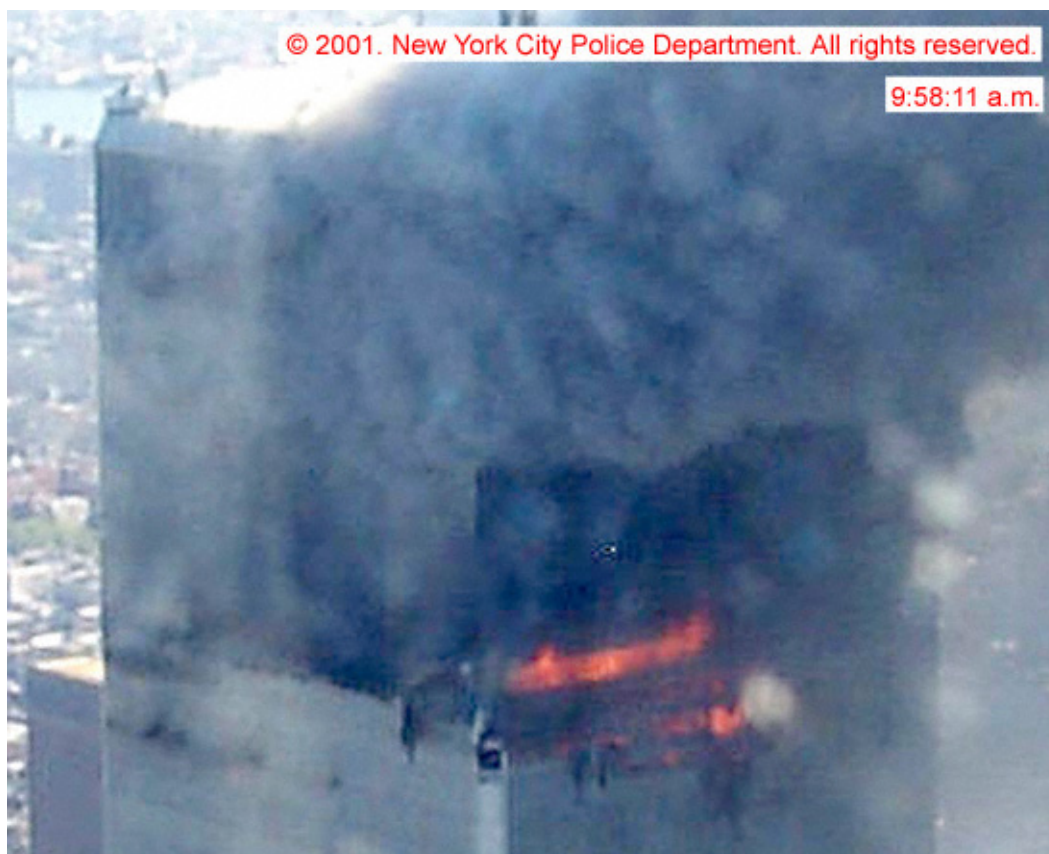
An image of WTC 1, taken roughly a minute prior to the collapse of WTC 2, is shown in Figure 8–67. This photograph was shot from a helicopter looking down on the southwest corner of the tower. The fire on the 98th floor of the south face continues to burn intensely at this time, with limited flame extension from windows. Fires present on the 95th to 97th floors have continued to decrease in size, with one exception. On the 96th floor long flames extend from the area near the center of the south face where the panel section is believed to be missing. From this angle there is no indication of flames on the eastern side of the face.

**Figure 8-67. This cropped photograph showing the southwest corner of WTC 1 was shot from a helicopter around 9:58:11 a.m. The time has an uncertainty of 30 s. The original image has been cropped and enhanced.**

The photograph shot from a helicopter shown in Figure 8–67 was taken less than a minute before the collapse of WTC 2. The appearance of the west face of WTC 1 at this oblique angle is consistent with the fire distributions described above.

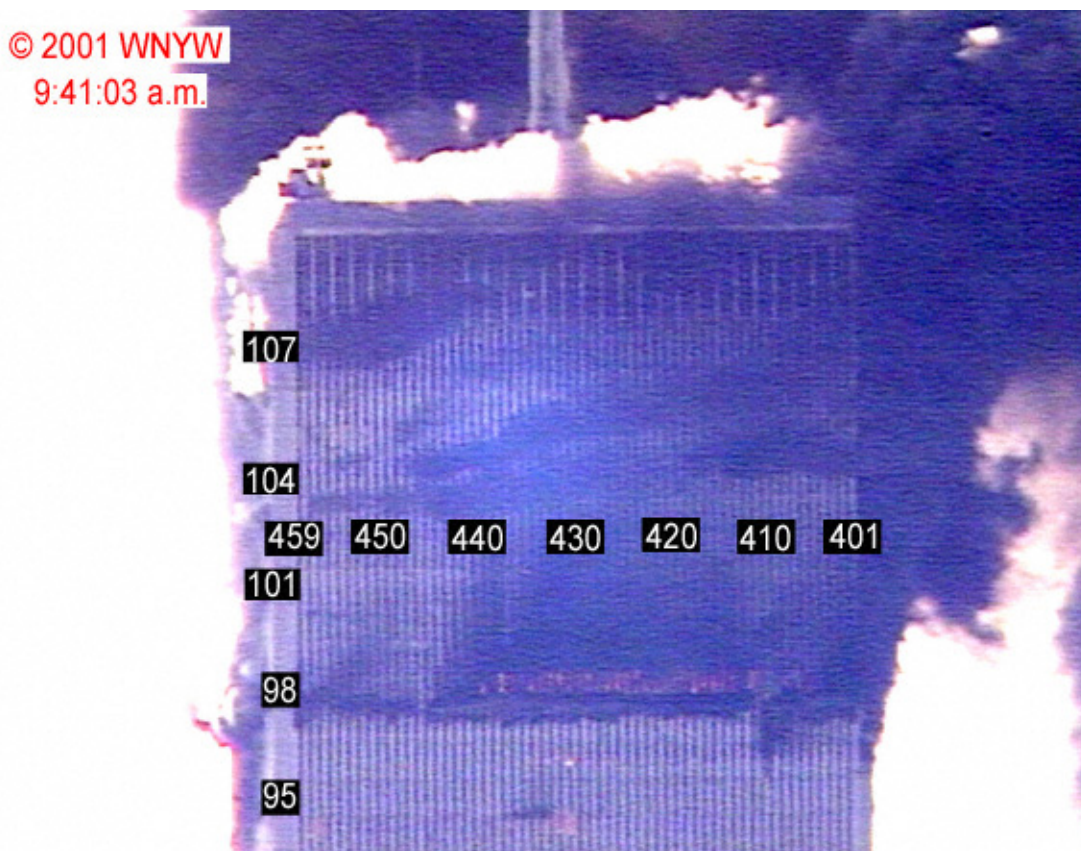
Fires are now visible near the center of the 94th floor just to the right of the black mark at the top of the columns covers, which starts at column 94-433, and very close to the north edge of the face. Flames are

also present on the 96th floor near the center of the face. This fire has apparently continued its movement to the north, since at 9:34:48 a.m. its northern edge appeared to be near window 96-426, and it can now be seen at least as far as window 96-433. While the flames are not completely visible in the frozen frame shown in Figure 8–68, by reviewing the video it is apparent that this low-intensity fire covers at least thirteen windows.

**Figure 8-68.** This image of the west face of WTC 1 is a frame captured from a video recorded by a news helicopter at 9:41:03 a.m. The image has been enhanced by adjusting the intensity range, and areas to the left and right of the tower are saturated. Column and floor numbers have been added.

The most dramatic change in the fire distribution is on the 98th floor. At the earlier time there was no indication of fire on the west side of this floor, while in Figure 8–68 flames can be seen over a length running from the south edge of the face to at least window 98-440. From the available imagery, it has proven difficult to determine precisely when this fire appeared, but a review of helicopter video suggests it occurred between 9:38:10 a.m. and 9:39:05 a.m. Given the low intensity of the fire, such apparent rapid fire spread is difficult to understand.

The development of the fire visible in Figure 8–68 on the 94th floor near window 94-430 was sudden. A video shot from a helicopter shows that it appeared at 9:39:08 a.m. The observations of falling people summarized in Appendix M also suggest that fire reached the area shortly after 9:35 a.m. At 9:38:37 a.m. a person was observed falling from this floor near the center of the face. During the next 97 s, at least six more people fell from the same vicinity. Appendix M lists the windows from which some of these people fell. The windows were either 94-435 or 94-437. There was an additional person who came from this

The floor plan layout for the 94th floor in Figure B-3 shows that there were a series of rooms located along the west face. It indicates that window 94-433 was in a room with walls located at columns 94-430 and 94-434, and windows 94-434 to 94-437 were in a second room with walls at columns 94-434 and 94-438. Recall that the glass in windows 94-434 to 94-437 was broken out shortly after 9:00 a.m. and that light smoke was later observed coming from these windows. This smoke flow explains the black band across the tops of the covers for columns 94-433 to 94-437, evident in Figure 8-68.

The other area of fire visible on the 94th floor at the north edge of the west face in Figure 8-68 also appeared abruptly. The video, shot from a helicopter, shows that fire first became visible in window 94-457 at 9:39:54 a.m. This window was located in the northwest corner room, with walls terminating at columns 94-106 and 94-454 (see Figure B-3). Recall that the first visual evidence for fire in this room from the north was at 9:39:51 a.m. The evidence suggests that windows opened on the north and west sides of the room nearly simultaneously, indicating that flashover occurred in the room at this time.

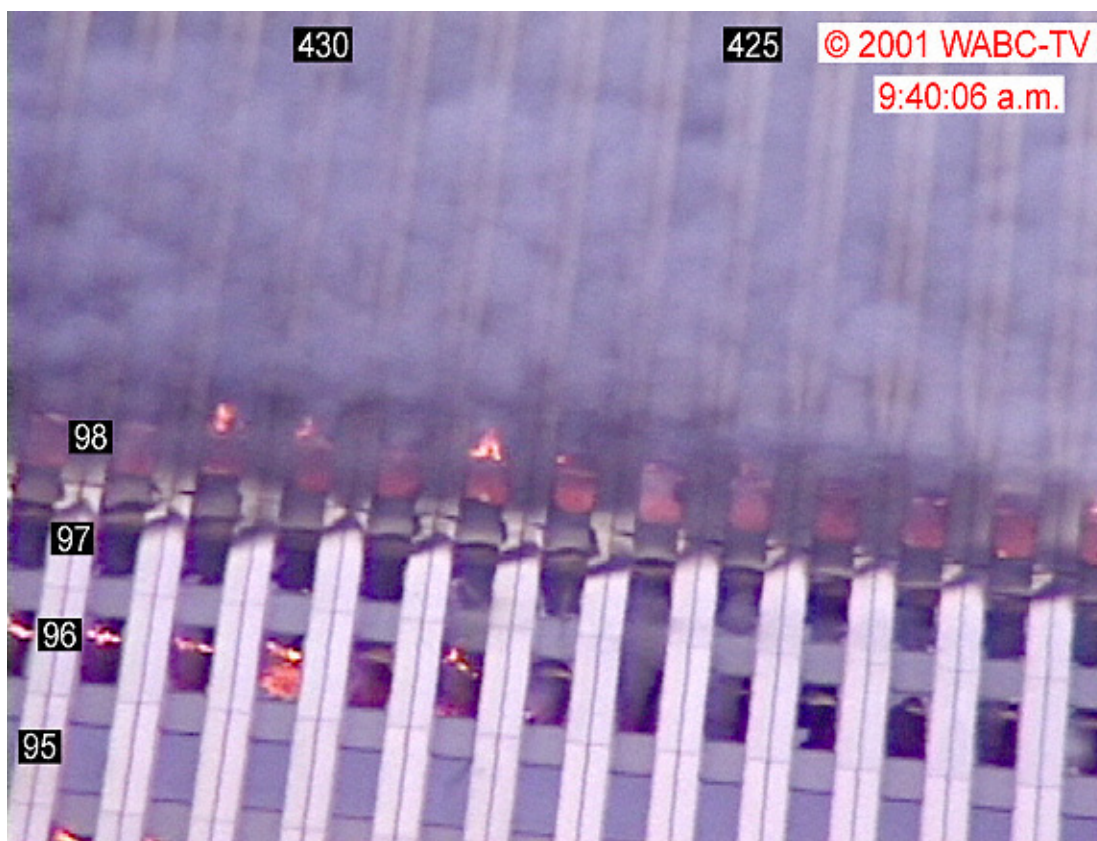
The amount of close-up visual material of the west face is relatively limited, but a close-up video was shot around 9:40 a.m. from just across West Street that provides details concerning the fires and conditions of windows. Figure 8-69 shows a frame captured from this video that was recorded at 9:40:06 a.m. At this time every window visible (windows numbered 420 to 432) on the 96th, 97th, and 98th floors is open, while the glass appears to be intact on the 95th floor and floors above the 98th.

On the 98th floor, a red glow is present in all of the windows, indicating that a fire is burning away from, but near the windows. This is consistent with the appearance of the fires on this floor in Figure 8-68, which was recorded a short time after Figure 8-69. Flames are visible at the tops of several of the windows, particularly windows 98-427, 98-429, and 98-430. It is clear that the flames are positioned just inside of the open windows near the tops of the window frames. The burning material appears to be located on the tops of plates that are hanging down from above. Several of these plates are also visible in windows on the 96th and 98th floors in windows where flames at the tops of windows are not present. It is likely that the plates are actually hanging aluminum head casings (see the discussion in Section 4.2.2) that have dropped down from above the windows as the result of heating. These observations provide additional visual evidence that the burning areas that were frequently observed at the tops of open windows were due to burning polyurethane that was exposed when the aluminum head casings located just inside the tops of the windows at the ceiling dropped down.

There is no indication of active fire on the 97th floor in the video frame. However, the presence of caretts at the tops of the aluminum column covers attests to the intensity of the fires that burned on this floor earlier. On some of the columns, portions of the aluminum column covers near the tops of windows appear to have melted.

**Figure 8-69.** This close up view of the west face of WTC 1 was captured from a video recorded at 9:40:06 a.m. It has been enhanced by adjusting the intensity levels. Column and floors numbers have been added.

Even though fires are clearly present on the 96th floor in the vicinity of the windows at 9:40:06 a.m., they appear to be burning with low intensity. This is consistent with videos shot from helicopters that showed that the fires on this floor were visible intermittently and were located close to the floor. With the exception of the fires at the tops of the windows, flames fill only one opening, window 96-429, and there are no indications of flames coming from the windows. There is very little smoke flowing from this floor, and there are no smoke marks at the tops of the column covers.

In the lower left-hand corner of Figure 8–69, flames can just be seen at the tops of windows 94-430 and 94-431 on the 94th floor. These flames appear to be due to burning thermal insulation, similar to the fires visible on the 96th and 98th floors.
