**NIST NCSTAR 1-5A**

**Federal Building and Fire Safety Investigation of the  
World Trade Center Disaster**

**Visual Evidence, Damage Estimates,  
and Timeline Analysis**

September 2005

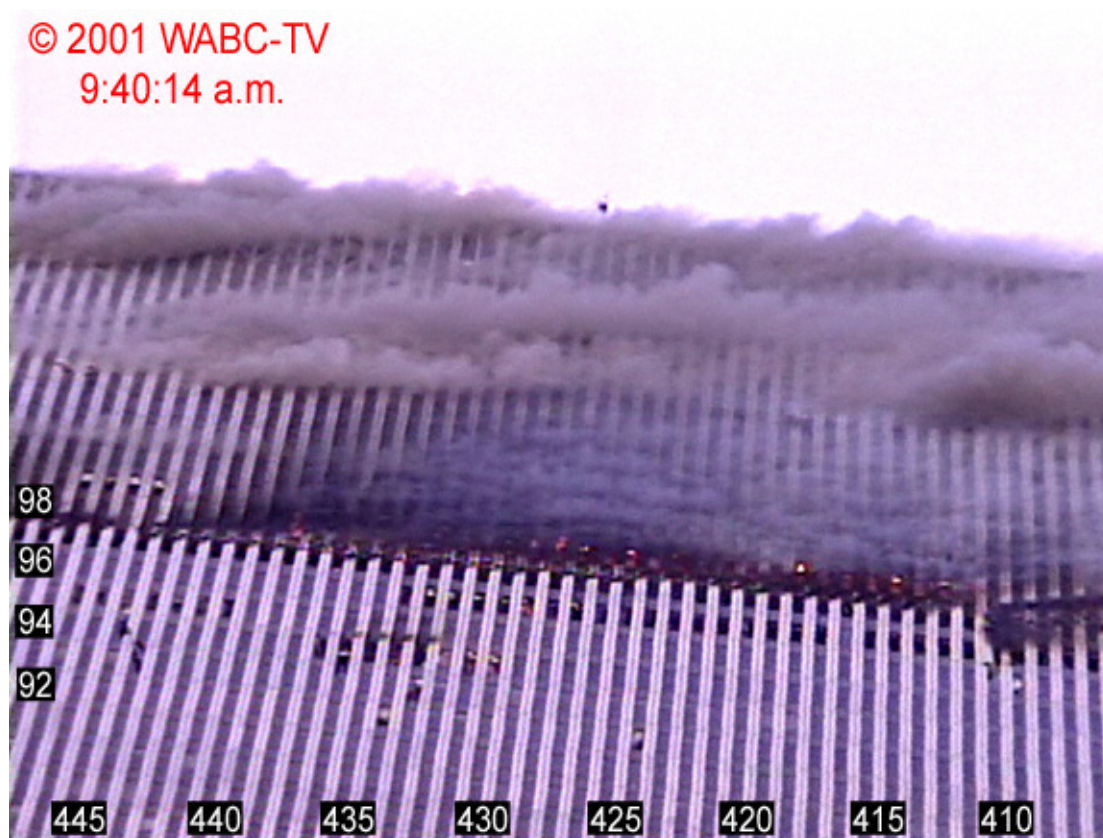
Shortly after the video frame in Figure 8–69 was recorded, the camera zoomed out and revealed a larger area of the west face. Figure 8–70 shows a captured frame from this video recorded at 9:40:14 a.m. The image provides sufficient detail to determine whether windows are open or closed. On the 94th floor the only windows in the image that are open are windows 94-430, 94-431, and 94-433 through 94-437. Fires burning at the tops of windows 94-430 and 94-431 can be seen, along with an orange flame in window 94-434. This image was recorded during the period that people were observed falling and climbing down from windows 94-433 to 94-437. The presence of flames in the immediate vicinity suggests that the people had no other means of escape from the spreading fire.

With one exception, window 96-416, all of the windows on the 96th floor as far north as window 96-434 are open. Light flames are visible at the tops of several of the windows, and flames are present in window 96-429. Despite the fact that these windows have apparently been opened by nearby fires on this floor, there is very little or no smoke coming from any of the windows, and, with the exception of column covers near the south end of the floor, the covers are unmarked.

There are no flames evident in the open windows across the entire extent of the 97th floor visible in Figure 8-70. The carets and smoke marks on the column covers near the tops of the windows on this floor contrast sharply with the appearance of the column covers next to the tops of the 96th floor windows.

**Figure 8-70. This view of the west face of WTC 1 was captured from a video recorded at 9:40:14 a.m. It has been enhanced by adjusting the intensity levels, and some locations above the building are saturated. Column and floors numbers have been added.**

The expanded view of Figure 8-70 shows that fire is visible on the 98th floor from roughly window 98-411 to window 98-439. Further to the north, the window glass appears to be intact. Bright fires are present at the tops of several of the open windows. Larger flames are also present in windows 98-428 and 98-439. Even so, compared to the intense burning observed on the other faces of the tower, these fires appear to be burning relatively gently at this time.

The smoke flows coming from some of the open windows above the 98th floor are quite heavy. At other open windows relatively little smoke is present. The four open windows on the 99th floor, windows 99-445 to 99-448, are an example of the latter behavior.

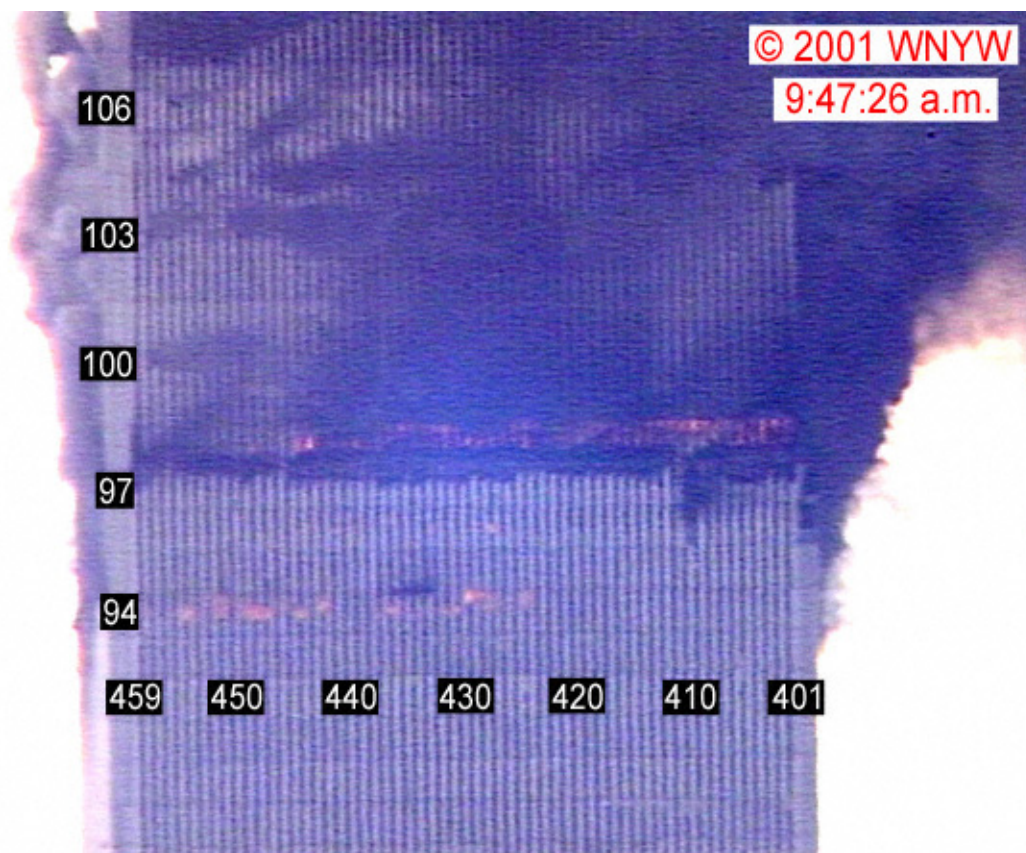
Another view of the west face taken from a video recorded from a news helicopter at 9:47:46 a.m. is shown in Figure 8-71. Since 9:41:03 a.m. (compare with Figure 8-68), the fires on the 94th floor have continued to spread; now appearing at several different locations ranging from the north edge of the face to window 94-425. By comparing the fire locations with the floor plan layout shown in Figure B-3, it is discovered that fires have entered seven of the eight rooms located along the west face, running from the north edge to as far south as column 94-425. The one exception is the room with walls at columns 94-438 and 94-442. Even though the fire area is extensive, the flames are not very vigorous. There is no apparent external flaming, and no smoke is visible coming from the windows.

**Figure 8-71.** This image of the west face of WTC 1 is a frame captured from a video recorded by a news helicopter at 9:47:26 a.m. The image has been enhanced by adjusting the intensity range, and areas to the left and right of the tower are saturated. Column and floor numbers have been added.

Small fires are still evident on the 96th floor. In the video the flames appear intermittently over a range of windows that reaches as far north as window 96-441. As at the earlier time, there is no smoke or flame coming from the windows.

The fire on the 98th floor has continued to spread north. It now extends from the south edge continuously to at least window 98-444. From this distance, the fire still appears to be located away from the west wall. There is little indication of fire or smoke coming from the windows on this floor.

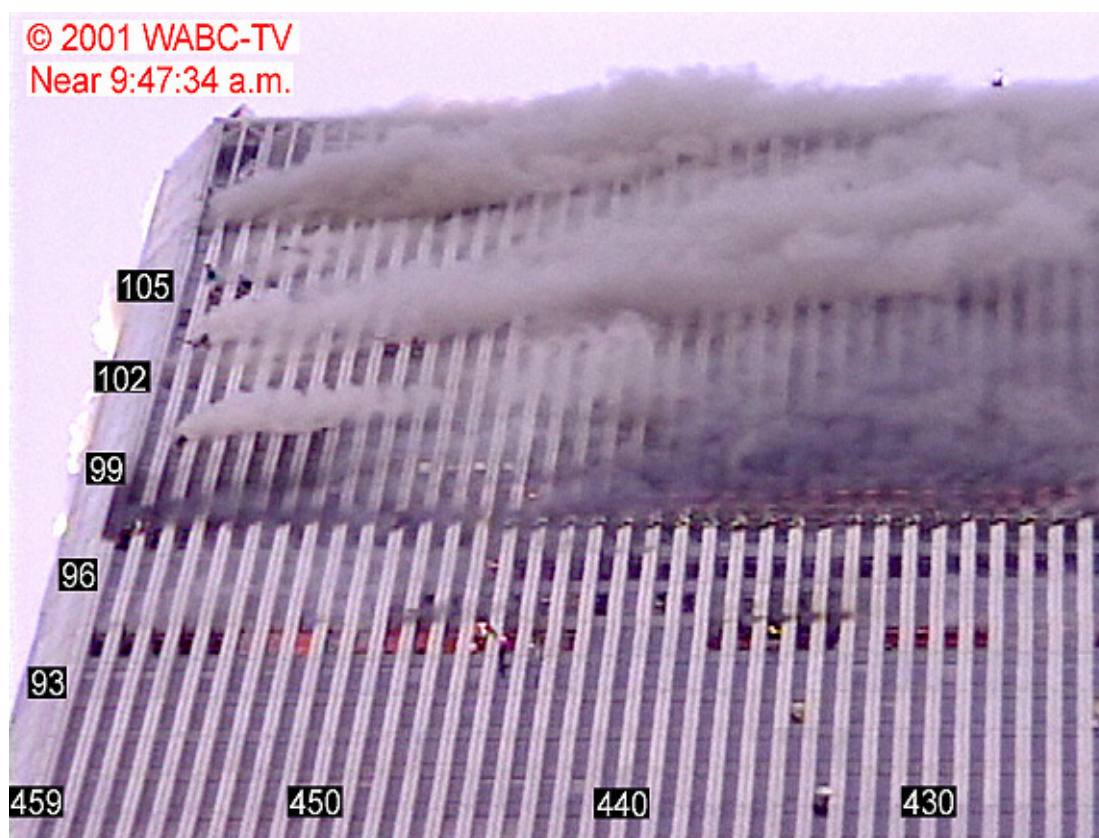
A much closer view of the north side of the west face recorded at roughly the same time as Figure 8–71 is shown in Figure 8–72. Even though this image is assigned a time of 9:47:34 a.m., there is an associated uncertainty of 30 s. The closer image provides confirmation of many of the conclusions drawn from Figure 8–71. On the 94th floor fire is visible at many of the windows, and a number are open from window 94-424 to window 94-459. The glass panes between windows 94-438 and 94-442 are indeed in place, with no indication of fire in the room located between these columns (see Figure B-3). The five windows along the west face in the northeast corner room are open. The adjacent room to the south has walls at columns 94-450 and 94-454 (Figure B-3). The fire is apparently just growing in this room since flames are visible, but three of the four windows are in place. Flames are visible, and most of the windows are missing for the next two rooms to the south. Window 94-424 is open, but the panes are still in place in nearby windows. This indicates that the observed fire has moved one room further south since 9:41:03 a.m.

**Figure 8-72.** This view of the west face of WTC 1 was captured from a video recorded at 9:47:34 a.m. There is a 30 s uncertainty in the assigned time. The image has been enhanced by adjusting the intensity levels, and some locations above the building are saturated. Column and floors numbers have been added.

On the 95th floor, two additional windows (95-438 and 95-439) have opened since 9:40:14 a.m. Since there is still no indication of fire in this area, it is possible that people have broken out the glass. Very

little fire is visible on the 96th floor, but there is an area of flame at the top of window 96-447. Windows to the north of this location are still in place. The northern advance of the fire on the 98th floor has reached roughly the same location. Fire is visible at the top of window 98-444, and window 98-445 appears to be open. A deep red glow on this floor from the windows that are open indicates that burning areas continue to be located well away from the windows.

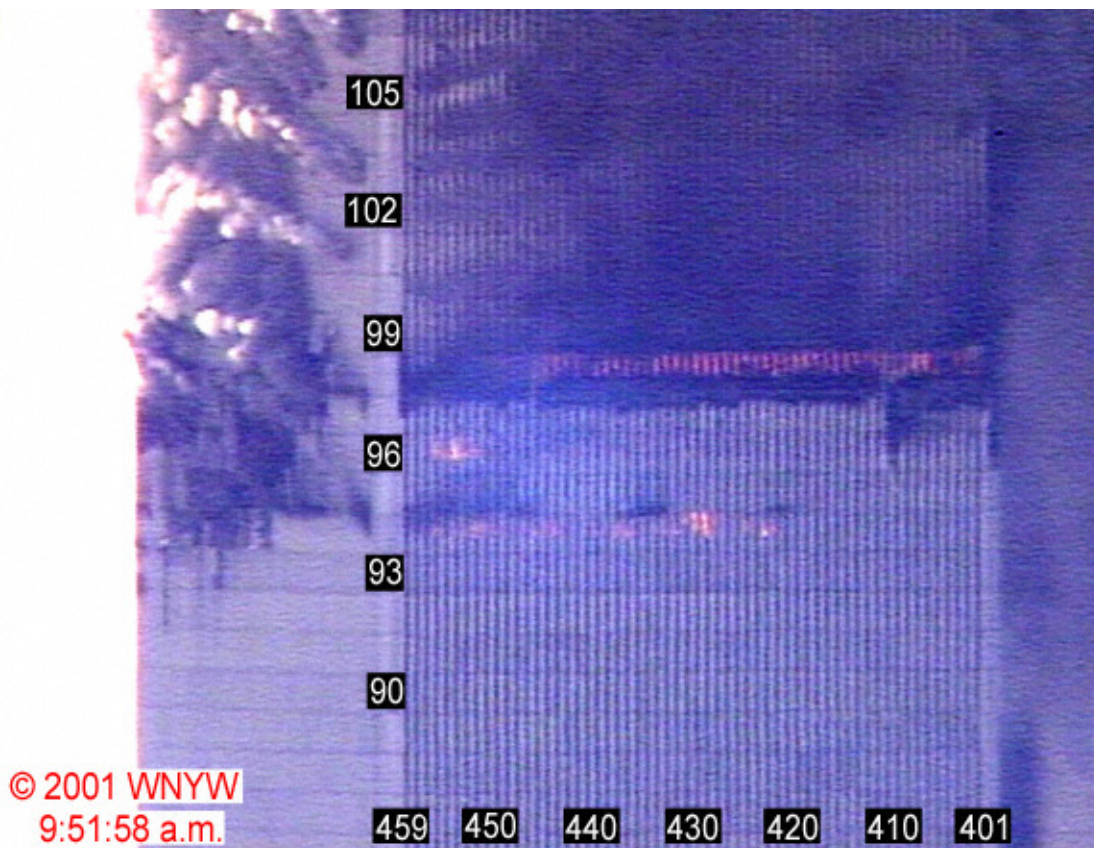
Another frame taken from a video shot from a helicopter at 9:51:58 a.m. is shown in Figure 8-73. Fire development on the west face has continued. The largest differences as compared to Figure 8-71, which was recorded at 9:47:26 a.m., are the appearance of fire at multiple windows on the 96th floor near the north edge of the west face and the spread of the fire toward the south on the 94th floor. It has not been possible to determine exactly when the fire at the north edge of the 96th floor appeared, but it was between 9:50:09 a.m. and 9:51:19 a.m. The flames are visible in windows 96-453 to 96-455. The floor plan layout in Figure B-5 indicates that these windows were inside a room with internal walls at columns 96-452 and 96-456. Fire is not yet visible from windows in the room on the northeast corner with walls at columns 96-456 and 96-108. On the 94th floor flames are now visible in windows 94-423 and 94-424. This indicates that a fire was growing within the room with walls located at columns 94-421 and 94-425. (see Figure B-3) The appearance of the fire on the 98th floor did not change dramatically over the four and a half minute period between the images.

**Figure 8-73.** This image of the north and west faces of WTC 1 is a frame captured from a video recorded by a news helicopter at 9:51:58 a.m. The image has been enhanced by adjusting the intensity range, and areas to the left of the tower are saturated. Column and floor numbers have been added.

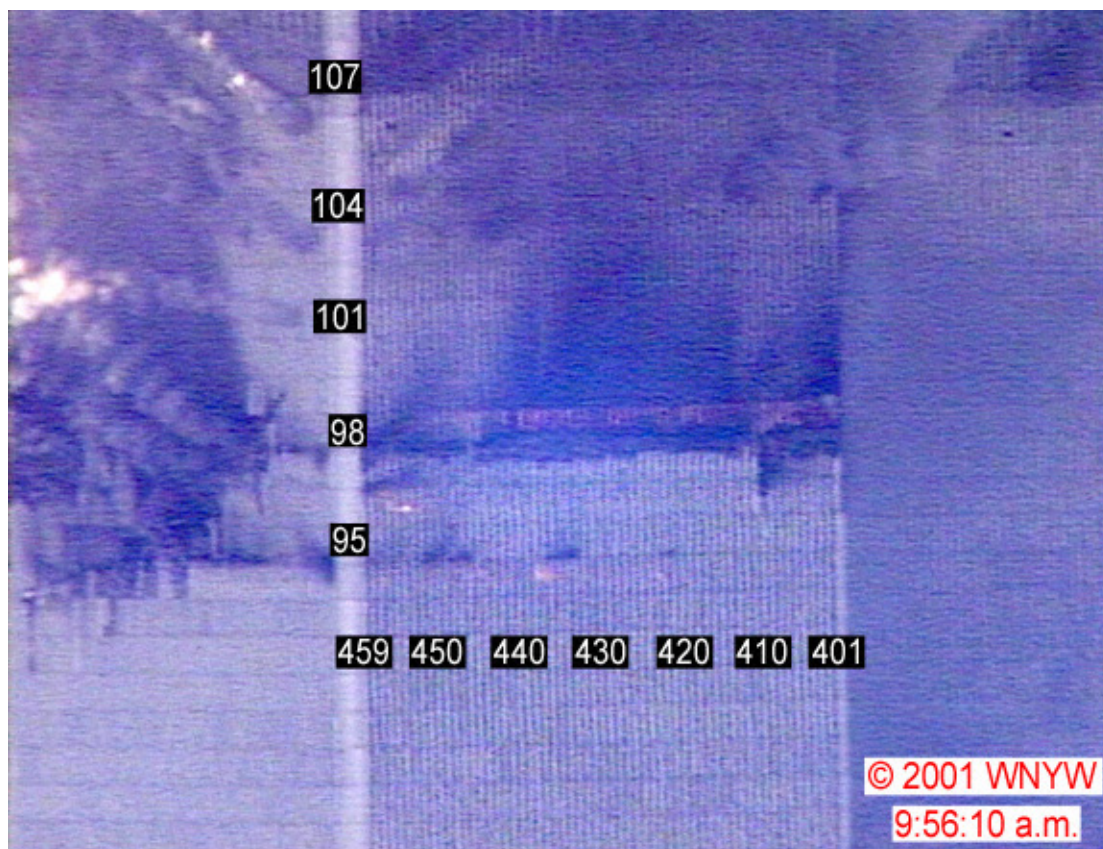
**Figure 8-74.** This image of the north and west faces of WTC 1 is a frame captured from a video recorded by a news helicopter at 9:56:10 a.m. The image has been enhanced by adjusting the intensity range. WTC 2 appears in the background to the right. Column and floor numbers have been added to WTC 1.

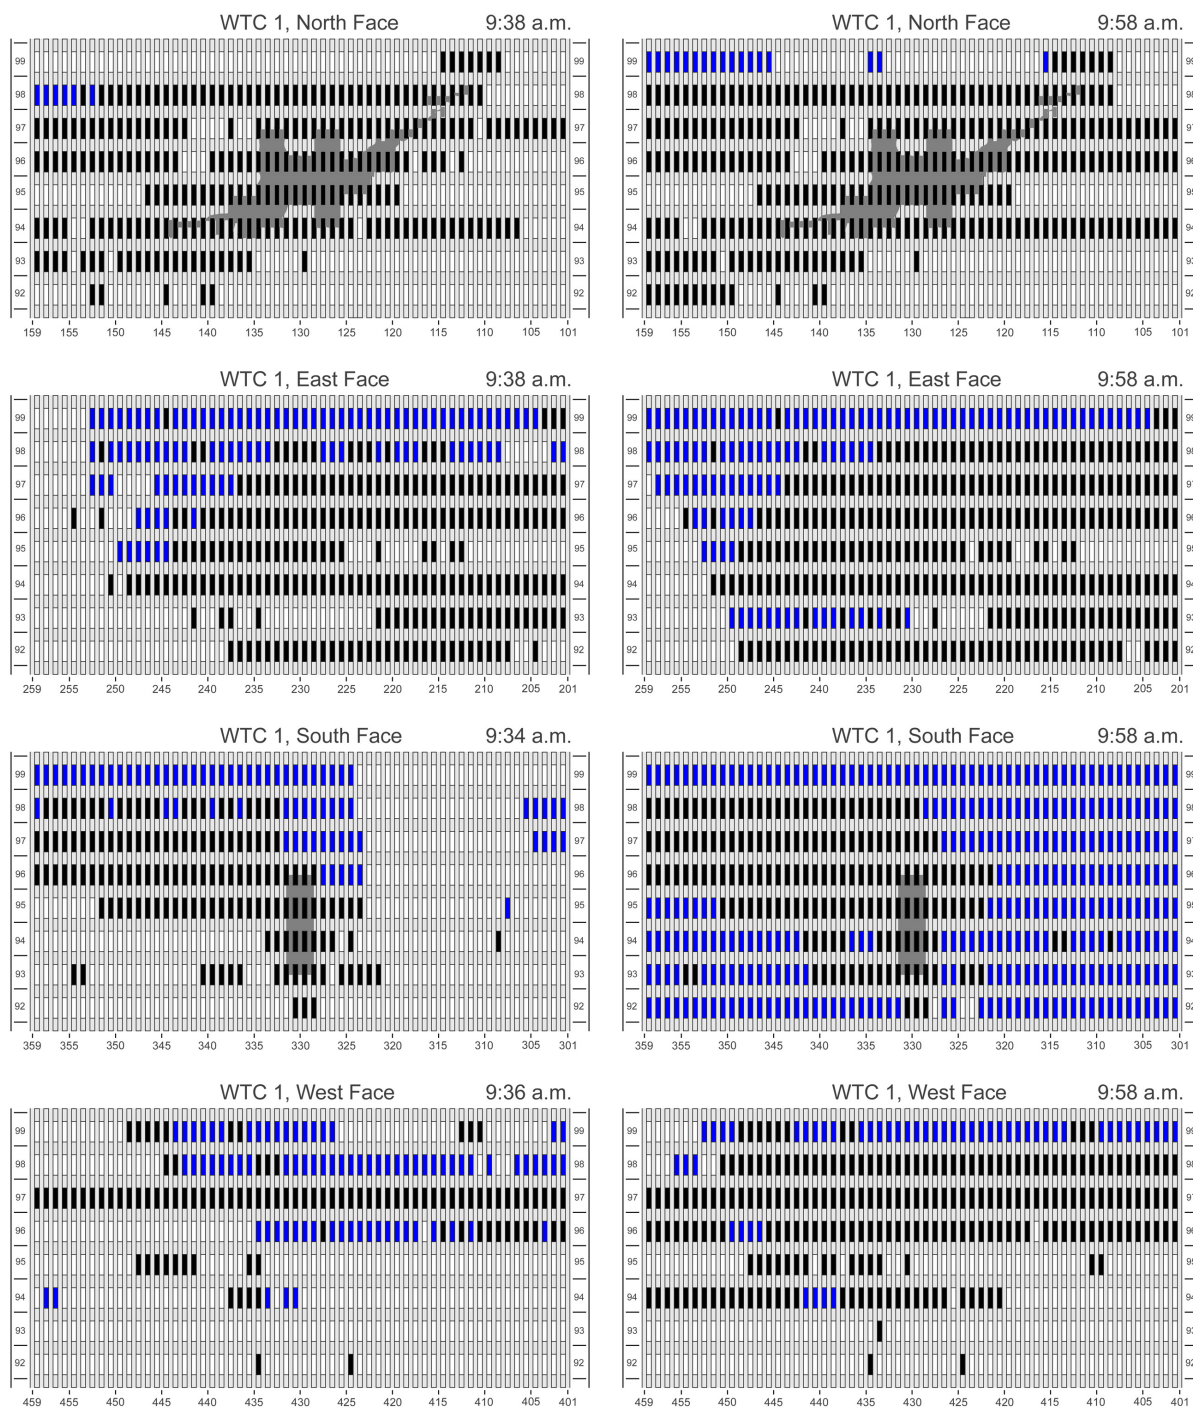
Observed window conditions for the four tower faces at the beginning and end of the period are compared in Figure 8–75. The windows that opened during the period, which generally implies the presence of an active fire, are consistent with the fire-spread observations discussed above. On the north face, windows opened along a long length of the 98th floor and near the eastern edge of the 92nd floor. The growth of the large fire on the east side of the 98th floor is reflected in the large increase in open windows at the later time. On the other floors the fires on the east face appear to be moving relatively deliberately toward the south, but note the large increase in the number of open windows on the 92nd floor. Windows also opened on the east side of the 92nd floor near the north edge. The maps for the south face are consistent with observations that major fire growth during the period was on the 95th and 98th floors. There was evidence of a small fire on the east side of the south face on the 94th floor, but in general, the fires on the south face still have not moved in this direction much beyond the center of the face. Note that most of the windows on the eastern side of the face at the later time are marked as not visible. This is because the imagery available does not allow the conditions of these windows to be assessed. The imagery does indicate that there was no significant smoke or fire coming from windows on the fire floors above the 94th floor. By far, the largest changes in window condition during the period were on the west face. Large numbers of windows have been opened on the 94th, 96th, and 98th floors. These changes are even more remarkable when the nature of the fires, which generally appeared to be gently burning, is recalled.

**Figure 8-75. Maps for the 92nd through the 99th floors compare missing window glass for the four faces of WTC 1 at two times, around 9:35 a.m. and at 9:58 a.m. The color coding used for the maps is indicated in Figure 5-1.**

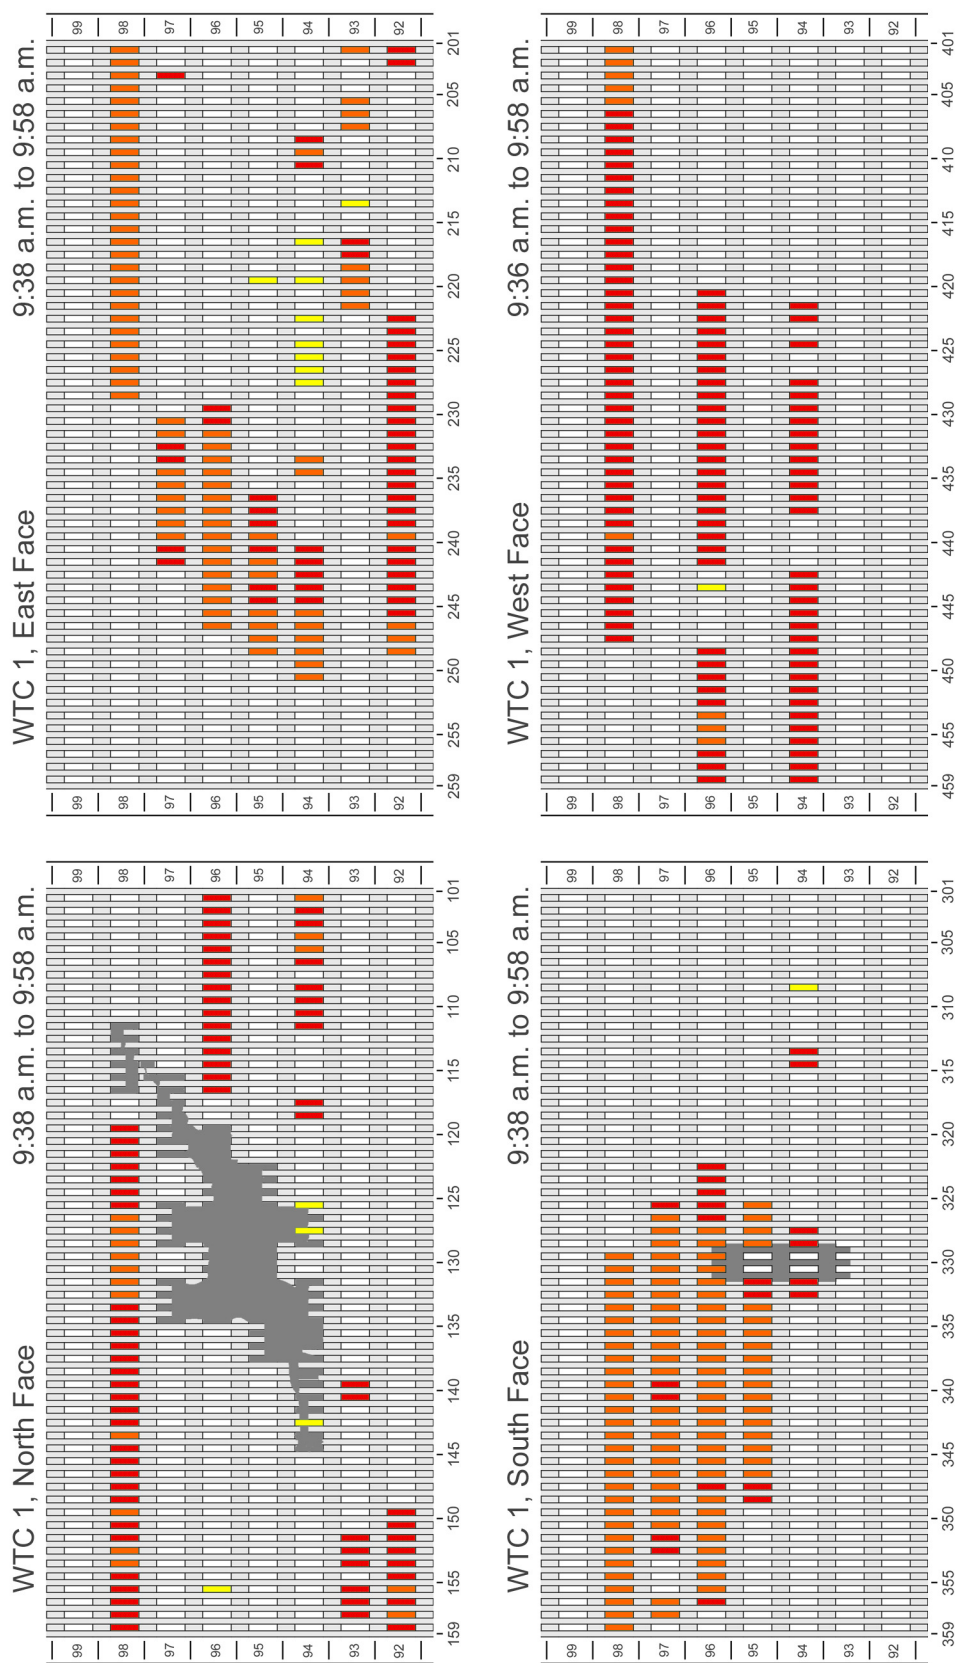
Maps of integrated fire behavior for the four tower faces for the period from 9:35 a.m. to 9:59 a.m. are shown in Figure 8–76. These maps can be compared with the corresponding versions in Figure 8–51 for 9:19 a.m. to 9:35 a.m. This comparison highlights the growth of fires on the north face across much of the 98th floor, on the 96th floor to the west of aircraft impact cavity, and on the 92nd floor near the east edge of the face. Other areas of fire that were identified during the earlier time period were no longer visible during the current period.

On the south face, the fire that appeared near the center of the western half near the end of the previous period continued to spread in both directions and filled in the length of windows between the western edge and center of the face. Extensive fires were still present on the western sides of the 95th through 97th floors, but these fires decreased in both extent and intensity during the period. Relatively small flames were observed briefly in three windows on the east side of the 94th floor.

The changes in the west face integrated fire distributions between the two periods mirror the large changes observed in the window maps. Areas of fire appeared along extensive lengths of the 94th and 98th floors during the period. At the same time, fires on the 96th floor completed their slow migration from the south edge of the 96th floor to the north edge. Fires that were visible on the 97th floor during the earlier periods had died down by the start of the current period.

The most distinctive change in the window condition and integrated fire maps between 9:35 a.m. and 9:59 a.m. was the wide-spread appearance of fire on the 98th floor. By roughly twenty minutes after a growing fire first became evident on the north side of the 98th floor, fire was visible on this floor in two long bands. One of these bands started near the center of the south face, ran to the southwest corner and extended north on the west face to at least window 98-444. The second band began near window 98-119 on the north face and ran around the northeast corner to the vicinity of window 98-223 on the east face. The observed fire behavior of these rapidly developing fires varied from face to face. On the east and south faces very intense flames were observed extending large distances from open windows, while on the west and north sides, the fires appeared much less intense and to be burning at interior locations removed from the outer walls. These observations are reflected in the integrated fire distribution maps shown in Figure 8–76.

**Figure 8-76. Maps of integrated fire observations between 9:36 a.m. and 9:59 a.m. are shown for the four faces of WTC 1. Colors represent the highest intensity fire observed in a window using the color scale defined in Figure 5-1.**

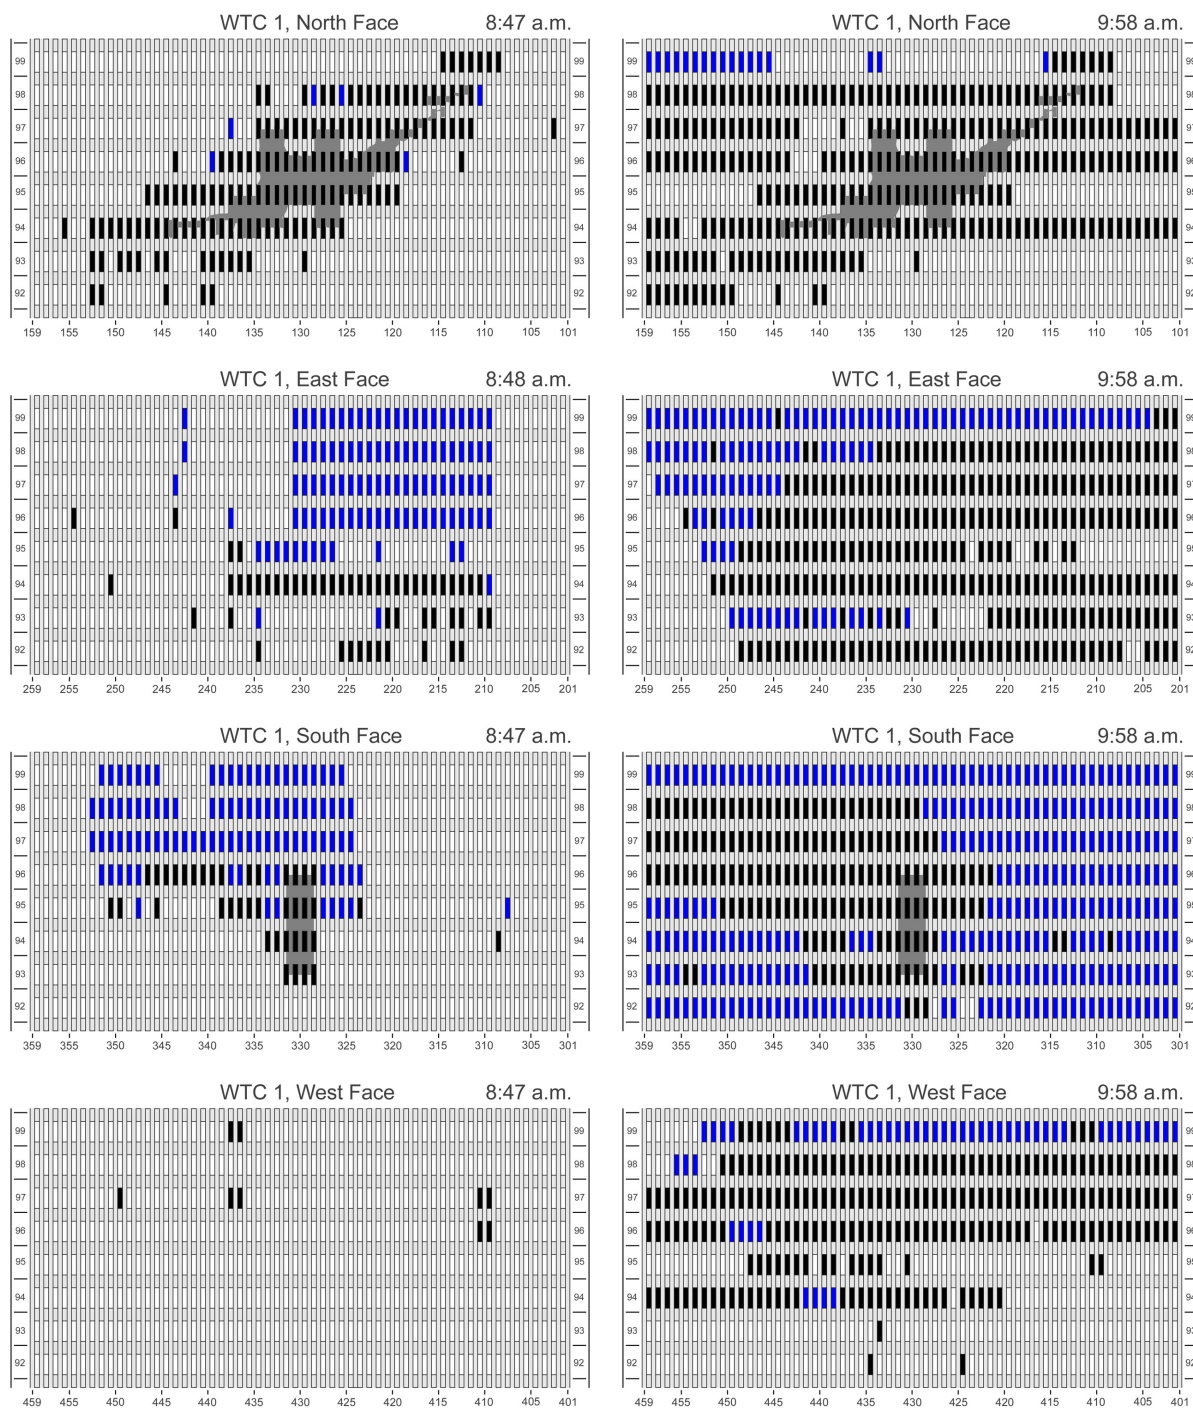
After WTC 2 fell at 9:58:59 a.m., the number of detailed views of WTC 1 decreased markedly. As a result, the time line and façade maps become less certain. Therefore, this is an appropriate point to quantitatively compare the changes in window condition that took place between the time of the aircraft impact on WTC 1 and the collapse of WTC 2. Façade maps for these two times are compared for the four faces of WTC 1 in Figure 8–77. Only a quick glance is necessary to recognize how extensive the fire spread and growth has been on the 92nd through 98th floors.

The maps also provide some insights into several general fire behaviors. Perhaps the most significant is the absence of significant window breakage on the east side of the south face and the adjoining area on the east face. This indicates that on most of these floors the fires have not yet migrated to the outer walls in these locations. Similarly, the fires that grew fairly early on the eastern sides of the 92nd and 93rd floors have not yet spread to the western faces of these floors. On the 94th floor the fires that were originally ignited on the east face have burned across the north face and the northern portion of the west face, but there is still an apparently unburned area near the southwest corner. Even though there have been significant fires on the eastern and southern sides of the 95th floor, significant lengths of window glass remain in place on the northern and western sides of this floor.

**Figure 8-77. Maps for the 92nd through the 99th floors compare missing window glass for the four faces of WTC 1 at two times, immediately following the aircraft impact on WTC 1 at 8:46:30 a.m. and just prior to the collapse of WTC 2 at 9:58:59 a.m. The color coding used for the maps is indicated in Figure 5-1.**

The changes in the number of open windows on the individual faces of WTC 1 are consistent with the observed fire behaviors. The largest increases were on the east and west faces. The façade maps in Figure 8–77 show how extensive the fire spread was on these faces during the period under consideration. There was also considerable fire spread observed on the north face, but the percentage increase in the number of open windows is smaller due to the large number of windows that were opened when the aircraft struck. The smallest increase in total open windows was for the south face. This reflects the fact that the fires did not migrate substantially into areas on the eastern side of this face during the 1 hr and 13 min period.

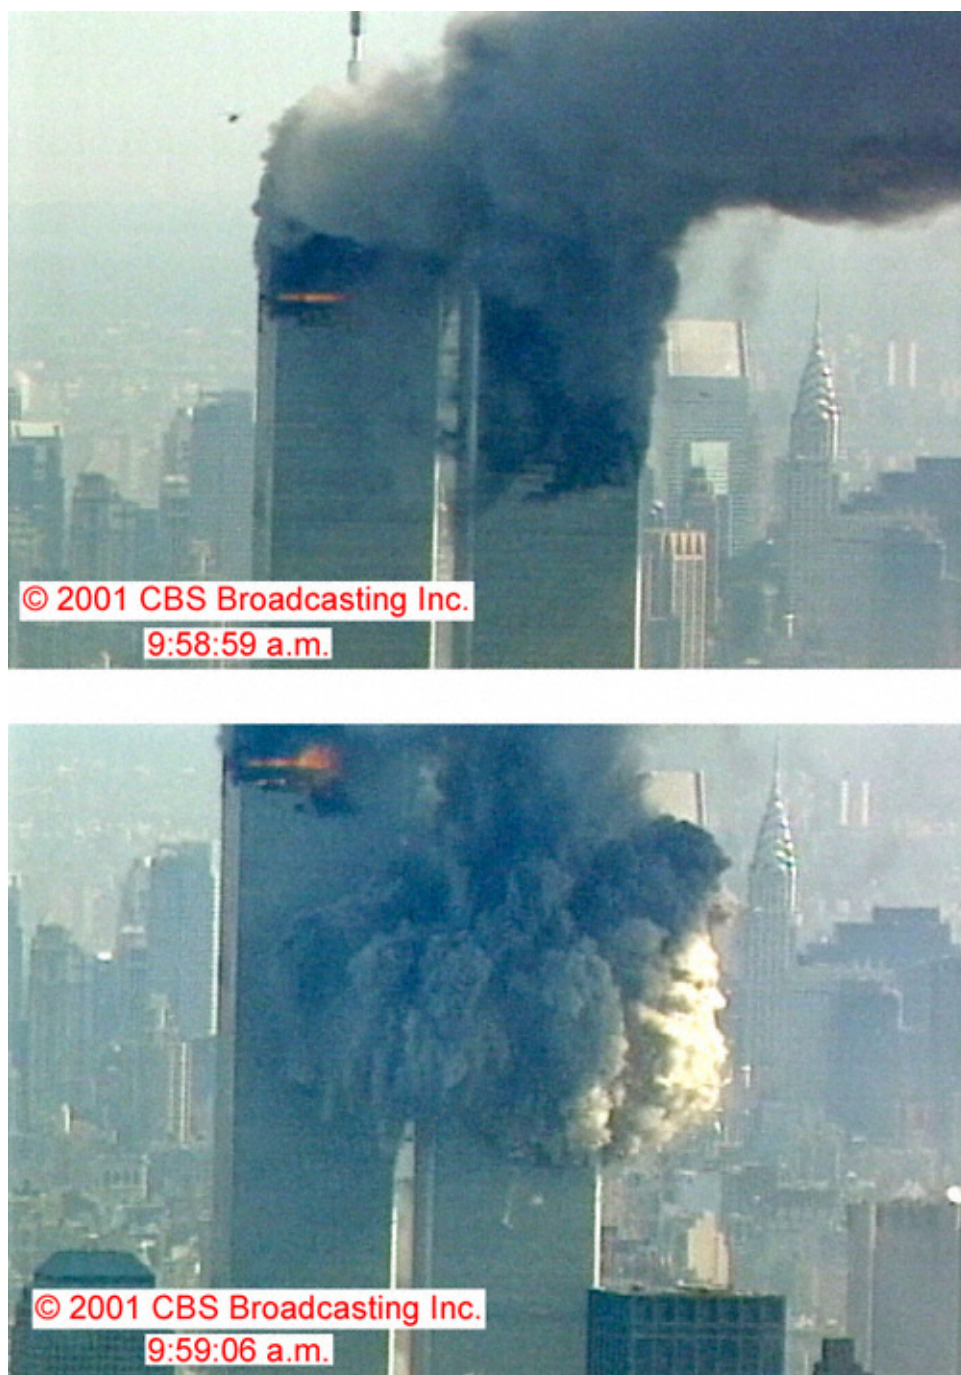
At 9:58:59 a.m. WTC 2 began to collapse, and roughly ten seconds later debris reached the ground. Very shortly after the collapse began, fire and smoke were pushed out of the south face of WTC 1. Figure 8–78 contains two frames taken from a video showing the south faces of the towers. The first frame was recorded just as WTC 2 began to collapse, and the second was shot seven seconds later. In both frames the fire burning on the 98th floor of WTC 1 is very distinct. At the earlier time there does not appear to be external flames, but in the second frame long flames extend from near the center of the face. Review of the video indicates that these flames were pushed out of WTC 1 starting four seconds after collapse initiation. Closer inspection shows that an area of flame is visible on the western side of the 96th floor at the later time that was not evident seven seconds earlier. It is significant that flames do not appear elsewhere on the face at the later time, perhaps indicating that large flames are only present near the periphery of the face at these locations.

**Figure 8-78. Two frames taken from a video shot from a news helicopter show the south face of WTC 1 just as WTC 2 starts to collapse at 9:58:59 a.m. and 7 seconds later. WTC 1 and WTC 2 are to the left and right, respectively. Images have been enhanced by adjusting the intensity levels.**

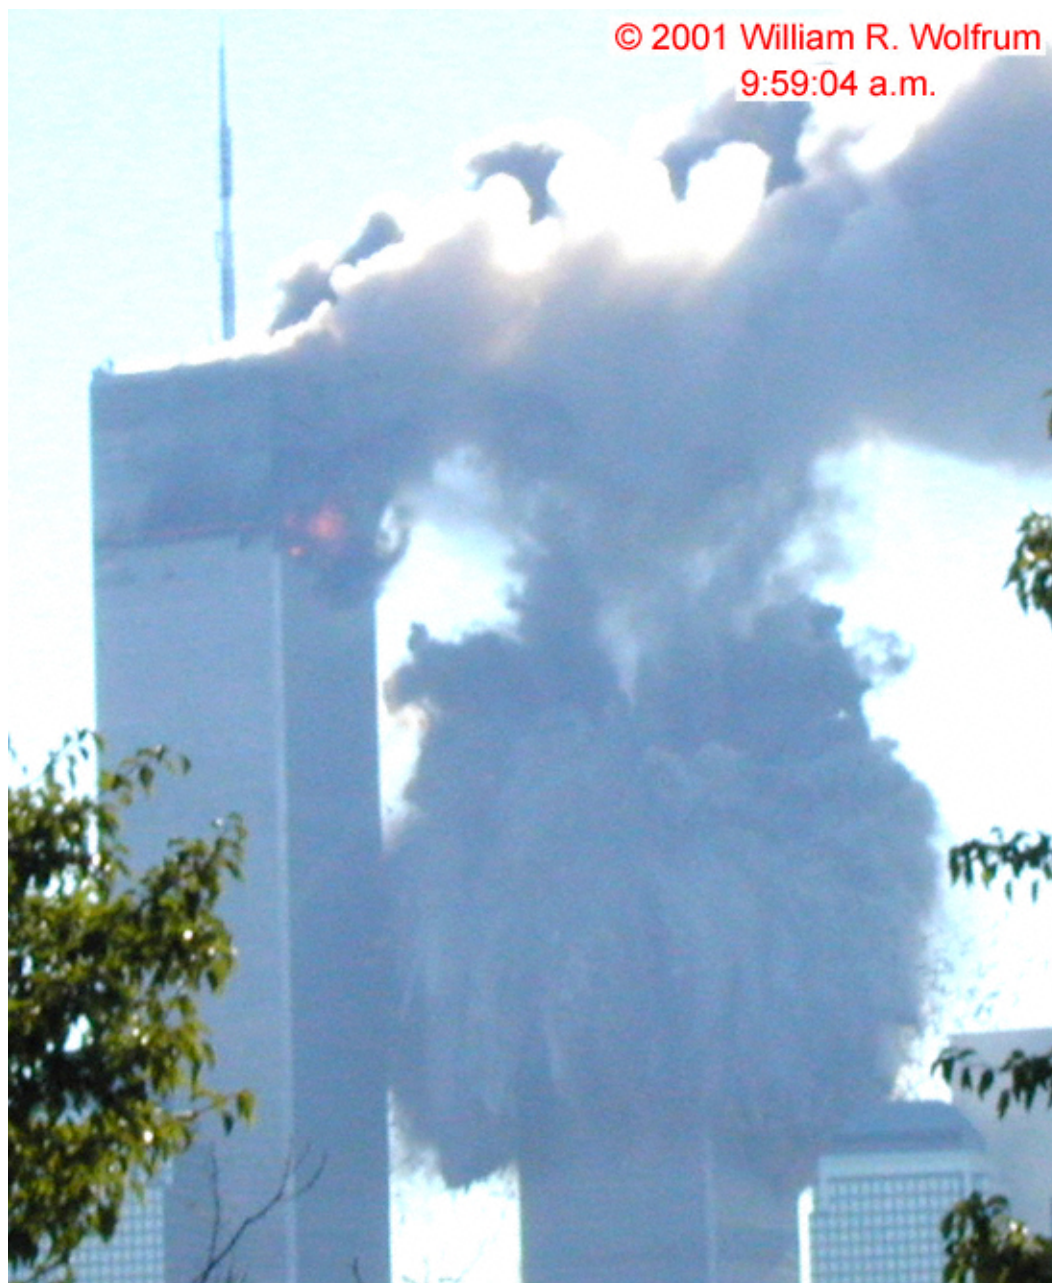
**Figure 8-79. This cropped photograph was shot from the southwest and shows WTC 1 and the collapsing WTC 2 at 9:59:04 a.m. The image was enhanced by adjusting the intensity levels, and some bright areas are saturated.**

Figure 8–79 includes a photograph that was shot at 9:59:04 a.m. and shows the flames coming out of the 98th floor windows while WTC 2 collapses nearby. Flames have also been pushed out of open windows on the 96th floor near the western edge of the south face. Fires are also visible on the west face of WTC 1 on the 94th, 96th, and 98th floors, but flames are not visible outside of the windows. In the photo it appears as if debris from WTC 2 is either striking WTC 1 or just passing by on the east side.

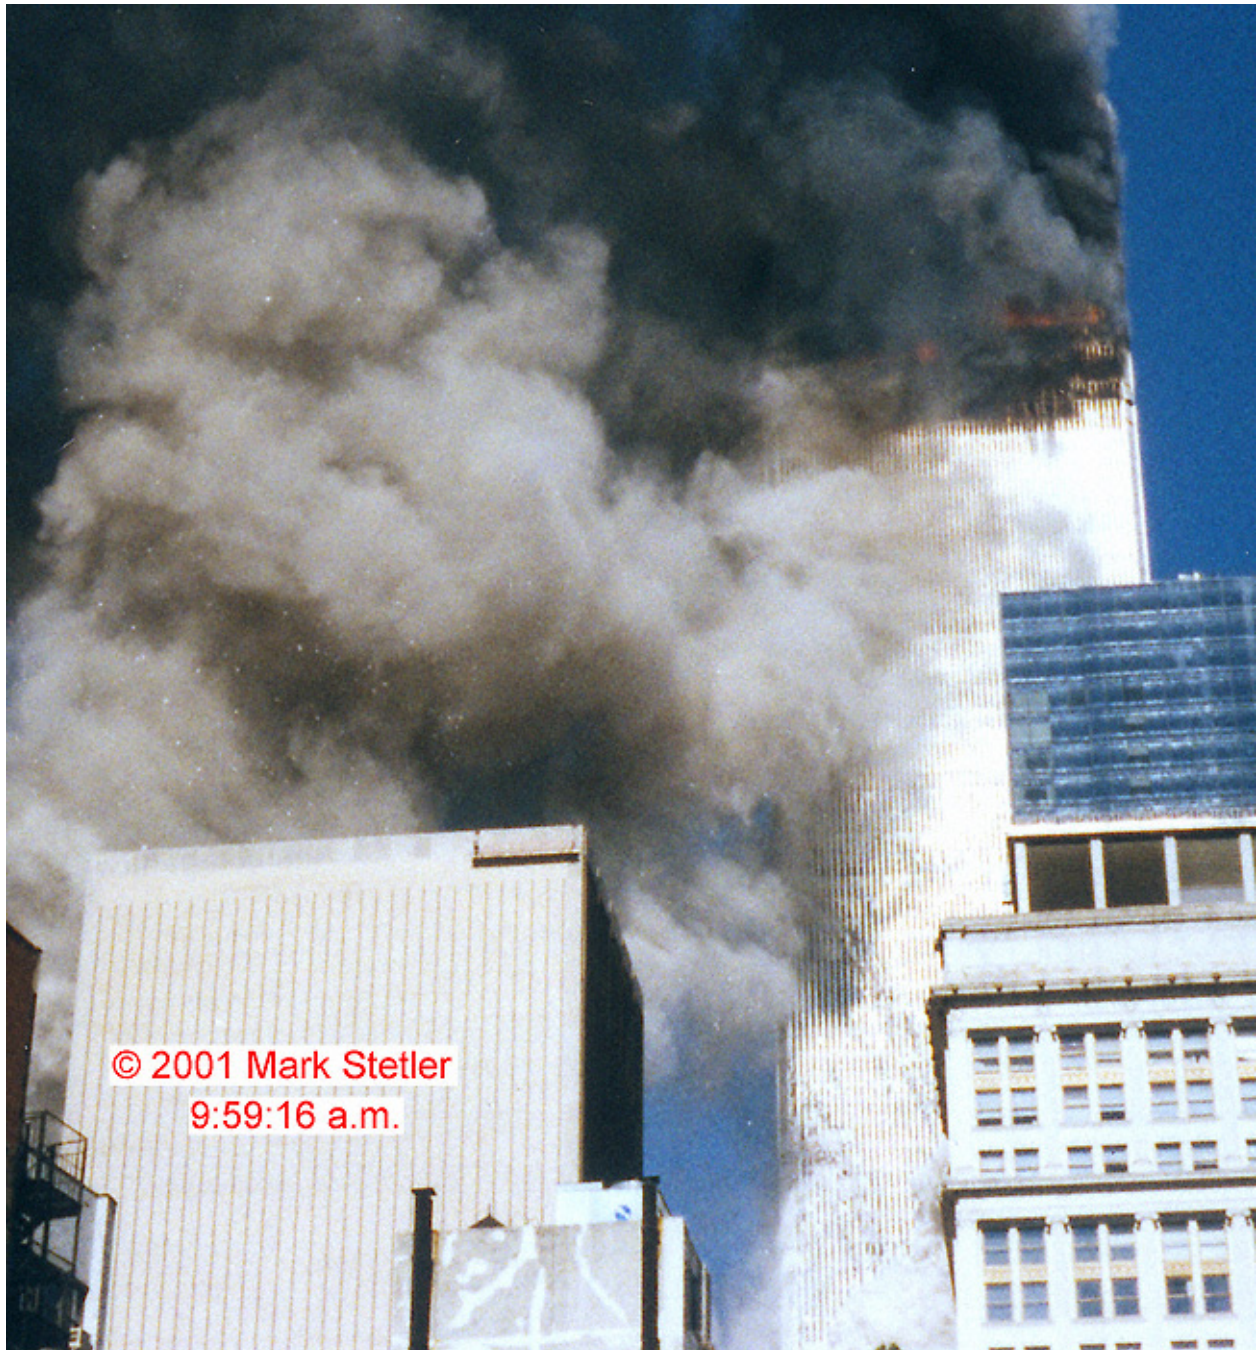
Videos shot from the east show that debris from WTC 2 did indeed pass in an arc across the east face of WTC 1. The damage created by this debris to the façade of WTC 1 can be seen in Figure 8–80 near the bottom of the photograph. This damage was only visible for a short period before dust rose upward from below and hid the area. The highest marks on the building are just below the mechanical equipment room on the 75th and 76th floors. The damage appears relatively superficial, and it is considered unlikely that it affected the subsequent fire behavior. Videos and eyewitness accounts indicate that large amounts of dust and some debris entered the lower floors of WTC 1 during the collapse of WTC 2. It is not known if damage at these lower locations could influence the fires near the top of the tower, but it seems unlikely.

**Figure 8-80.** This cropped photograph shows the east face of WTC 1 at 9:59:16 a.m., i.e., 17 s after WTC 2 began to collapse.

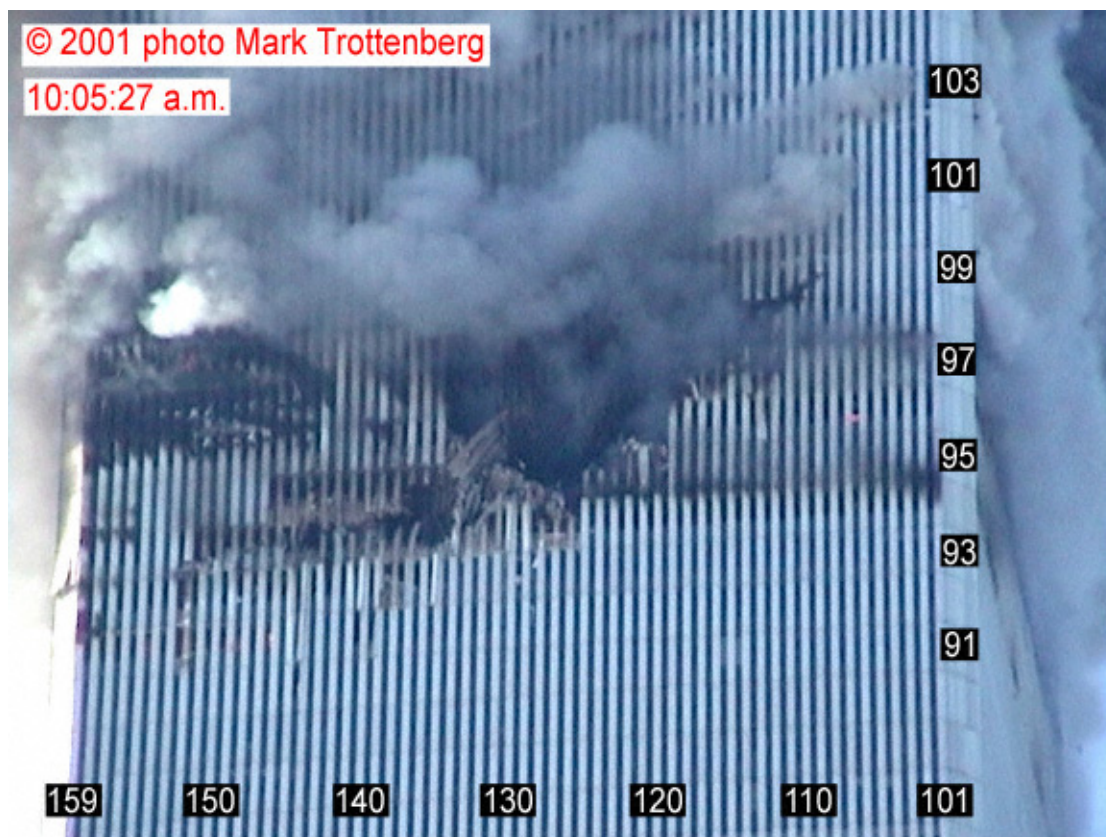
The most complete information during the current period is available for the north face of WTC 1. A view of this face at 10:05:27 a.m. is shown in Figure 8–81, which is a frame captured from a video. Remarkably little fire is visible in the image. Small flames are present near windows 92-146, 96-106, and 98-152. More extensive fires were evident at each of these locations at 9:57:59 a.m. (see Figure 8–55). Apparently, these fires had died down in the intervening seven and a half minutes.

**Figure 8-81.** This view of the north face of WTC 1 was captured from a video recorded at 10:05:27 a.m. The image has been enhanced by adjusting the intensity levels. Column and floor numbers have been added.

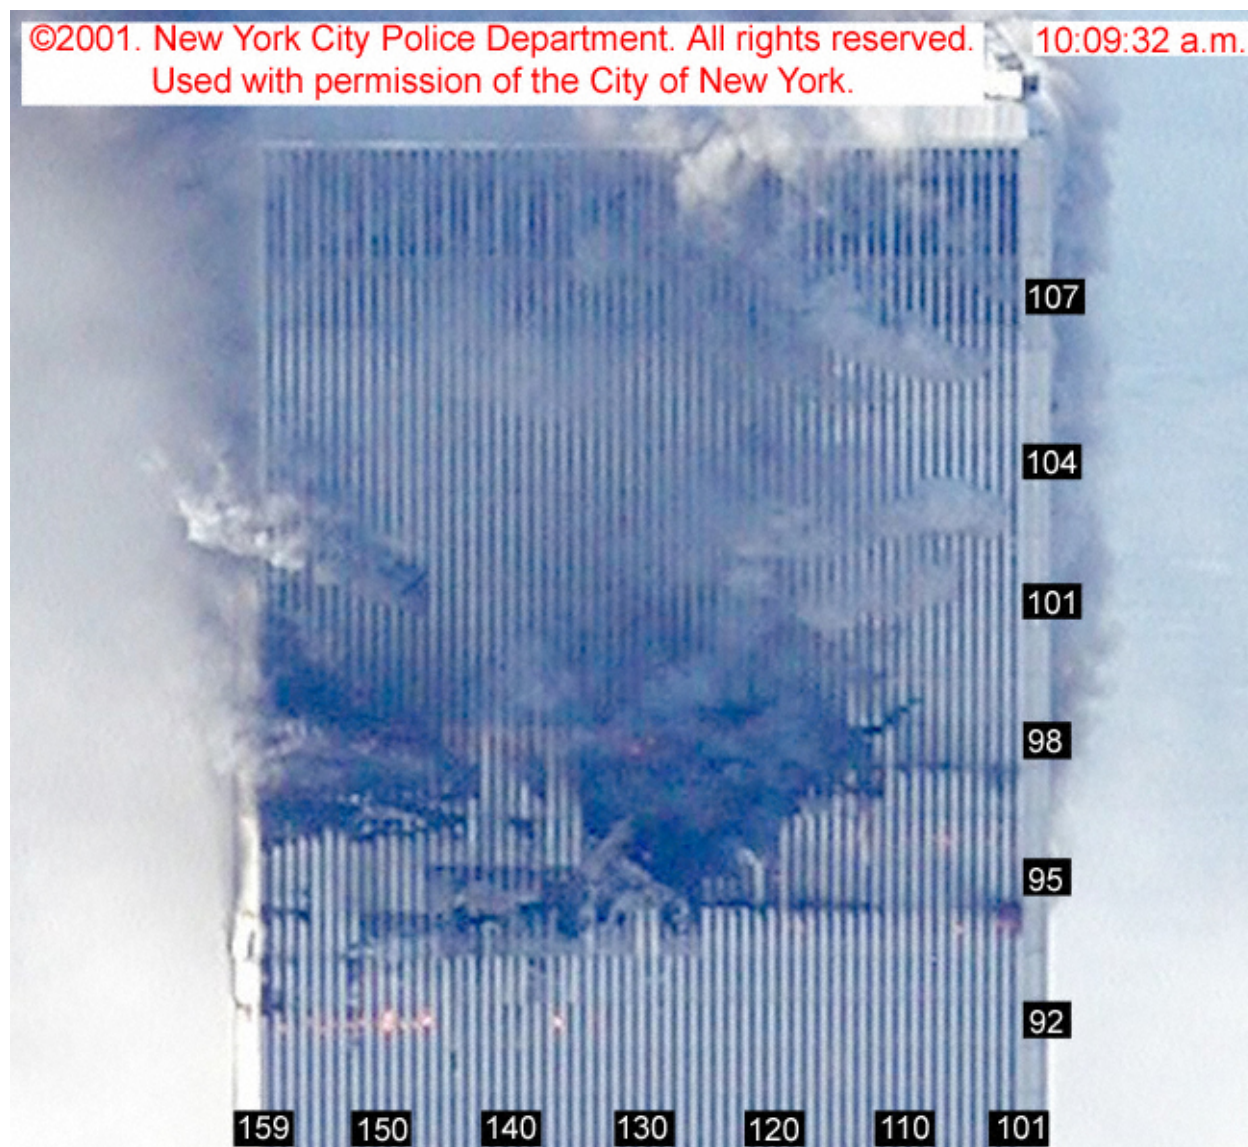
The photograph shown in Figure 8–82 was shot from a helicopter looking down on the north face of WTC 1 at 10:09:32 a.m. Considerably more flame is visible than could be seen in Figure 8–81. The difference is due to the angles from which the images were taken. The video frame shown in Figure 8–81 was taken from the ground a few blocks away from the WTC site, while the photograph in Figure 8–82 was shot from a much greater distance looking down into the windows. In effect, the latter photograph is looking much deeper into the building. On the 92nd floor a length of flames is evident extending from the eastern edge of the tower to window 92-146. At 9:57:59 a.m. flames were only visible as far as window 92-149. Windows further to the west were still intact. The fire has moved into the room that has walls terminating at columns 92-146 and 92-149 (see Figure B-1).

A single isolated flame is also evident at window 92-136, which indicates that the fire has apparently bypassed the next room to the west and entered the room with walls at columns 92-132 and 92-138. It has not been possible to determine exactly when this fire appeared, since it was not visible in videos shot from the ground around 10:08 a.m., but was easily seen just after 10:10 a.m.

Low intensity fires are also visible in Figure 8–82 on the west sides of the 94th and 96th floors and over much of the eastern half of the 98th floor. These are locations where much larger fires were present at earlier times, and these fires are likely the remnants. They were not visible from the ground around this time because they were low intensity and were burning near the floors, where they were hidden from view.

In Figure 8–82 there is no evidence of fire on the north face near the west edge of the 98th floor. At 10:10:15 a.m. a burst of heavy smoke was released from window 98-105, and less than two seconds later smoke came from window 98-102. A series of photographs taken around this time indicates that fire appeared in window 98-102 between 10:10:19 a.m. and 10:10:20 a.m. A photograph recorded at 10:10:55 a.m. showed flames were present in windows 98-101 to 98-108 and that flames were coming from windows on the adjacent west face.

**Figure 8-82. This cropped photograph was shot from a helicopter looking down on the north face of WTC 1 at 10:09:32 a.m. The intensity levels have been adjusted and column and floor numbers have been added.**
