**NIST NCSTAR 1-5A**

**Federal Building and Fire Safety Investigation of the  
World Trade Center Disaster**

**Visual Evidence, Damage Estimates,  
and Timeline Analysis**

September 2005

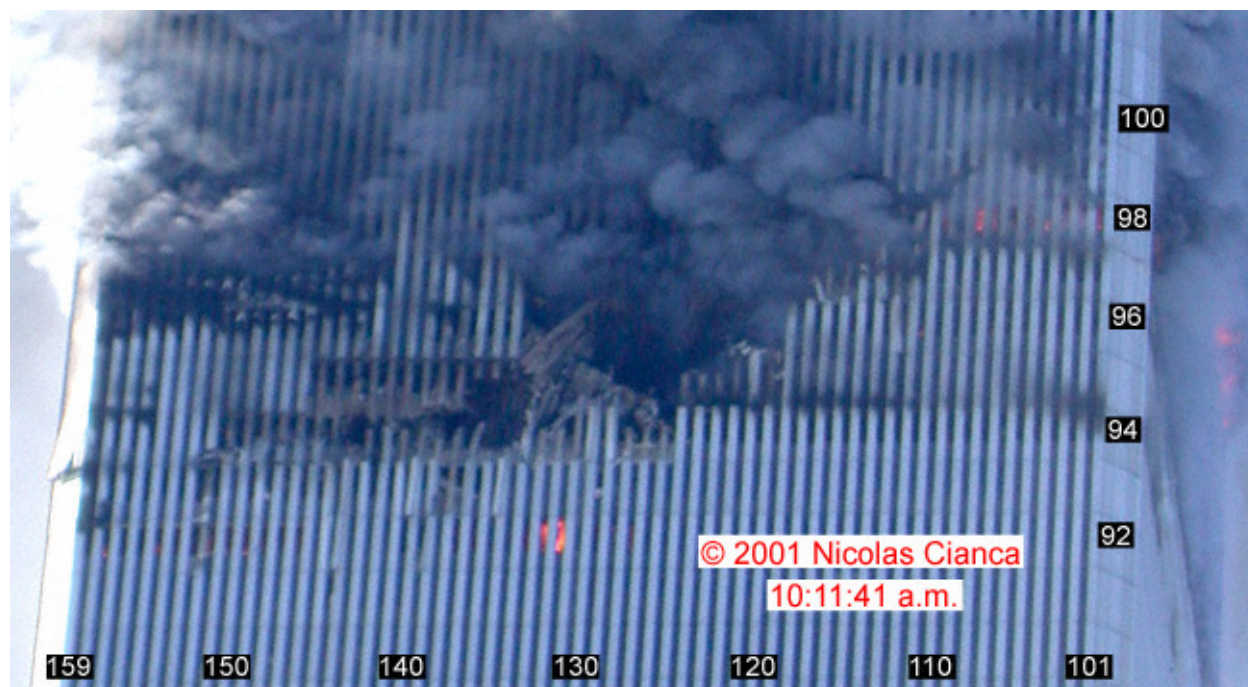
Figure 8-83 shows the north face at 10:11:41 a.m. The fire at the western edge of the 98th floor is visible in windows 98-101 to 98-110. On the 92nd floor there are bright flames present in windows 92-131 and 92-132. These two windows are on the west side of the room on this floor that has walls ending at columns 92-132 and 92-138 (see Figure B-1). The windows to the west of this point appear to still have glass in place. There appear to be some small fires on the east side of the 92nd floor, but flames are not observed elsewhere from this vantage point.

**Figure 8-83. This photograph shows the north face of WTC 1 at 10:11:41 a.m. The original image has been cropped, rotated, and adjusted for intensity levels. Column and floor numbers have been added**

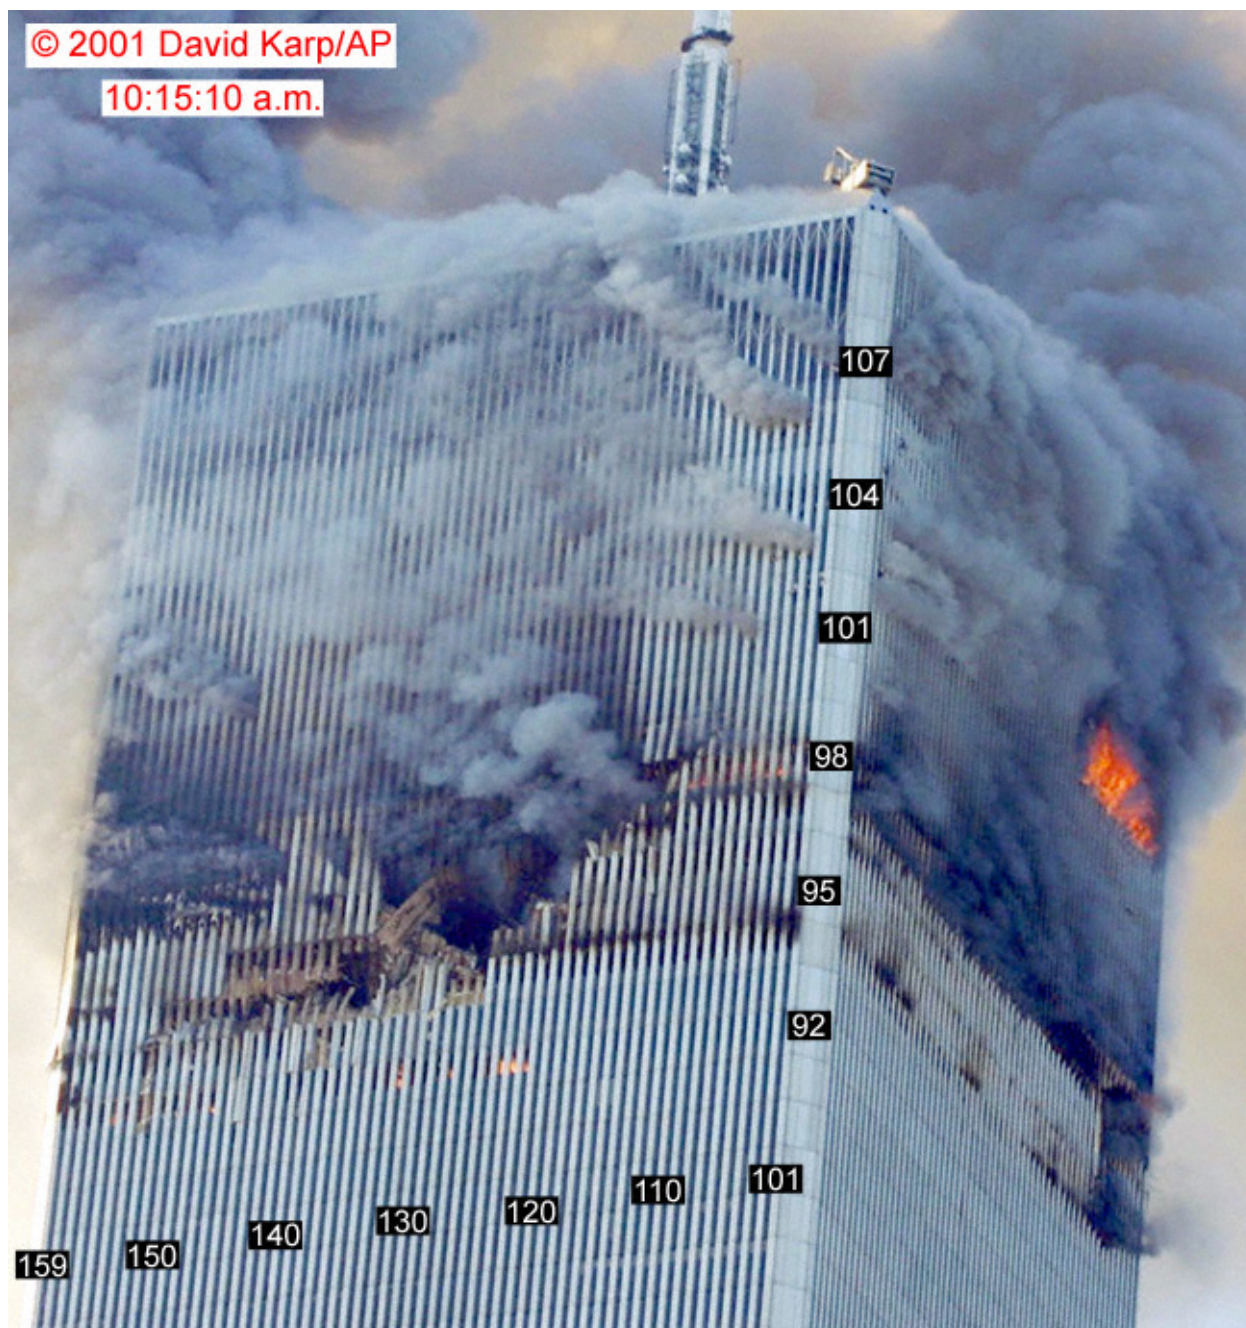
A view of WTC 1 shot from the northwest at 10:15:10 a.m. is shown in Figure 8–84. The fire on the north face of the 92nd floor has grown and moved toward the west. Flames are now visible as far west as window 92-121. As seen in Figure B-1, there was a large open area on the 92nd floor that ran between walls that terminated at columns 92-105 and 92-132. A fire is now burning on the east side of this open area, having apparently appeared in the room around 10:11:14 a.m. (see Figure 8–83). At the time the photograph in Figure 8–84 was taken, the glass for windows to the west of column 92-121 still appeared to be in place. It is interesting that even though a fire was growing in the area, there was no smoke coming from the open windows. This must be another case where the smoke was venting elsewhere.

**Figure 8-84.** This photograph of WTC 1 shows the north and west faces of WTC 1 at 10:15:10 a.m. The image has been cropped and rotated, and the intensity levels have been adjusted. Column and floor numbers have been added.

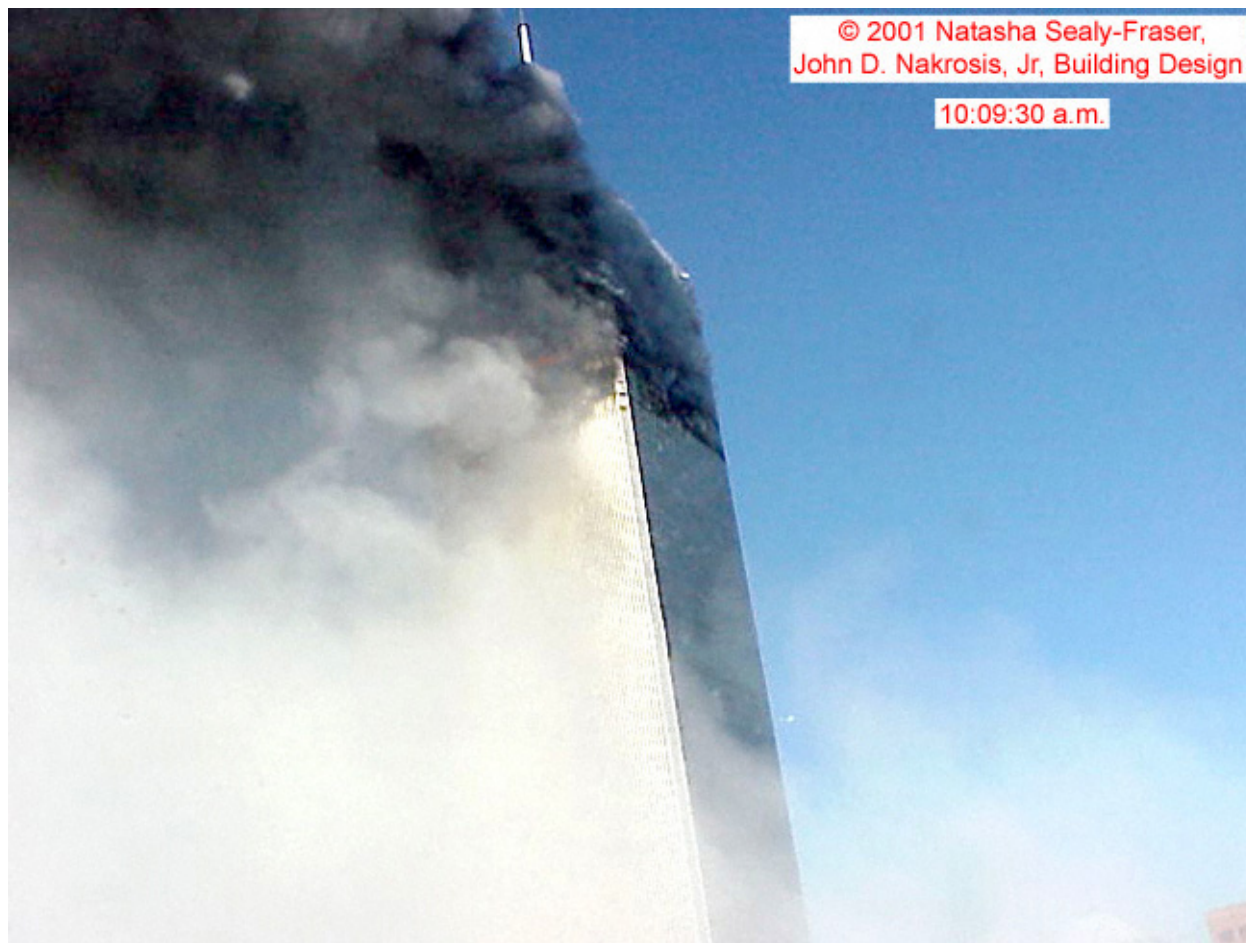
**Figure 8-85. This photograph shows the east and north faces of WTC 1 at 10:09:30 a.m. The intensity levels have been adjusted.**

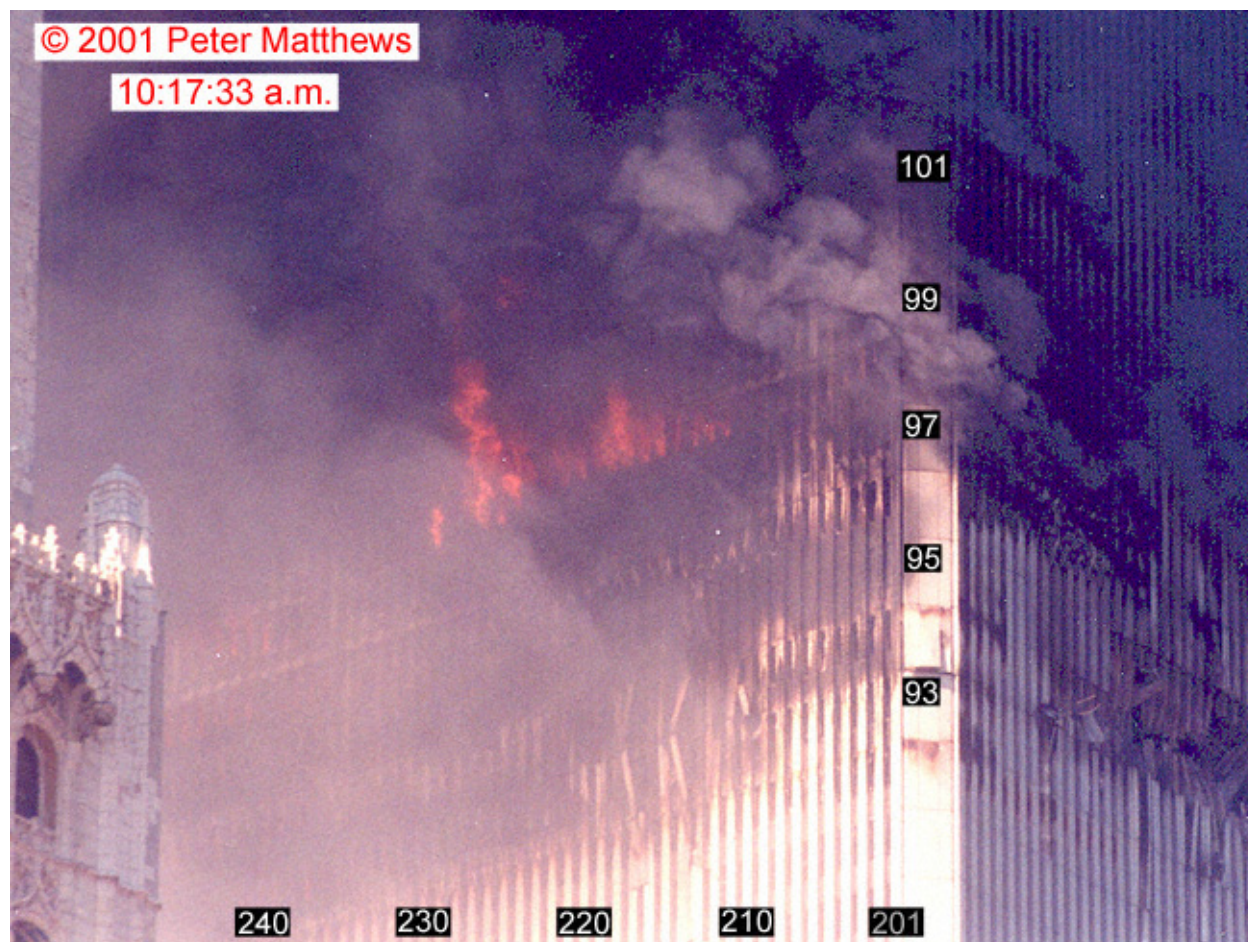
Flames are also visible on the 96th and 97th floor extending south from near windows 96-240 and 97-240 to the last windows (96-245 and 97-245) that can be seen in the image. Closer inspection of Figure 8–86 shows what appears to be a small fire on the 101st floor near window 101-224. There is some ambiguity

because of the flames coming from below, but the fire visible higher up seems to be well isolated. This observation suggests that fire has spread upward on the east face by jumping over a couple of floors.

**Figure 8-86.** This photograph shows the north and east faces of WTC 1 at 10:17:33 a.m. The original has been cropped and enhanced by adjusting the intensities. Column and floor numbers have been added.

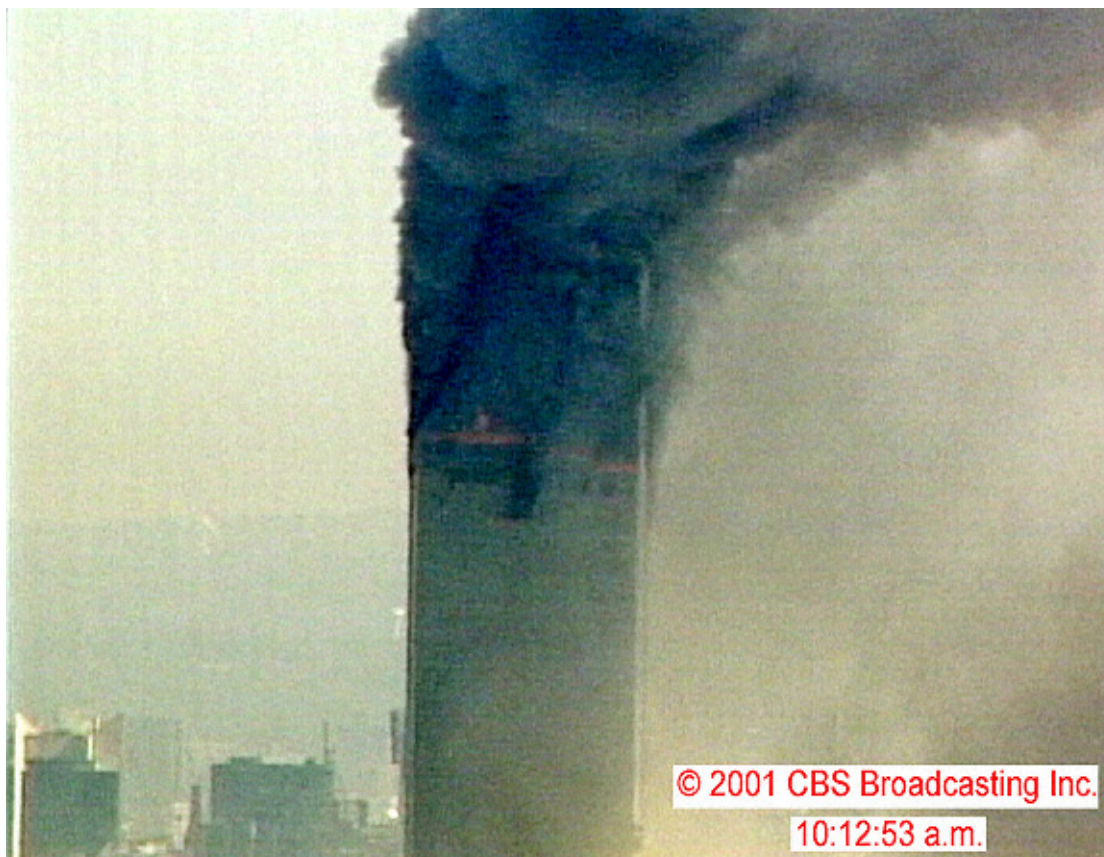
Figure 8-87 shows one of the clearer views of the south face captured from the news helicopter video. It was shot at 10:12:53 a.m. With one major exception, fires are distributed much as described above. The bright flames on the east sides of the 96th and 97th floors and the west side of the 98th floor are easily seen. In addition, an intense jet of flame is apparent on the west side of the face. This external flame, which is over a story tall, appears to be coming from the 99th floor. This is an indication that the fires had now progressed upward to this floor. Near the center of the face, there is a smoke plume coming from one of the lower floors. It is difficult to be sure, but this smoke appears to be coming from the 92nd floor. If correct, this suggests that a fire was burning on the south side of the 92nd floor.

**Figure 8-87. This view of the south face of WTC 1 was captured from a video recorded by a news helicopter at 10:12:53 a.m. The image has been enhanced by adjusting the intensity levels.**

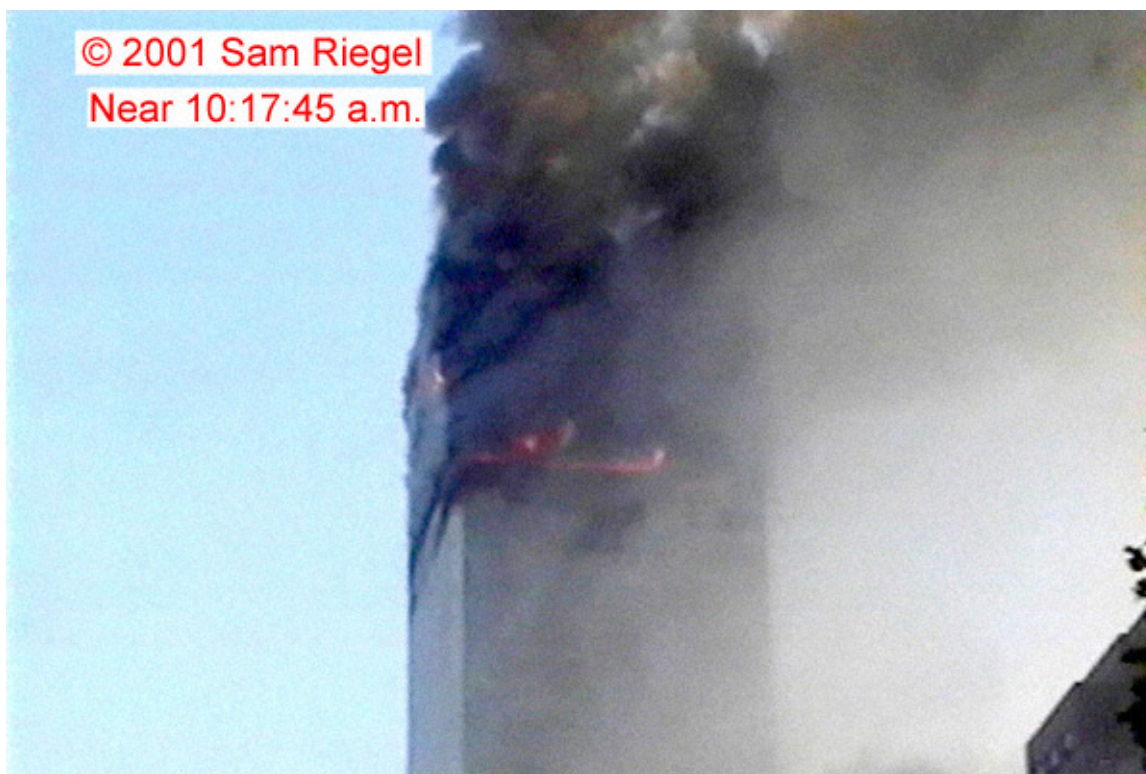
the video shot from a news helicopter. There is a relatively large uncertainty associated with this assignment since many of the views from the helicopter video around this time were taken from such a distance that the fires were not visible. A frame captured from this video is shown in Figure 8–88. It provides additional support for many of the observations based on Figure 8–87.

The line of fire on the 98th floor is still quite distinct. There is an intense external flame on the eastern side of this fire located at a point to the east of the center of the face. This fire appears to be moving toward the east. Two tongues of flame are evident coming from the floor above, i.e., the 99th floor, near the center of the western half of the south face. The video shows that the entire region between the two tongues of external flames is involved. The fire on the 97th floor on the eastern side of the face is just barely visible. Flames are not visible on the 96th floor. The smoke plume coming from windows lower down near the center of the face is also visible. Even though individual floors are not resolved in this image, the location of the smoke relative to other details indicates that it is indeed coming from the 92nd floor.

**Figure 8-88.** This image shows the south face of WTC 1. It was captured from a video shot from the ground and has been enhanced by adjusting the intensity levels. The estimated time of 10:17:45 a.m. is based on a comparison of the fire distribution with a video recorded from a news helicopter and could be off by as much as a few minutes.

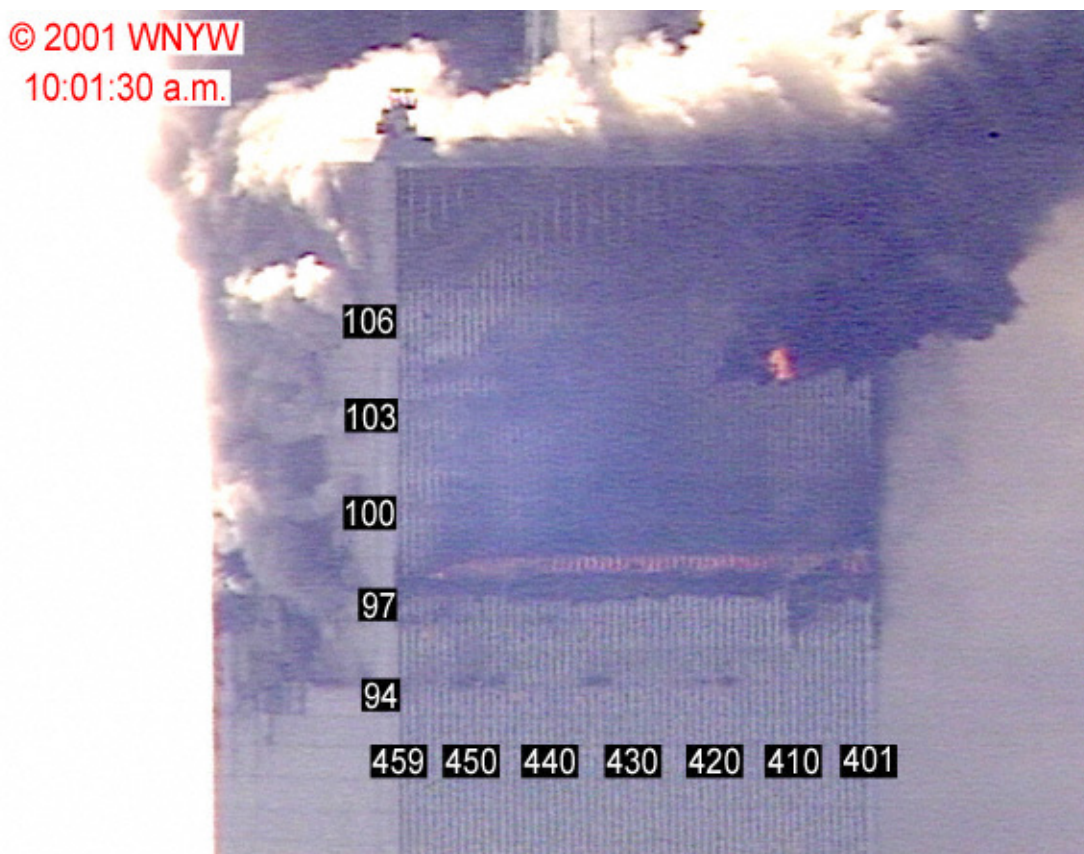
Figure 8-89 shows an image of the west face shot from a news helicopter at 10:01:30 a.m. The flames on the 104th floor are coming from several windows centered near window 104-411. Heavy black smoke is venting from multiple windows over a much larger area. It is informative to compare the appearance of the smoke in Figure 8-89 with that in Figure 8-74, which shows the west face at 9:56:10 a.m. The smoke has clearly become much heavier and darker.

**Figure 8-89.** This image of the north and west faces of WTC 1 is a frame captured from a video recorded by a news helicopter at 10:01:30 a.m. The image has been enhanced by adjusting the intensity range, and some areas are saturated. Column and floor numbers have been added.

The deep orange glow along the 98th floor in Figure 8–89 indicates that the interior fire on this floor is continuing to burn along much of the length of the west face. The fire on this floor has moved north since around 9:58 a.m. Flames can now be seen as far as window 98-455. The floor plan layout shown in Figure B-7 indicates that there were two rooms along the west face in the northwest corner of the 98th floor. Fire has entered the southernmost of these rooms, which had interior walls at columns 98-452 and 98-456. There is as yet no visual evidence for fire on the west side of the corner room with walls at columns 98-456 and 98-108.

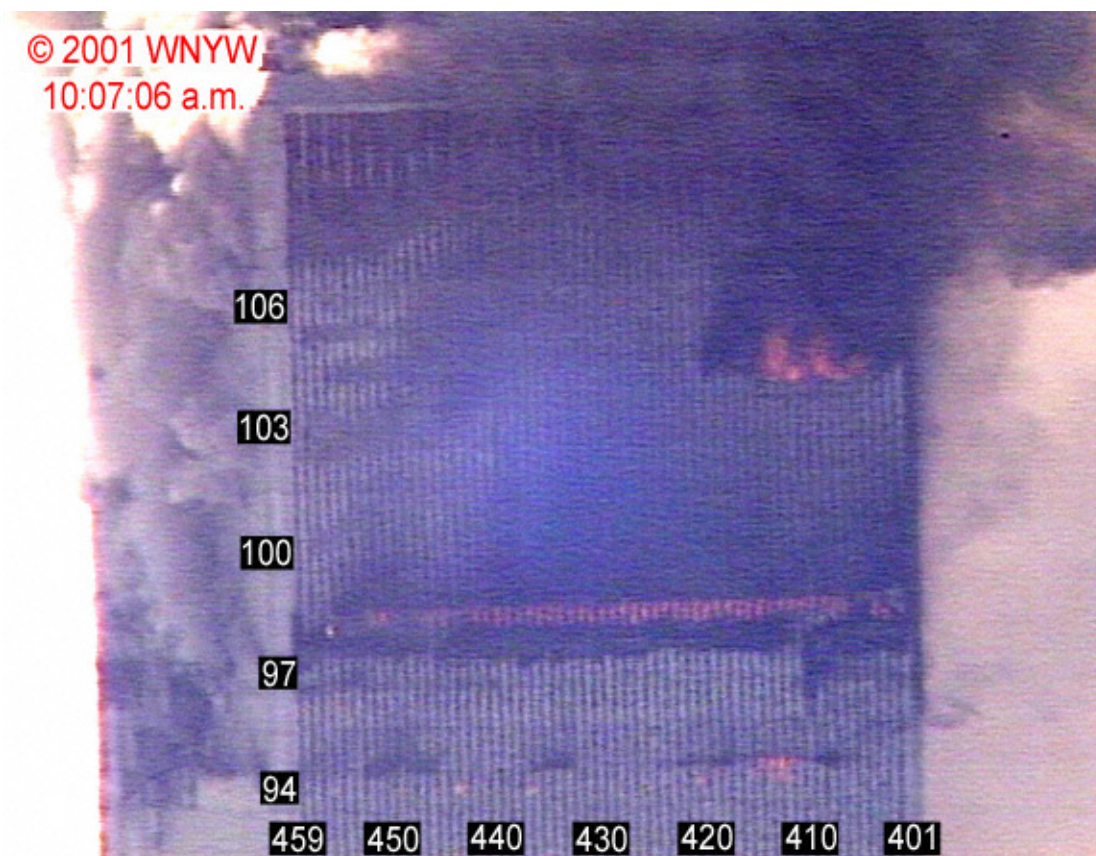
Another view of the west face taken from a video shot from one of the news helicopters at 10:07:06 a.m. is shown in Figure 8–90. The fire on the 104th floor is still raging, with flames coming from windows 104-404 to 104-414. On the 98th floor the deep orange glow from the internal fire is still present along nearly the entire length. A small flame extends from window 98-455, but the fire does not yet appear to have moved into the room on the northwest corner. On the 94th floor the most intense fire is observed in windows 94-412 to 94-414. Smoke is also evident coming from window 94-408. This smoke had appeared abruptly six seconds earlier.

**Figure 8-90.** This image of the north and west faces of WTC 1 is a frame captured from a video recorded by a news helicopter at 10:07:06 a.m. The image has been enhanced by adjusting the intensity range, and some areas are saturated. Column and floor numbers have been added.

In Figure 8–90 there is no visual indication of fire on the west side of the 95th floor. However, the summary of observations of falling people in Appendix M provides evidence that fires were moving into the area. At 10:06:11 a.m. a person fell from the west side of the 95th floor. During the next minute and forty-five seconds 12 more people fell from the same floor. For some of these people, the windows that they fell from have been identified. They ranged from window 95-424 to window 95-428. These windows were closed at 9:40:14 a.m. as seen in Figure 8–70.

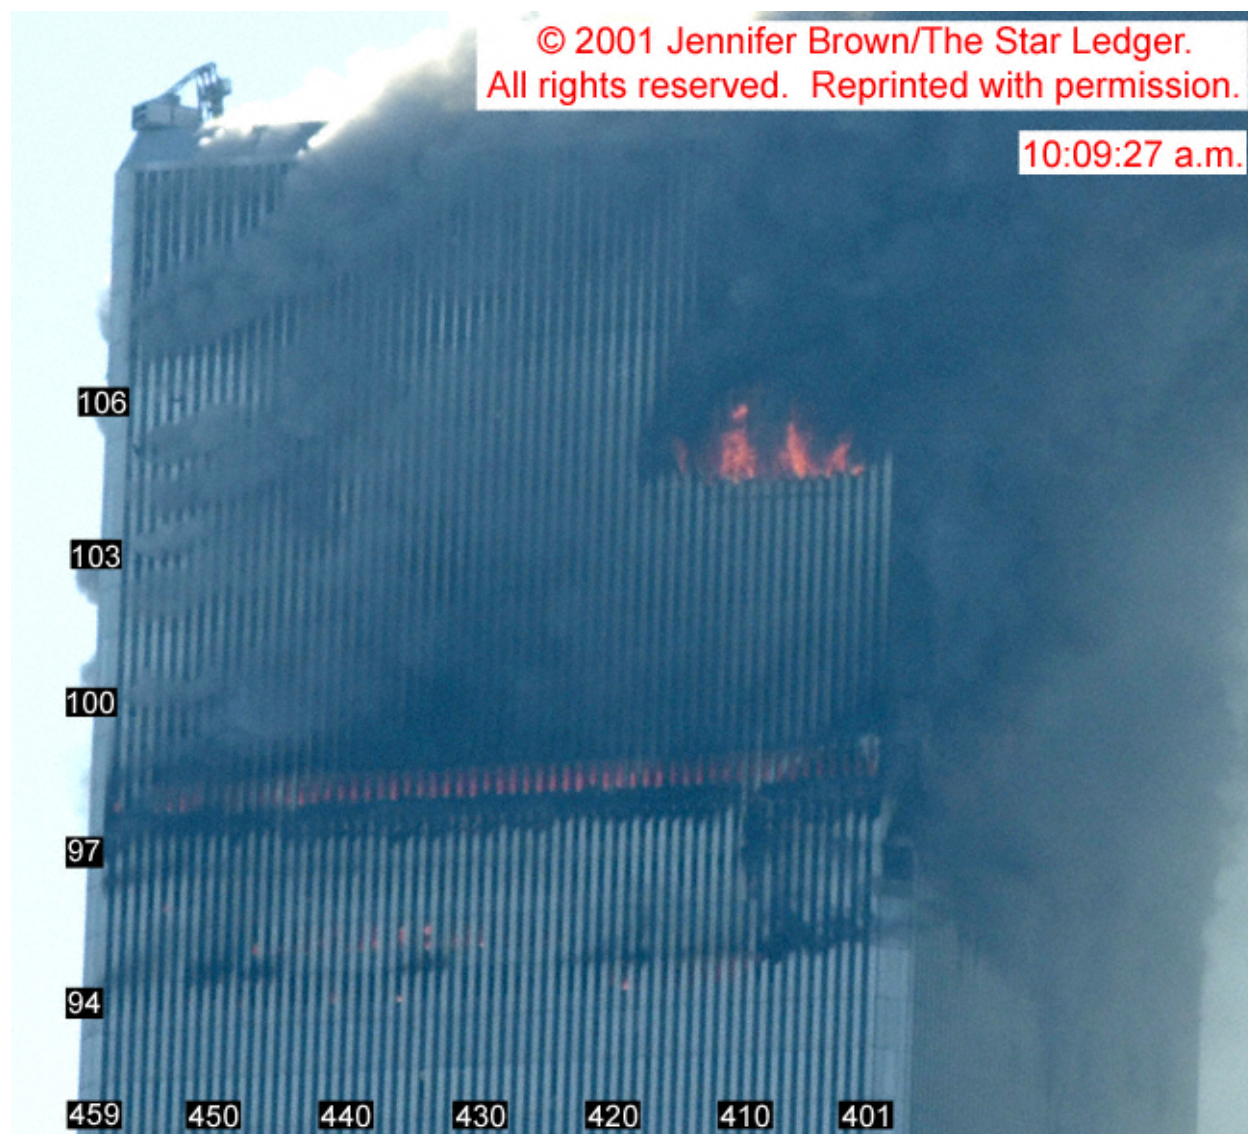
Figure 8–91 shows a photograph of the west face recorded shortly afterward at 10:09:27 a.m. Flames are visible on the 95th floor in windows 95-430 to 95-447. A video of the west face indicates that fire was present as far south as window 95-425 by 10:10:10 a.m. The images indicate that an extensive fire that had not been visible three minutes earlier appeared over a large length of the west side of the 95th floor.

The sudden appearance of such an extensive fire has two possible explanations. The first is that the fire grew rapidly in place from smaller fires that were initially hidden from the outside. Such rapid fire

**Figure 8-91.** This photograph, showing the west face of WTC 1 and an oblique view of the south face, was recorded at 10:09:27 a.m. The image has been cropped and enhanced by adjusting intensity levels. Column and floor numbers have been added.

growth has been observed when nearby windows are broken or interior walls are breeched. The other explanation is that a fire burning over a broad section of the floor spread from interior regions of the tower toward the west wall. A review of the floor plan layout for this floor shown in Figure B-4 indicates that there were no separated rooms with interior walls along the west face of the floor, except at the corners. These fires were growing in a large open space. The absence of walls and the fact that the area was tenable immediately prior to the fire becoming visible support a conclusion that the fire spread to the west face from interior locations on this floor. Recall that fires had previously been visible on this floor on both the east and south faces (see the earlier discussion).

The orange glow seen in Figure 8–91 over much of the 98th floor indicates that the interior fire present on this floor continued to burn at this time. By entering the room on the northeast corner around 10:10 a.m., this fire had completed its spread across the entire west side of the floor. Recall that the fire had entered the adjacent room with walls at columns 98-252 and 98-256 (see Figure B-7) around 10:00 a.m.

Small areas of isolated flames can be seen in several windows on the 94th floor in Figure 8–91. There appears to be a somewhat larger fire present at window 94-408 and windows immediately to the north. The smoke stream that appeared at 10:07:00 a.m. from window 94-408 is still apparent. Windows to the south appear to be intact. The fact that the fire did not appear to move south in the nearly 150 s period between these images is somewhat surprising because the floor plan layout (see Figure B-3) indicates that the fire was burning in a room with walls at columns 94-405 and 94-417. The fire might have been expected to spread to the southern wall of this room. Videos shot from the west indicate that the stream of smoke coming from window 94-408 was present until the end of the current period at 10:18 a.m.

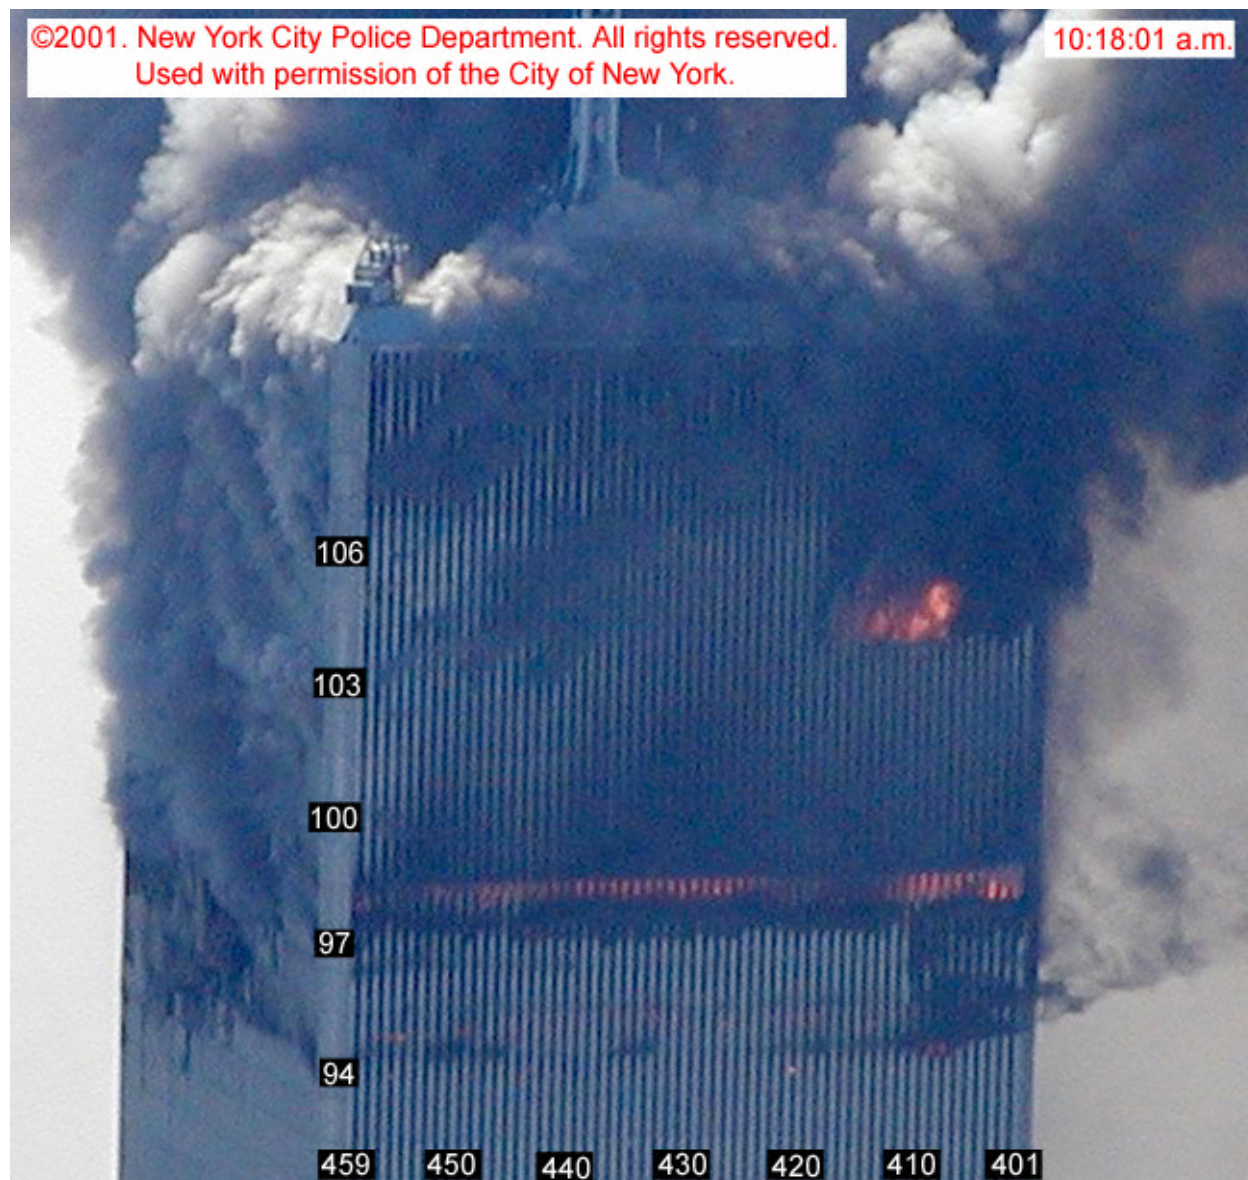
Figure 8–92 shows an image of the west face of WTC 1 recorded at the end of the current time period at 10:18:01 a.m. With a few exceptions, the appearance is similar to that seen around 10:10 a.m. The fire on the 95th floor has spread in both directions across the face. Low intensity flames can be seen in windows over a length from window 95-413 to window 95-455. Even though the fire extends over a long length of the face, there is very little smoke, and there are no flames coming from the windows on this

floor. The absence of significant smoke marks on the column covers near the tops of the windows is consistent with these observations. Based on the floor plan layout shown in Figure B-4, the fire on this floor has penetrated the room with walls at columns 95-452 and 95-456, but there is no indication that it is yet inside the room on the northwest corner with walls at columns 95-456 and 95-108.

**Figure 8-92.** This cropped photograph of the west face of WTC 1 and an oblique view of the north face was shot at 10:18:01 a.m. The image was enhanced by adjusting the intensity levels, and column and floor numbers have been added.

Relatively small fires are observed at several locations on the 94th floor. Heavy smoke continues to come from window 94-108. In fact, heavy smoke and fire are apparent at windows 94-108 and 94-109. The fire on the 98th floor can still be seen across most of the west face, and it is still primarily an interior fire. Heavy smoke and flames continue to come from the fire on the 104th floor. The location of this fire appears to be the same as at 10:10 a.m.

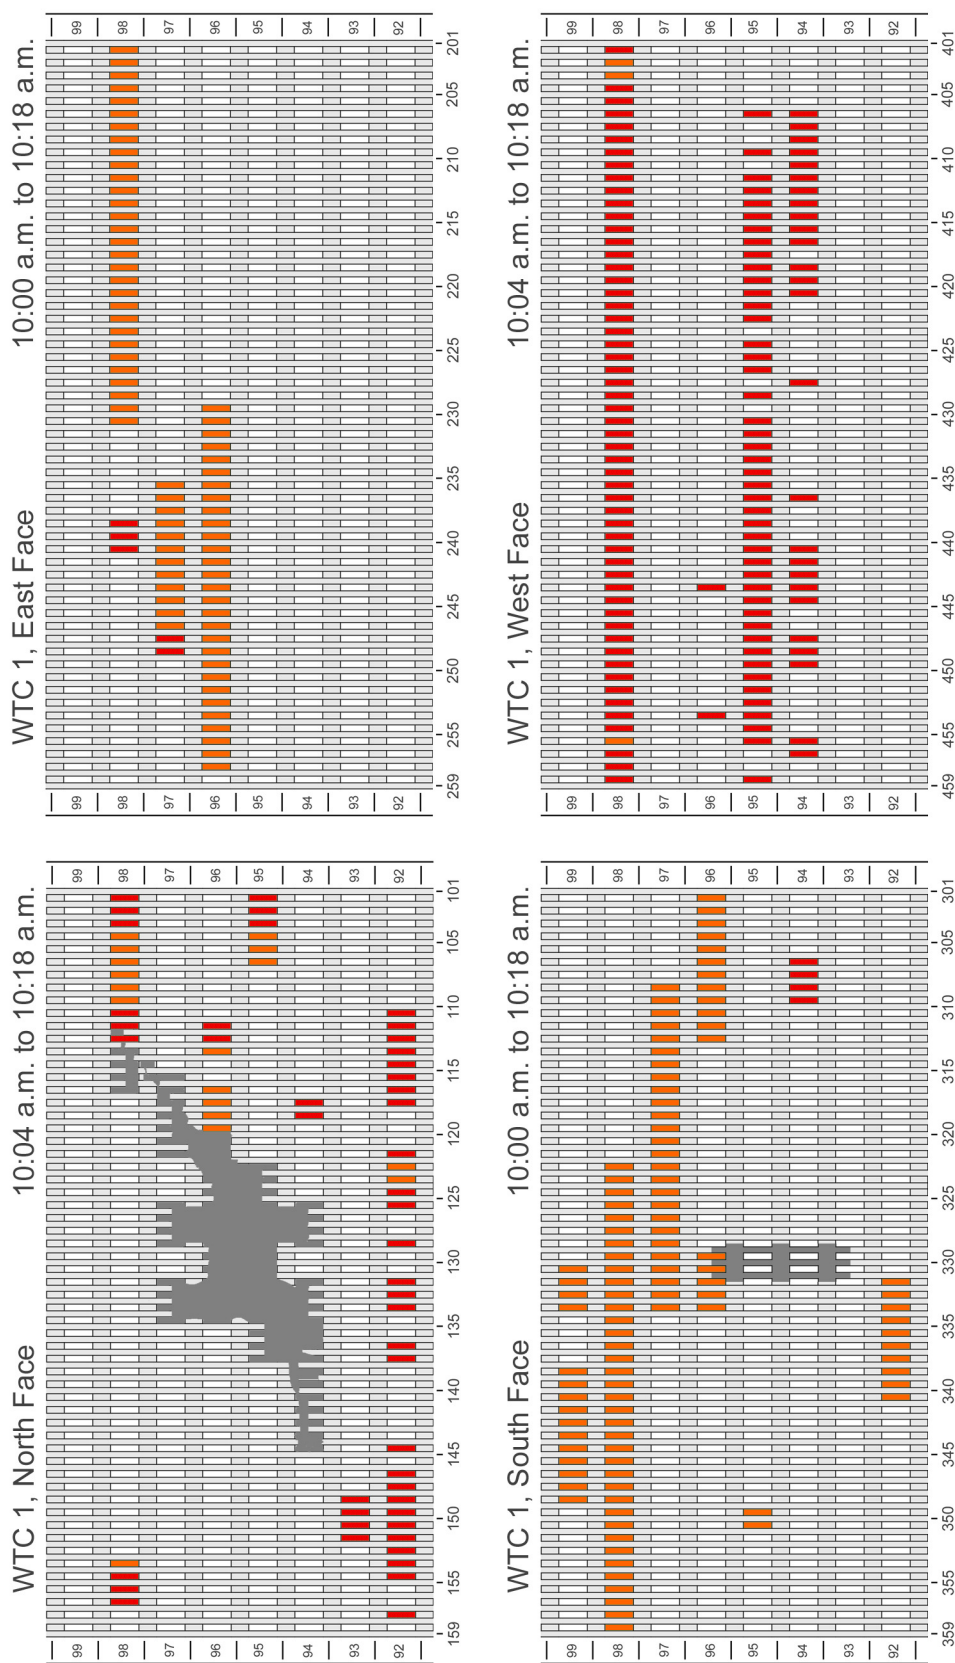
The most prominent feature of the fire growth on the west face was the appearance (not included in Figure 8–93) of an intense fire with extended flames on the 104th floor shortly after the collapse of WTC 2. This fire continued to burn intensely during the entire period. The fire on the 98th floor continued moving toward the north, reaching the north face during the period. A relatively low-intensity fire appeared on the 95th floor and subsequently covered a large fraction of the floor across the face. The fire burning on the 94th floor continued to spread toward the south early in the period, but then seemed to halt near window 94-108 for several minutes.

**Figure 8-93. Maps of integrated fire observations between 10:00 a.m. and 10:18 a.m. are shown for the four faces of WTC 1. Colors represent the highest intensity fire observed in a window using the color scale defined in Figure 5-1.**

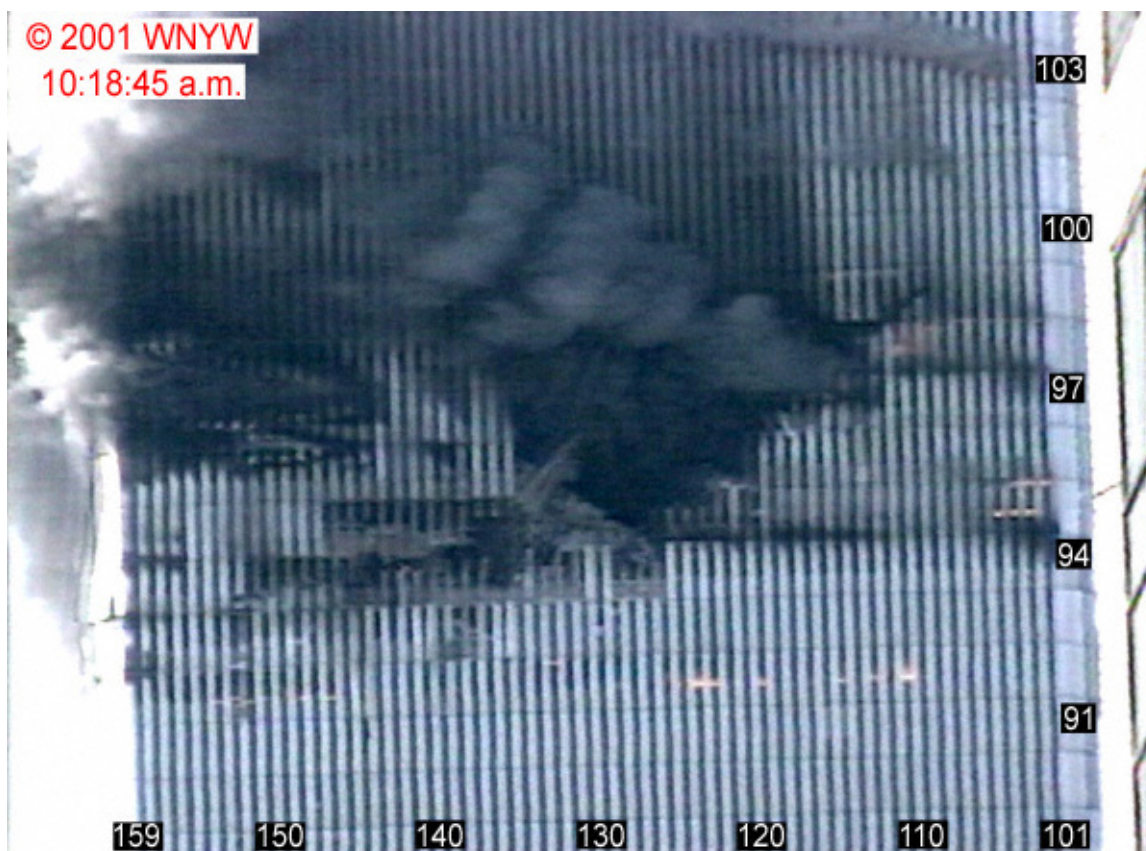
Figure 8–94 provides a view of the north face of WTC 1 at 10:18:45 a.m. Comparison with Figure 8–84 shows that, during the just over three and a half minutes between the images, the fire on the 92nd floor continued to move toward the west. In the later image fire is visible as far west as window 92-110. At the earlier time windows to the west of window 92-120 appeared to be intact, with fire present in window 92-121. Despite the presence of flames over a significant length of the floor, the fires appear to be burning at low levels at separated locations. There is essentially no smoke coming from the open windows on the north side of the floor. This indicates that the smoke is likely venting elsewhere.

**Figure 8-94.** This image of the north face of WTC 1 was captured from a video shot at 10:18:45 a.m. It has been enhanced by adjusting the intensity range. Some portions of the image to the left of the tower are saturated. Column and floor numbers have been added.

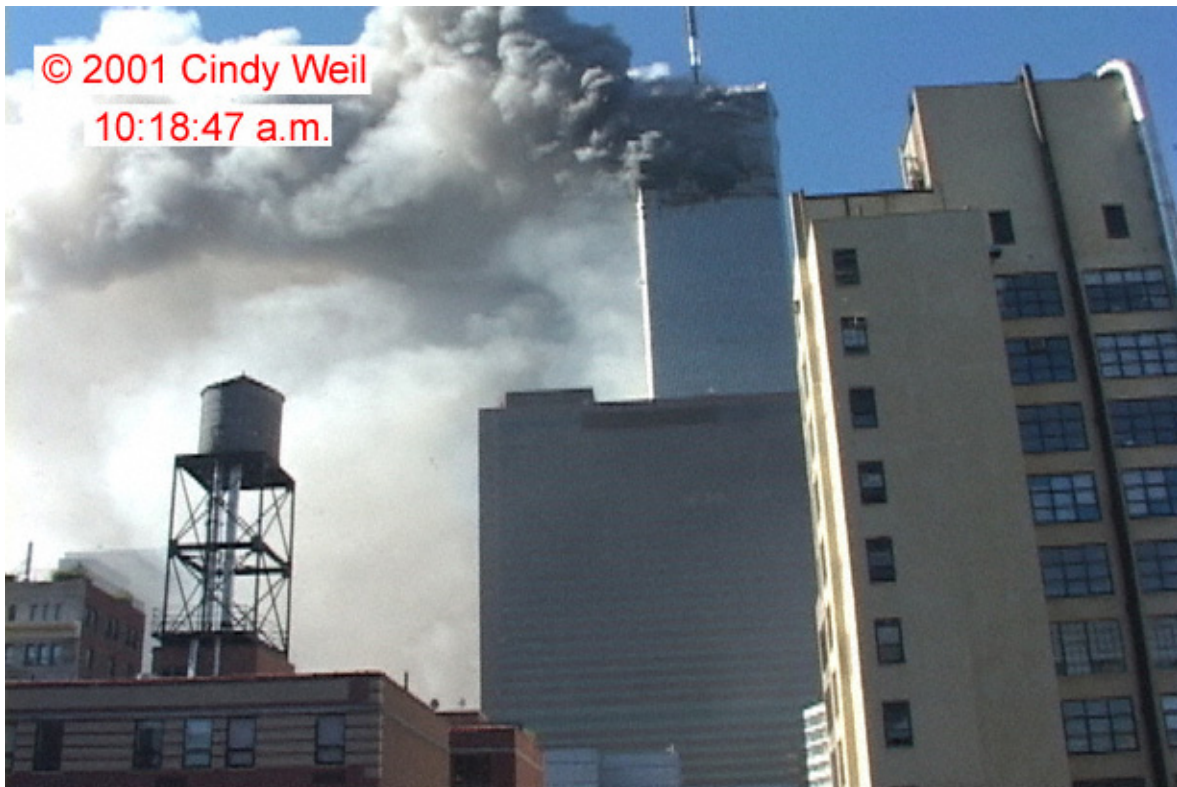
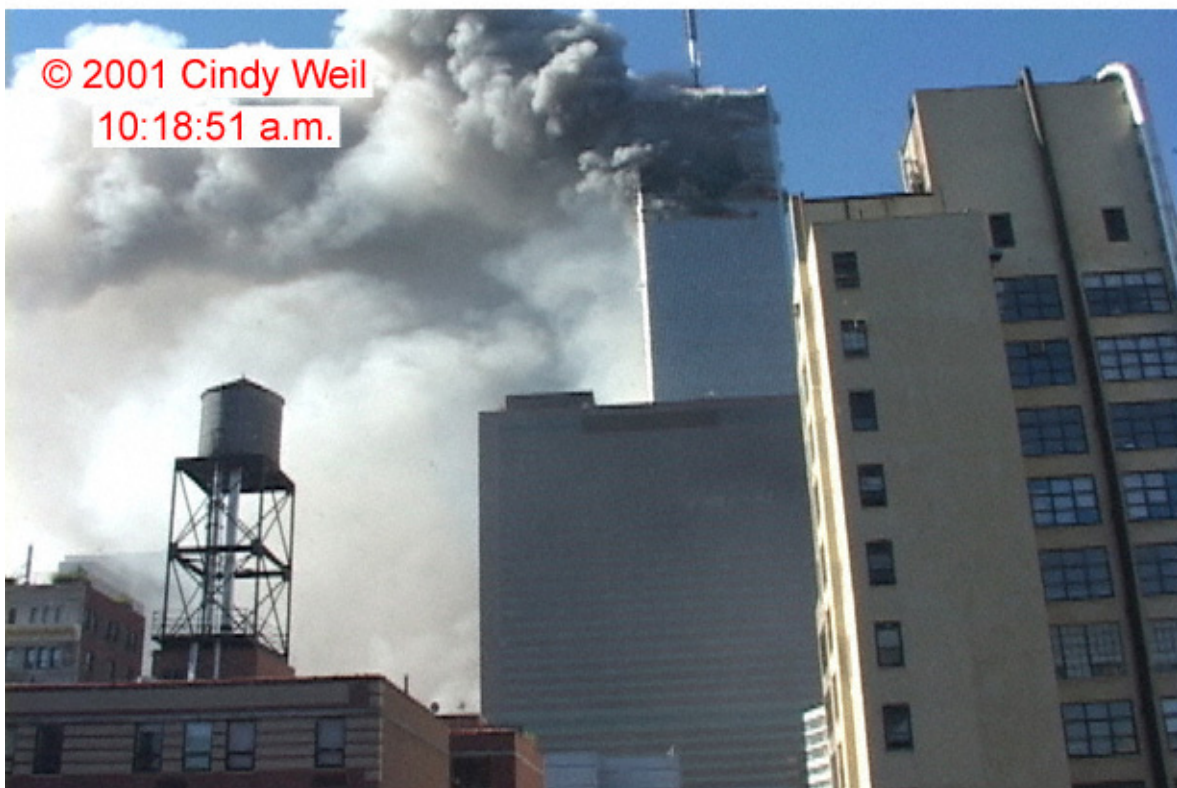
At 10:18:48 a.m. an event took place within the tower that created a pressure pulse of sufficient magnitude to force smoke out of numerous windows on the north face, as well as from the other faces. The most obvious effect of this pressure pulse was the release of a dense line of smoke along a length of the 92nd floor on the north face, extending from roughly window 94-110 to window 94-139. This smoke release was evident in numerous videos, including a number shot at great distances. Figure 8–95 compares two frames taken from a video showing the north face just prior to the smoke release and the appearance just over 4 s later. Even though the video was shot from a distance, the line of smoke that has appeared from the 92nd floor is readily apparent. It is significant that until this time very little smoke had been observed coming from the open windows on this floor, even though fires had been burning on the floor for some time.

Closer inspection of this video, as well as others, shows many additional effects of the pressure pulse at other locations on the tower. Smoke and/or dust were pushed out of windows on the east side of the north face at the 94th floor. This material is responsible for the light-colored “smoke” seen near the eastern edge of the building immediately above the darker smoke released from the 92nd floor in Figure 8–95.

**Figure 8-95. Two images of the north face of WTC 1 captured from a video are shown. The times are 10:18:47 a.m. and 10:18:51 a.m.**

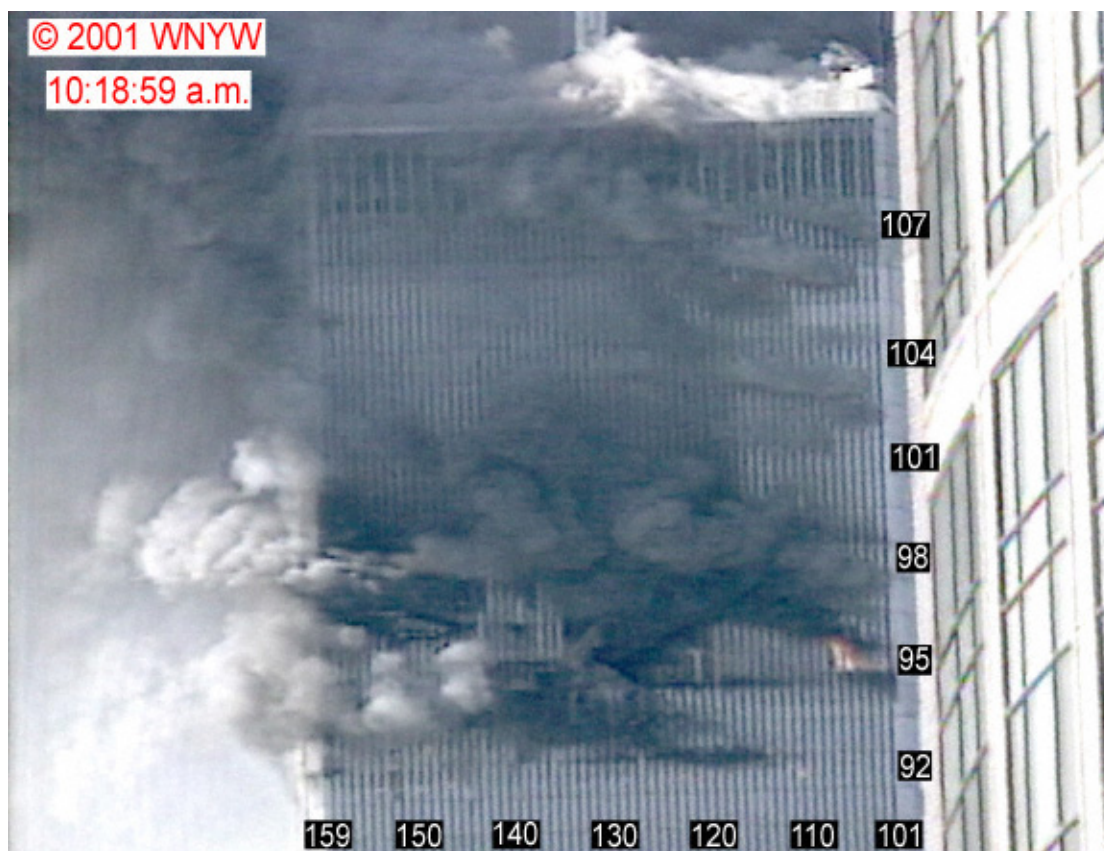
Figure 8-96 shows a closer view of the north face recorded at 10:18:59 a.m. This image is taken from the same video as Figure 8-94, which was recorded 14 s earlier. The effects of the changes in the smoke and fire described above are easily seen. The black line at the tops of the column covers on the 92nd floor created by the smoke release is visible. The fire on the western edge of the 95th floor has grown dramatically, and flames now extend from windows 95-105 and 95-106. Heavy smoke is now coming from windows on the 95th floor as well as windows at the western edge of the face on the 96th and 97th floors. Smoke is also now flowing from window 102-101 on the 102nd floor.

**Figure 8-96.** This image of the north face of WTC 1 was captured from a video shot at 10:18:59 a.m. It has been enhanced by adjusting the intensity range. Column and floor numbers have been added.

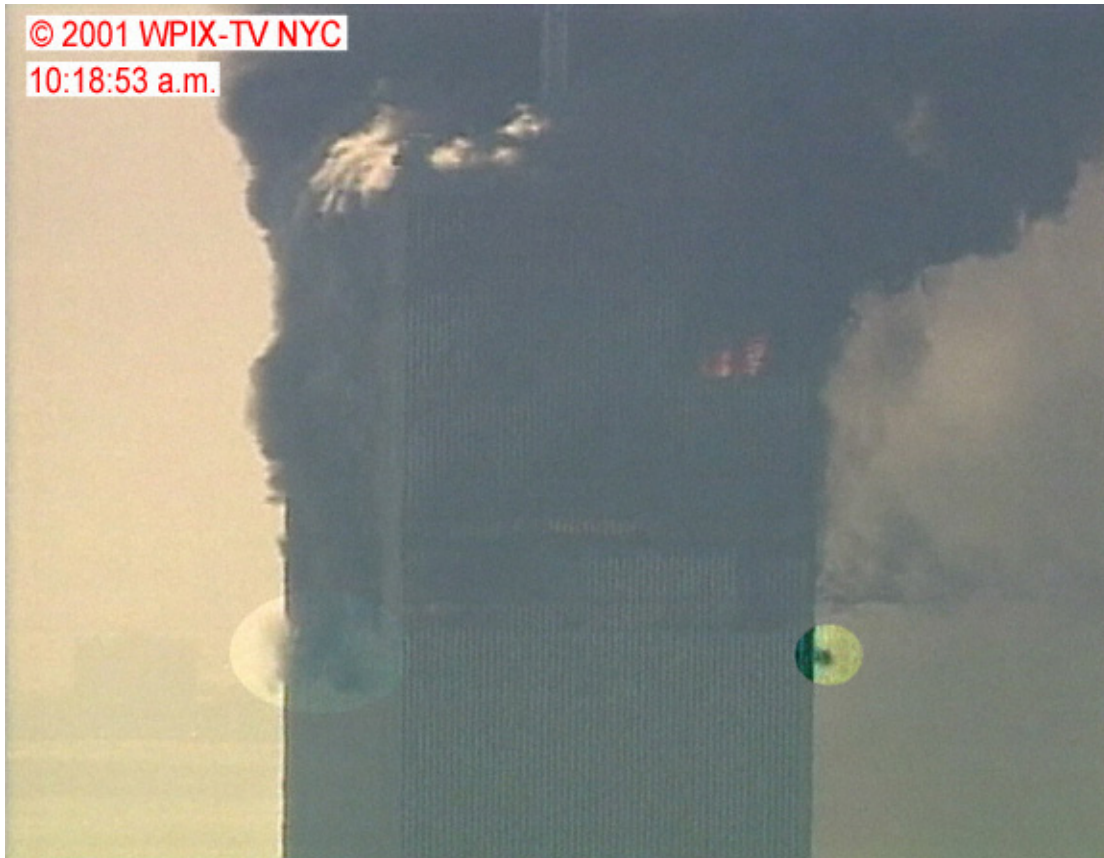
A video shot from the west shows that heavy smoke was pushed out of windows on the 95th and 98th floors on the north side of the west face at the same time the changes were observed on the north face. This video also shows what appears to be a jet of smoke being ejected from a lower floor on the south face of the tower. A view of this jet is highlighted in Figure 8–97, which shows a frame taken from the video 5 s after the start of the pressure pulse, i.e., at 10:18:53 a.m. The smoke coming from the 92nd floor on the north face is also highlighted. The video also shows a large amount of debris falling along the north and south faces of the tower around the time of the pressure pulse.

**Figure 8-97. This image showing the west face and an oblique view of the north face was captured from a video shot from a news helicopter at 10:18:53 a.m. The highlighted areas with adjusted intensities indicate smoke and/or dust plumes that were pushed from the north and south faces by a pressure pulse that passed through the tower at 10:18:48 a.m.**
