**NIST NCSTAR 1-5A**

**Federal Building and Fire Safety Investigation of the  
World Trade Center Disaster**

**Visual Evidence, Damage Estimates,  
and Timeline Analysis**

September 2005

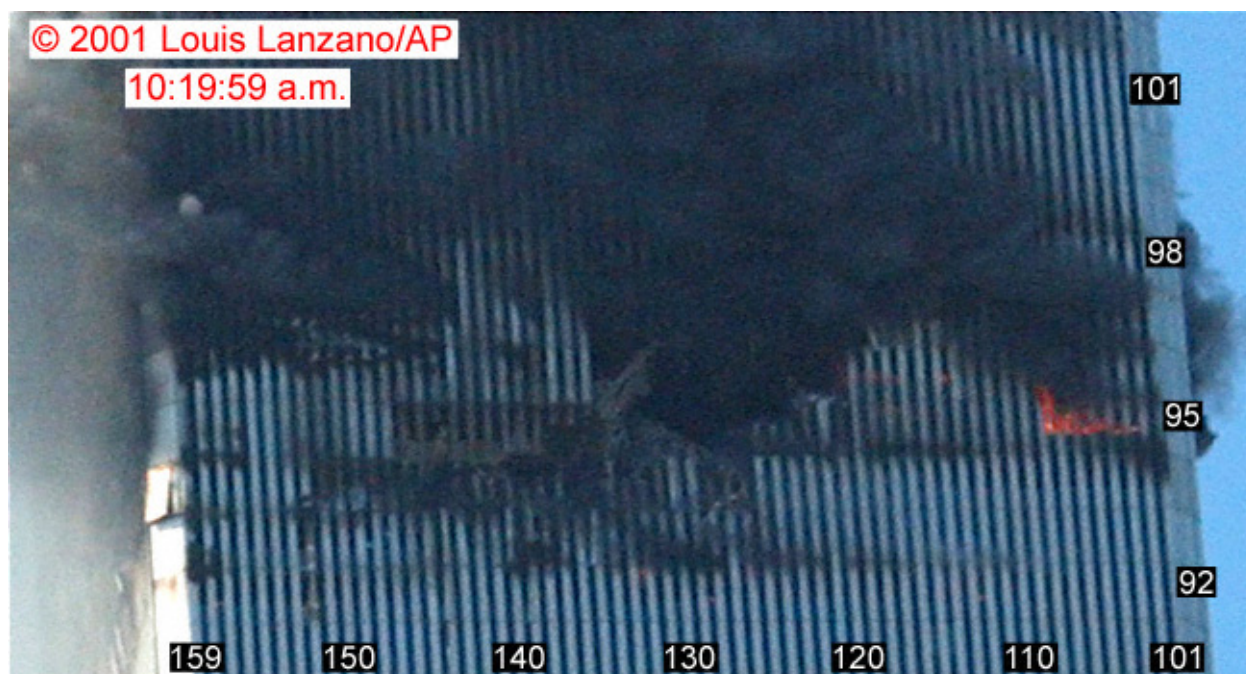
Figure 8-98 shows an image of the north face cropped from a photograph that was taken a minute later than Figure 8-96. Light smoke continues to come from the 92nd floor, where low level fires are apparent in windows 92-112 to 92-132. The fire that grew rapidly on the 95th floor immediately following the pressure pulse is still burning intensely, with flames coming from windows 95-106 and 95-107. A review of the floor plan layout for this floor in Figure B-4 shows that this fire is burning within a corner room with walls located at columns 95-456 and 95-108. Apparently, at this time the wall at column 95-108 has halted the spread of the fire toward the east. There does appear to be a fire even further to the east on this floor near window 95-115. A low level fire continues to burn on the 96th floor, with flames visible from windows 96-113 to 96-118. Heavy smoke is still flowing from windows on the 96th and 97th floors.

**Figure 8-98.** This cropped photograph shows the north face of WTC 1 at 10:19:59 a.m. The image has been enhanced by adjusting the intensity range. Column and floor numbers have been added.

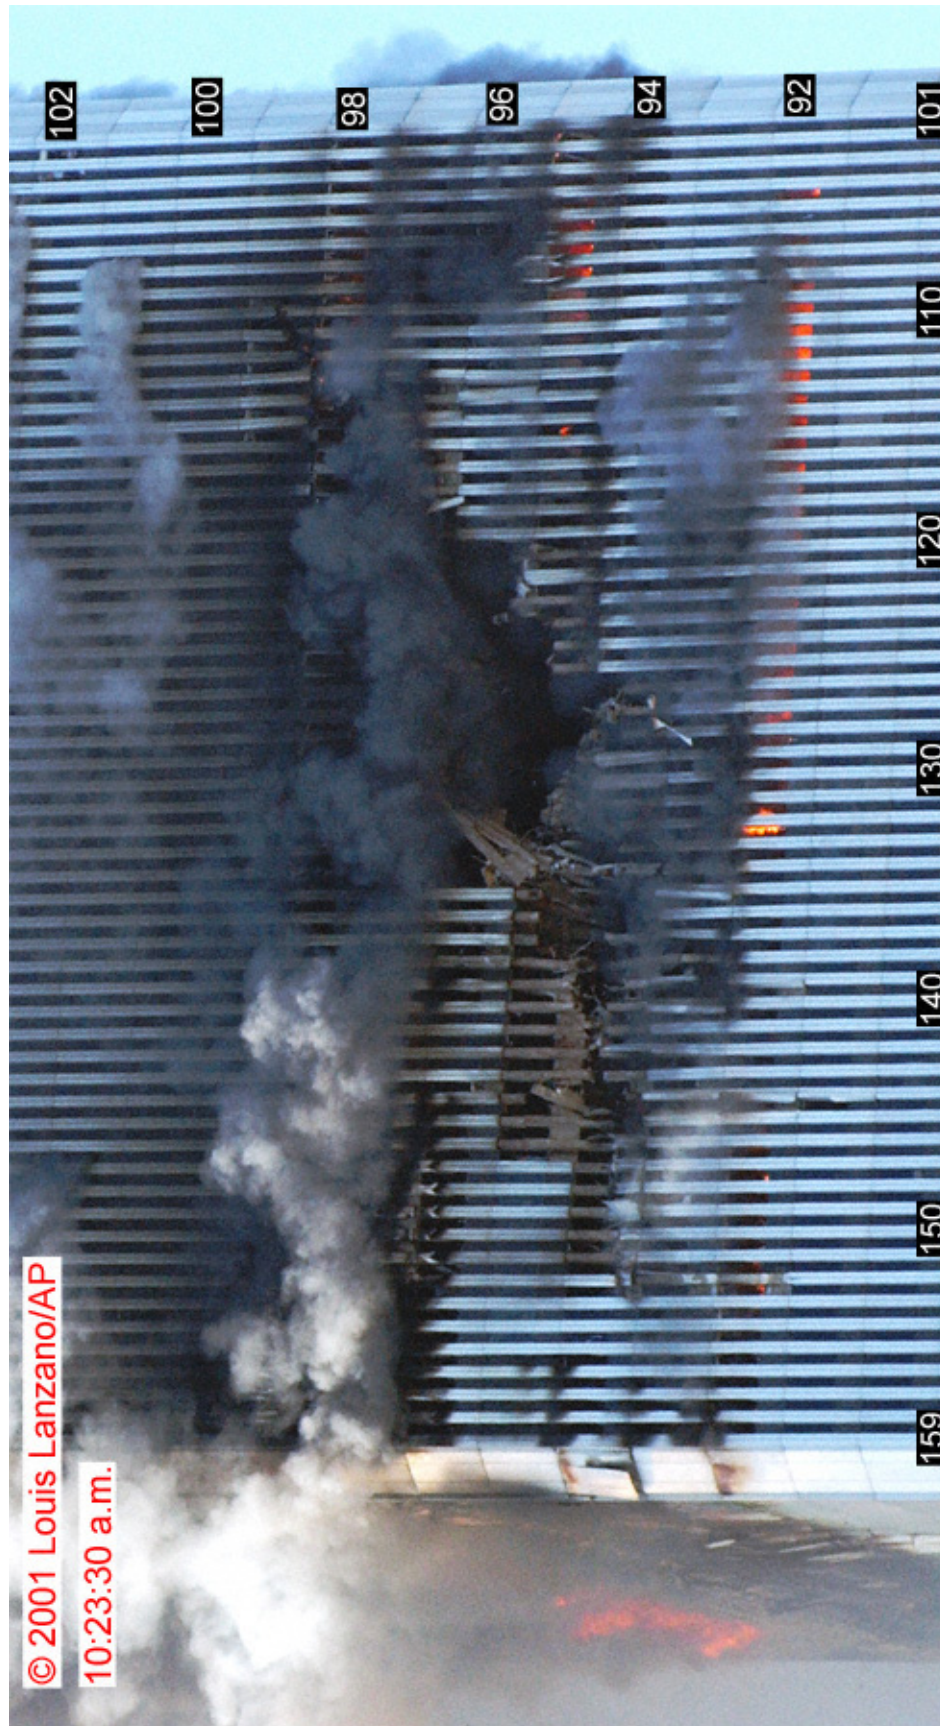
A view of the north face at 10:23:30 a.m. is shown in Figure 8-99. The fire on west side of the 92nd floor has grown dramatically since the photograph in Figure 8-98 was taken, three and a half minutes earlier. Heavy flames fill the openings from window 92-108 to window 92-114, and a nearly continuous region of flame is apparent from window 92-108 to window 92-132. The floor plan layout for the 92nd floor in Figure B-1 shows that a large open area extended along the north face between walls located at columns 92-132 and 92-105. Figure 8-99 indicates that nearly this entire area was involved in fire at this time. A small fire is evident in window 92-104, while windows 92-101 to 92-103 and window 92-105 appear to be closed. This indicates that a fire has moved into the northwest corner room with walls located at columns 92-105 and 92-455. Interestingly, in an almost identical photograph recorded five seconds earlier, the fire in window 92-104 was not visible, and all of the glass for windows in the corner room appeared to be intact. This suggests that the fire in the northwest corner room of this floor has just become large enough to break windows at this time. This close-up photograph also reveals that small spot fires continued to burn on this floor at the eastern side, where larger fires had been present earlier.

Figure 8-99. This cropped photograph shows the north face of WTC 1 at 10:23:30 a.m. The image has been rotated and enhanced by adjusting the intensity range. Column and floor numbers have been added.

By 10:23:30 a.m. the fire in the northwest corner room of the 95th floor had begun to die down, and the flames that were outside of windows at the time of Figure 8–98 had receded back into the building. The carets created by these external flames on the aluminum covers for columns 95-105 to 95-108 are distinct in Figure 8–99. Dull orange flames can be seen through windows 95-108 and 95-109, indicating that a fire was present on the other side of the wall located at column 95-108 (see Figure B-4). It is not clear whether the glass in these windows has broken or not. A small spot fire is also visible in window 95-115. The dying fire on the western side of the 96th floor is not visible in Figure 8–99, but small flames can be seen higher up on the 98th floor.

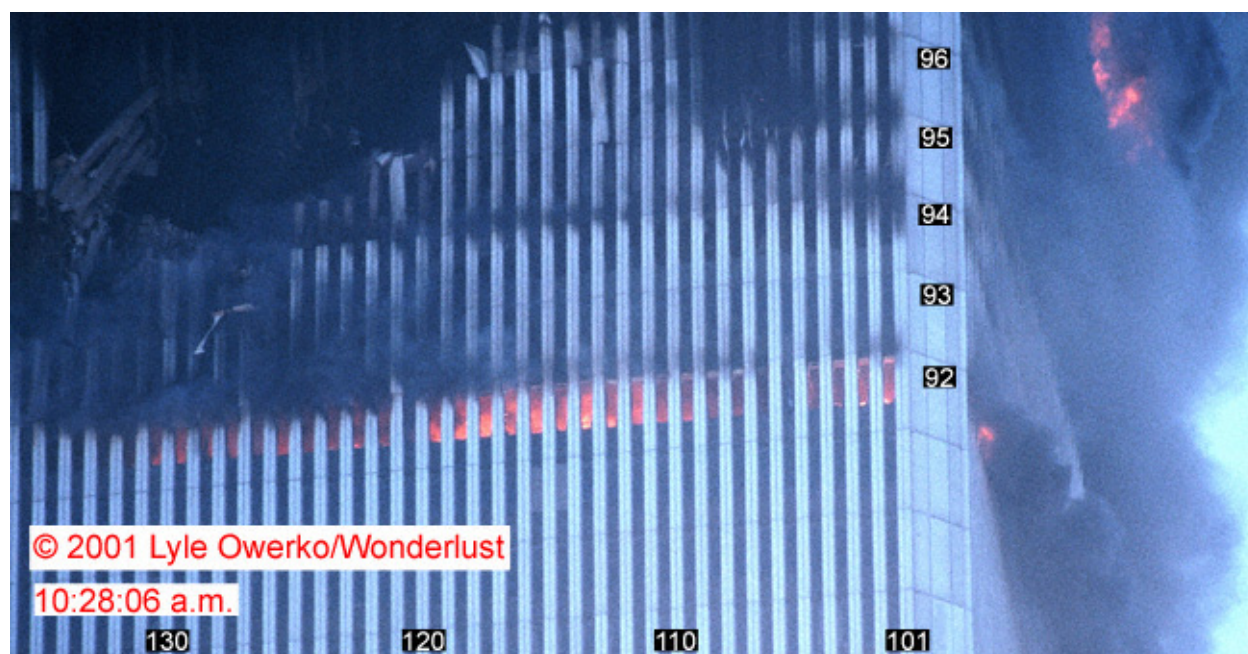
Over the next several minutes, the fire on the western half of the north side of the 92nd floor continued to grow more intense, while the other fires on the north side of the floor continued to decay. Figure 8–100 shows a photograph of a portion of the north face of WTC 1 taken at 10:28:06 a.m. This is roughly 16 s before the tower began to collapse. The large fire burning on the 92nd floor at this time is evident. Flames can also be seen on the north edge of the west face, indicating that the fire has turned the northwest corner and begun moving south on the west face.

**Figure 8-100.** This cropped photograph shows a portion of the north face and an oblique view of the west face for WTC 1 at 10:28:06 a.m. The intensity levels of the image have been adjusted, and column and floor number have been added.

This photograph has sufficient resolution and contrast to allow a determination of whether windows are open or intact. It appears as if three windows on the 92nd floor, windows 92-105, 92-106, and 92-120, still have glass in place. The other windows visible on this floor are open.

The photograph in Figure 8–100 was shot from a ground location relatively close to and slightly west of the tower. For this reason it may not provide as complete a view of interior fires as some of the other images shown earlier. Nonetheless, it is clear that the fires that were easily identified minutes earlier on the 95th, 96th, and 97th floors are not visible and must be burning at relatively low levels. The fact that the fire on the 92nd floor is so prominent supports this conclusion.

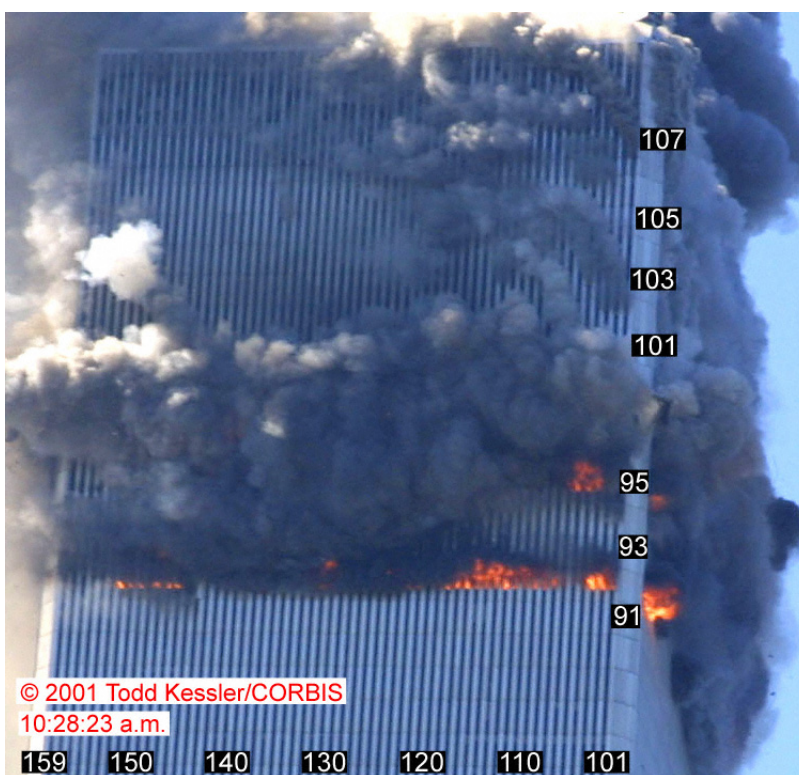
The photograph shown in Figure 8–101 was shot 1.4 s after WTC 1 began to collapse. The lines of dust visible coming from the 98th floor on the north and west faces of the tower may be an indication that the collapse began near this floor. As the building collapsed it acted as a piston, forcing air downward onto other floors. The resulting pressure increase forced gas flows out of open windows on lower floors. As a result of this process, fire and smoke were pushed out of the building.

**Figure 8-101.** This cropped photograph shows the north face of WTC 1 at 10:28:23 a.m. The image has been enhanced by adjusting the intensity levels. Column and floor numbers have been added.

In the photograph a large area of fire is being pushed from windows on the 92nd floor on the west side of the north face and the north side of the west face. This is the region where an intense fire had grown during the previous ten minutes or so. Fire is evident coming from windows across the large room on this floor with walls at columns 92-105 and 92-132 (see Figure B-1), as well as from the room in the northwest corner with internal walls at columns 92-455 and 92-105. The large volume of fire being pushed out of the windows provides an indication of how widespread the flames were in this area of the tower. Smaller flames are also visible coming from windows 92-146 to 92-152 on the eastern side of the

face. This indicates that fires had continued to burn in two of the small rooms located along the north face (see Figure B-1).

Flames were also pushed out of windows located in the northwest corner room on the 95th floor with walls at columns 95-108 and 95-456 (see Figure B-4). This is an area that had been burning earlier, but had appeared to have died down just prior to the initiation of the collapse. It is clear from this photograph that a significant fire was still burning in the immediate vicinity. The absence of visible fire being expelled elsewhere on the north face provides additional evidence that intense fires observed at other locations on the north face at earlier times had either died down or gone out.

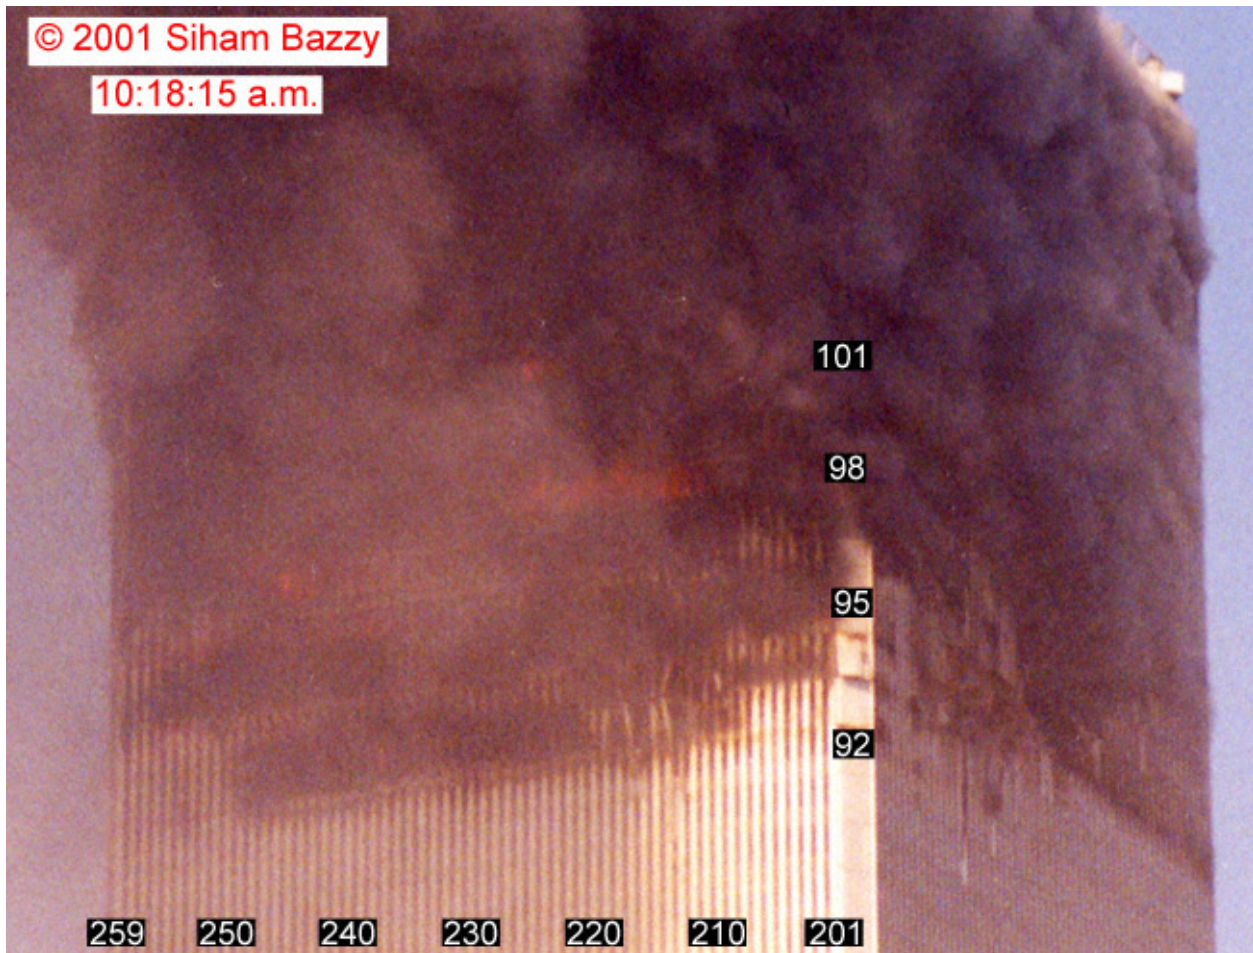
Figure 8-102 shows a view of the east face of WTC 1 recorded at 10:18:15 a.m. The face is still partially obscured by dust rising from below. The fire distribution is similar to that derived from the partial view of the east face shown in Figure 8-86 at 10:17:33 a.m. The largest fire is on the 98th floor and extends from roughly window 98-210 to window 98-228. There still appears to be some flame extension from open windows, but the large flames evident in Figure 8-86 are not present. Flames fill several adjacent windows on the 97th floor centered near window 97-244. Flames are also present on the 96th floor, but do not appear as intense as those seen on the 97th floor. There is definitely a fire burning higher up on the 101st floor near window 101-225. Recall that this fire was also visible in Figure 8-86, but that its presence could not be definitely confirmed due to the intense fire burning lower down on the 98th floor.

**Figure 8-102.** This cropped photograph showing the east and north faces of WTC 1 was shot at 10:18:15 a.m. It has been enhanced by adjusting the intensity levels. Column and floor numbers have been added.

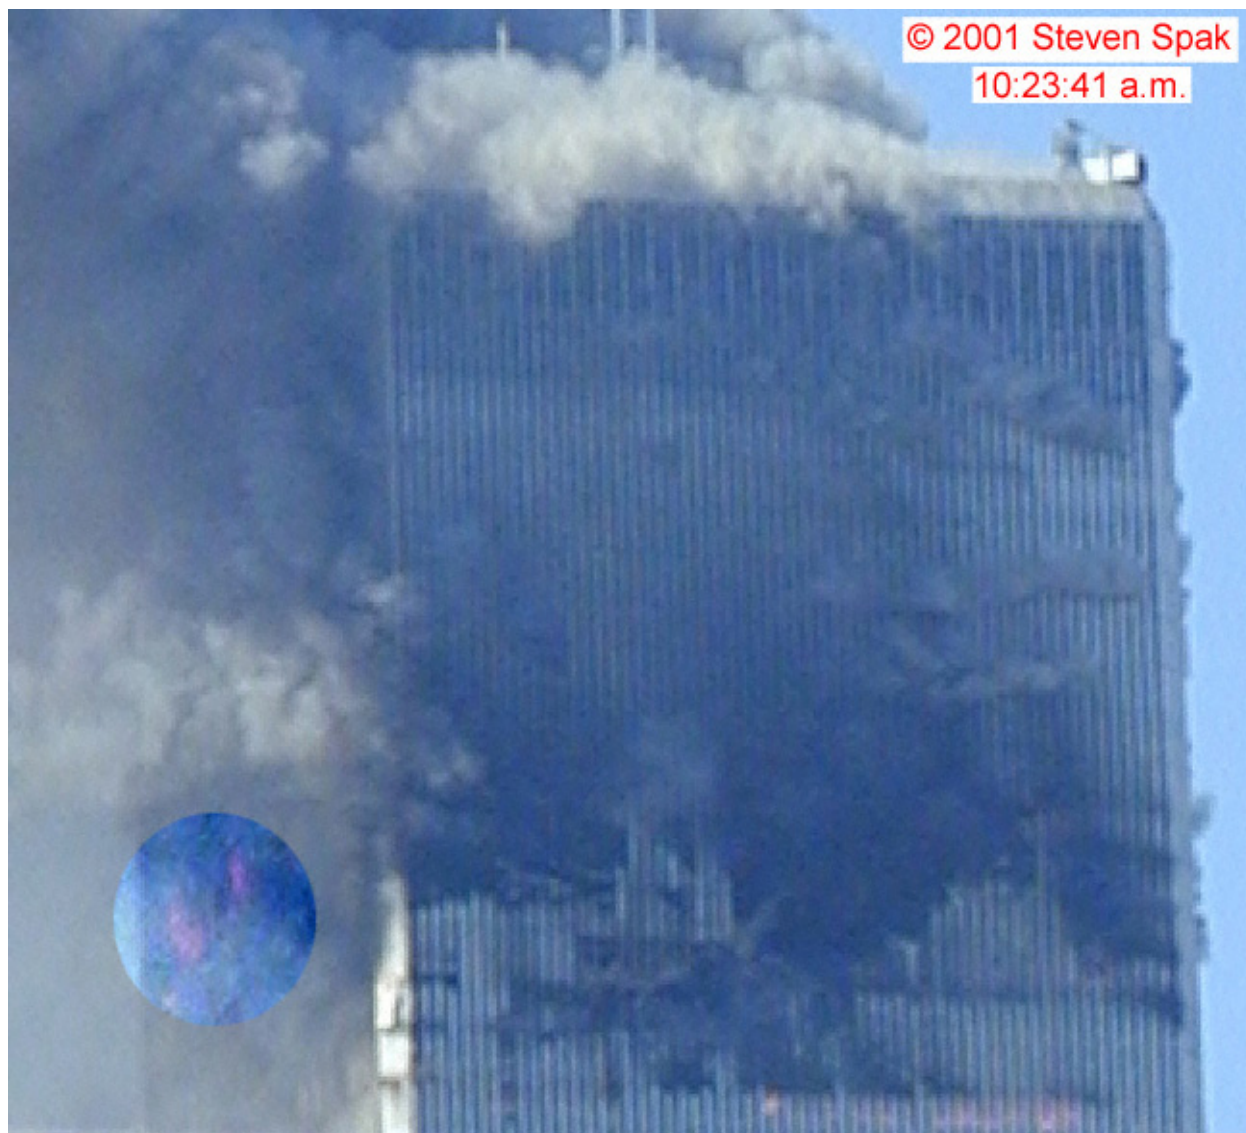
This area of flame on the southern side of the east face is visible in Figure 8-99, which was taken at 10:23:30 a.m. The fire is burning intensely with extended flames. Figure 8-103 shows a lower-resolution photograph taken at 10:23:41 a.m. that provides a slightly less oblique view of the east face in which it is easier to identify the flame location. The area where flames are visible coming from open windows has been highlighted. Flames can be seen on the 98th floor at two apparently separated locations. One of these is near the center of the face, and the second is well to the south. Even though the flames appear to be separated, videos and Figure 8-99 show that the flaming region was continuous over this length. A small area of fire is also visible on a lower floor. This fire is most likely on the 97th floor near the location where fire was present (near window 97-145) in Figure 8-102 at 10:18:15 a.m.

**Figure 8-103. This cropped photograph shows the north face and an oblique view of the east face of WTC 1 at 10:23:41 a.m. The intensity levels in an area of the east face have been adjusted to highlight an area of extended flame.**

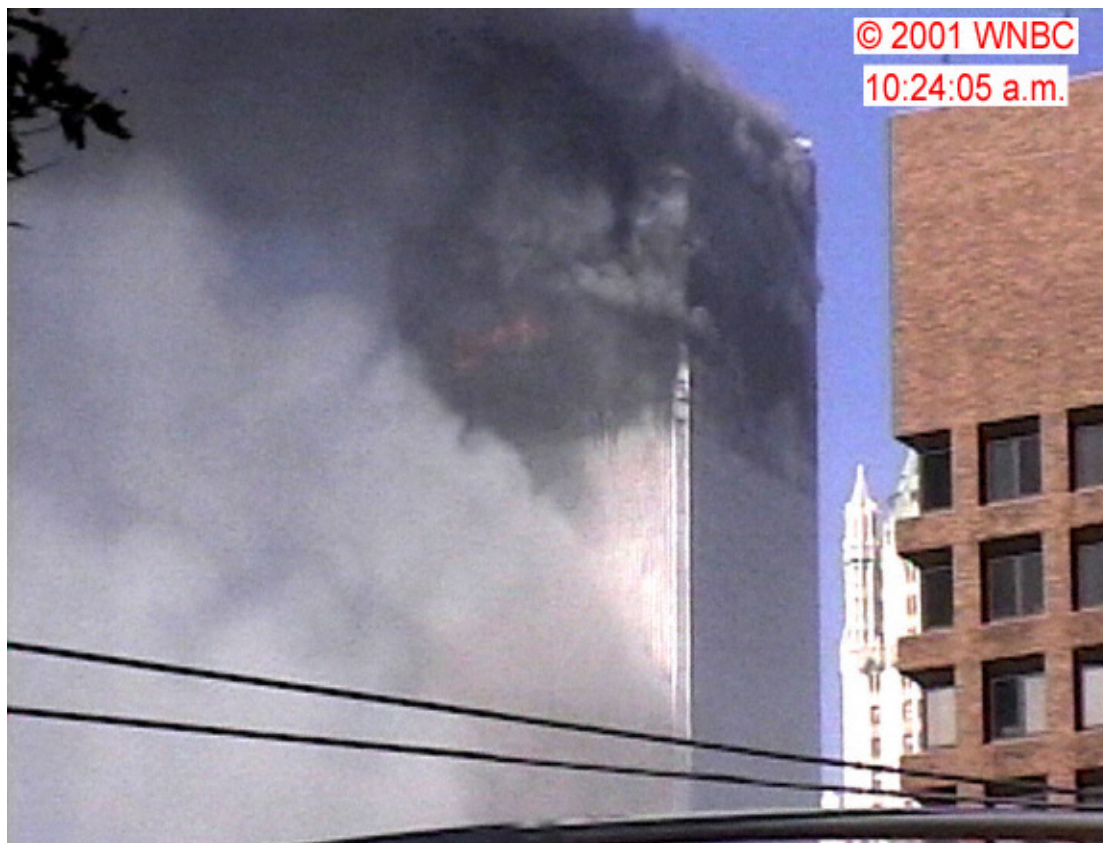
An image of the east face shown in Figure 8-104 taken from a video recorded at 10:24:05 a.m. provides another view of the fire burning on the south side of the 98th floor east face. Since this image was recorded from further east than Figure 8-103, it is easier to identify the location of the burning area. It does extend from near the center of the face toward the south. An area of fire on the 97th floor is visible immediately below. At 10:18:15 a.m. a similar area of fire was visible near window 97-245 (see Figure 8-102). This location is consistent with the apparent position of the fire in Figure 8-104. This suggests the intense fire present on the 98th floor roughly covers windows 98-230 to 98-245.

**Figure 8-104.** This frame was taken from a video recorded at 10:24:05 a.m. It was shot from the northeast and shows the north and east faces of WTC 1. The image has been enhanced by adjusting the intensity levels.

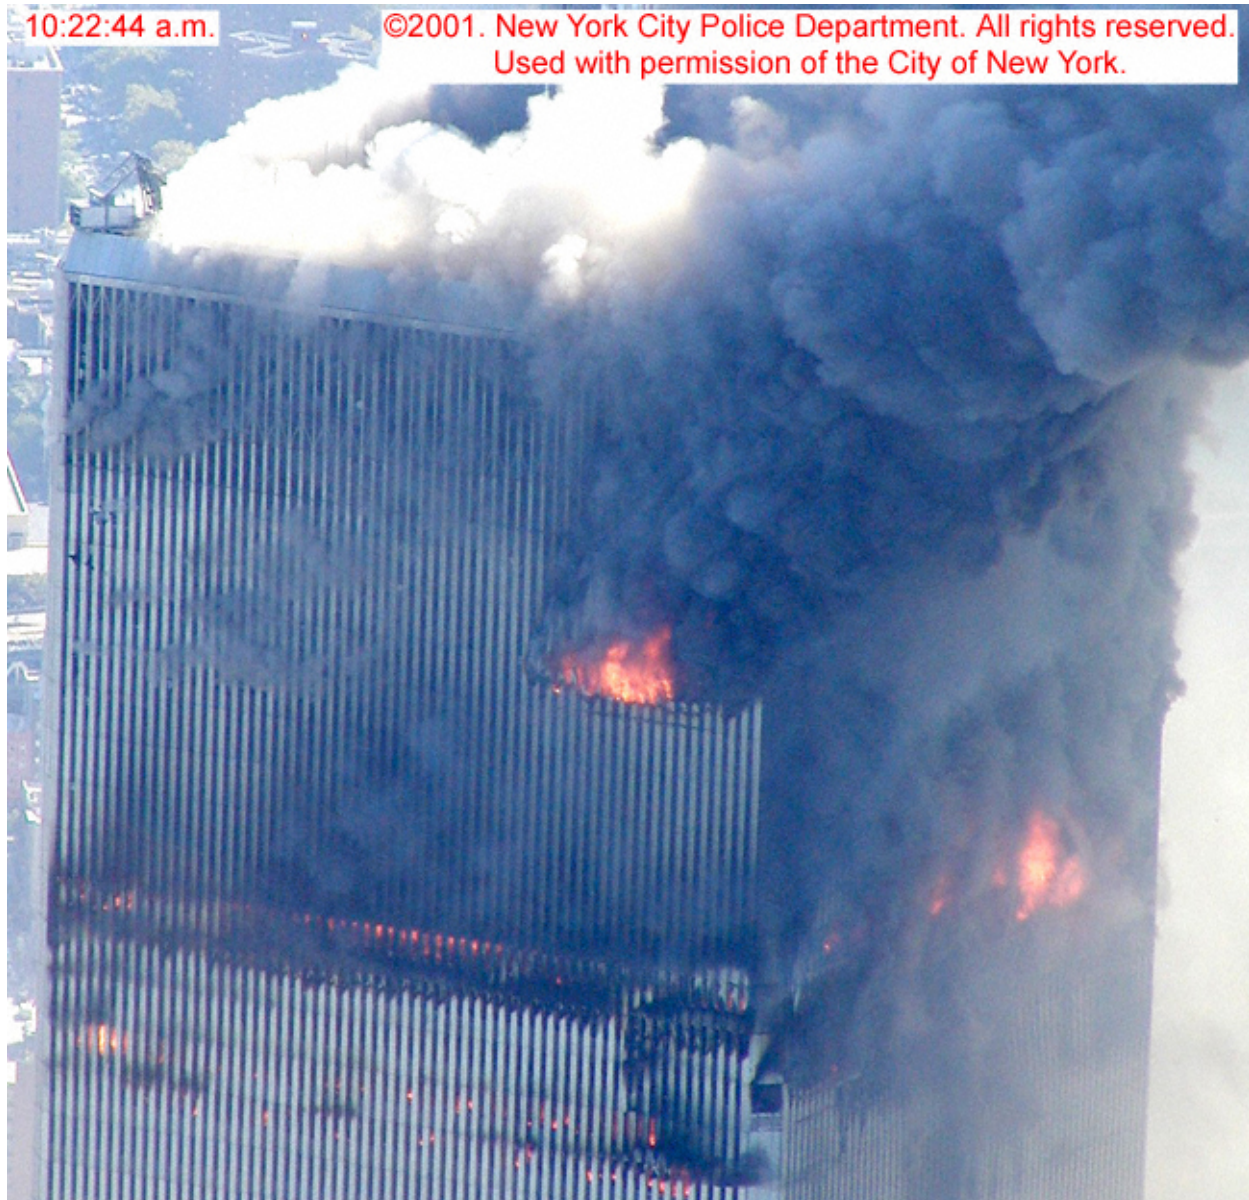
Figure 8-106 shows WTC 1 shot from the southwest at 10:22:44 a.m. The photographer was in a helicopter looking down on the tower. Individual floors are identifiable. Floor numbers can be assigned by noting that the floor with the missing aluminum panel on the southwest corner is the 96th floor. Fires are visible on both the south and west faces. Focusing on the south face, the most prominent feature is a flame jet emanating from an open window on the 98th floor on the east side. Flames are also coming out of nearby windows on this floor. Regions of fire are also visible on the 99th floor at locations starting on the west side of the face and reaching a position just to the east of the center of the face. From this angle, there are no flames evident on the 97th floor. Otherwise, the flame distribution is consistent with that described above.

**Figure 8-106.** This cropped photograph showing the south and west faces of WTC 1 was shot from a helicopter at 10:22:44 a.m. It has been enhanced by adjusting the intensity levels.

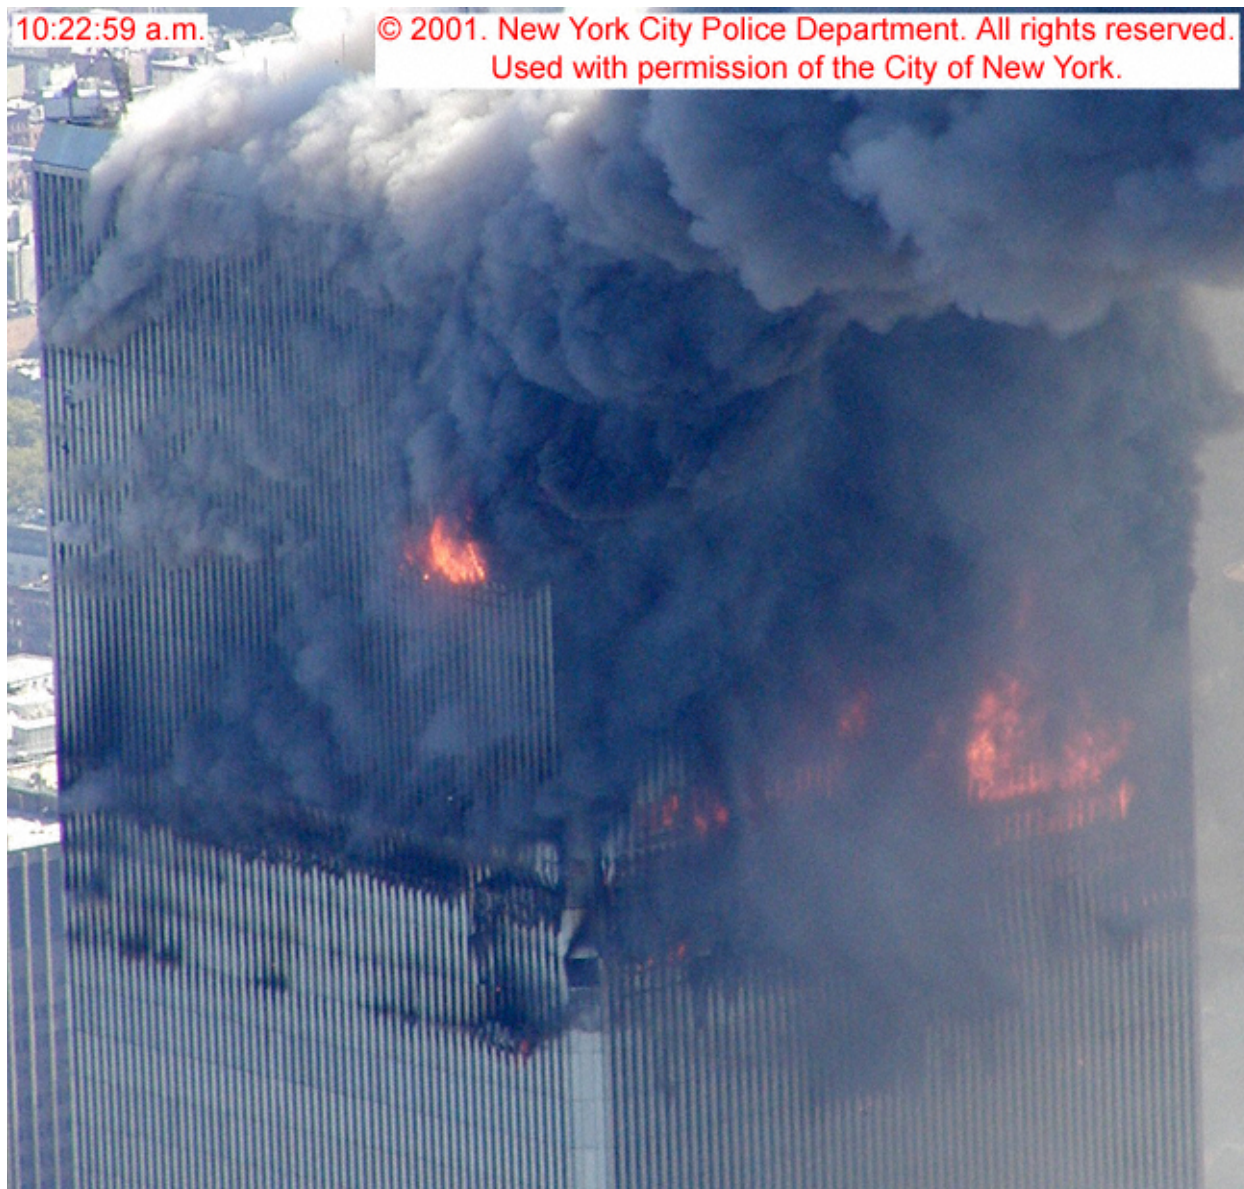
As the helicopter flew toward the south, the photographer continued to take pictures. Figure 8-107 shows a photograph taken 15 s later at 10:22:59 a.m. Since the helicopter was further south, this image has a more direct view of the south face than in Figure 8-106, and the view of the west face is from a more oblique angle. The fire distributions on both faces look quite different in the two photographs. This demonstrates the strong effects that the angle from which an image is taken can have on fire observations.

**Figure 8-107.** This cropped photograph showing the south and west faces of WTC 1 was shot from a helicopter at 10:22:59 a.m. It has been enhanced by adjusting the intensity levels.

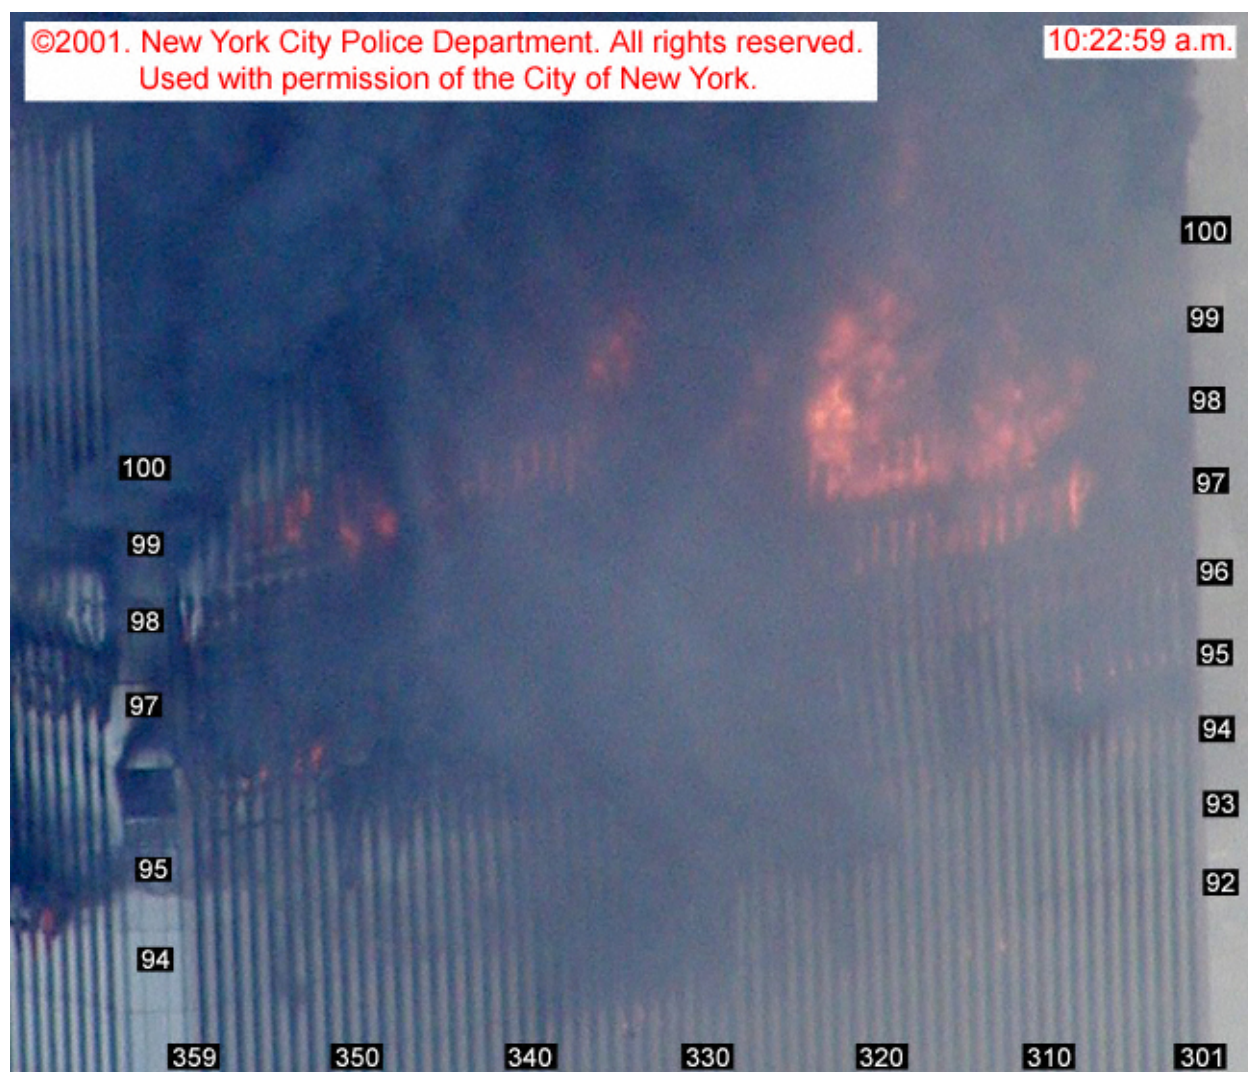
An important observation is readily apparent in Figure 8–108. Many of the columns on the south face in the vicinity of the 95th floor to 98th floors were bowed inward at this time. The easiest way to identify this bowing is to start lower down on the building and use your eyes to follow a particular column upward. The bowing appears as a curvature in the column. The bowing is most apparent on the eastern side of the face. It may be present on the western side as well, but it is more difficult to identify because of angular effects along with the blackening of the column covers on the western side of the face. Recall

that this blackening occurred as a result of the heavy smoke released on this side of the face by earlier fires on the 95th and 96th floors. The degree of column bowing is analyzed in the Investigation report dealing with the structural steel (NIST NCSTAR 1-3C) and compared with building response calculations in NIST NCSTAR 1-6.

Figure 8-108 shows that there were extensive fires on the south face of WTC 1 at 10:23 a.m. There is visual evidence for the presence of active fires on the 92nd floor upward through at least the 101st floor. Consistent with conclusions based on long-range images, the most intense fire is on the east side of the 98th floor. Flames that appear to be at least two stories in height are coming from windows 98-308 to 98-322. There are also large fires visible on the east side of the 97th floor and the west side of the

99th floor. On both floors the flames cover roughly half the width of the tower. In this photograph the flames on these floors do not appear to extend from the open windows. In reviewing the videos, it is clear that flames on both floors occasionally formed large external flares around this time. In fact, such a flare is visible coming from near window 97-308 in another photograph (not shown) taken from the helicopter at 10:22:50 a.m.

**Figure 8-108.** This photograph showing the south face of WTC 1 is a blowup of a portion of Figure 8-107. It was shot from a helicopter at 10:22:59 a.m. It has been enhanced by adjusting the intensity levels, and column and floor numbers have been added.

It is interesting that the fires on the 97th and 98th floors do not appear to have spread to the east end of the face. The last window with fire on the 97th floor appears to be window 97-308. A check of the floor plan layout in Figure B-6 shows that there was a room in the southeast corner of this floor with walls at columns 97-256 and 97-308. Recall that the fire spreading south on the east face of this floor did not appear to have reached the south edge at this time. These observations suggest that the walls of this room were acting as a fire barrier. A similar room was present and acting as a fire barrier on the 98th floor (see Figure B-7).

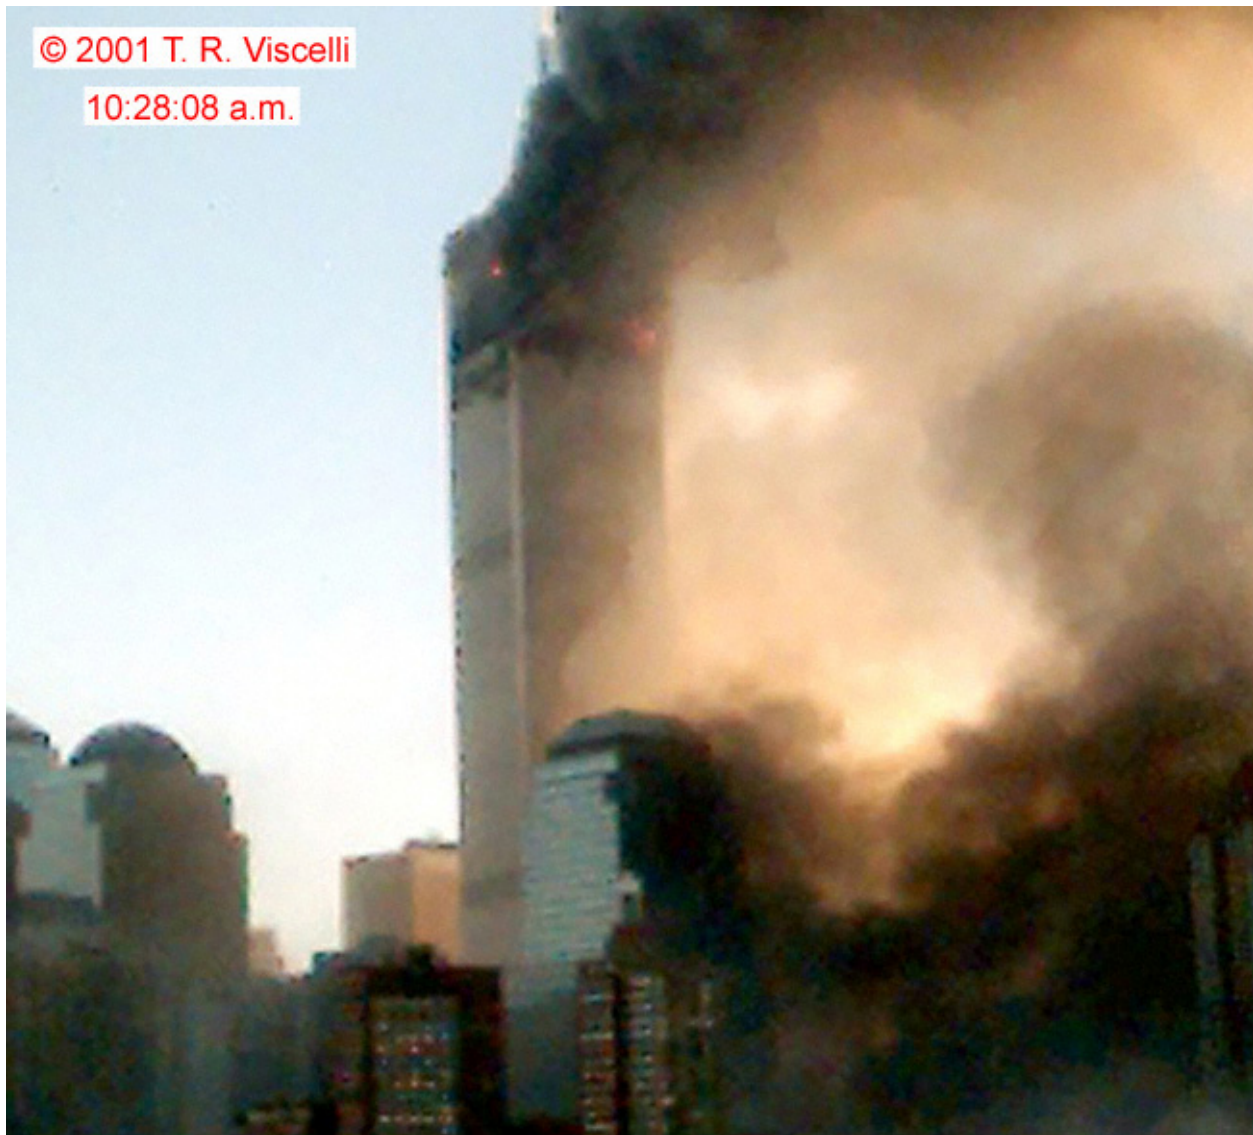
Figure 8–109 shows a long-distance photograph of WTC 1 that was shot at 10:28:08 a.m., i.e., 14 s prior to collapse. Even at this distance the intense fires burning on the east side of the south face on the 98th and 99th floors are readily apparent.

**Figure 8-109. This cropped photograph taken from the south southwest shows WTC 1 at 10:28:08 a.m.**

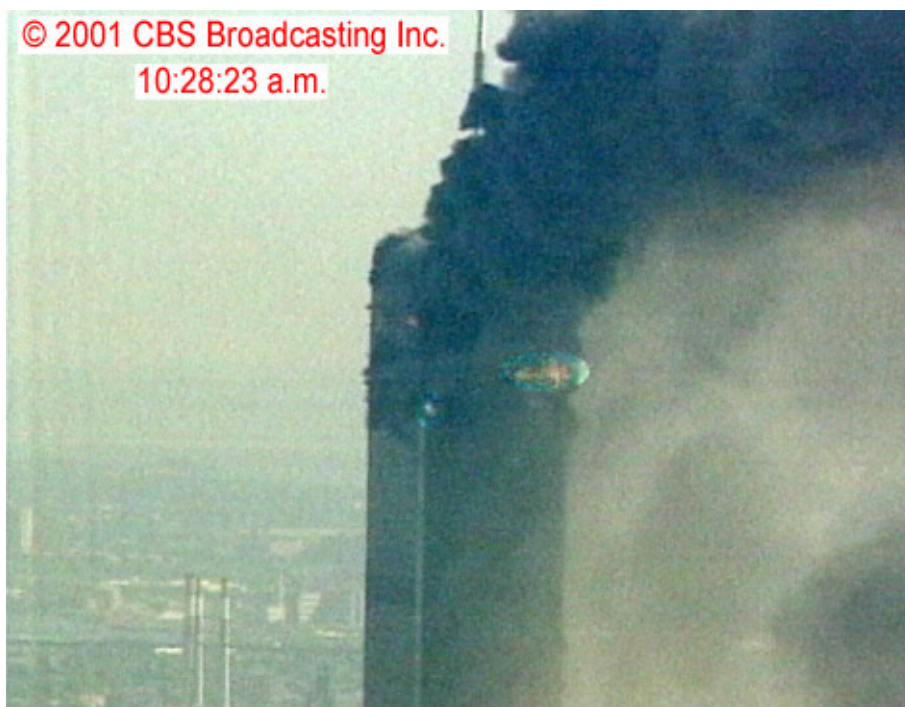
**Figure 8-110.** This image showing the south face of WTC 1 was taken from a video shot from a news helicopter at 10:28:23 a.m. The intensity levels of the image have been adjusted. Two areas showing flames that were pushed out of the tower as it started to collapse are highlighted.

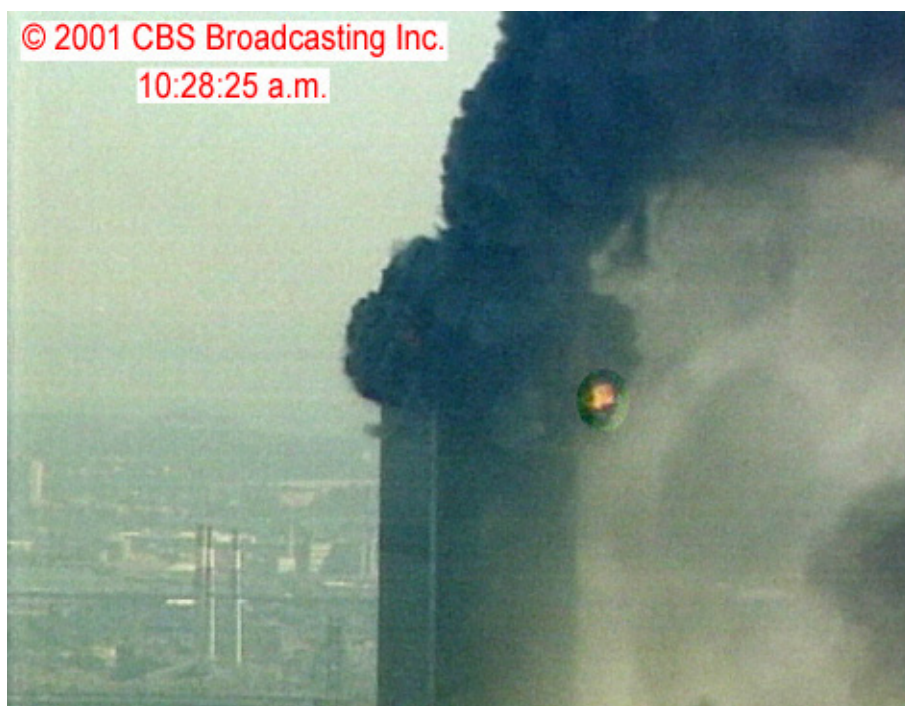
**Figure 8-111.** This image showing the south face of WTC 1 was taken from a video shot from a news helicopter at 10:28:25 a.m. The intensity levels of the image have been adjusted. An area showing a fireball generated by fire pushed from the tower by the collapse is highlighted.

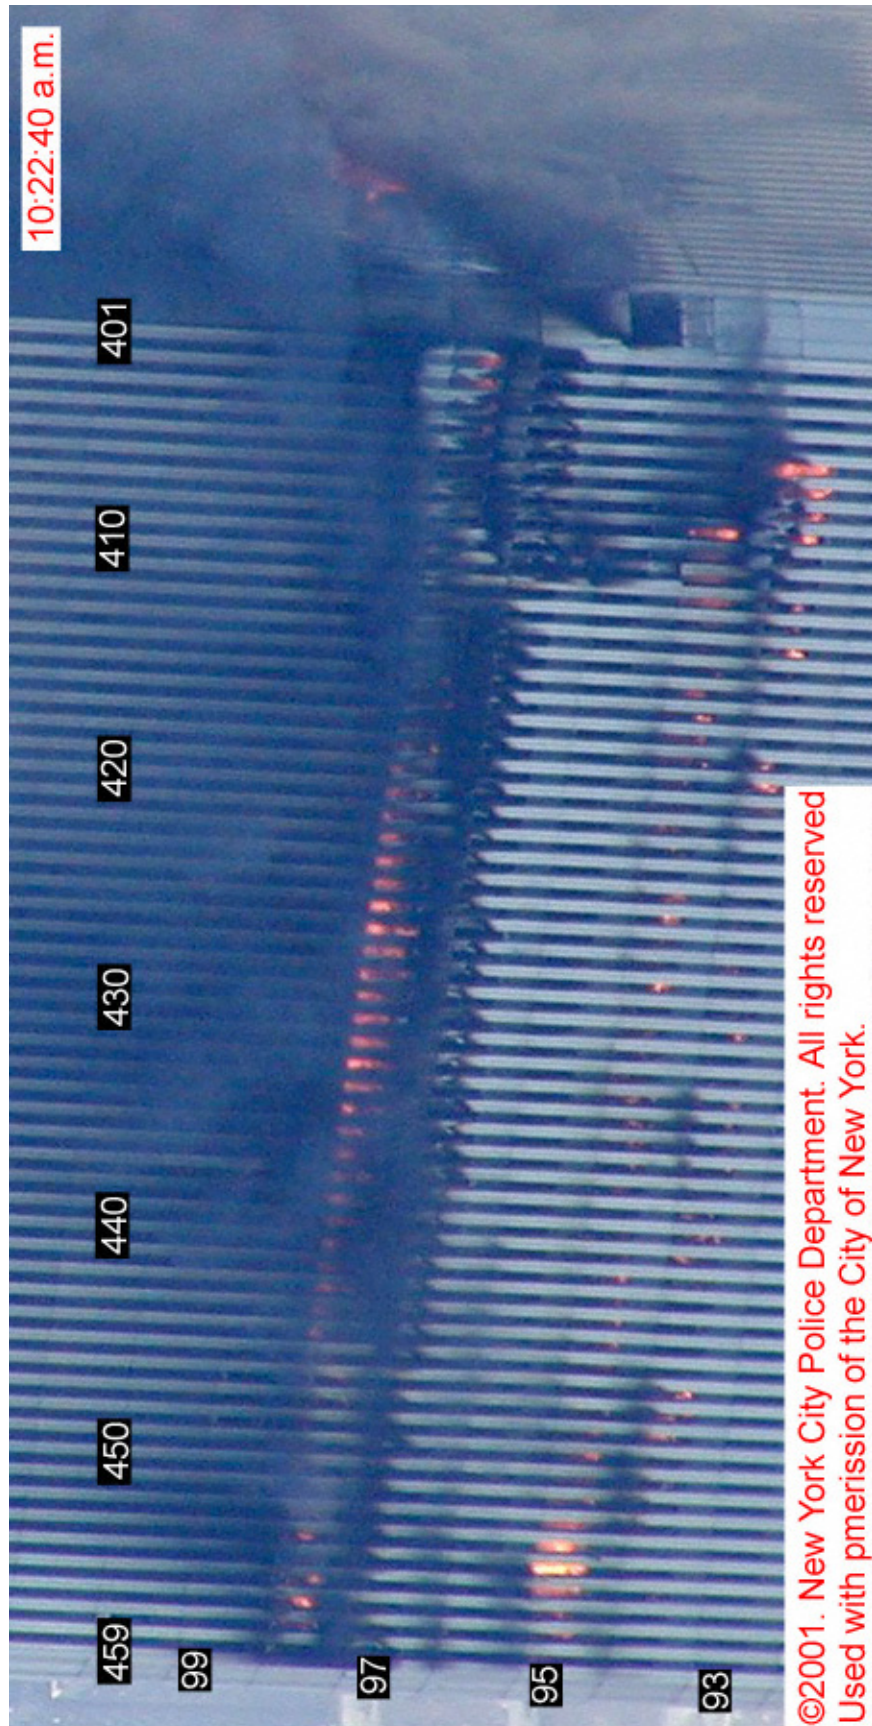
A close-up photograph of the west face taken at 10:22:40 a.m. from a helicopter looking down on the tower is shown in Figure 8–112. Fires are visible on the 94th, 95th, and 98th floors. In general, the fire distributions are consistent with the discussion immediately above.

On the 94th floor fires can be seen at many locations between windows 94-405 and 94-448. Most of the fires are burning at isolated locations near the floor. The only window where flames are protruding out is 94-405. The presence of carets on nearby column covers is consistent with the intense fire seen earlier at windows 94-407 and 94-408. The smoke marks at the tops of the column covers indicate that at many locations only light smoke or no smoke had passed through the open windows. This agrees with earlier observations that the fires burning on the west side of the 94th floor were relatively gentle at most locations. In Figure 8–112 windows 94-438 to 94-441 appear to be open, and flames are visible in windows 94-438 to 94-440. These windows were clearly intact at 9:47:34 a.m. in Figure 8–72. The floor plan layout in Figure B-3 indicates that these four windows were located in a room with walls at columns 94-438 and 94-441. Fire had clearly spread into this room since 9:48 a.m. Many other windows on this floor that had intact glass at the earlier time are also open in Figure 8–112.

Figure 8-112. This cropped photograph was shot from a helicopter at 10:22:40 a.m. and shows the west face of WTC 1 from above. The image has been enhanced by adjusting the intensity levels, and column and floor numbers have been added.

Fires are visible on the 95th floor over most of the length of the west face. At most locations the fires look similar to those on the 94th floor, appearing to burn with low intensities near the floor. Exceptions are the most intense flames located in the room having walls at columns 95-452 and 95-456 (see Figure B-4) and the fire in windows 95-408 to 95-411. The fire on the north side has already been described, while the fire on the south side is located next to a room with walls at columns 95-404 and 95-408. Over most of this floor there are no smoke marks on the column covers despite the wide spread fires. This observation most likely means that the smoke from fires on this side of the 95th floor vented within the building elsewhere.

From the angle from which Figure 8-112 was taken the internal fires on the 98th floor are only visible near the center of the floor and at a few locations on either end. This fire has clearly died down considerably since Figure 8-92 was taken at 10:18:01 a.m. Carets are visible at the tops of the column covers near the two ends, but very little marking is evident elsewhere. This suggests that the only places flames came out of windows were from fires burning inside the corner rooms (see Figure B-7). Consistent with earlier observations, the absence of column cover marks elsewhere indicates that neither fire nor smoke flowed from most 98th floor windows on the west face where fire was present.

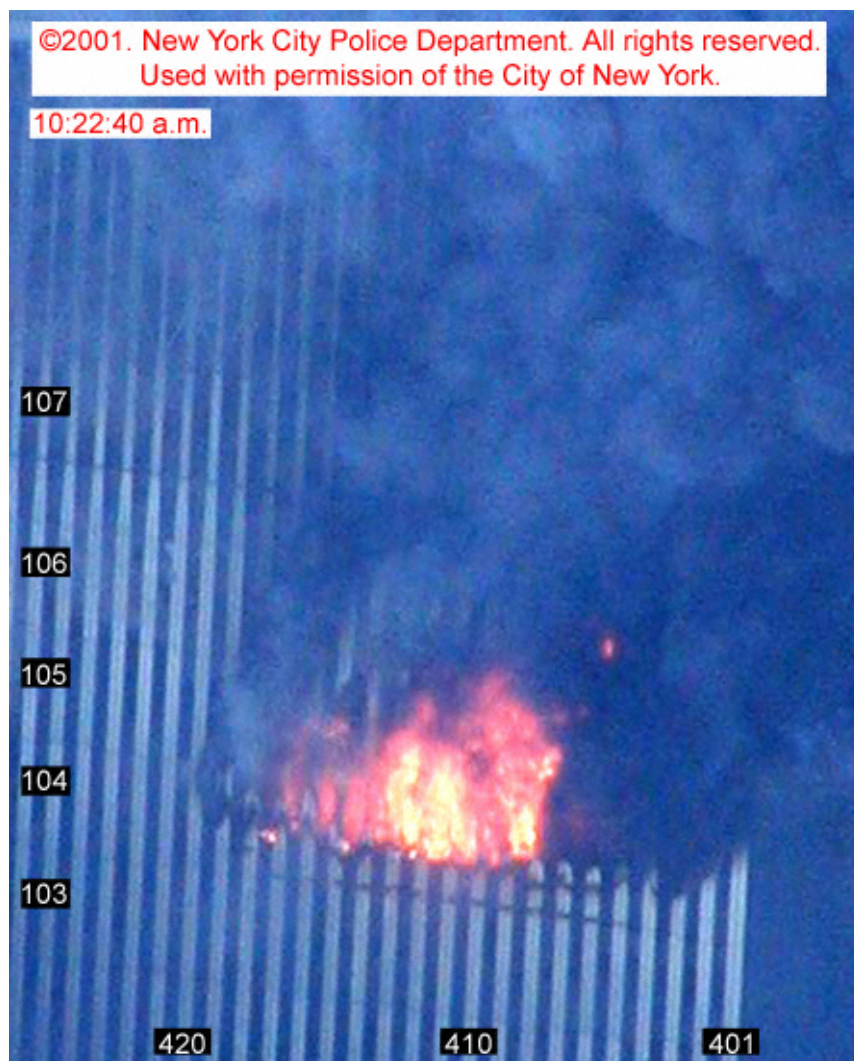
An image of the fires on the 104th floor at 10:22:40 a.m. is shown in Figure 8-113. It was cropped from the same photograph as Figure 8-112. It shows that after first appearing twenty minutes earlier, this fire continues to burn very intensely with long flames extending out of the windows. Visible flames and column cover smoke marks indicate this fire has burned from window 104-403 to window 104-418. Despite the intensity of the fire, it has not spread significantly since its initial growth period, as indicated by comparison with earlier photographs.

**Figure 8-113.** This cropped photograph shows a view of the west face of WTC 1 shot looking down from a helicopter at 10:22:40 a.m. The image has been enhanced by adjusting the intensity levels, and column and floor numbers have been added.
