**NIST NCSTAR 1-5A**

**Federal Building and Fire Safety Investigation of the  
World Trade Center Disaster**

**Visual Evidence, Damage Estimates,  
and Timeline Analysis**

September 2005

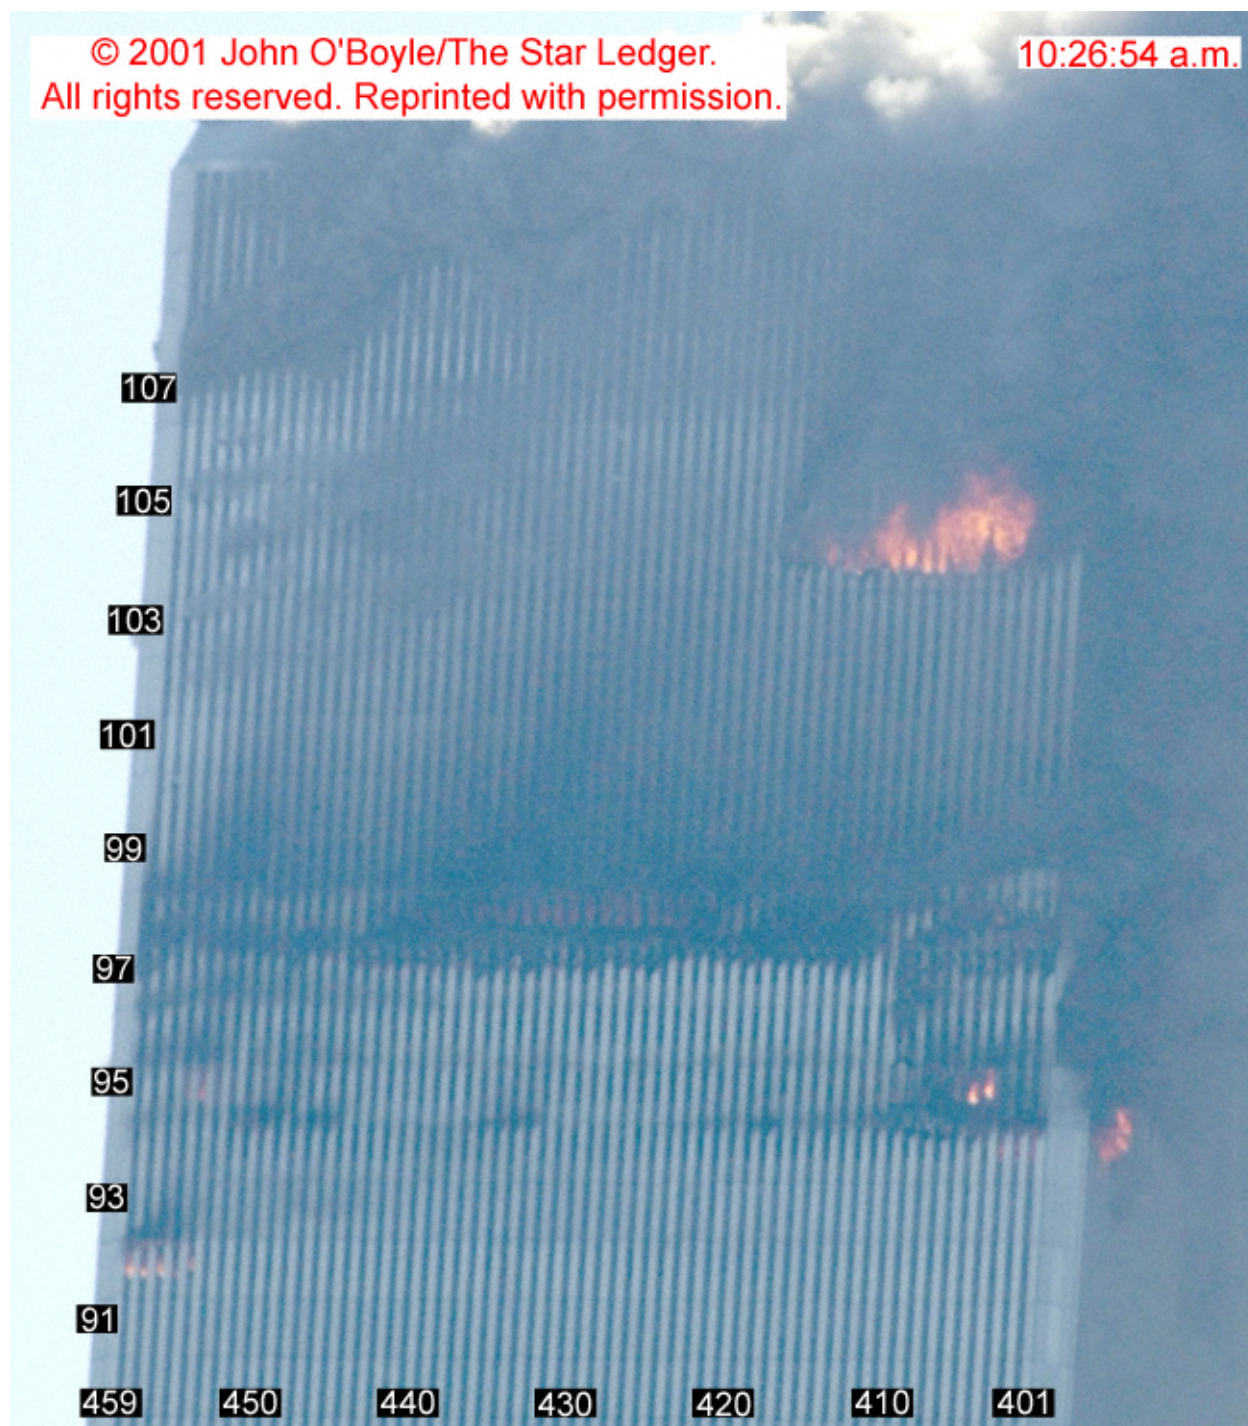
Close-up imagery of the west face over the next several minutes was very limited. Figure 8-114 shows an image of the face recorded at 10:26:54 a.m. that provides sufficient resolution to resolve windows and floors. Fires are visible at several locations on the face. Some changes have taken place since Figure 8-112 was taken at 10:22:40 a.m. Fire has appeared in the two adjacent rooms nearest the northwest corner of the 92nd floor (see Figure B-1), which have walls at columns 92-452 and 92-455 and share an east wall that terminates at column 92-105. Flames are now present in windows 92-454 to 92-458. Videos shot from the northwest and southwest show that heavy smoke first appeared in this area at 10:25:21 a.m. As already discussed, a similar stream of smoke came from window 92-101 on the north face at 10:24:26 a.m. These observations indicate that flashover occurred in these rooms around this time.

Flames are also visible in Figure 8–114 on the 94th floor in windows 94-101 to 94-104 that were not visible in Figure 8–112. This is consistent with the conclusion (discussed above) that flashover occurred in the southwest corner room of this floor (see Figure B-3) around 10:23 a.m. Flames also extend a significant distance from open windows in this room on the south face.

The interior fire near the center of the 98th floor is still visible in Figure 8–114. Flames are also visible in the windows located in the room on the 95th floor that had walls at columns 95-452 and 95-456, but the flames appear to have died down somewhat since 10:22:40 a.m. The flames seen at other locations on the

**Figure 8-114.** This cropped photograph showing the west face of WTC 1 was taken at 10:26:54 a.m. The image has been enhanced by adjusting the intensity levels, and column and floor numbers have been added.

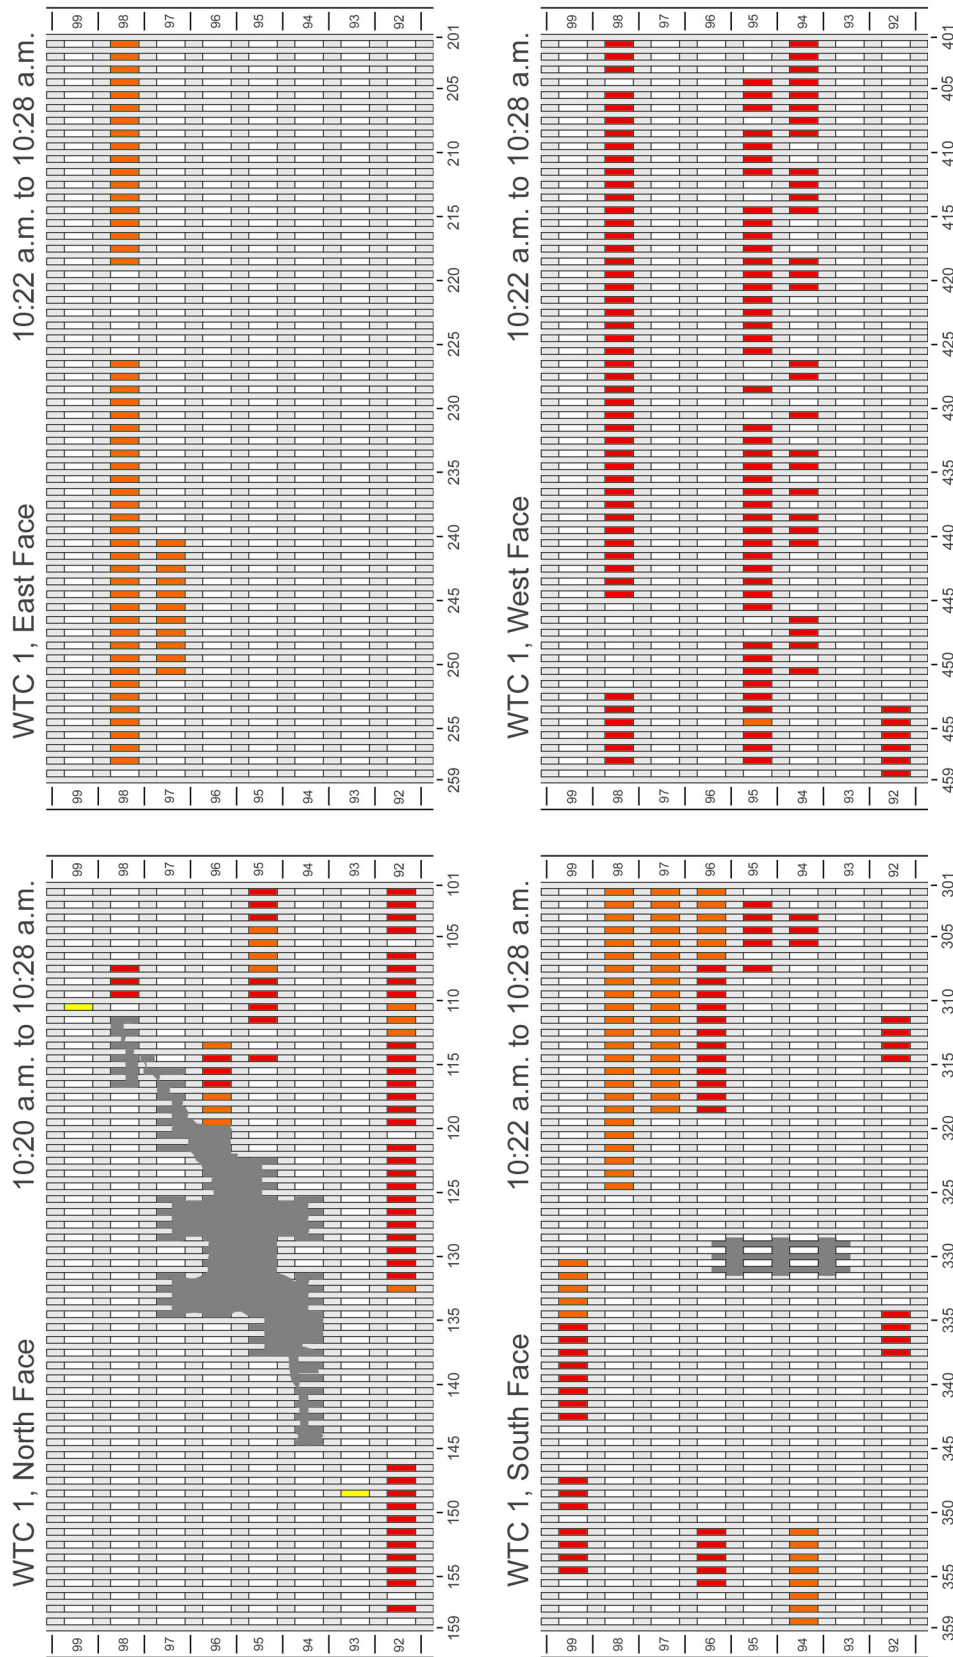
**Figure 8-115. Maps of integrated fire observations between 10:20 a.m. and 10:28 a.m. are shown for the four faces of WTC 1. Colors represent the highest intensity fire observed in a window using the color scale defined in Figure 5-1.**

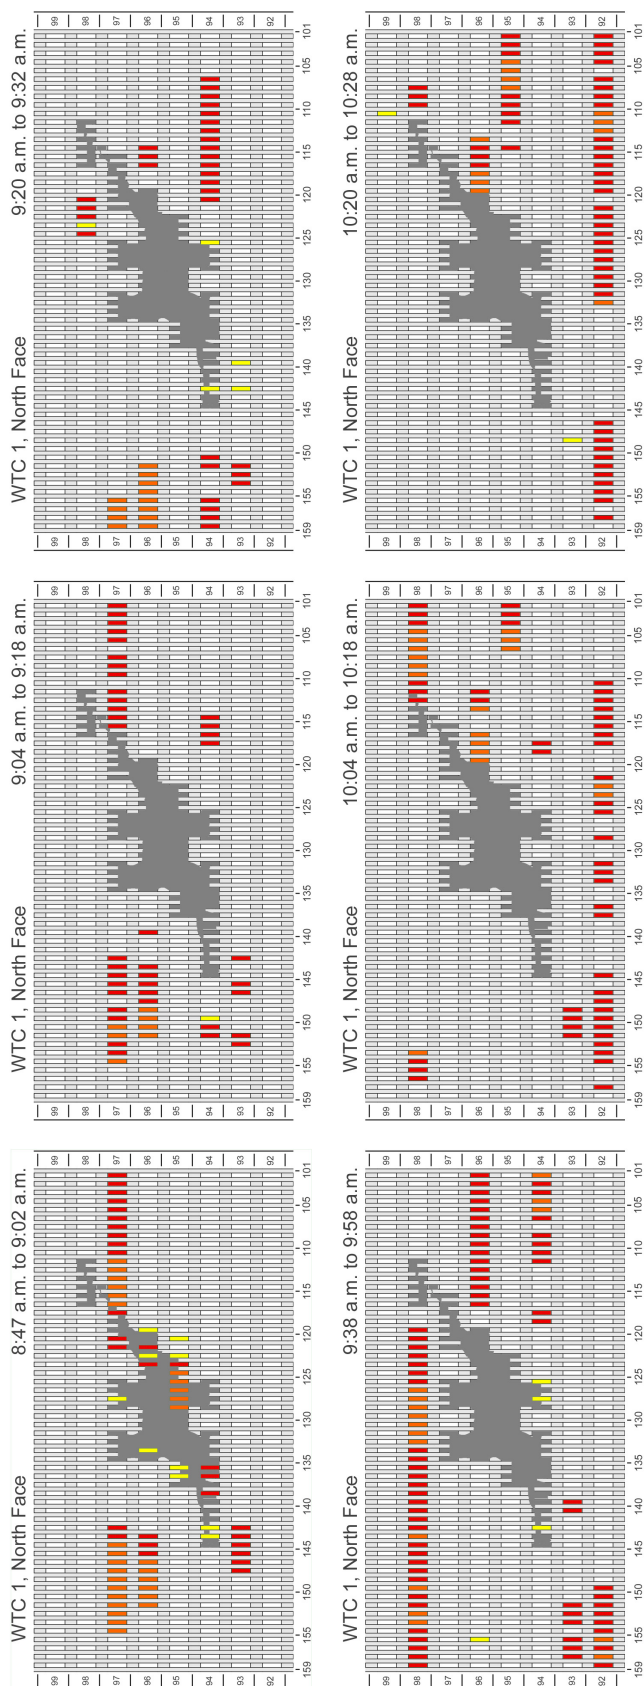
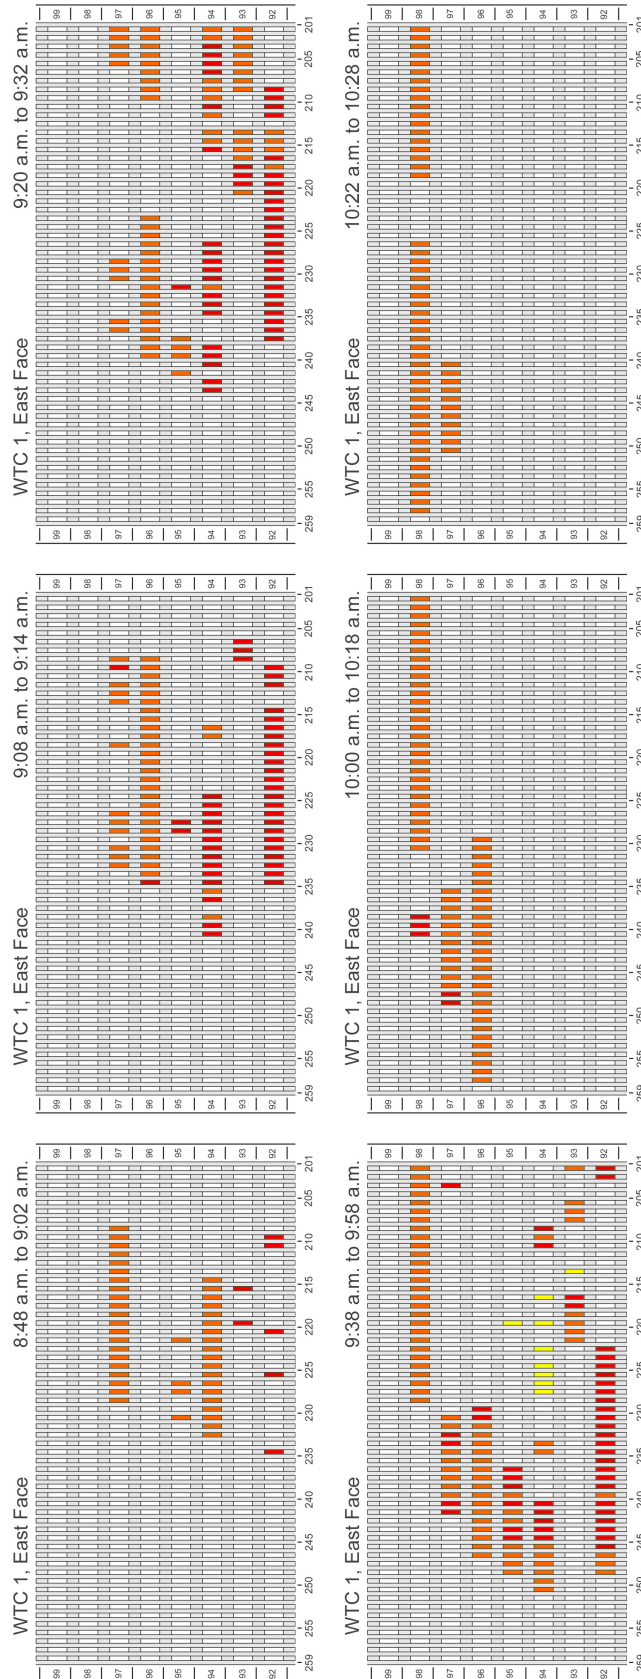
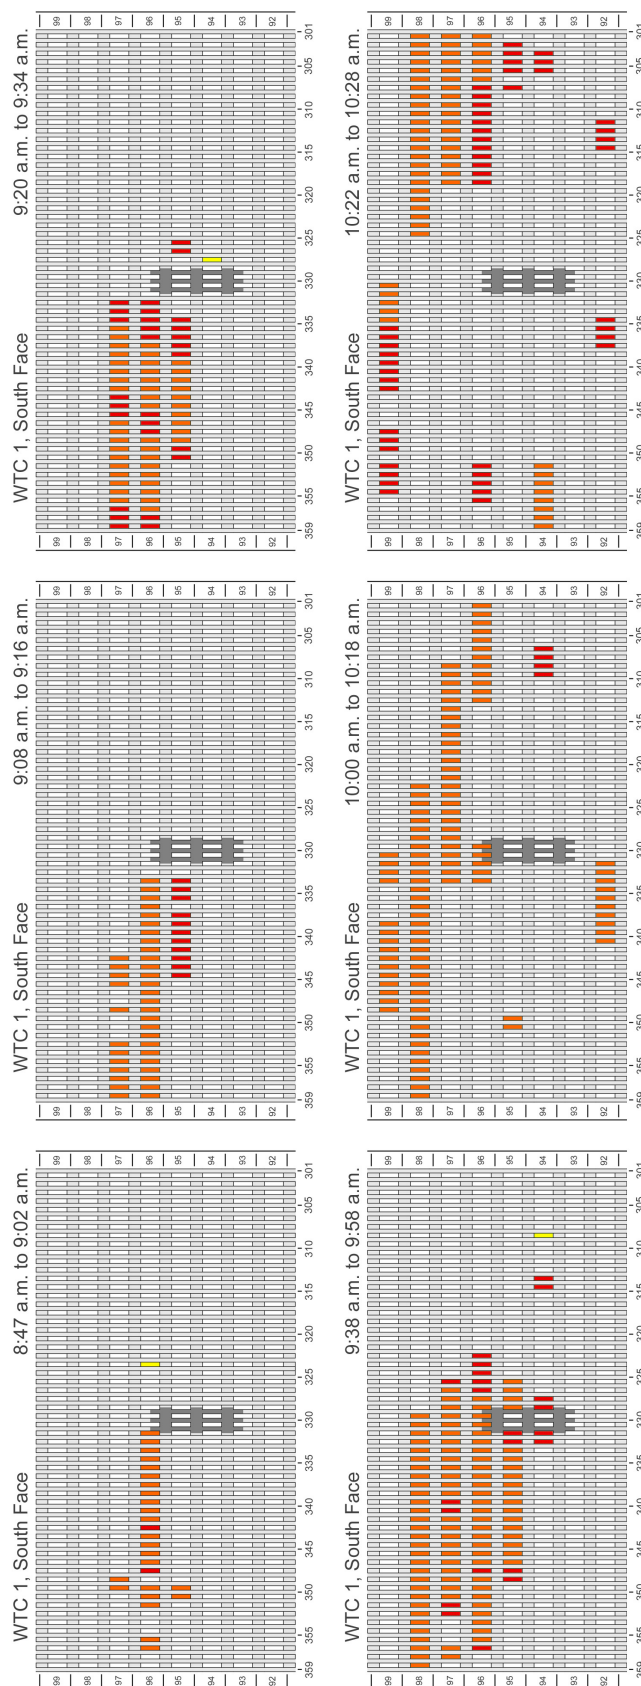
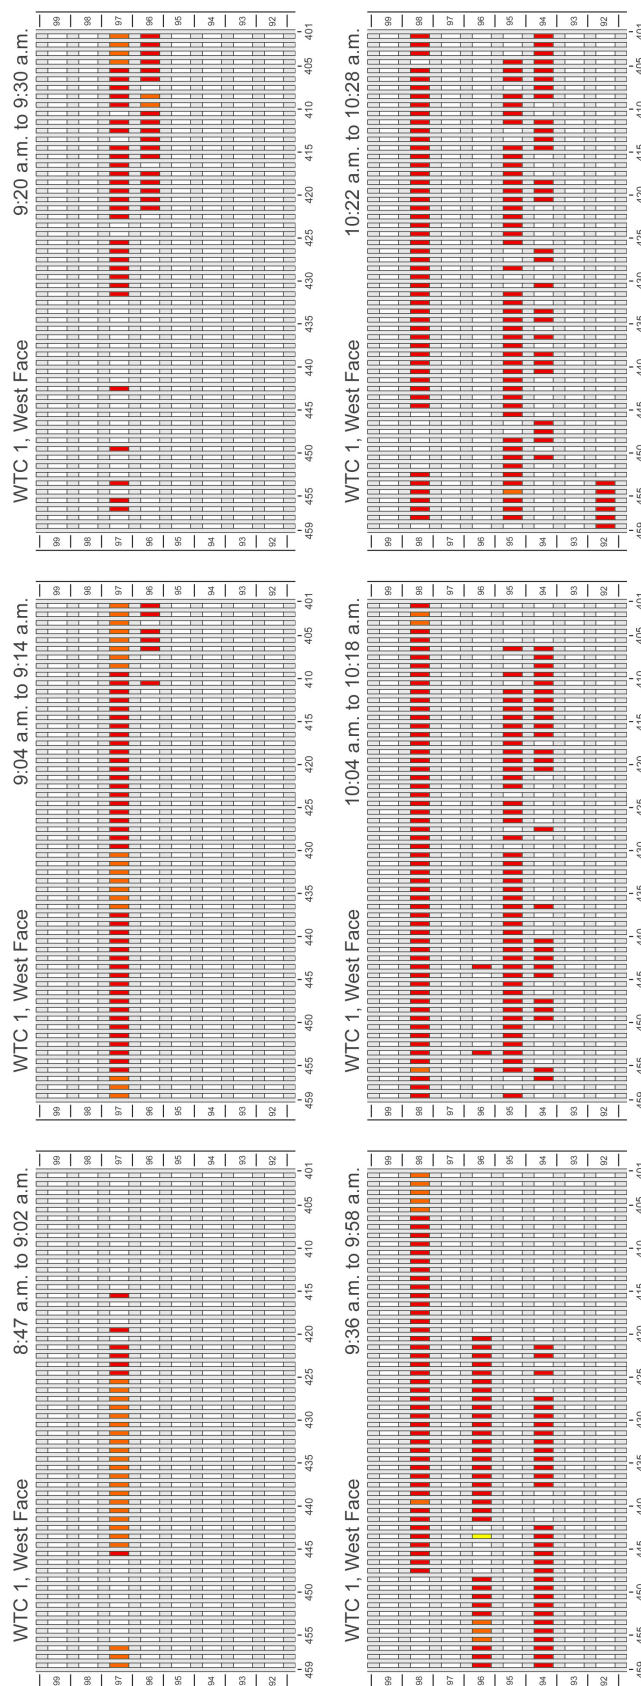
The development of multiple fires and their rapid growth and spread over much of the 97th floor is not a typical behavior for building fires. While not conclusively demonstrated, a plausible explanation for the rapid growth is that this fire spread was accelerated by the presence of aviation fuel. Such a fire spread mechanism would require that the fuel was widely distributed over the 97th floor along the east, north, and west faces during the aircraft impact and that a significant fraction of the fuel did not burn inside and/or was not expelled from the floor by the resulting fireballs. There is some evidence to support the conclusion that a major fraction of the aviation fuel dispersed on the 97th floor did not initially ignite. No significant visible damage was observed on the east, south, or west faces of this floor immediately after the aircraft impact, suggesting that overpressures sufficient to break window glass or remove portions of the curtain wall were not generated on this floor. The conclusion is weakened somewhat because portions of the floor were hidden by heavy smoke for a time.

During this early phase, a fire also rapidly grew on the 96th floor on the north face to the east of the aircraft impact cavity. It is likely that this fire was also accelerated by aviation fuel dispersed into the area during the aircraft impact. Unlike for the 97th floor, fire growth and spread on the west side of the 96th floor was not apparent during this early period. A possible explanation for this observation is that most of the fuel that was released into this area from the aircraft's starboard fuel tank was either burned inside immediately or pushed out of the area by the overpressure generated by burning on this floor, subsequently forming the fireball observed on the south face and resulting in the damage observed on this floor. As a result, only limited amounts of liquid fuel likely remained to accelerate fire spread.

**Figure 8-116. Maps of integrated fire intensity data for the north face of WTC 1 are plotted in sequence for the six time periods. Colors represent the highest intensity fire observed in a window using the color scale defined in Figure 5-1.**

**Figure 8-117. Maps of integrated fire intensity data for the east face of WTC 1 are plotted in sequence for the six time periods. Colors represent the highest intensity fire observed in a window using the color scale defined in Figure 5-1.**

**Figure 8-118. Maps of integrated fire intensity data for the south face of WTC 1 are plotted in sequence for the six time periods. Colors represent the highest intensity fire observed in a window using the color scale defined in Figure 5-1.**

**Figure 8-119. Maps of integrated fire intensity data for the west face of WTC 1 are plotted in sequence for the six time periods. Colors represent the highest intensity fire observed in a window using the color scale defined in Figure 5-1.**

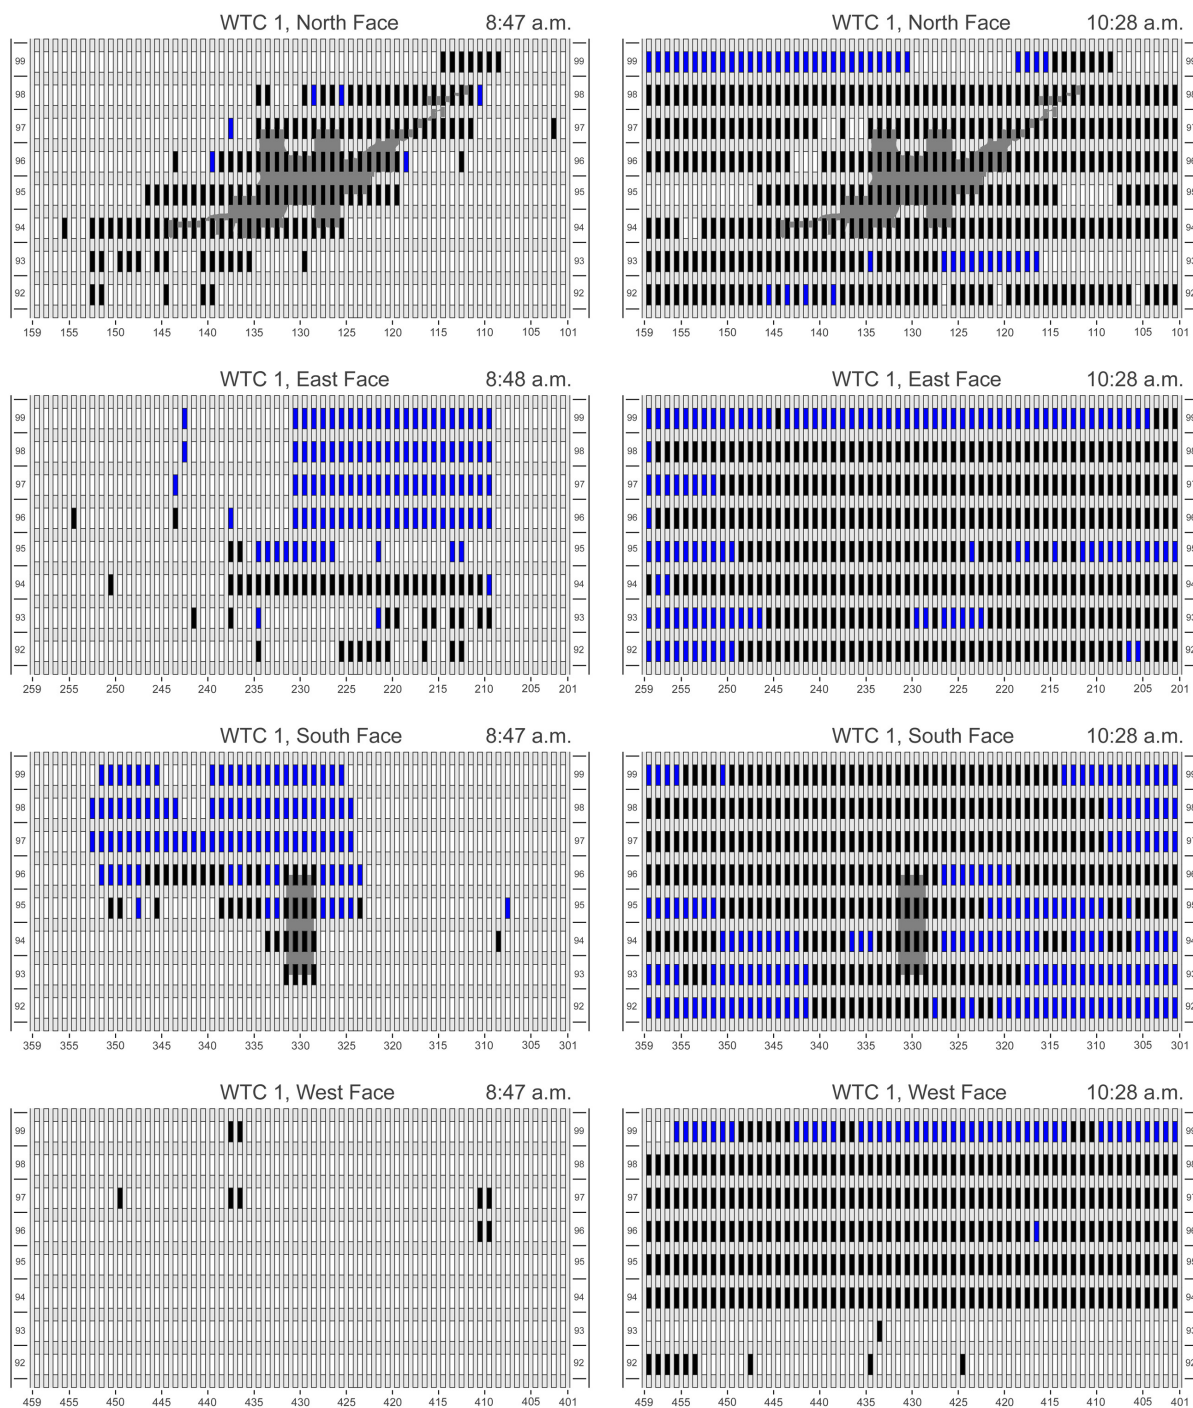
The information shown visually in Figure 8–120 is summarized numerically in Table 8–4 and Table 8–5. These two tables are similar to Table 8–2 and Table 8–3, which were generated using data from shortly after the aircraft impacted WTC 1 and just prior to the collapse of WTC 2. The results indicate that the total number of open windows on these floors increased by roughly 333 windows between 9:59 a.m. and 10:28 a.m. The increase in the number of open windows between the time from shortly after the aircraft struck WTC 1 and the collapse of the tower was approximately 1,048 windows, or a factor of 4.2. This corresponds to an increase in the open area on the façade available to provide air to the fires on these floors of around 12,190 ft<sup>2</sup>.

**Figure 8-120. Maps for the 92nd through the 99th floors compare missing windows for the four faces of WTC 1 at two times, immediately following the aircraft impact at 8:46:30 a.m. and just prior to the collapse of WTC 1 at 10:28:22 a.m.**

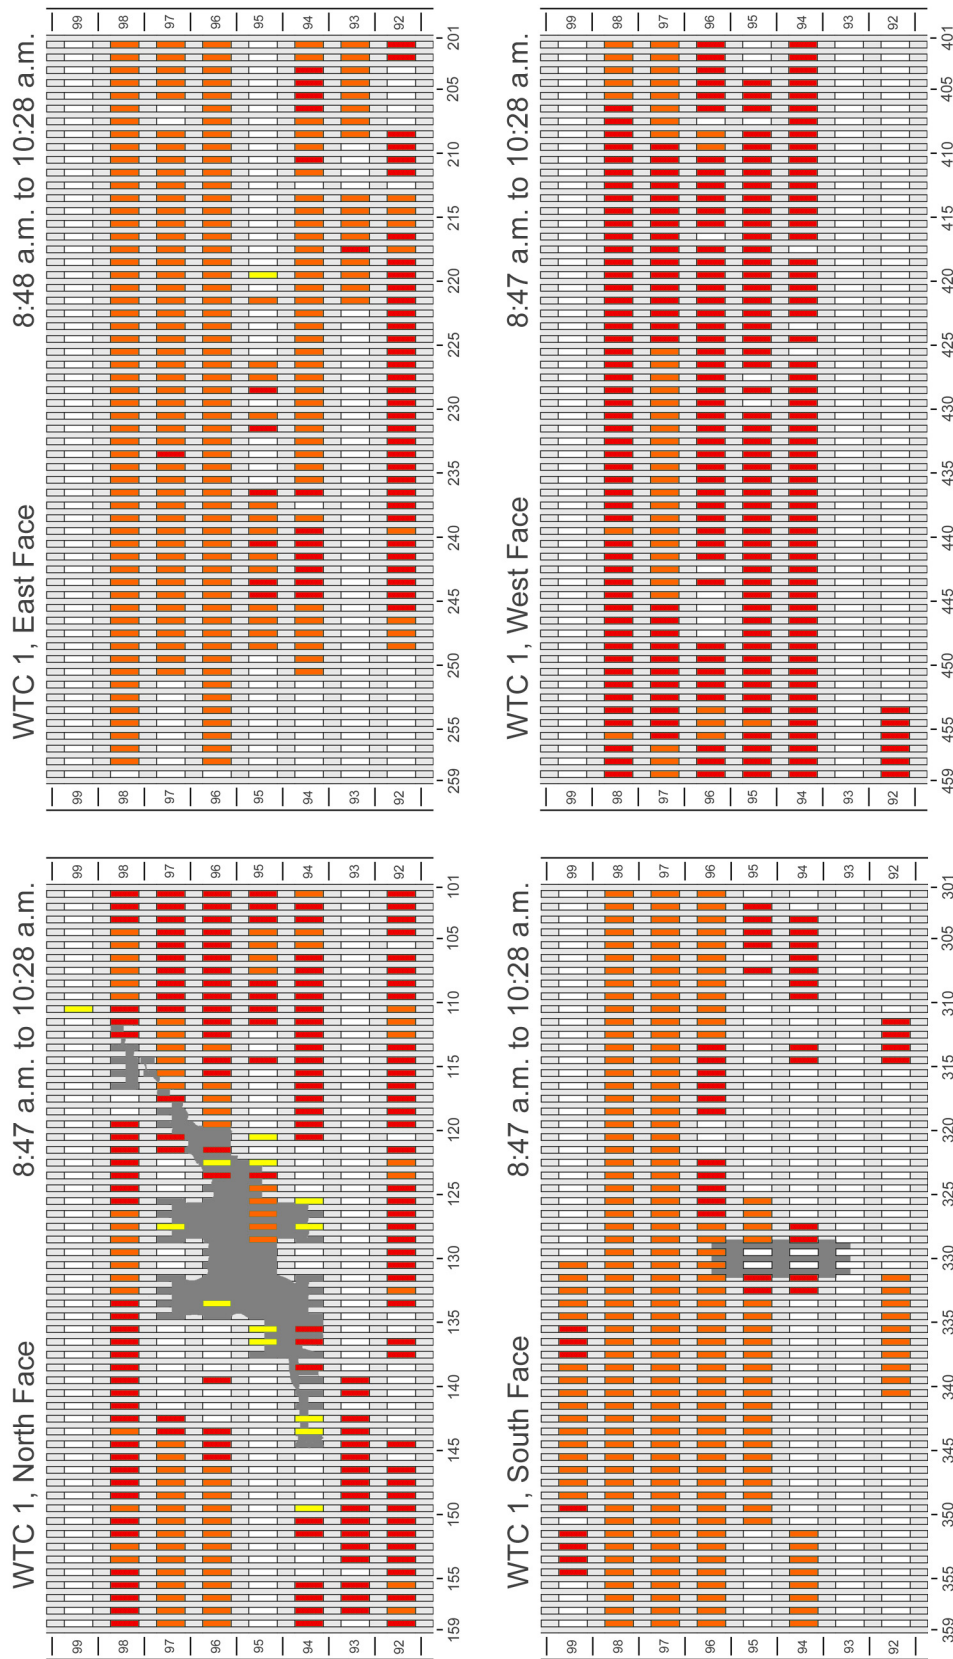
The results in the fire data sheets have been utilized to generate integrated fire data for the entire period between the aircraft impact and the collapse of WTC 1. The results are shown graphically in Figure 8–121 for the four faces of the tower. These maps demonstrate the extensive area of WTC 1 that was subjected to fire. Comparison with Figure 6–19, which shows the fire distribution on the four faces shortly after the aircraft impact, provides a graphic illustration of the amount of fire spread and growth that occurred. The relative numbers of windows in Figure 8–121 where external flames (orange) were observed compared to the total number of windows with observed fire reflects the differences between fire behaviors on the west and north faces as compared to the east and south faces, where external flaming was much more likely.

In contrast to the behavior on the west and north faces, fires burning on the east and south faces often generated heavy amounts of smoke and external flaming at nearby windows. It was common to observe many adjacent open windows with long extended flames. The tops of nearby column covers were often marked with carets. Examples of such fires were observed on the 94th, 96th, 97th, and 98th floors on the east face and on the 95th, 96th, 97th, 98th, and 99th floors on the south face. Exceptions to the general behavior included fires that developed on the 92nd floor on the east face and fires burning on the east side of the south face on the 92nd and 94th floors.

Various explanations for the different fire behaviors were considered. The most plausible is based on the effects of the prevailing wind. On September 11, 2001 the wind was striking WTC 1 from the northwest and then flowing down the north and west faces. This wind created positive pressures at the windows on these faces that tended to resist gas flows out of the tower. On the east and south faces the effect of the wind was the opposite, creating low pressure areas at the windows that tended to pull gases out of the building. The net effect of these pressure forces would be a tendency for gases to flow internally on a floor, if a pathway was available, from the west and north faces to the east and south faces. Such internal flows provide a possible explanation for the observed fire behaviors.

**Figure 8-121. Maps of integrated fire observations between 8:47 a.m. and 10:28 a.m. are shown for the four faces of WTC 1. Colors represent the highest intensity fire observed in a window using the color scale defined in Figure 5-1.**
