## World Trade Center Hot Spots

Notes:

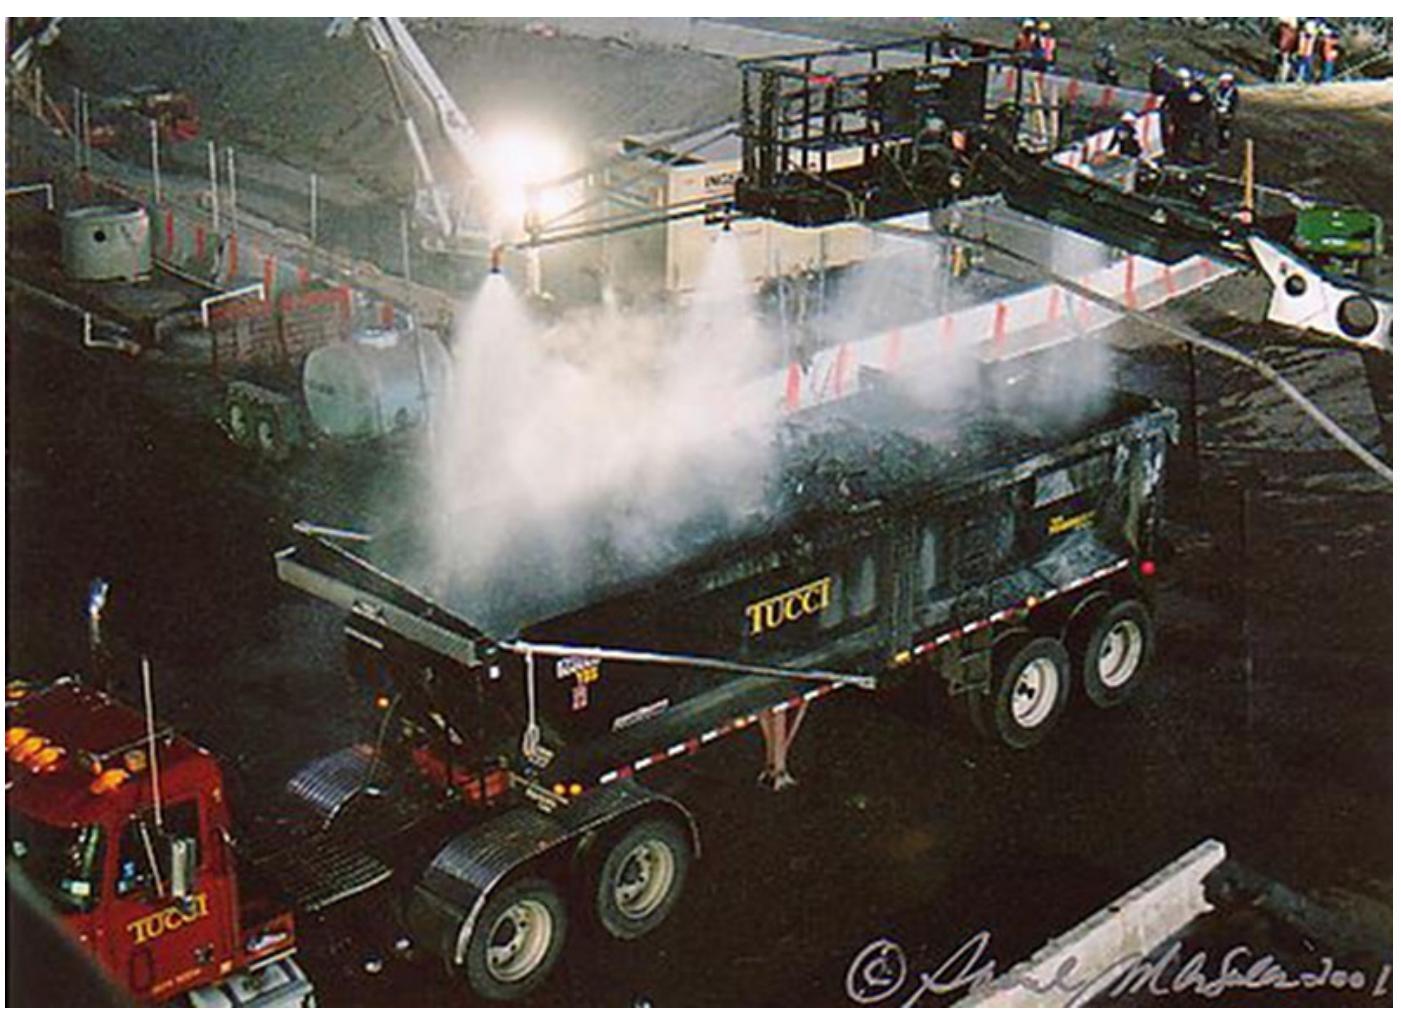
These sprayers were also used to cool the high temperature debris before it left the site. Several trucks were returned to the site for additional cooling because the law enforcement officers would not let them through the tunnels leaving Manhattan until they stopped steaming.

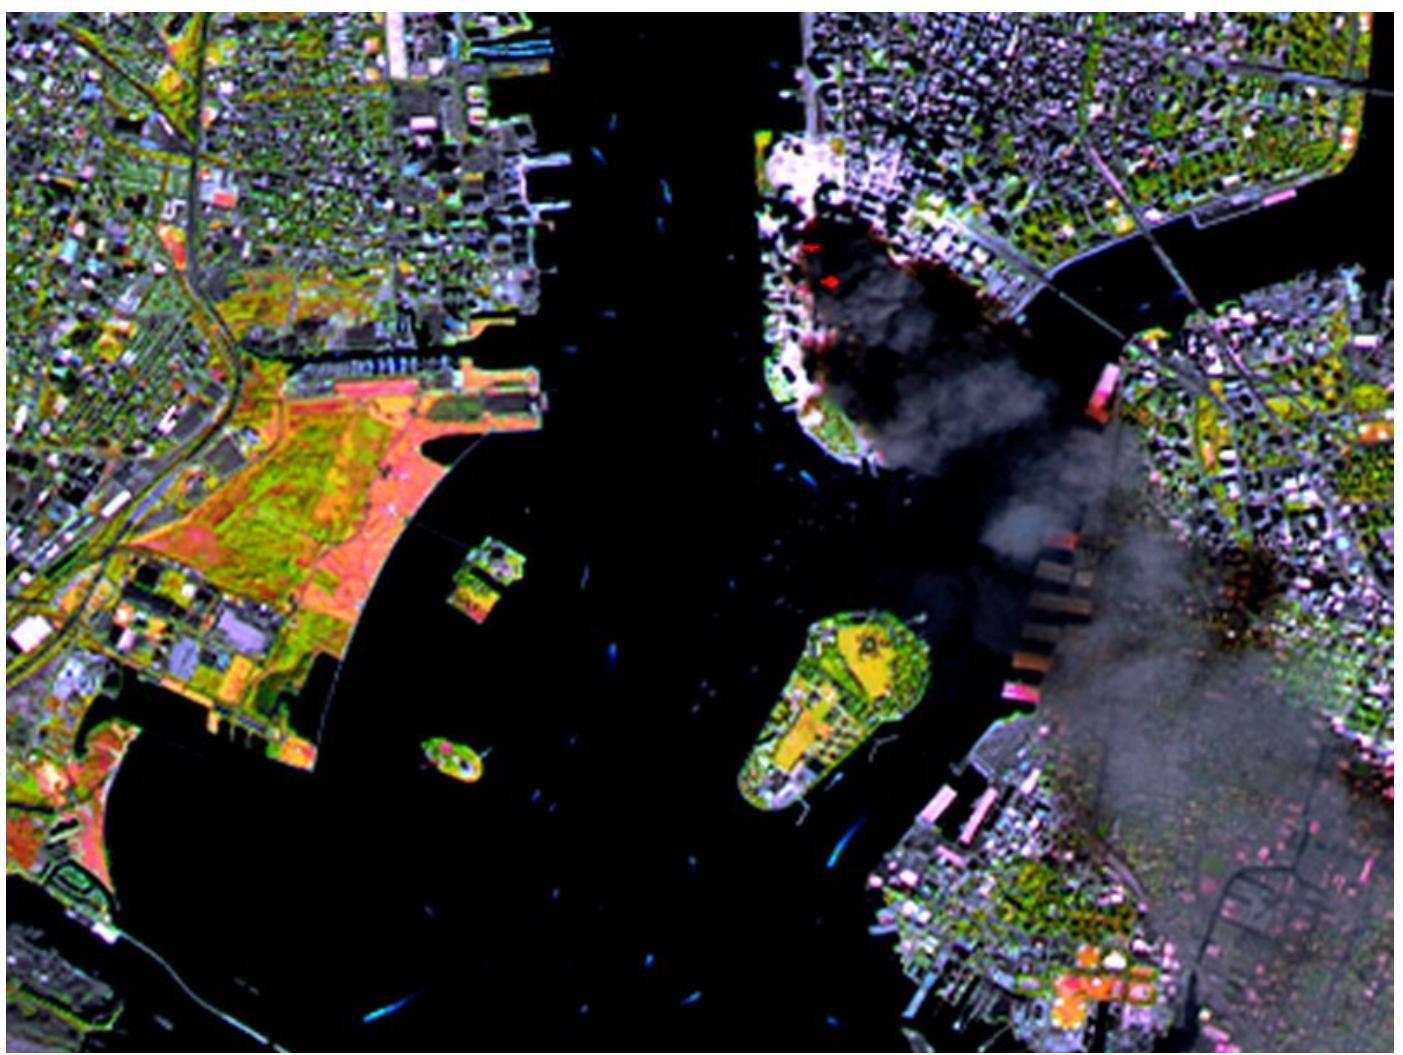
SPOT satellite image of Manhattan, using the HRVIR (High Resolution Visible Infra Red instrument) on SPOT 4, acquired on September 11 at 11:55 AM EST, 3 hours after two planes crashed into the World Trade Center. The colors result from the use of infrared bands to identify the actual fire hot spots (see red spots near the base of the smoke plume). The SPOT satellites orbit at an altitude of 822 km." (c) CNES/SPOT Image 2001

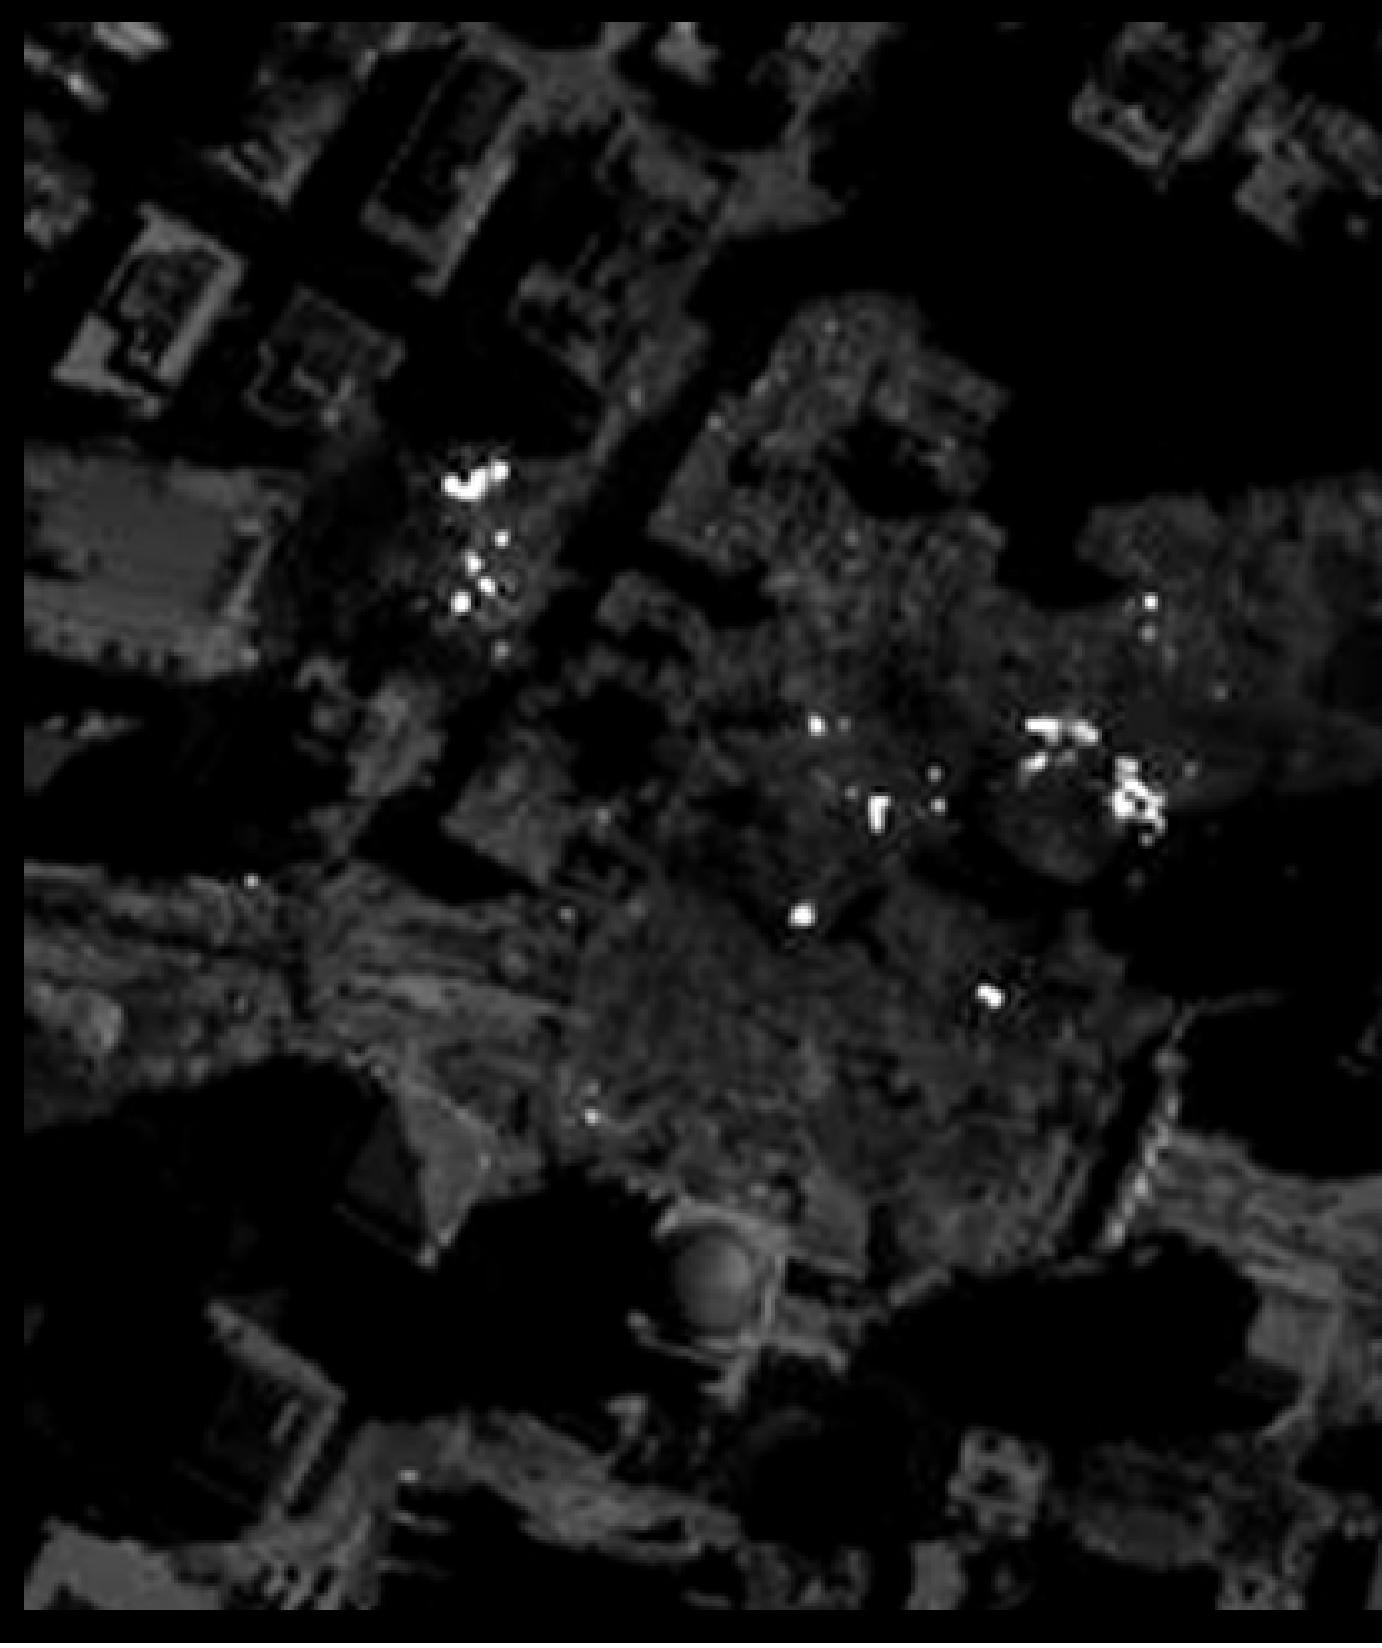
AVIRIS 2300-nm wavelength image of the World Trade Center disaster site acquired on the 16th of Septernasa.gov (ftp://popo.jpl.nasa.gov/pub/docs/workshops/02\_docs/2002\_Green\_wtc\_web.pdf)

As part of the World Trade Center disaster response, the NASA Airborne Visible/Infrared Imaging Spectrometer (AVIRIS) was flown over the site on the 16th and 18th of September 2001. AVIRIS measures the solar reflected spectrum from 370 to

2500-nm at 10-nm sampling. For this flight the data were acquired at 1.5-m spatial sampling with image coverage of the entire disaster site. AVIRIS measurements are spectrally, radiometrically, spatially calibrated in the laboratory and validated in flight. Rapid examination of the World Trade Center AVIRIS data in the 2300 nm spectral region showed numerous high radiance targets indicative of burning fires. A new spectroscopic algorithm was implemented to simultaneously solve for the temperature and fractional area of the fires. This algorithm uses the Planck function in conjunction with the full spectral shape measured by AVIRIS to determine the temperature and fractional area of the fire. This spectral algorithm overcomes the ambiguity between temperature and area that exists in single-spectral-band temperature estimation methods. With these AVIRIS data set and new algorithm, 8 hot spot zones were identified in the September 16th data with temperatures ranging from 700K to 1019K and fractional areas from 1.1 to 18%. Analysis of the data set acquired on September 18th showed 7 of the hot spot zones still present with temperatures ranging from 471K to 952K and fractional areas from 0.5 to 36%. These imaging spectrometer derived physical parameters of fire temperature and fractional-area were found useful to the personnel making decisions on the ground. The complete set measurements, analyses, and results of this effort are reported in this paper. cosis.net (http://www.cosis.net/abstracts/COSPAR02/00015/COSPAR02-A-00015.pdf)

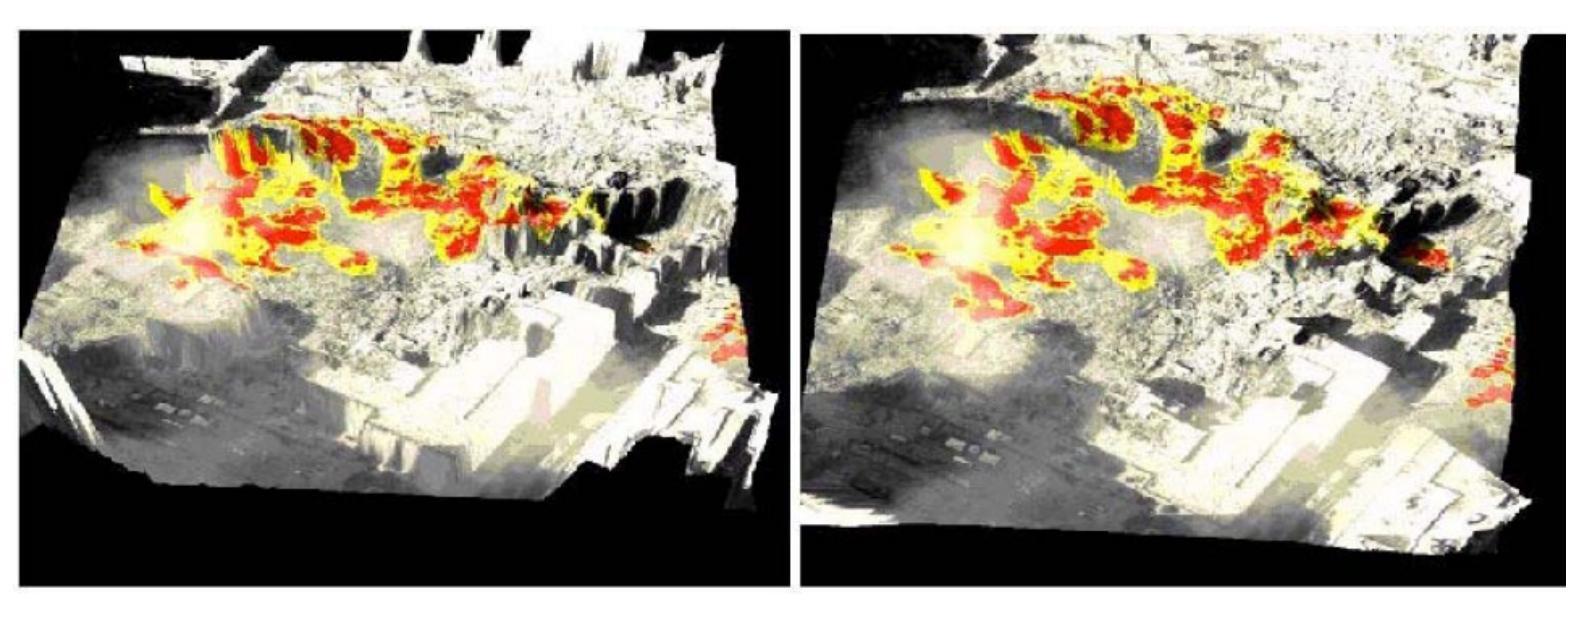
VRML visualization of Ground Zero from several perspectives, with orthophotography and thermal data draped over a LIE Datasets were acquired by EarthData on September 17th. http://gis2.esri.com/library/userconf/proc03/p0136.pdf esri.com

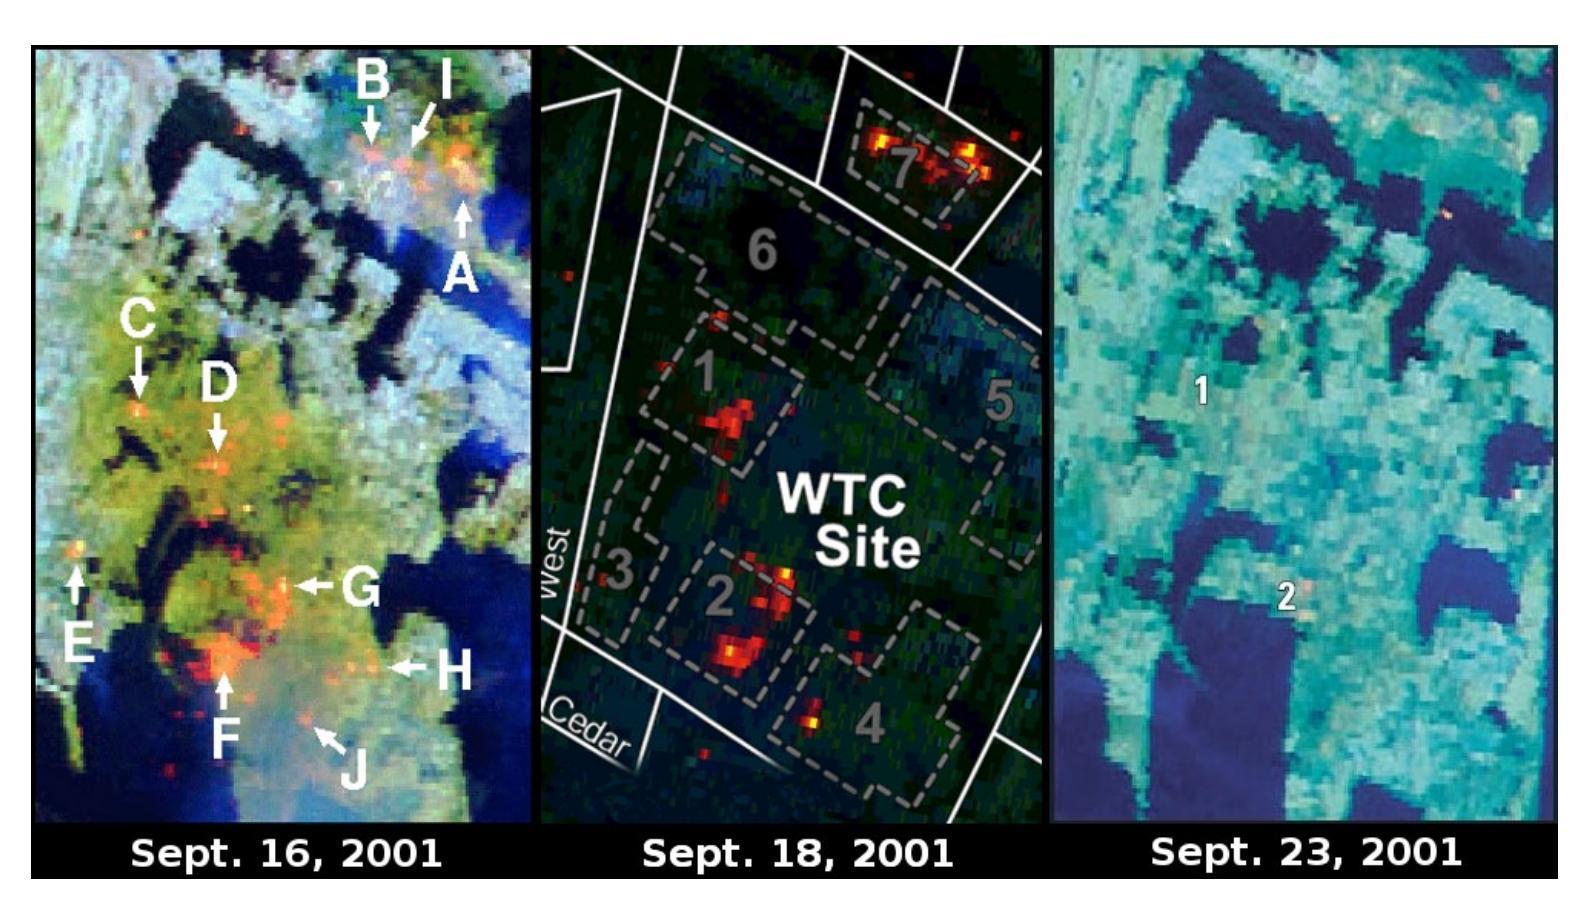
AVIRIS false color images showing the core affected area around the World Trade Center extending from 5 to 12 days after the collapse... The image on the 18th is dark because of clouds which blocked sunlight but not light emitted by the fires.

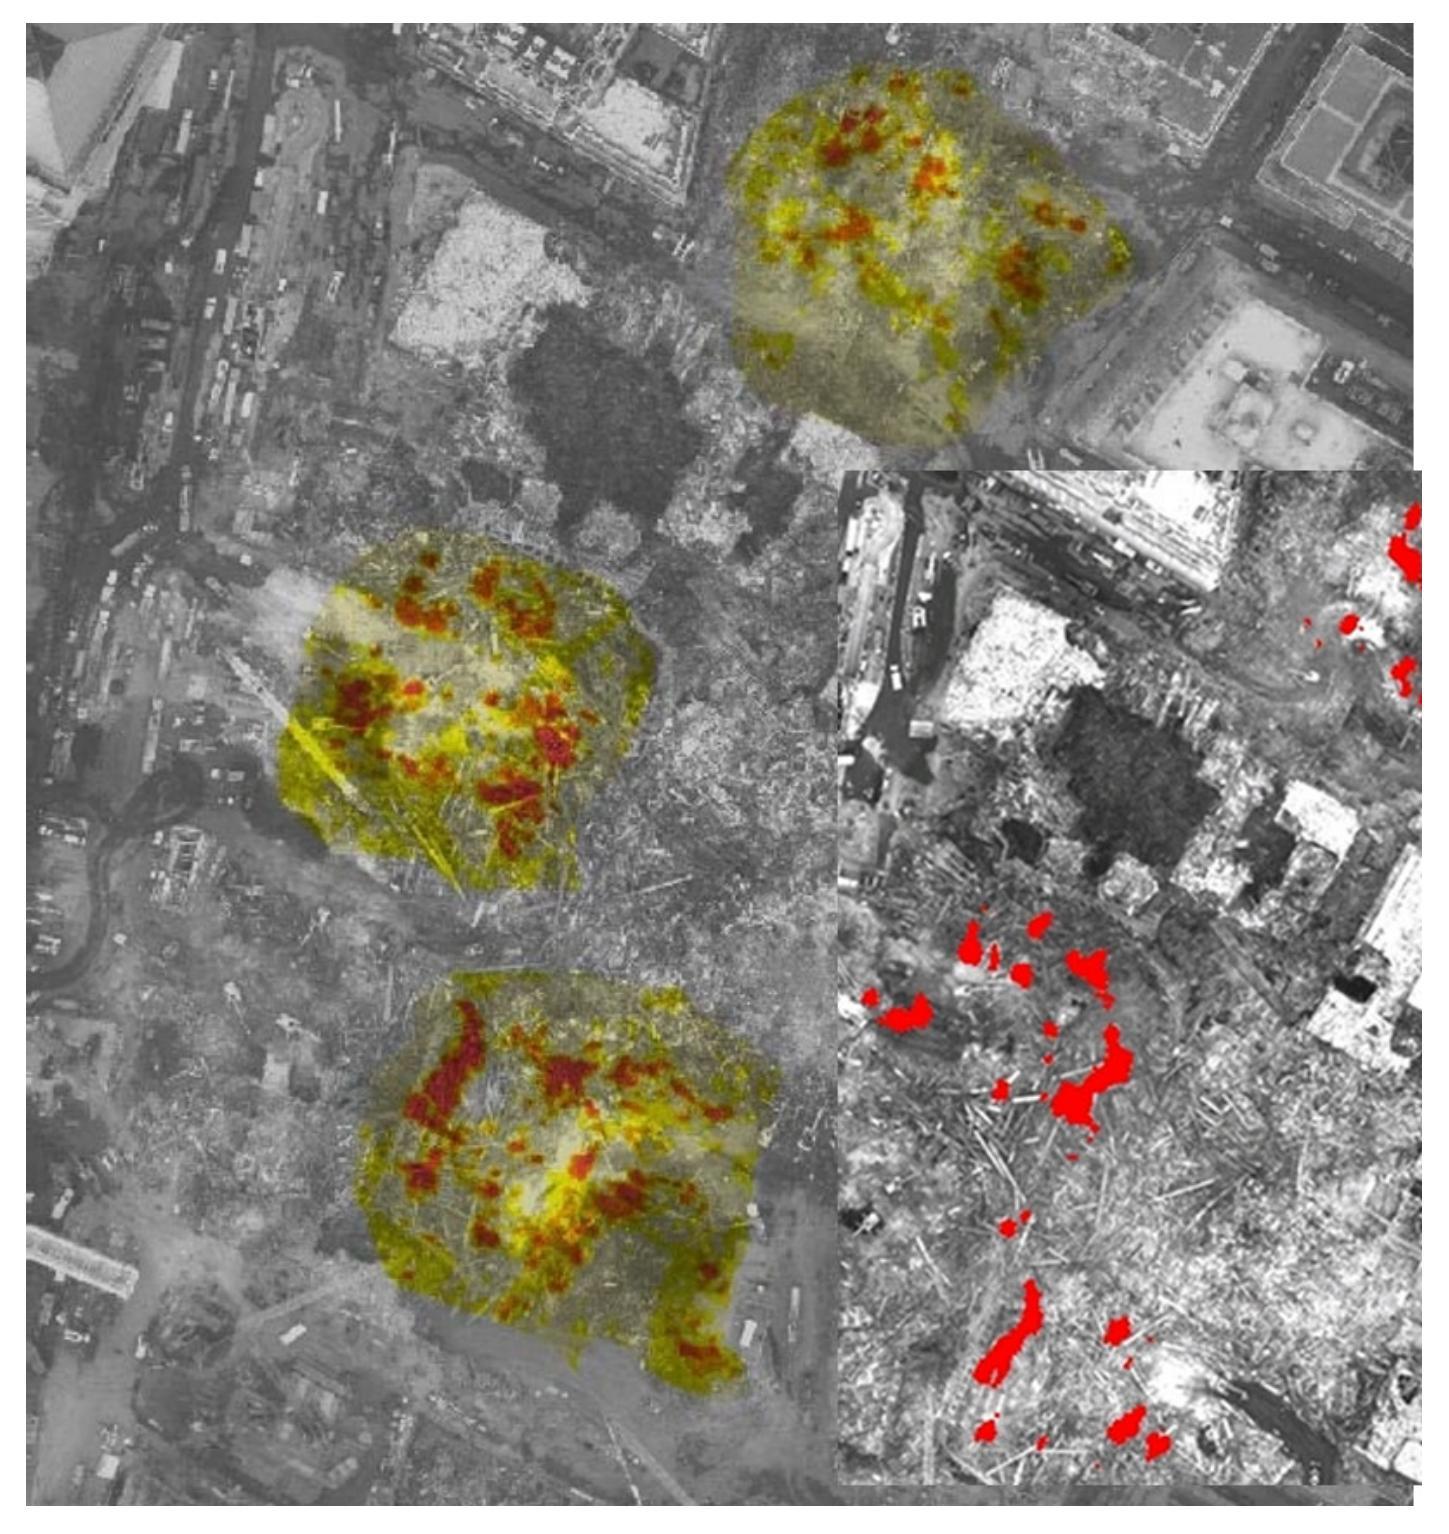
Thermal image of Ground Zero acquired by EarthData on October 7th using a Raytheon airborne sensor. The data are overlaid on an orthophotograph obtained on October 8th. Variations in temperature are evident across the site. However, these values were acquired (and are therefore displayed) using an 8-bit radiometric scale, rather than an absolute calibration such as degrees Fahrenheit. (source) (http://s3.amazonaws.com/nasathermalimages/public/images/wtc\_eev.pdf)

Sensor: Raytheon Nightsight (http://www.raytheon.com/newsroom/photogal/nightsight200\_l.htm)

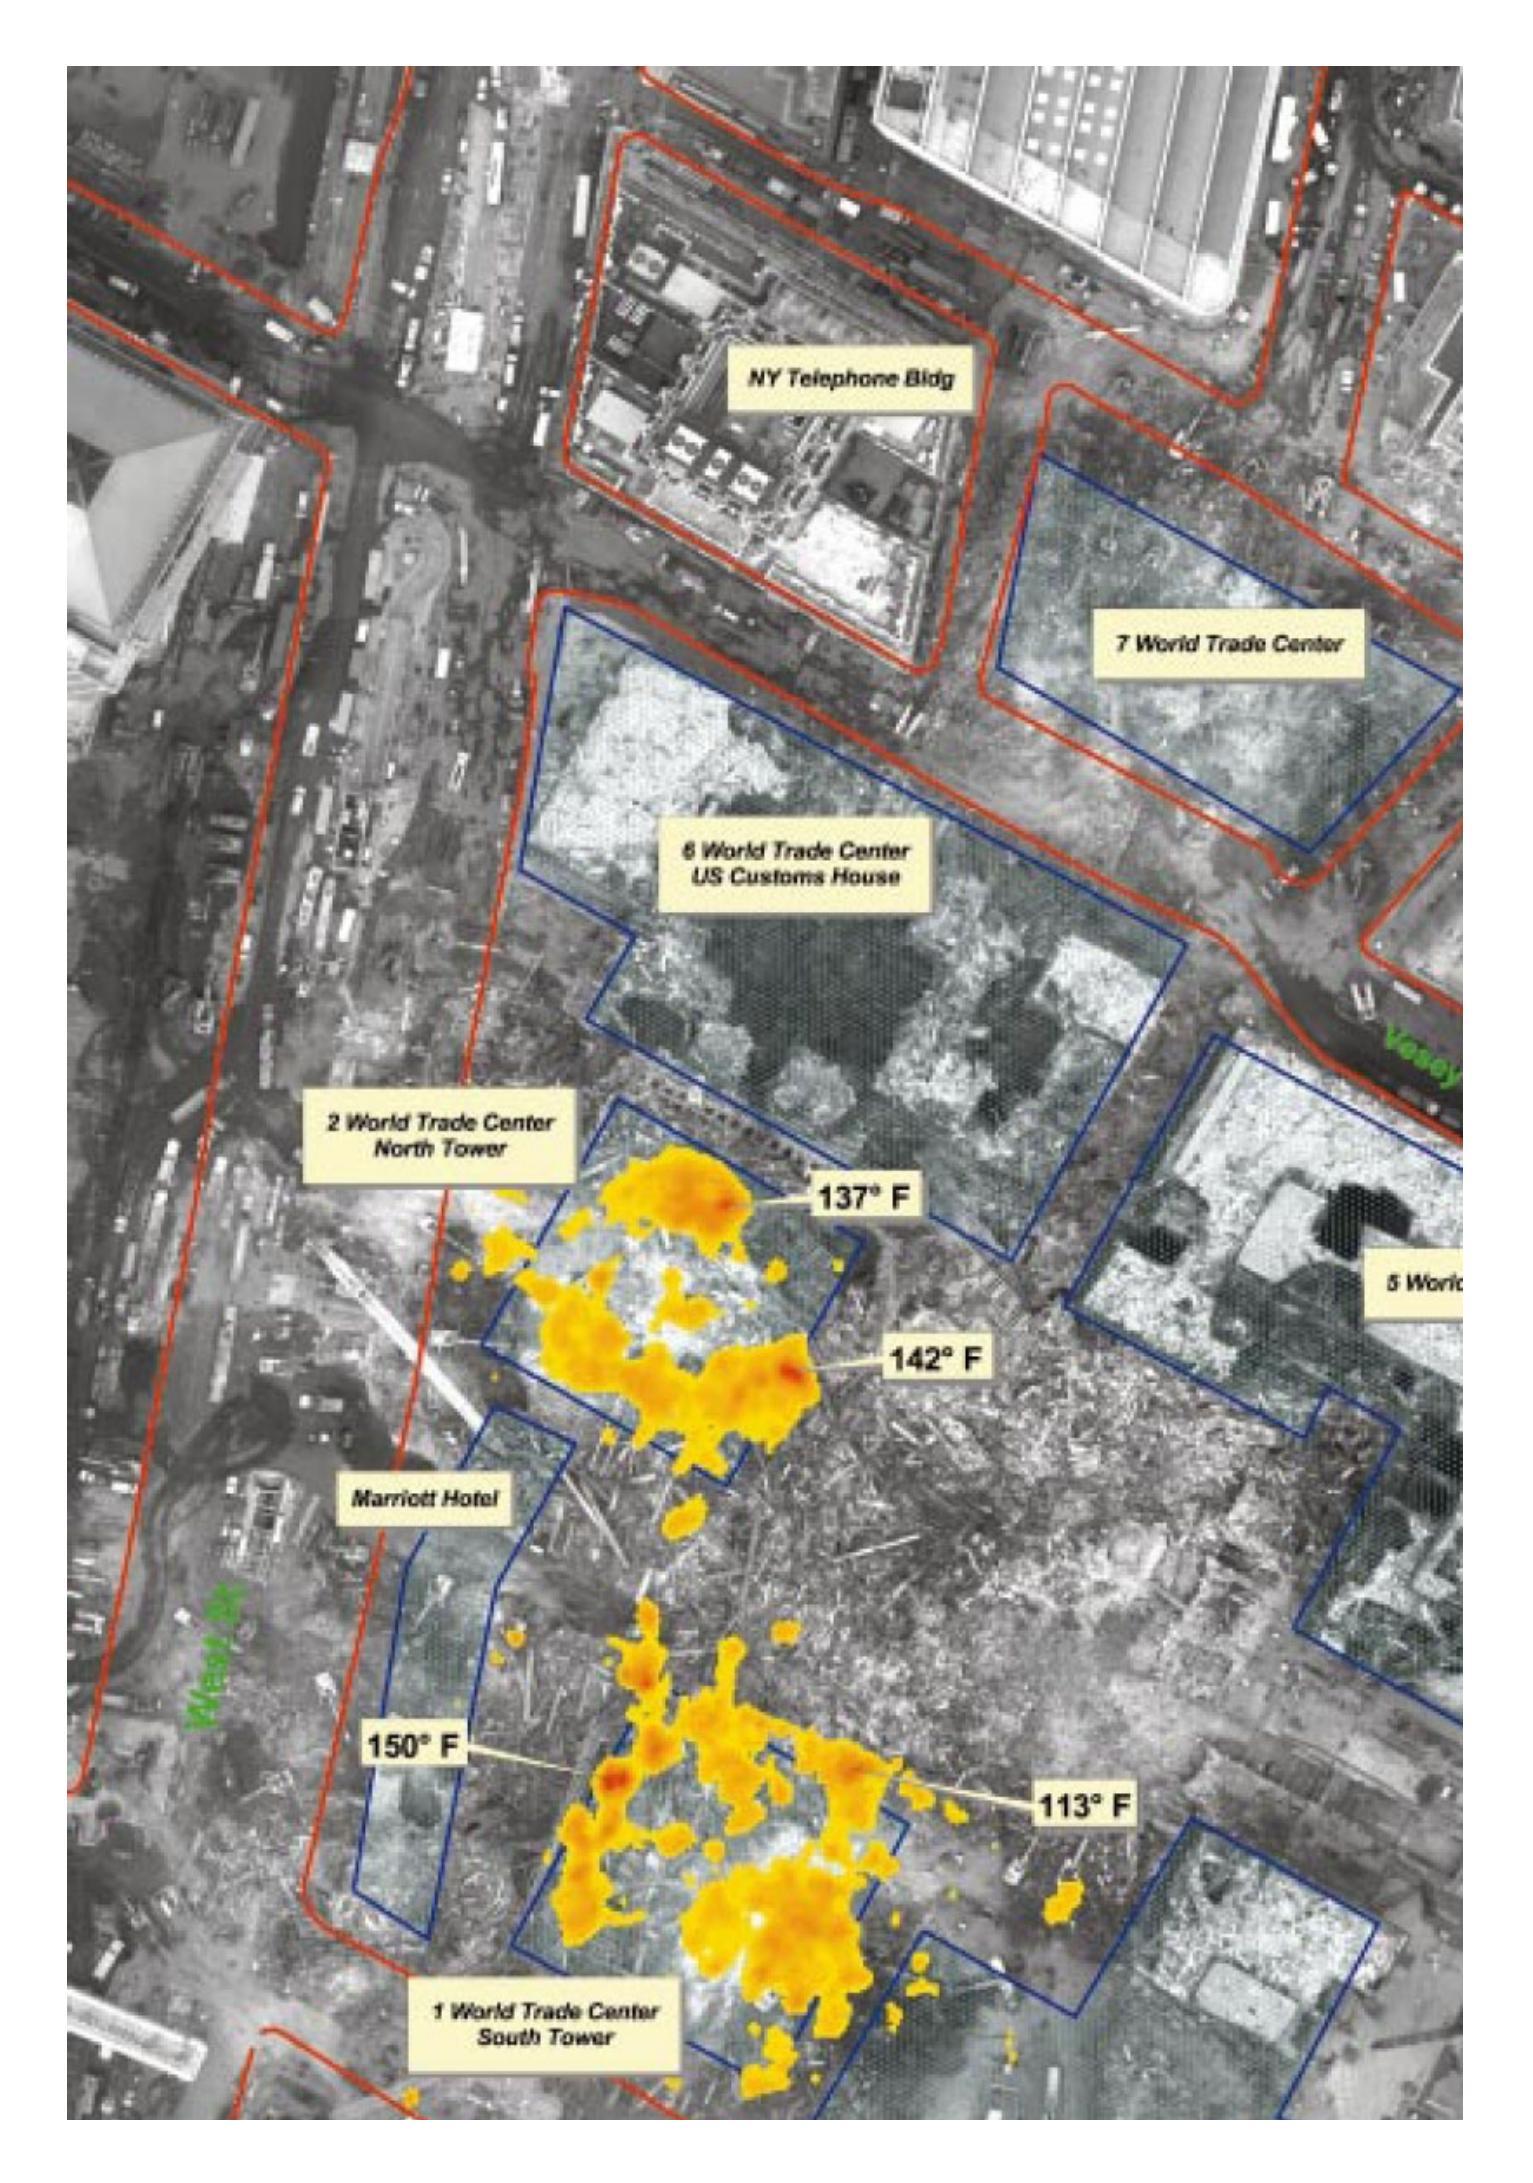
Thermal data acquired by EarthData over the World Trade Center site on October 18, 2001, overlaid on digital orthophotography collected on October 7, 2001 with a Kodak Megaplus 16.8i camera. (source) (http://s3.amazonaws.com /nasathermalimages/public/images/JOE002120.pdf)

Sensor: FLIR ThermaCAM PM 695, a radiometric thermal camera developed by FLIR Systems of North Billerica, Massachusetts (source p4) (http://s3.amazonaws.com/nasathermalimages/public/images/JOE002120.pdf)

Sensor: FLIR ThermaCAM SC2000 (gwu.edu p19) (http://www.gwu.edu/spi/RS-TransREP-wcover.pdf)

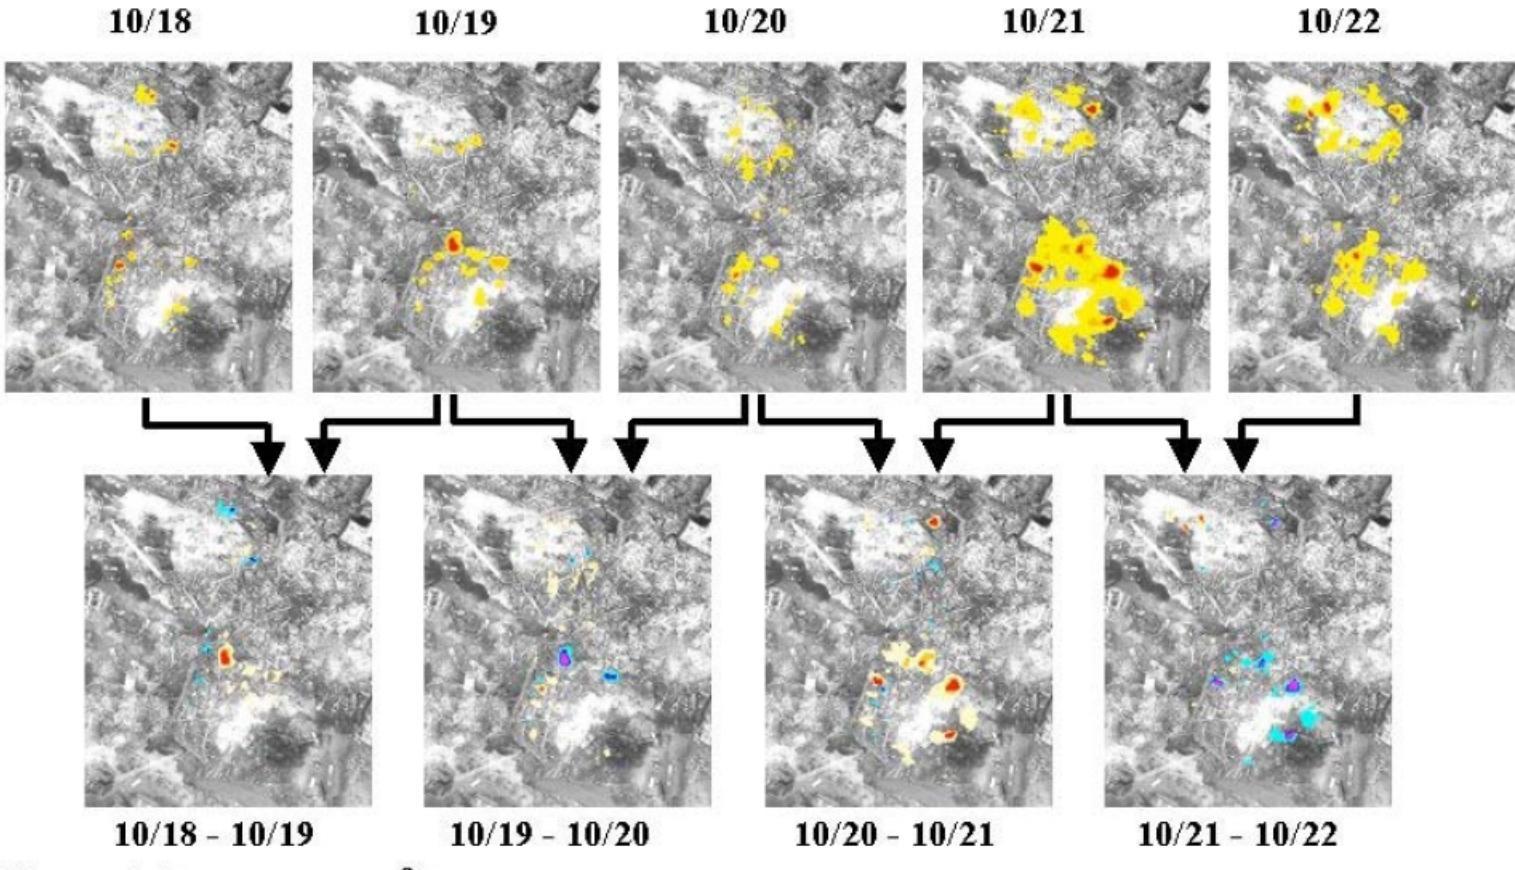
## Absolute Temperature (<sup>o</sup>F)

Change in Temperature (<sup>o</sup>F)

The sequence of temperature readings on the top row of were acquired by EarthData between 18th-22nd October, using the FLIR thermal imagining device. They are overlaid here with the aerial orthophotography from October 7th. Notably, the thermal data are calibrated to record temperature in degrees Fahrenheit, thereby addressing the limitations of relative magnitudes acquired using the Raytheon sensor. The red areas correspond with temperatures exceeding 125F and the yellow class equates with temperatures from 75F to 125F. Values < 75oF are omitted.

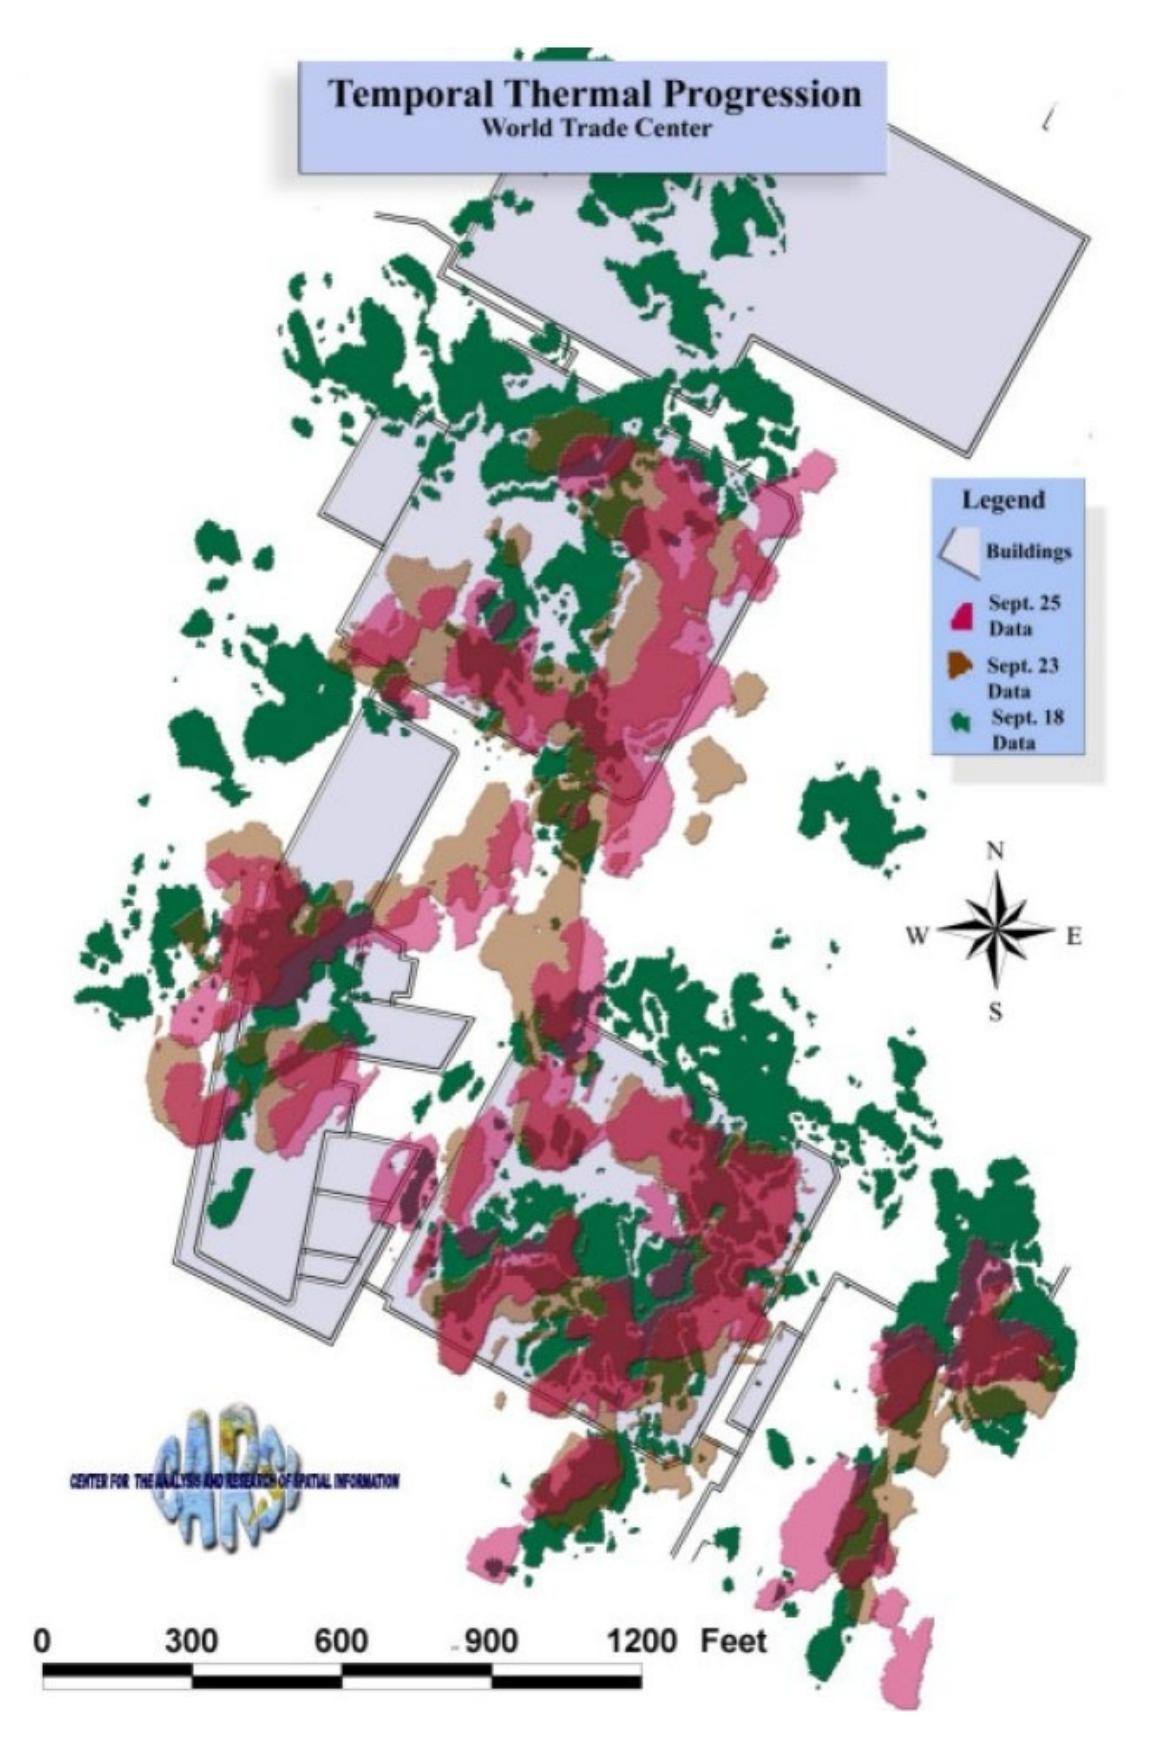
Thermal Imagery of the progression of molten steel hotspots from September 18 to September 25. Notice how the heat becomes concentrated towards the center from the fringe areas. The threshold between color ranges was 1/2 of the energy, so that in a range of 0-255, everything above 127.5 was kept (0-127.5) and everything below was ignored. -Maddalena Romano cuny.edu (http://www.geo.hunter.cuny.edu/geonews/october2001.pdf) Document.htm (source2) (http://www.geography.hunter.cuny.edu/carsi/INDEX/CURRENTAFFAIRS/ARTICLES/CUNYMatters/Untitled)

September 16-Thermal imagery measures the progression of underground heat on about a weekly basis. These images are
